Inspection Photos

API: 071-06799

Operator: EVERGREEN NATURAL RESOURCES

Inspection Date: 8/3/2020

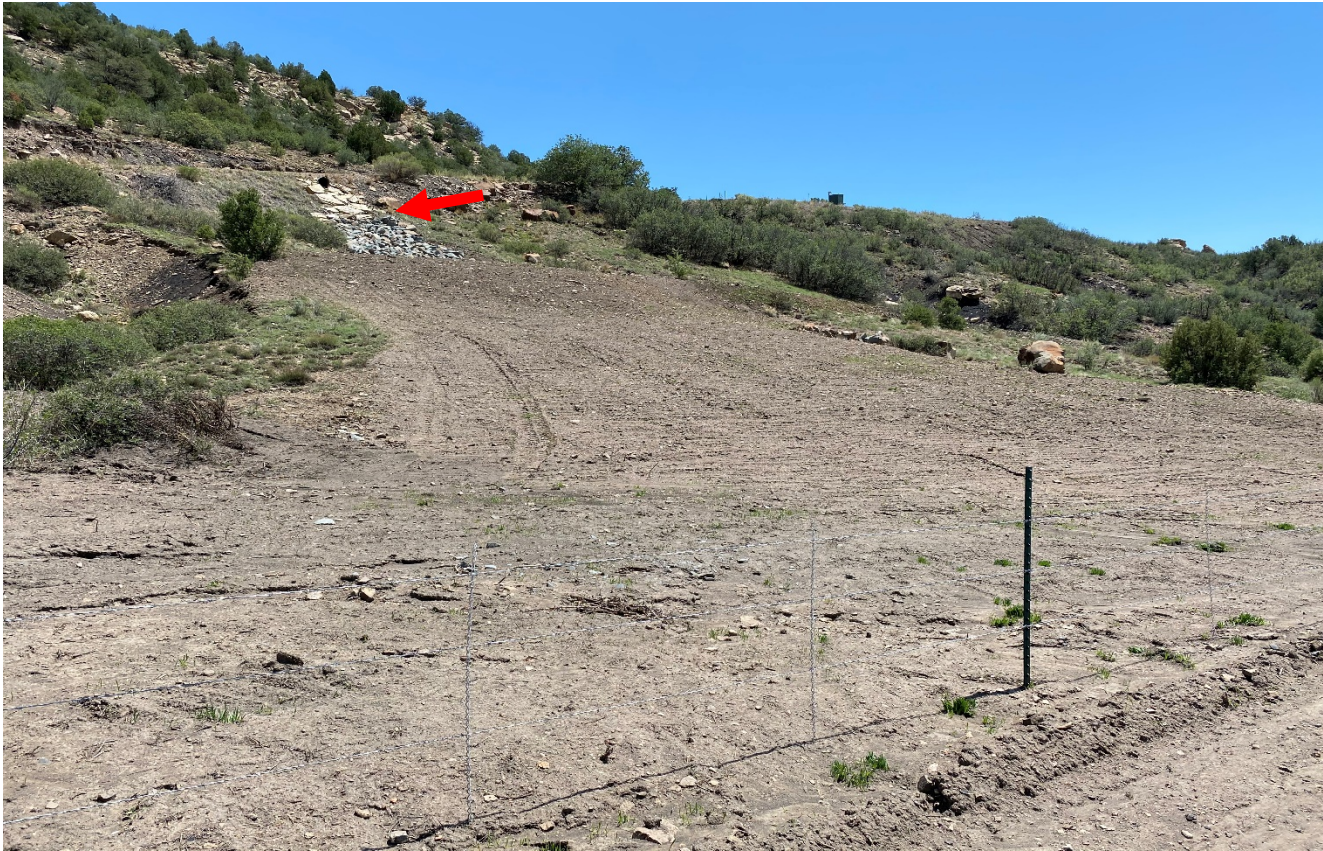
Photo 1. Facing southeast along CR 41.7. This area has been regraded and outlet protection has been installed at the culvert shown at red arrow.

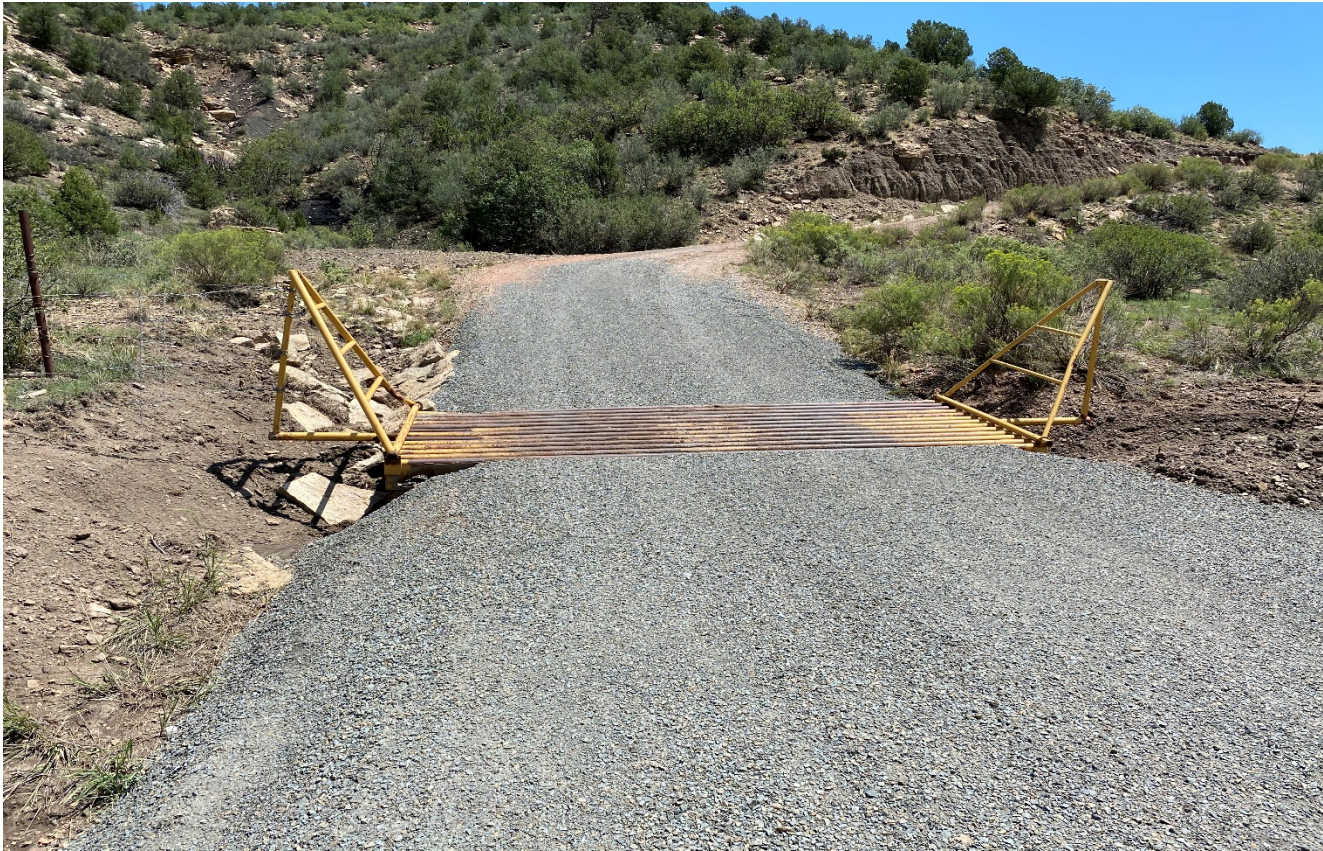
Photo 2. Facing toward the beginning of the access road. The cattle guard has been cleaned out and repaired.

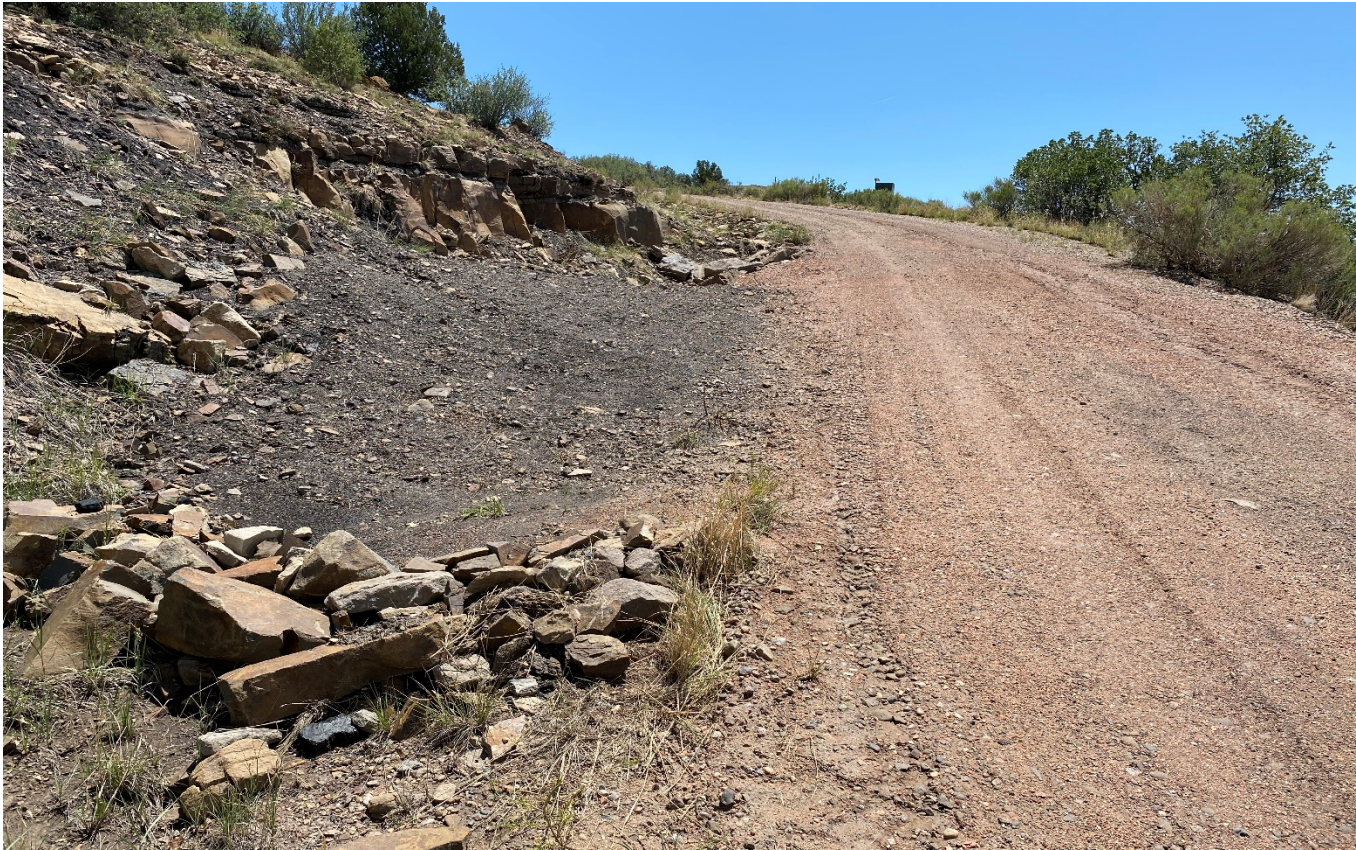
Photo 3. Facing southeast along the access road. Rock check dams have been installed along the road.

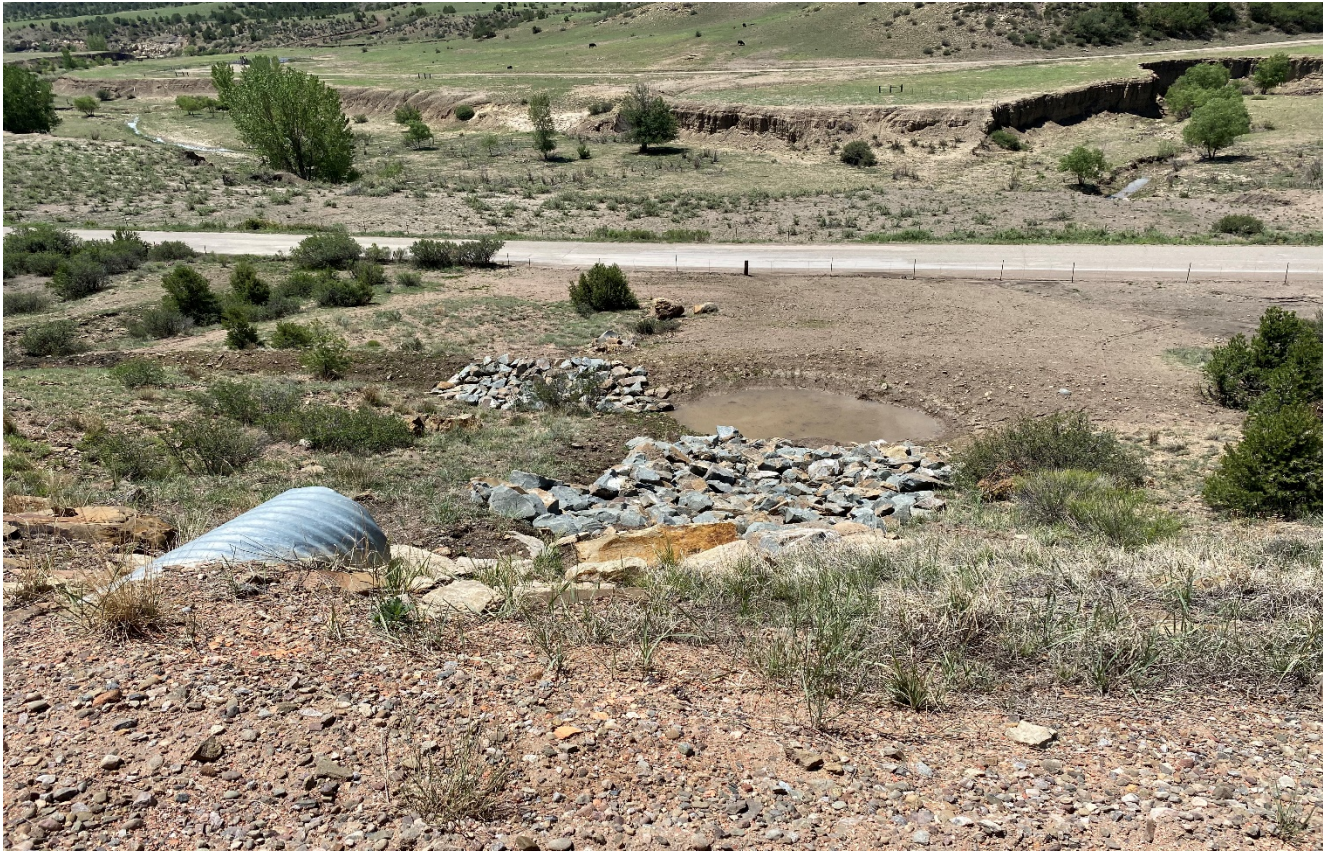
Photo 4. Facing toward the culvert outlet. The erosion from the culvert has been repaired. A sediment trap has been installed and culvert outlet protection.

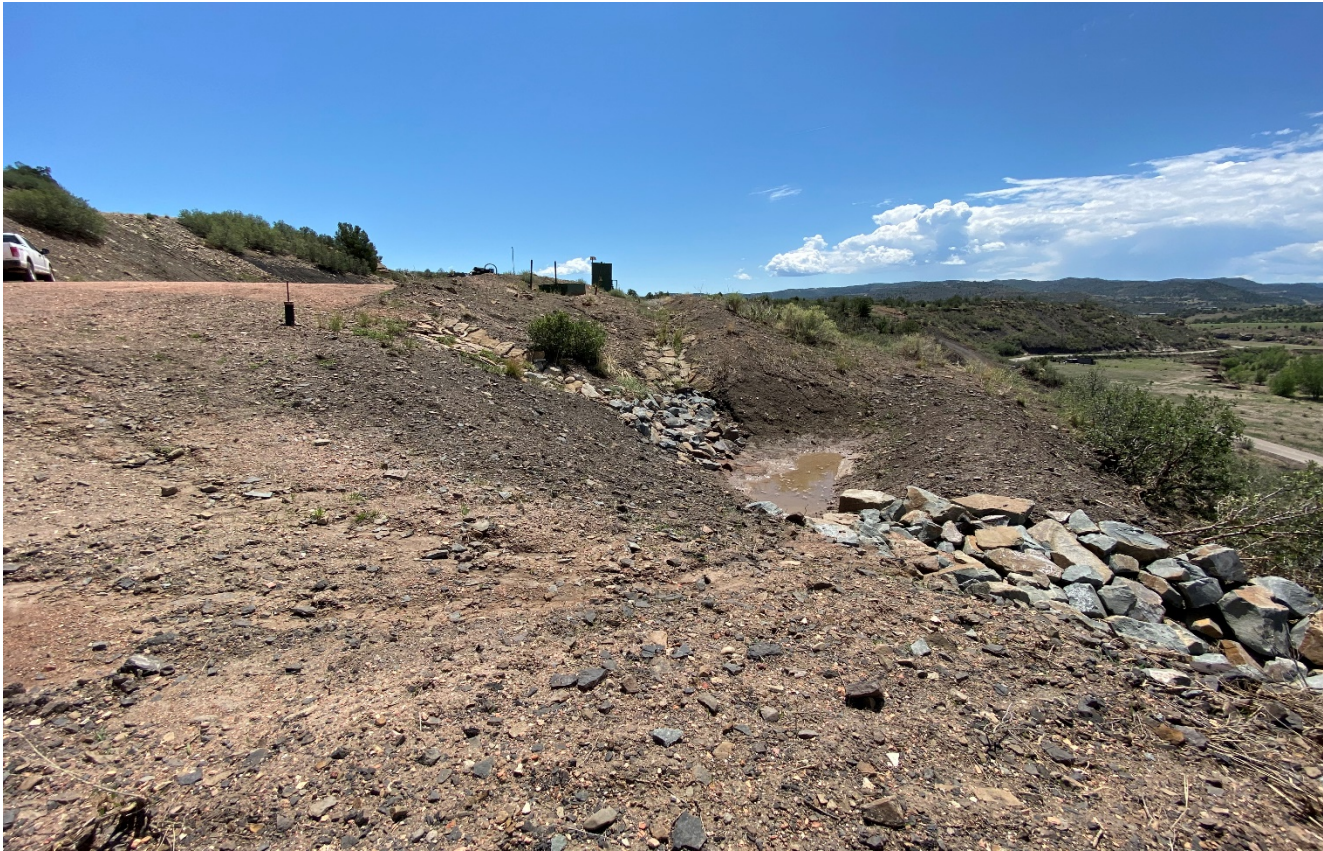
Photo 5. Facing southeast toward the location. The sediment trap has been cleaned out and maintained and rip/rap has been installed.
