# Inspection Photos

8/04/2020

Operator: NONSUCH NATURAL GAS INC #  
10163

Location ID: 453726  
Garfield County, CO

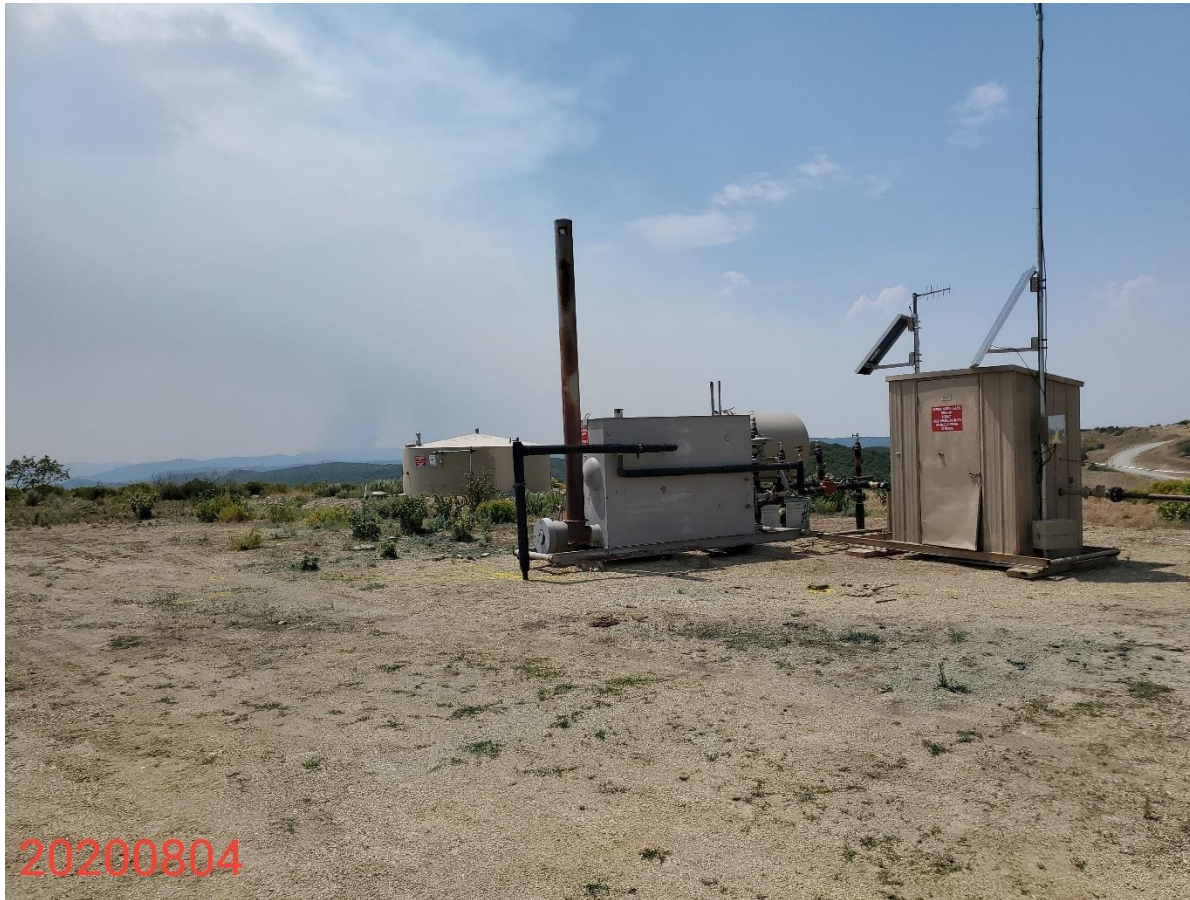
**Photo 1:** Photo taken from the Location, facing southwest. Photo shows production equipment.

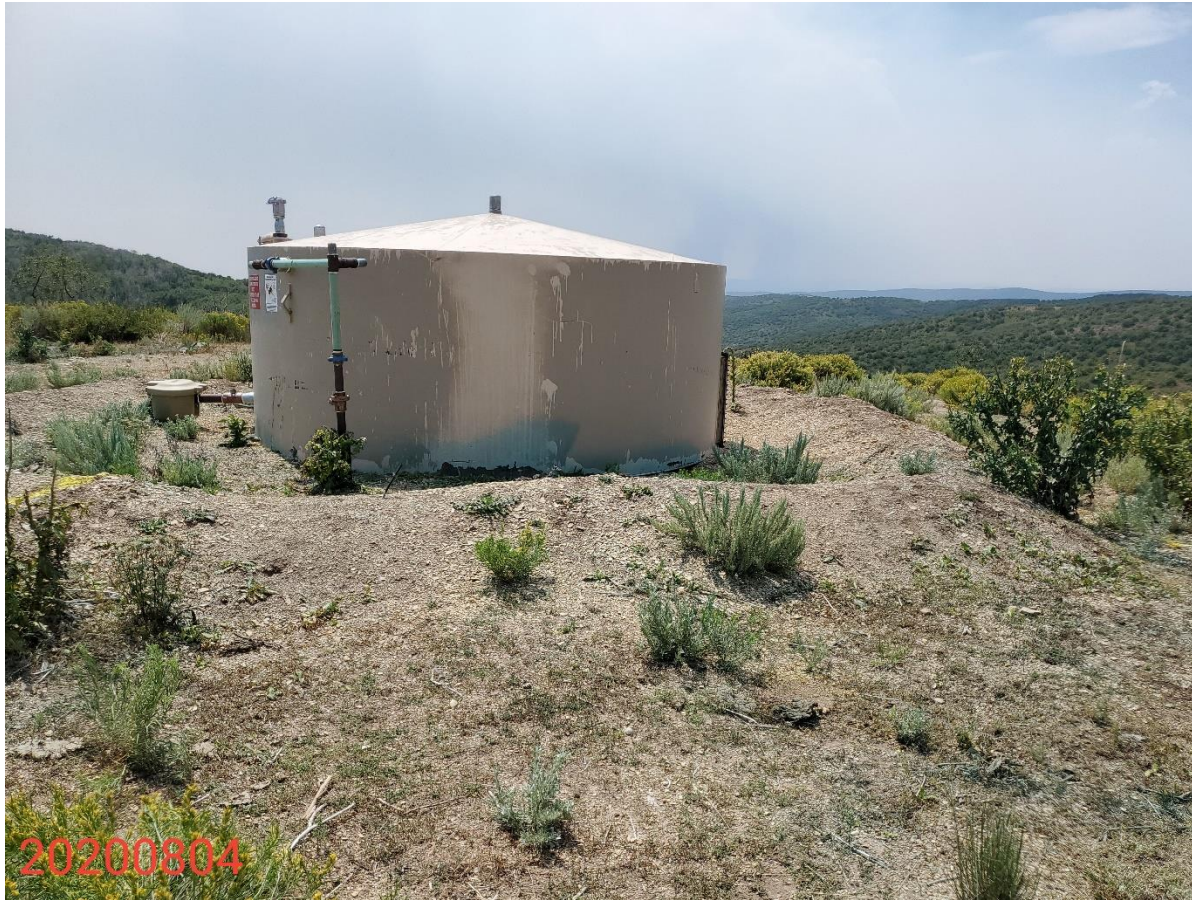
**Photo 3:** Photo of 200 bbl condensate tank. Photo shows vegetative establishment within and on secondary containment. Vegetative establishment within compromises the imperviability of the containment per rule 906.d.(1). Containment BMP does not appear to be sufficient to contain contents of tank and sufficient freeboard to contain precipitation.

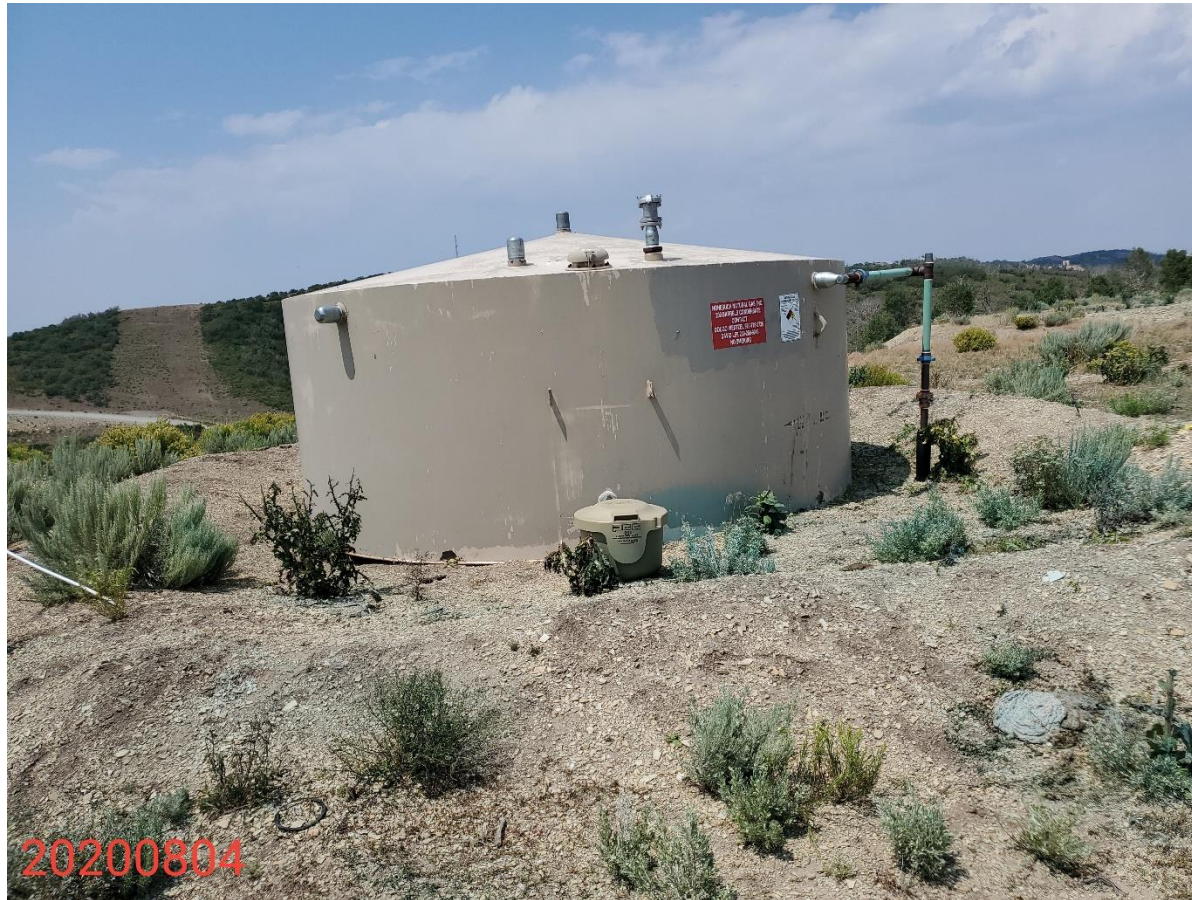
**Photo 4:** See comment under photo 3.

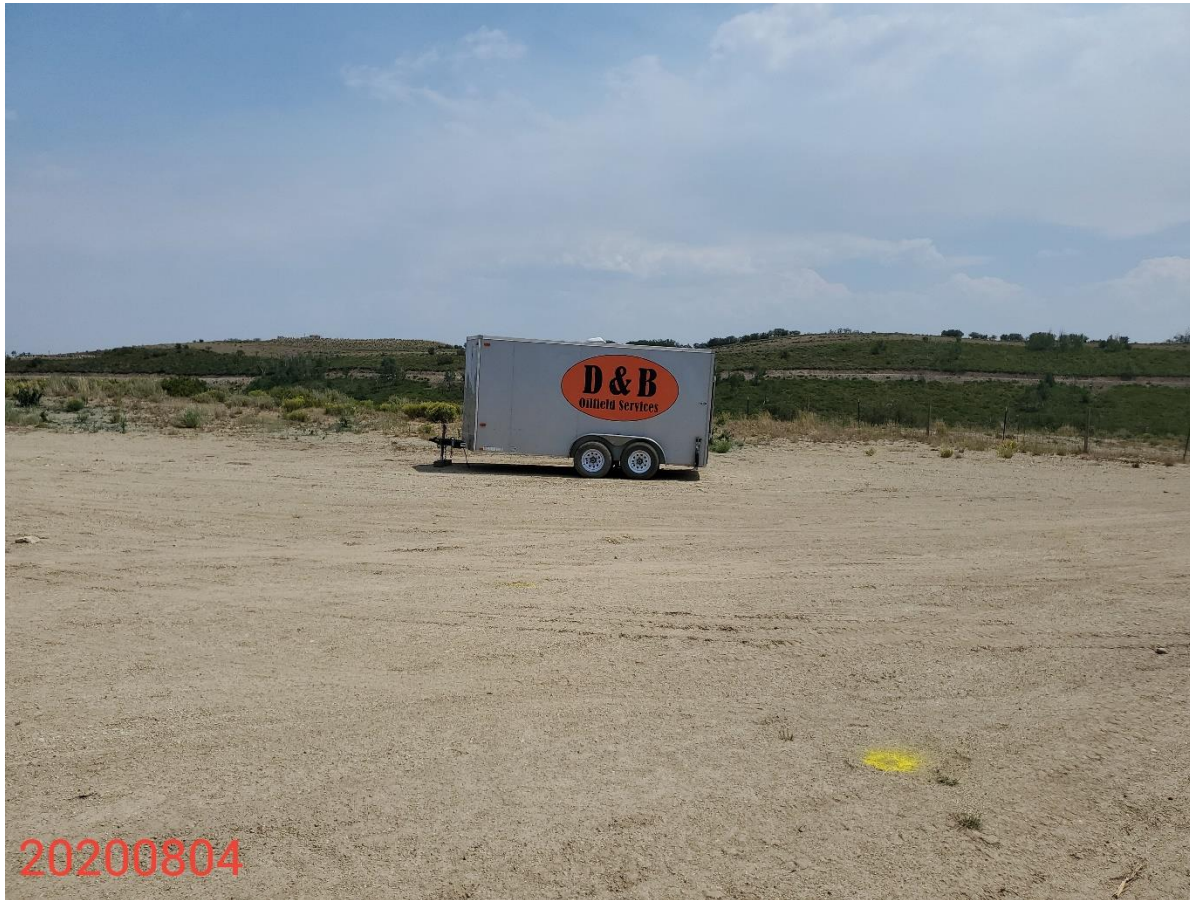
**Photo 5:** Photo taken from the Location, facing east. Photo shows trailer on location. This is equipment not needed for production and requires removal.
