Final Reclamation Inspection

Operator: PDC ENERGY INC - 69175

Location ID: 335954

Inspection Photos
Location Name: HINGLEY #2J
Location ID: 335954

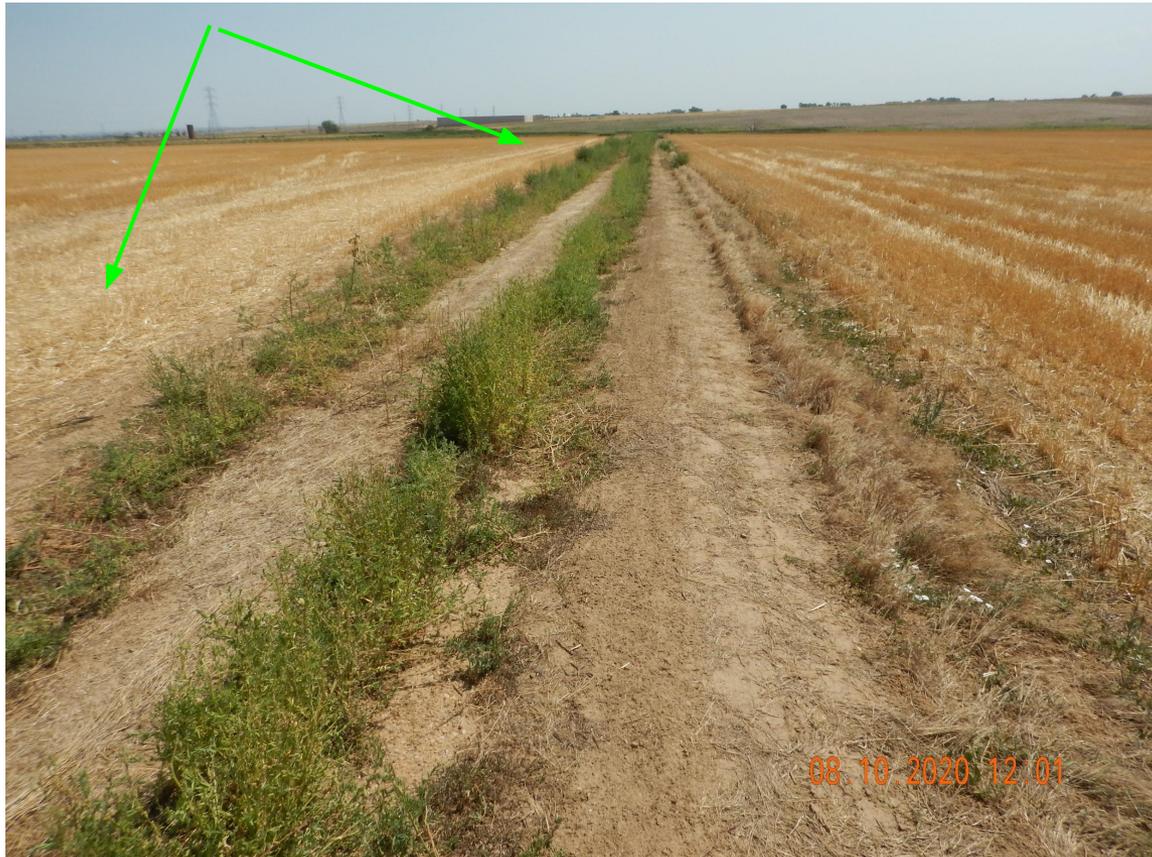
Photo 1. Photo taken from the western access road, facing East. Photo illustrates the Operator has failed to recontour the access road, as well as control undesirable weeds. Note- it does not appear the surface owner is using the access road; surface owner is driving north of the access road with the evidence of agricultural activities (green arrows). Also, refer to Photos 4-6.

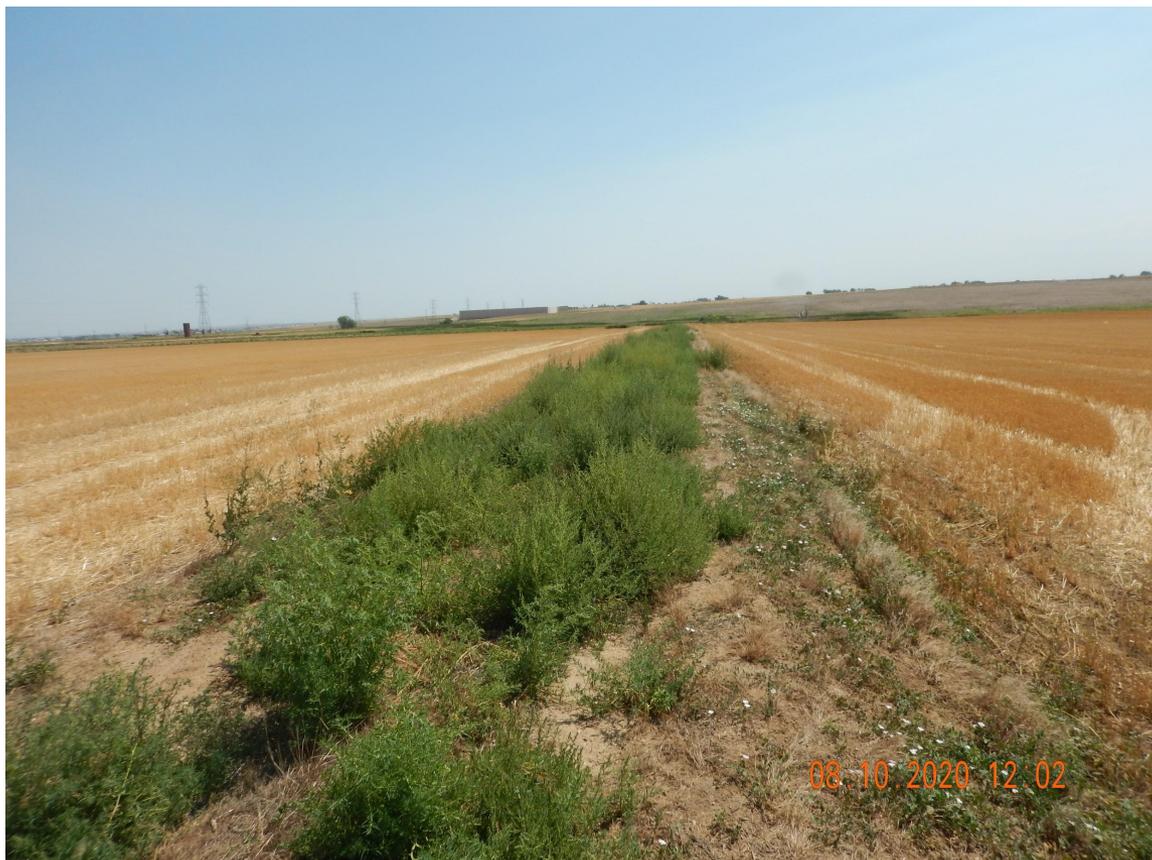
Photo 2. Photo taken from the central access road, facing East. See comments under Photo 1.

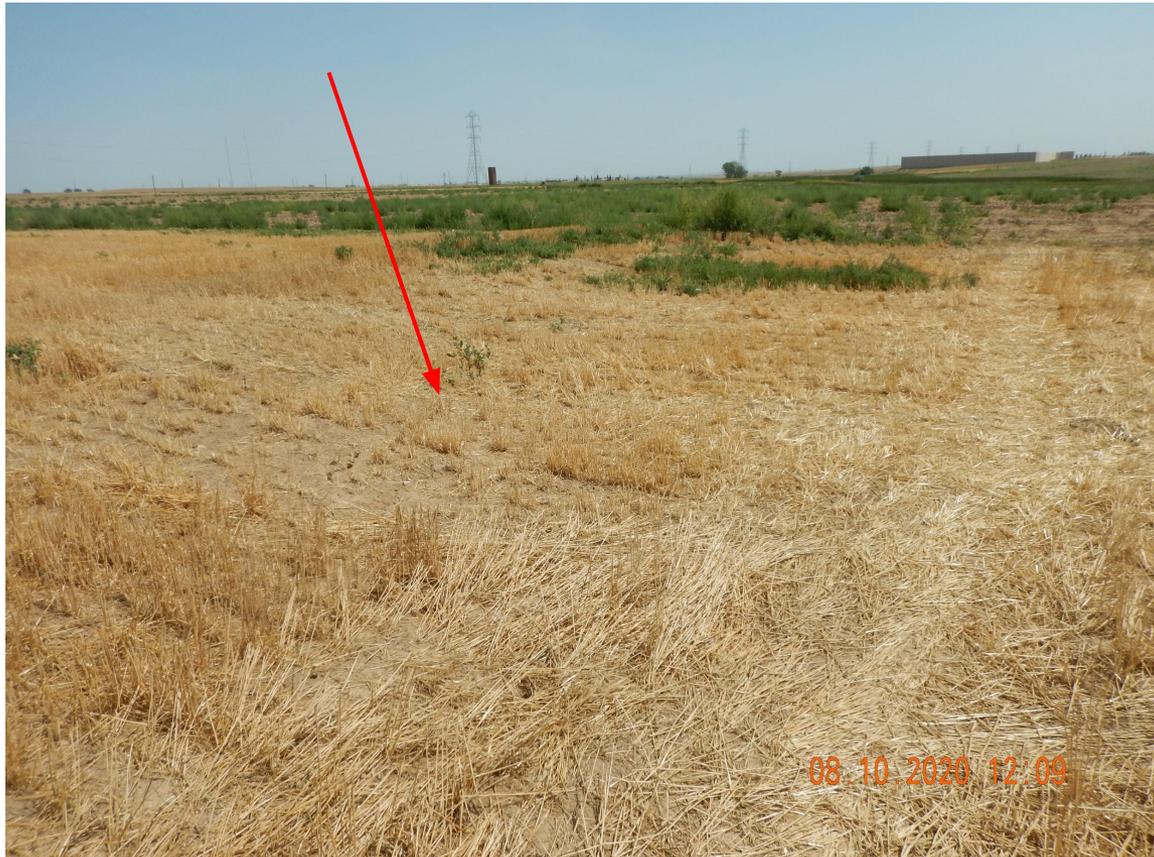
Photo 3. Photo taken from the northern location, facing East. Photo illustrates where the former tank was. Operator has failed to recontour the location.

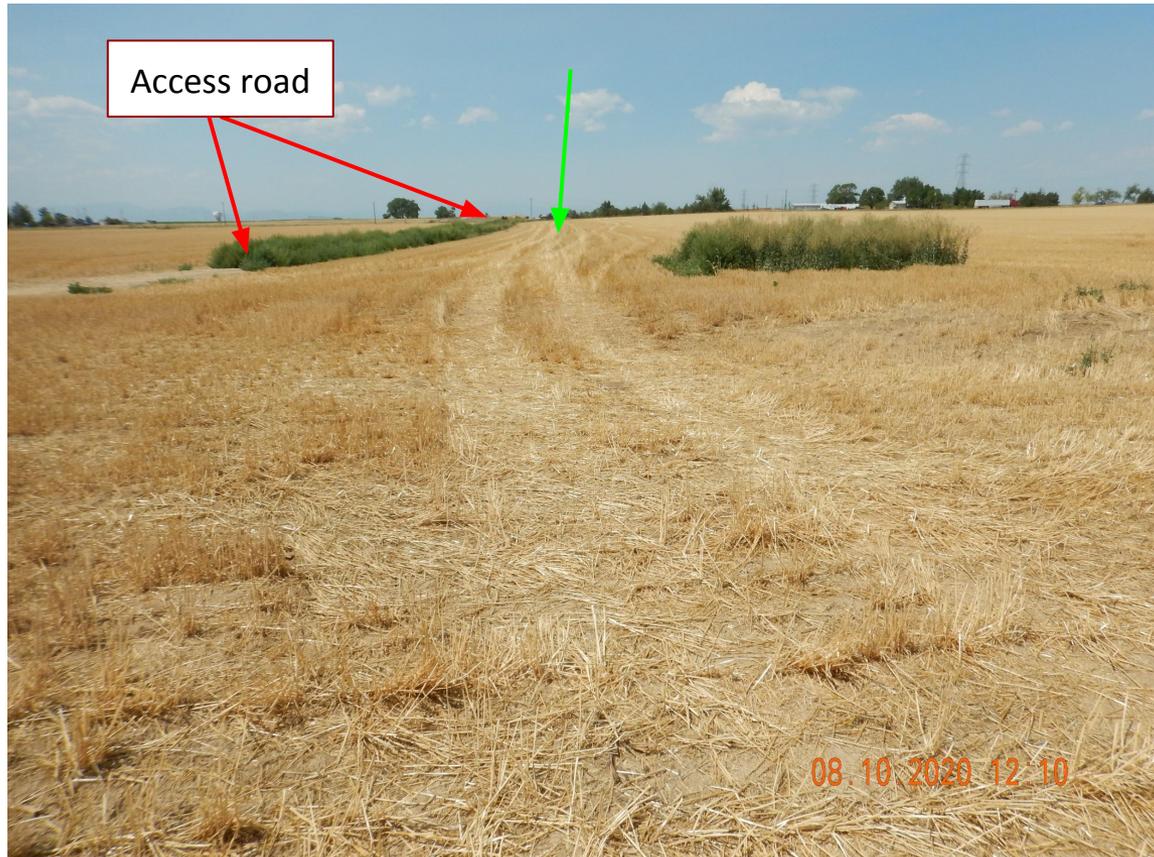
Photo 4. Photo taken from the northern location, facing West. Photo illustrates the oil and gas access road that is no longer being used. Surface owner is driving north of the access road with the evidence of agricultural activities.

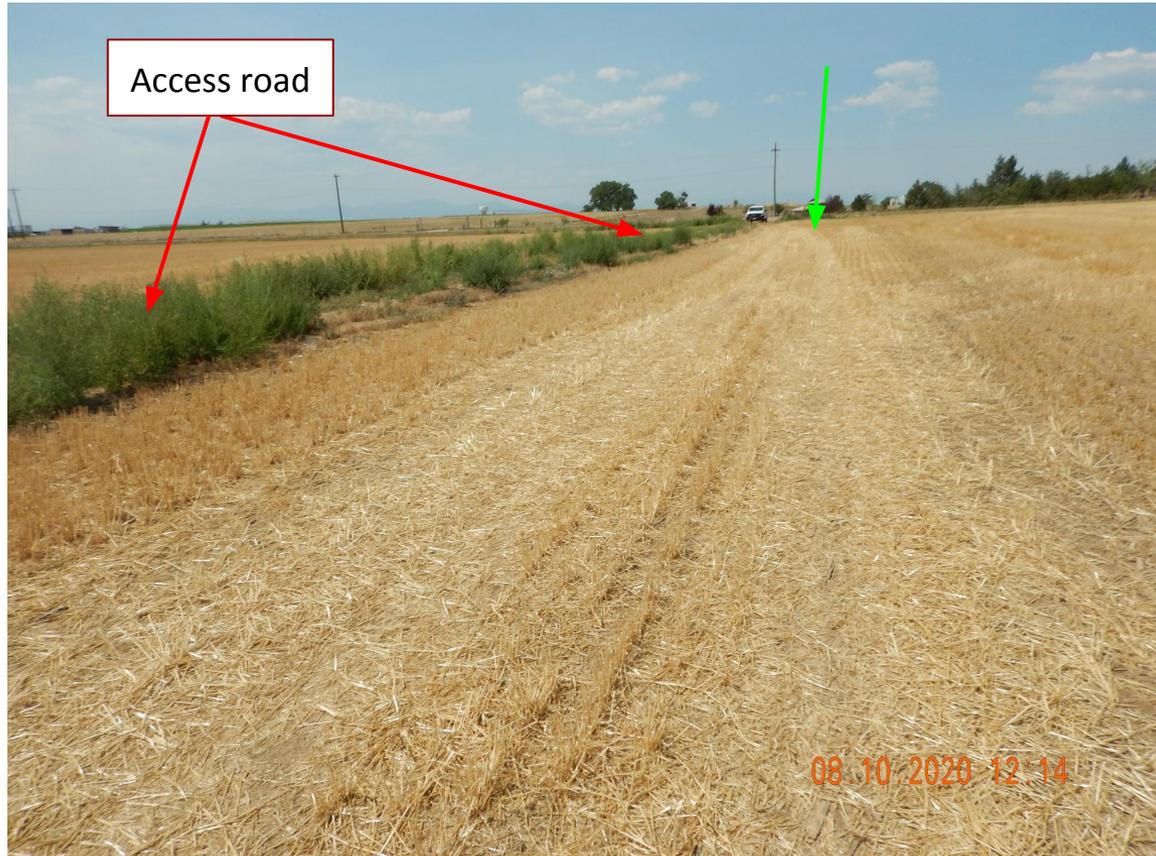
Photo 5. Photo taken from the central access road, facing West. See comments under Photo 4.

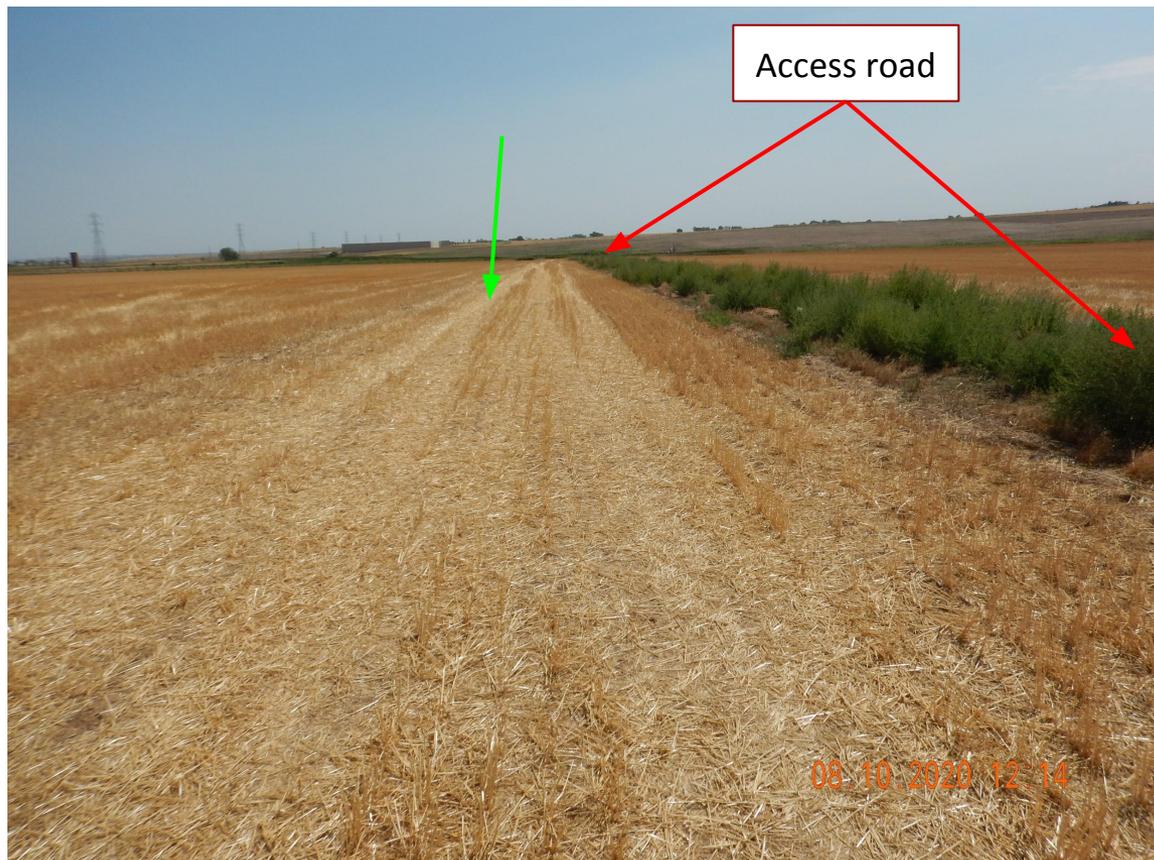
Photo 6. Photo taken from the western access road, facing East. See comments under Photo 4.
