# Interim Reclamation and Stormwater Inspection

Operator: CRESTONE PEAK RESOURCES OPERATING LLC - 10633

Location ID: 455598

Inspection Photos  
Location Name: Hingley /18H-A167  
Location ID: 455598

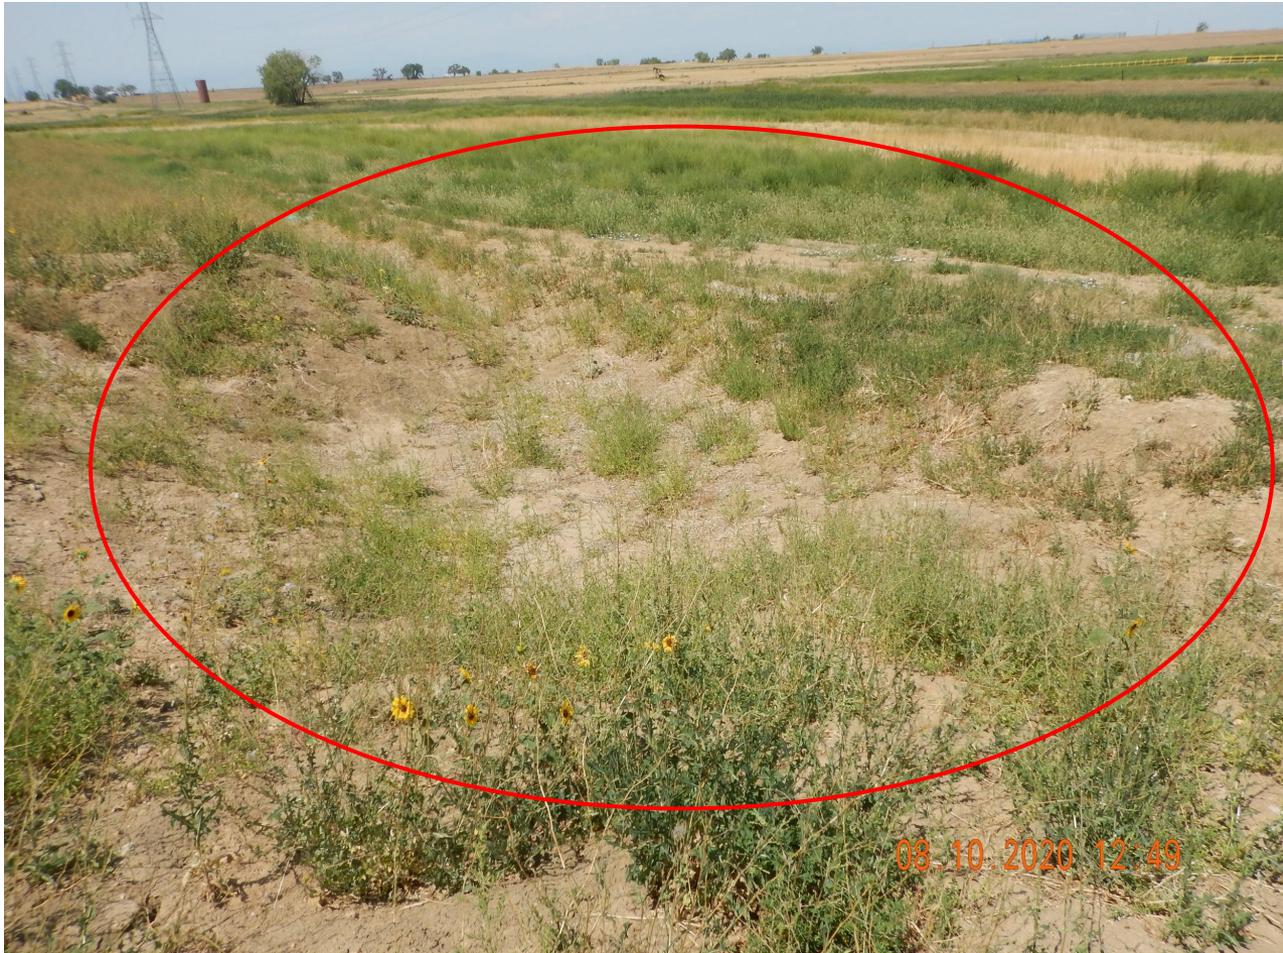
**Photo 1.** Photo taken from the northern location, facing Northwest. Photo illustrates a sediment trap stormwater BMP with a temporarily stabilized outlet. At the time of this inspection, BMPs appear to be in proper functioning condition. However, undesirable and noxious weed management is required. Refer to Photos 2-7 which also document weed management compliance issues.

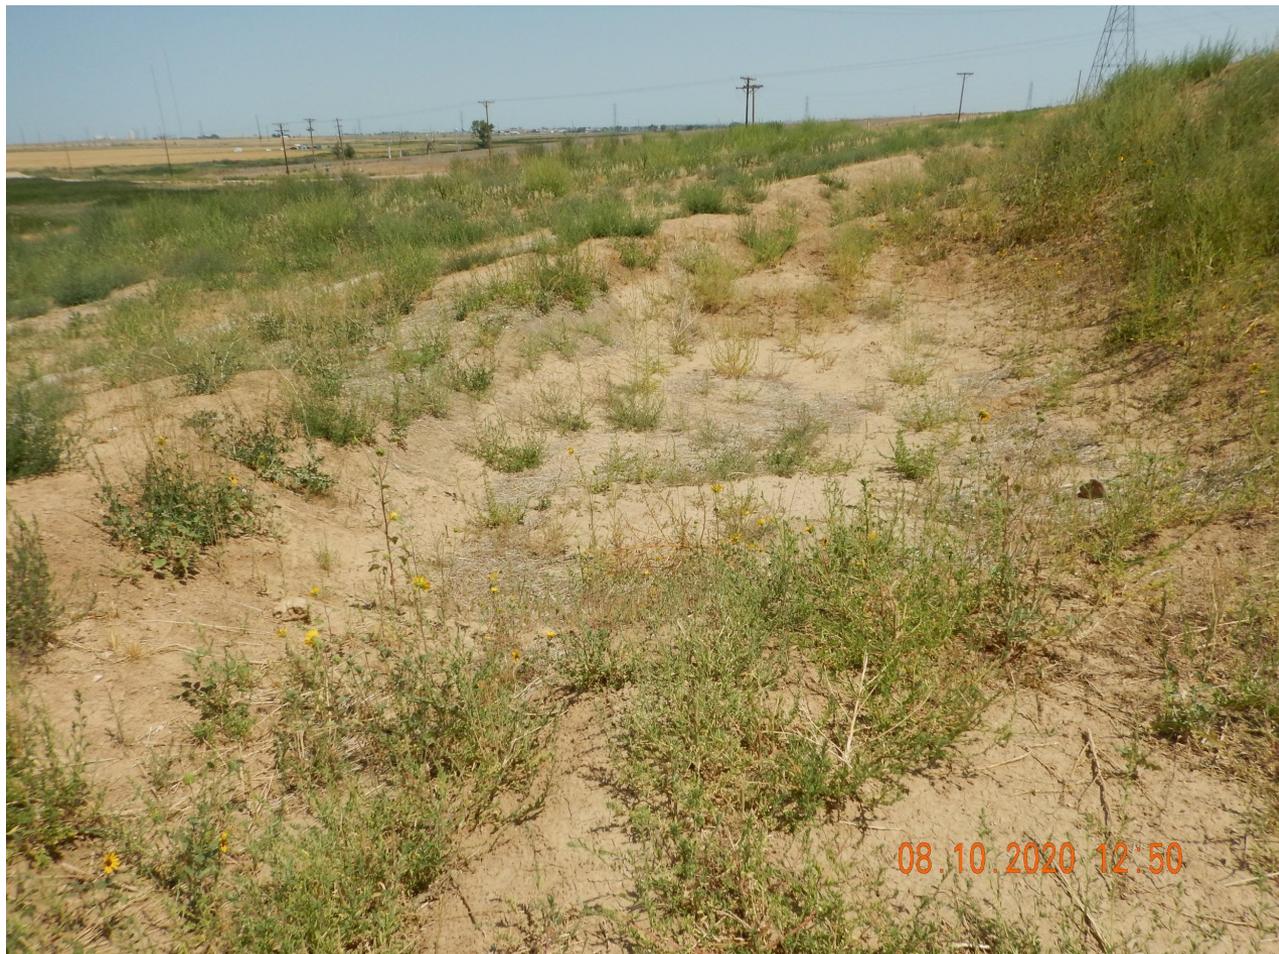
**Photo 2.** Photo taken from the northern location, facing East. See comments under Photo 1.

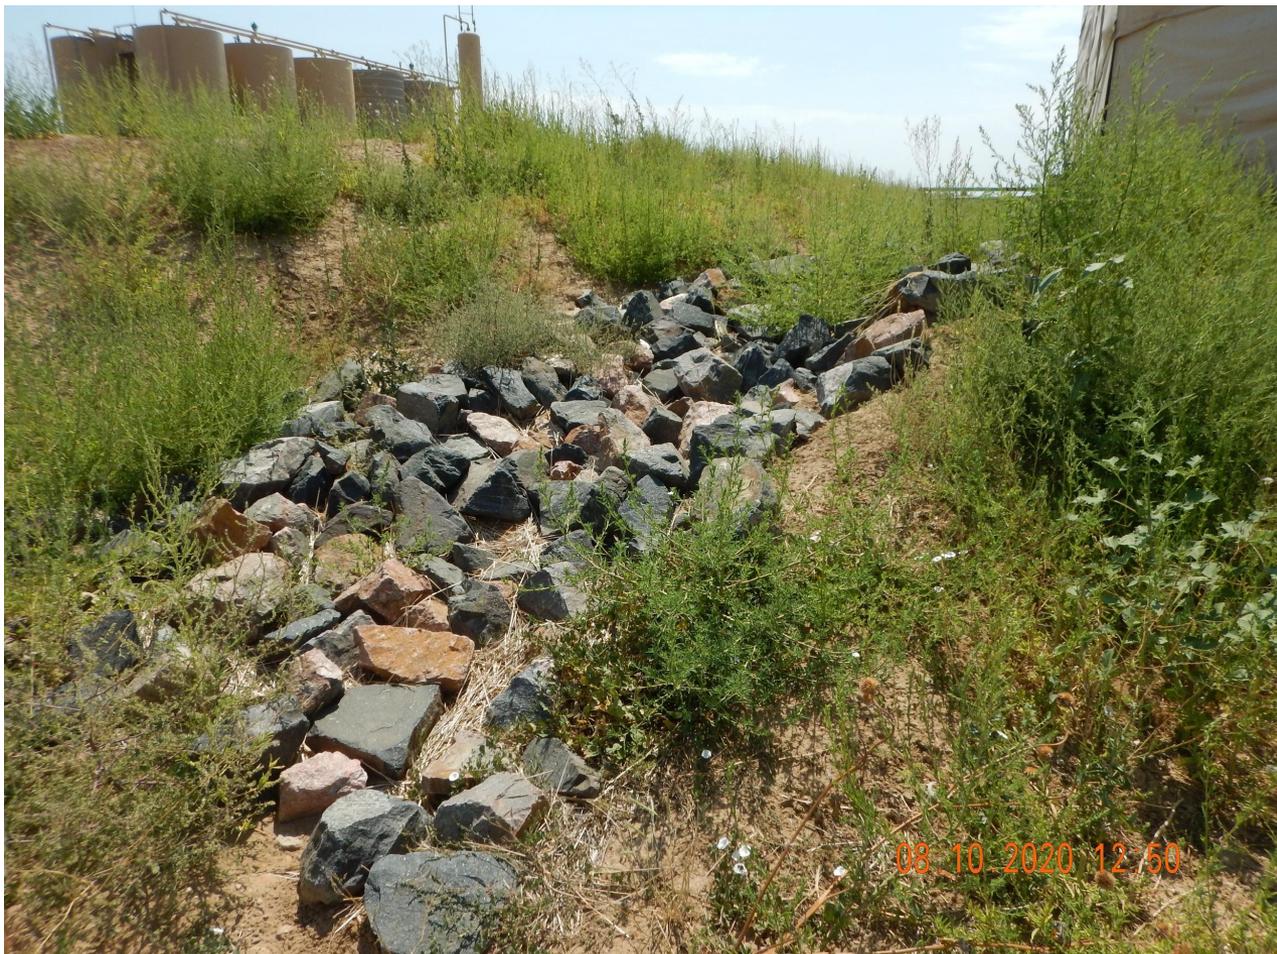
**Photo 3.** Photo taken from the northeastern location, facing South. Photo illustrates a stabilized diversion ditch which is directed to a temporarily stabilized outlet.

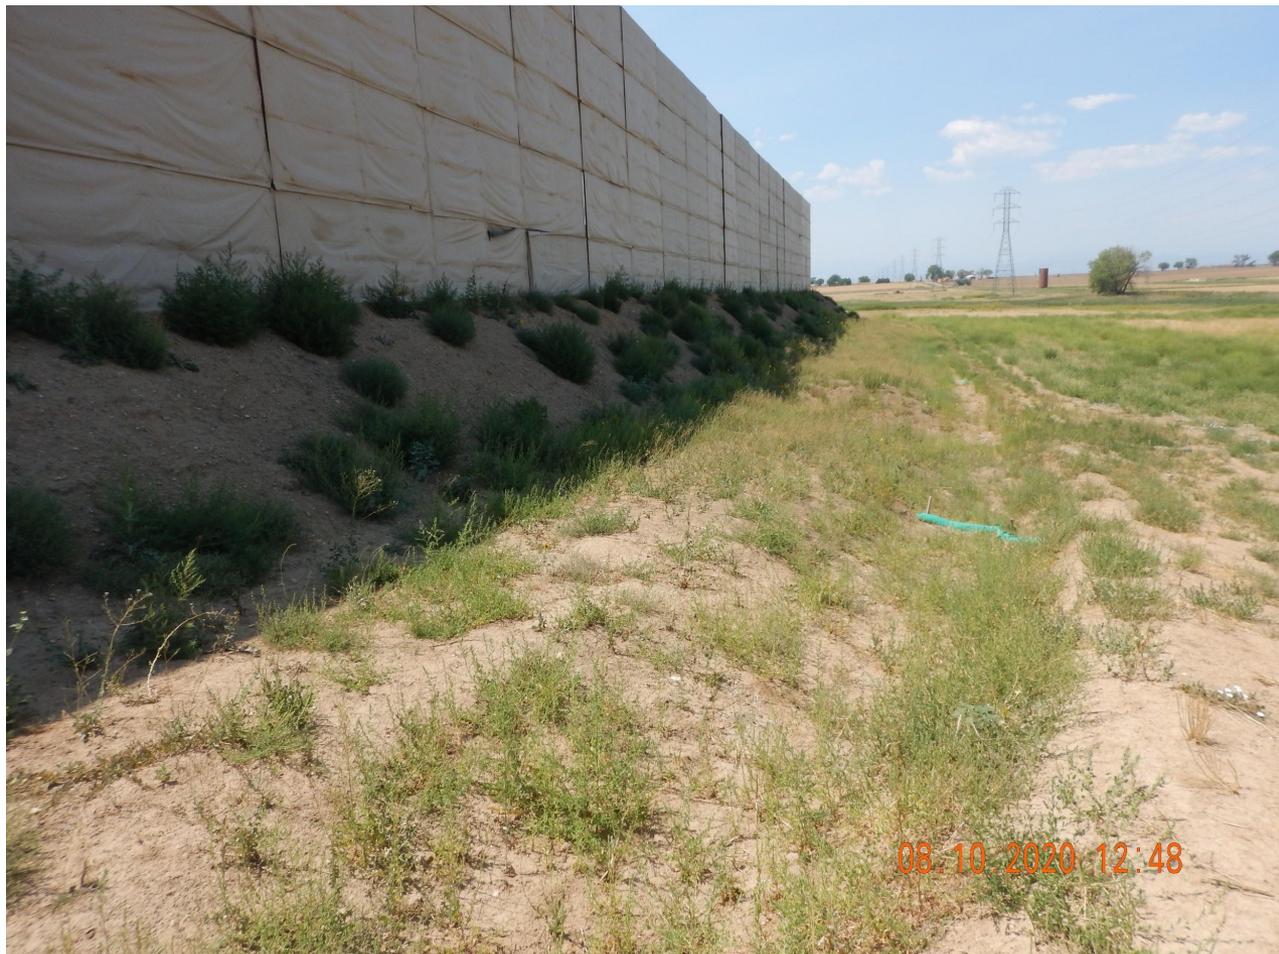
**Photo 4.** Photo taken from the northeastern location, facing West. Photo illustrates the Operator has repaired erosion along the northern fill slope.

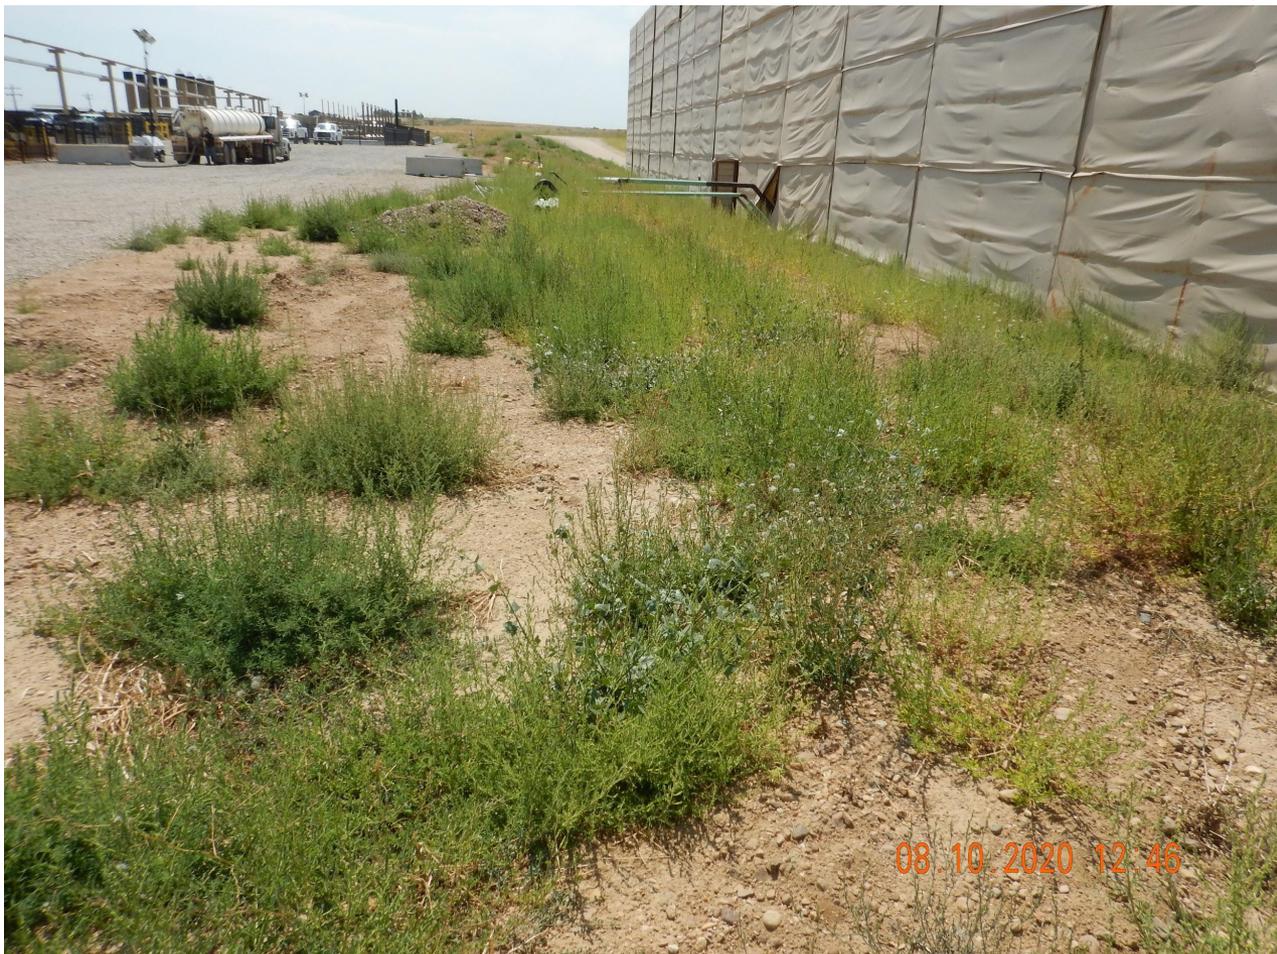
**Photo 5.** Photo taken from the northeastern location, facing South. Photo illustrates further weed management compliance issues.

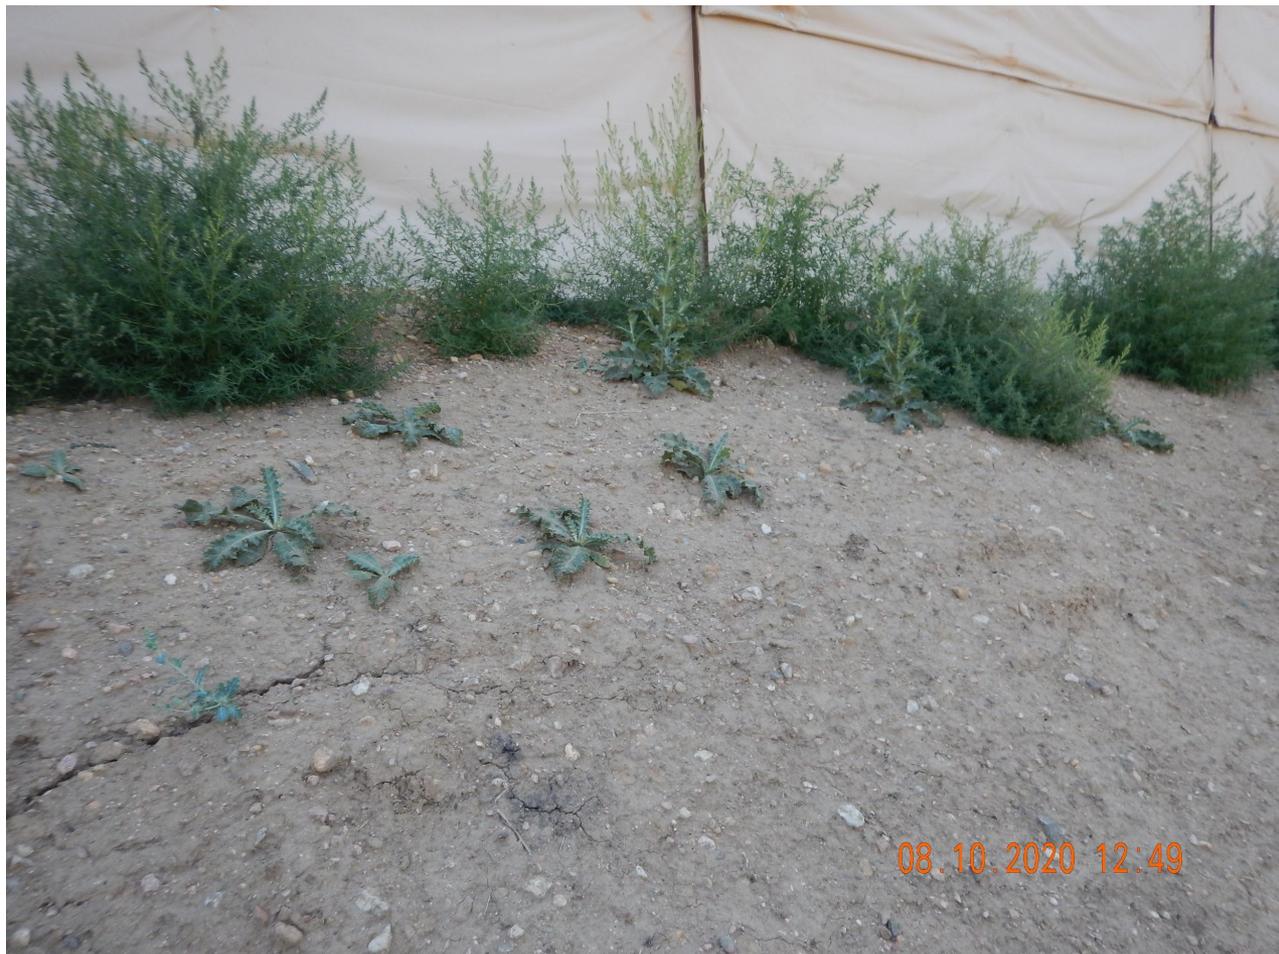
**Photo 6.** Photo taken from a portion of the northeastern fill slope. Photo illustrates the establishment of a List B Colorado noxious weed, Scotch thistle.

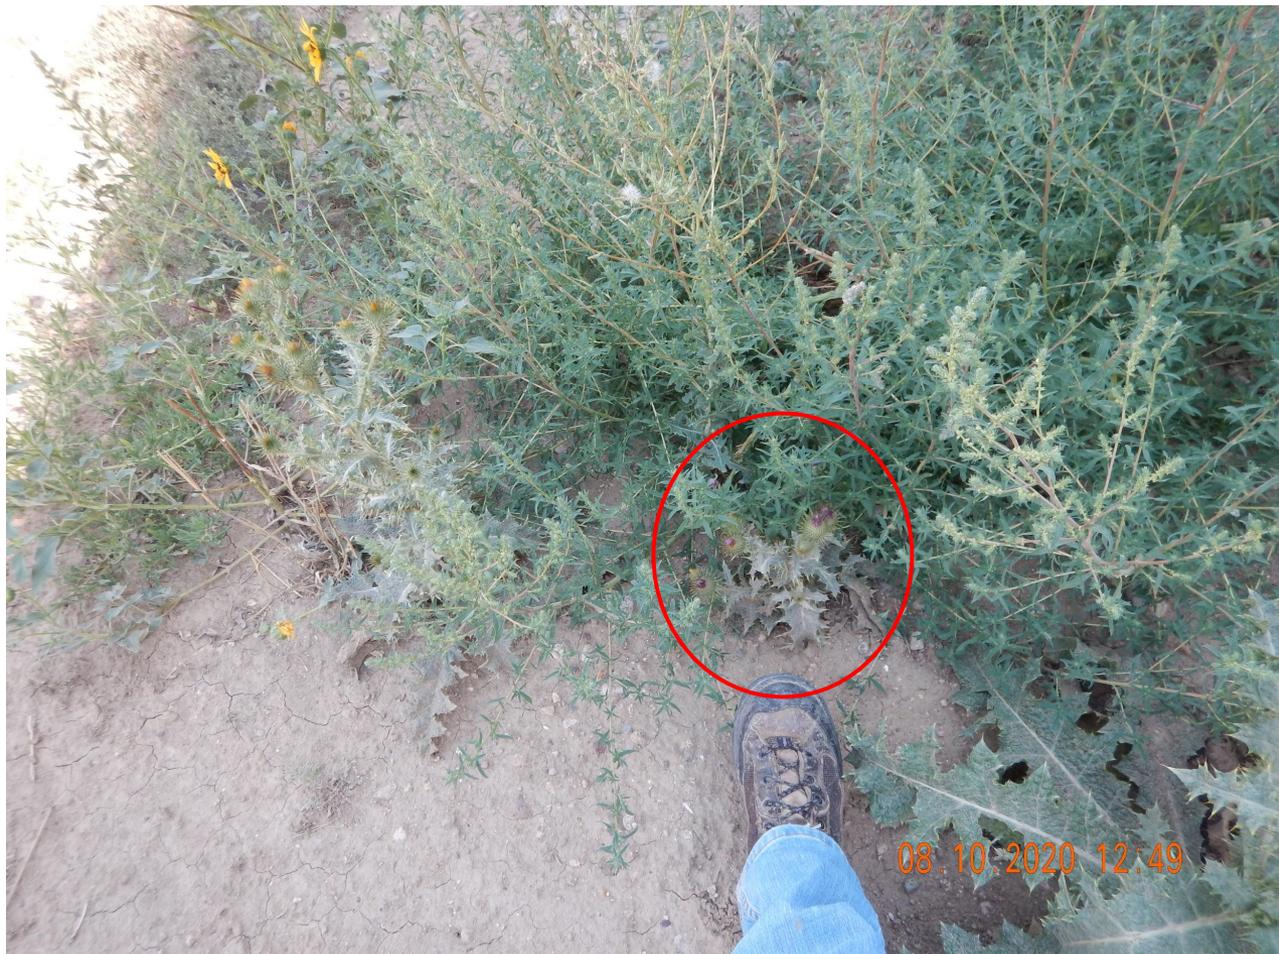
**Photo 7.** Close up photo illustrates a List B Colorado noxious weed, Scotch thistle, flowering.

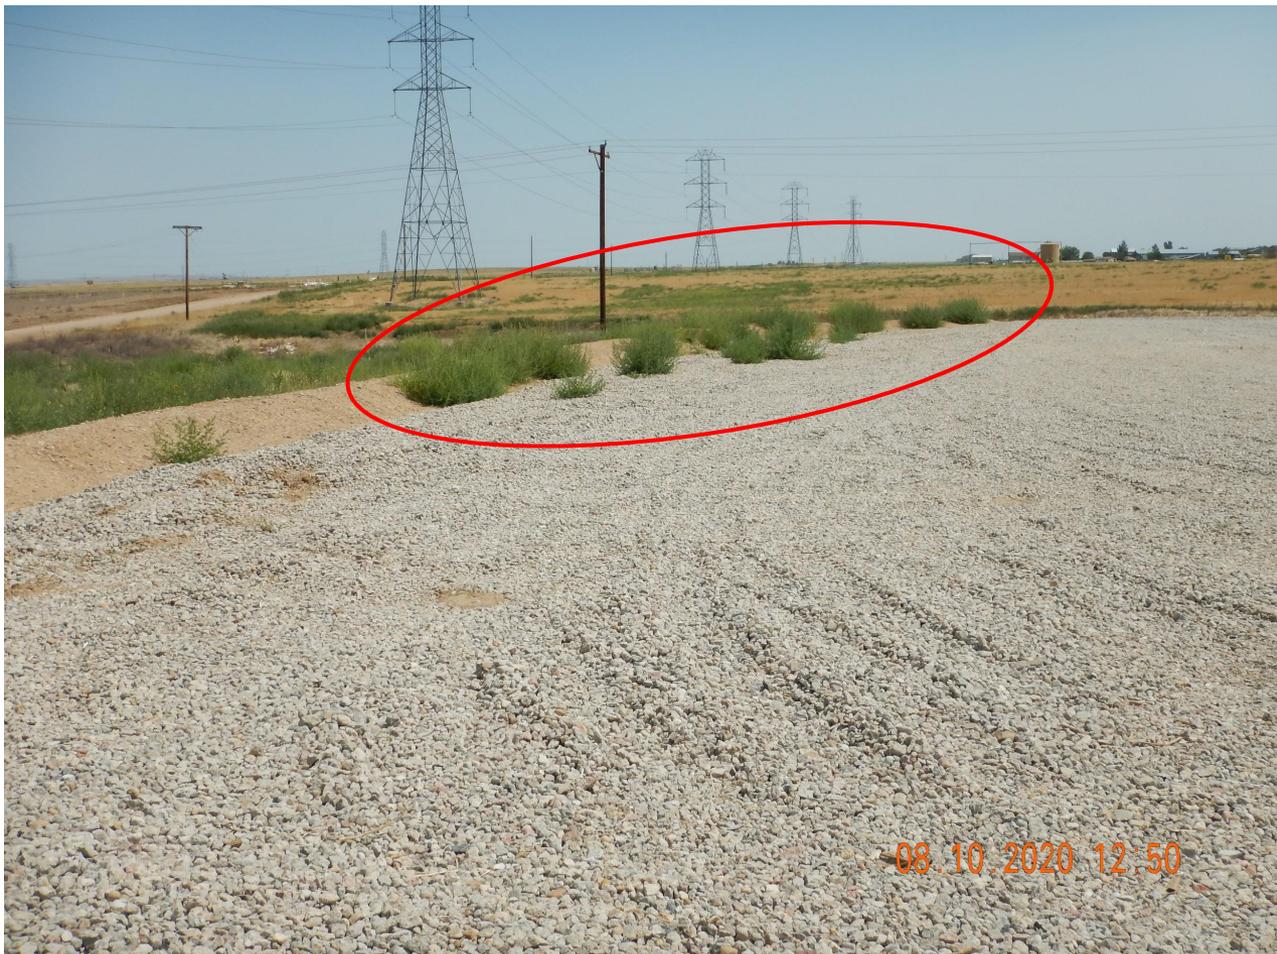
**Photo 8.** Photo taken from the northeastern location, facing East. Photo illustrates further weed management compliance issues.
