Inspection Photos

8/04/2020

Operator: TEP ROCKY MOUNTAIN LLC - 96850

Location ID: 335117

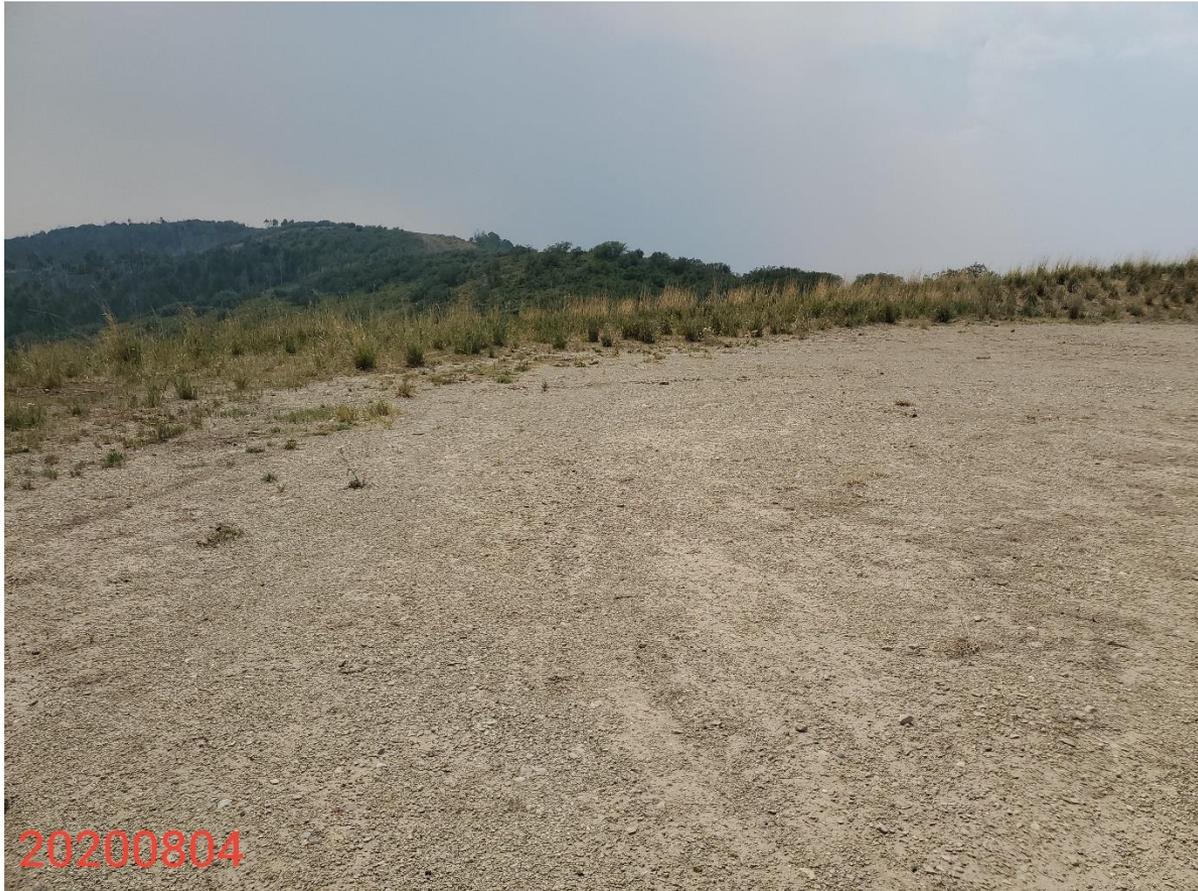
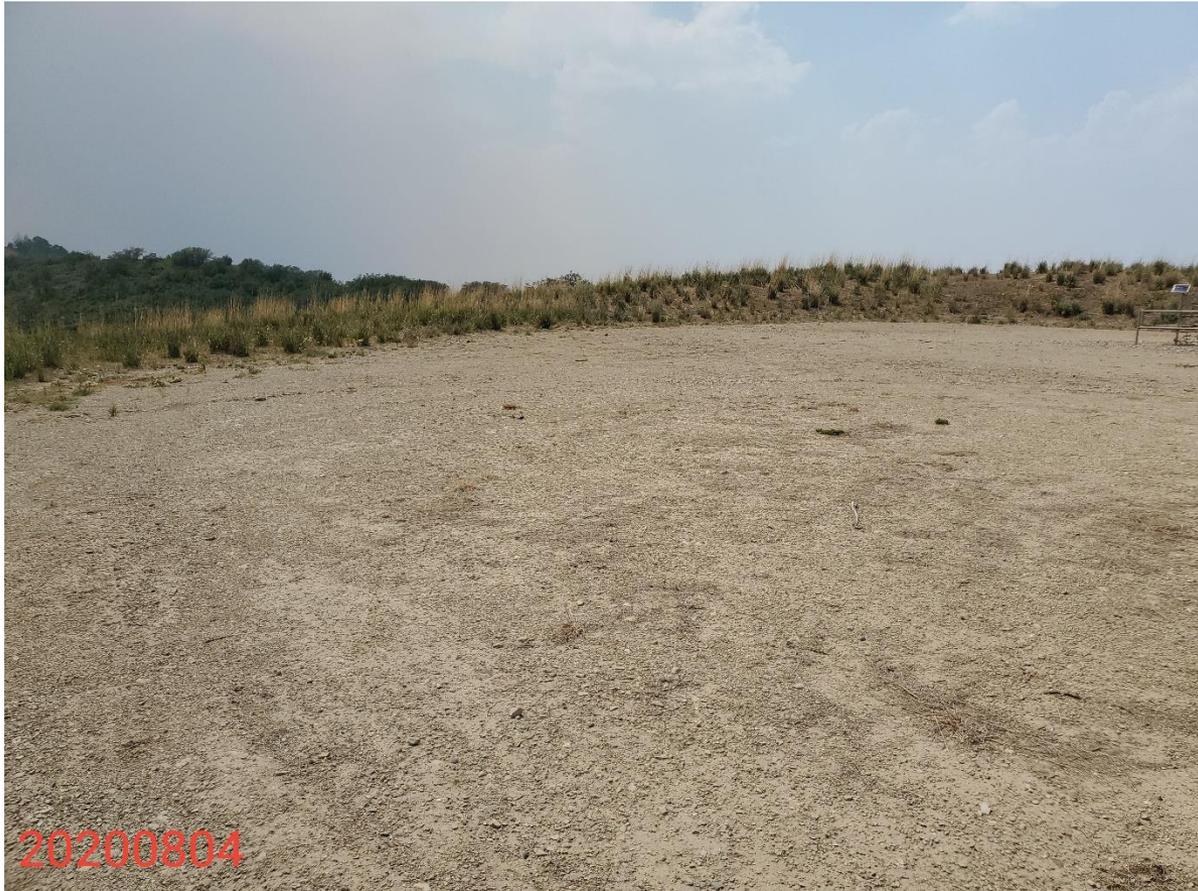
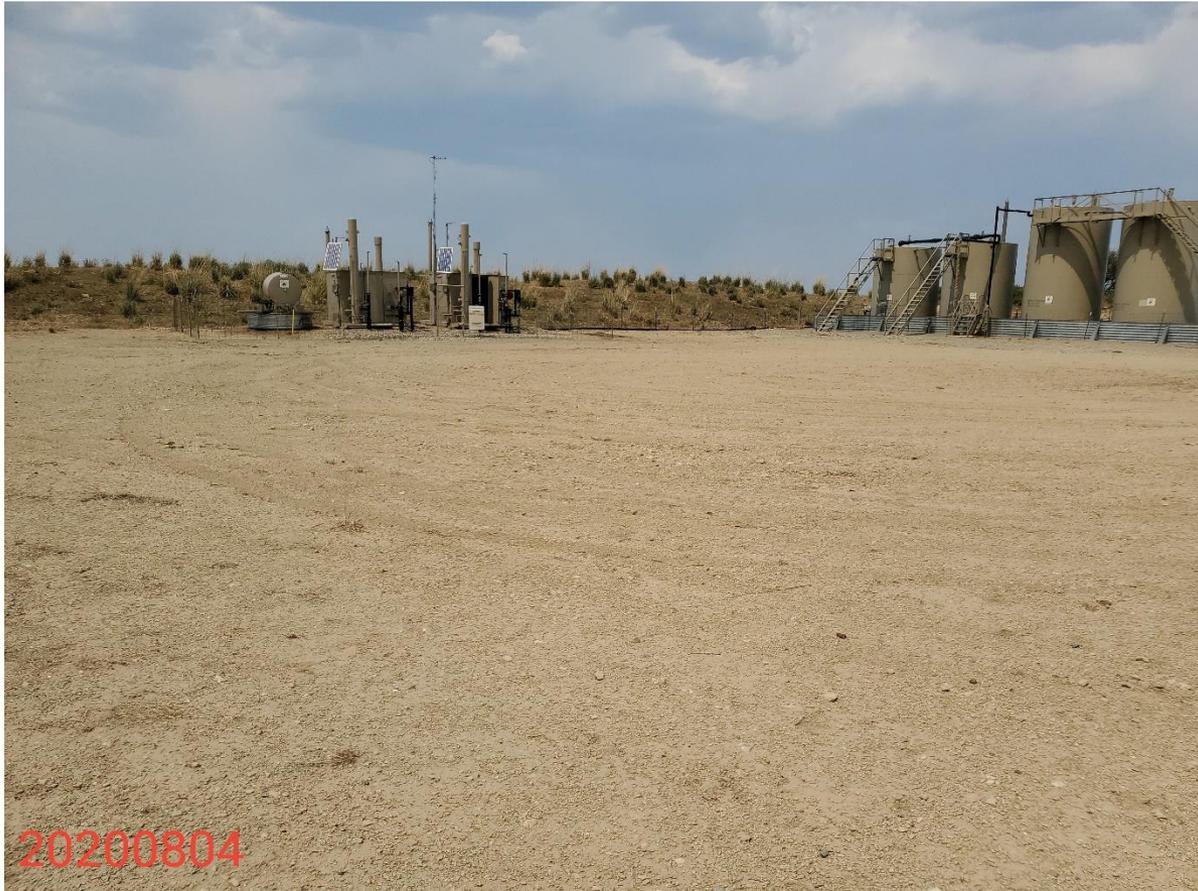
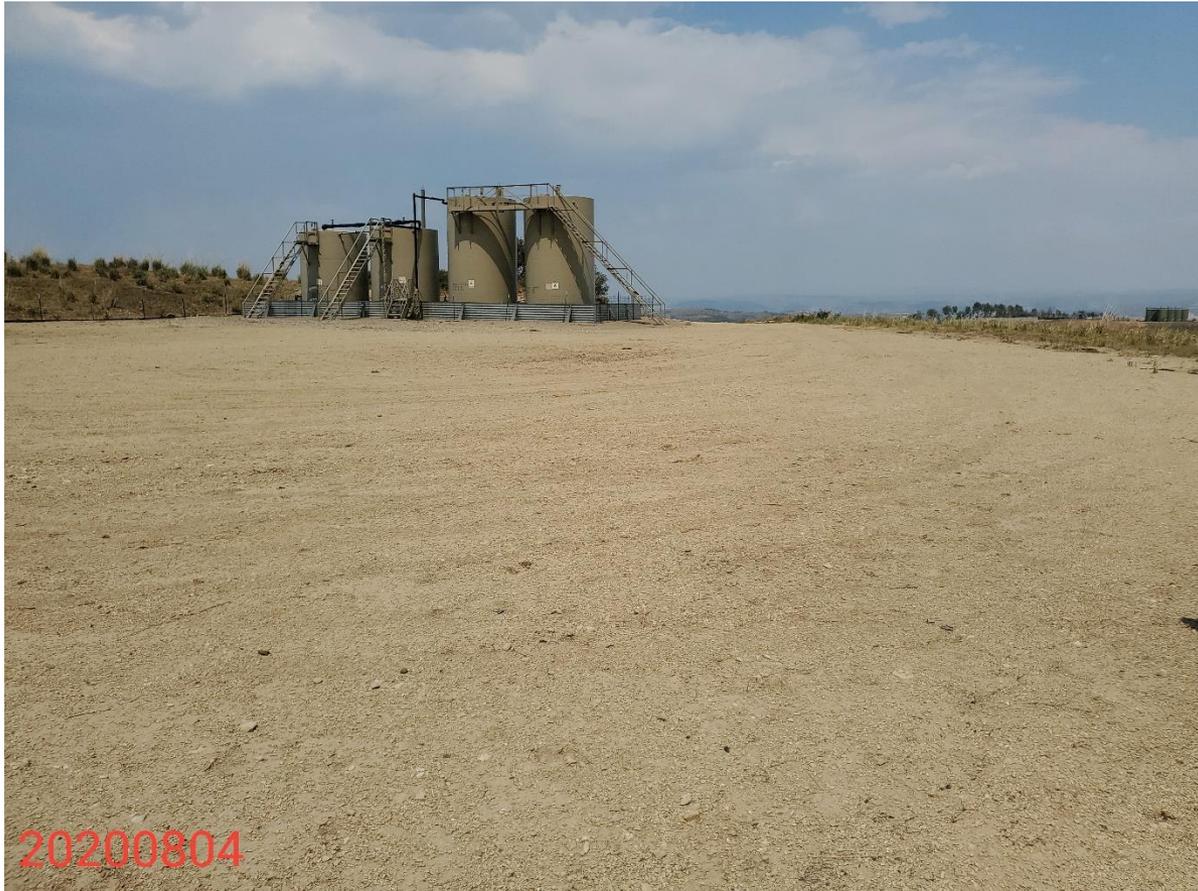
Photo 1: Photo taken from the south end of the Location, facing southwest. Photo 1-4 provide an overview of the Location from southwest, west, north to northeast.

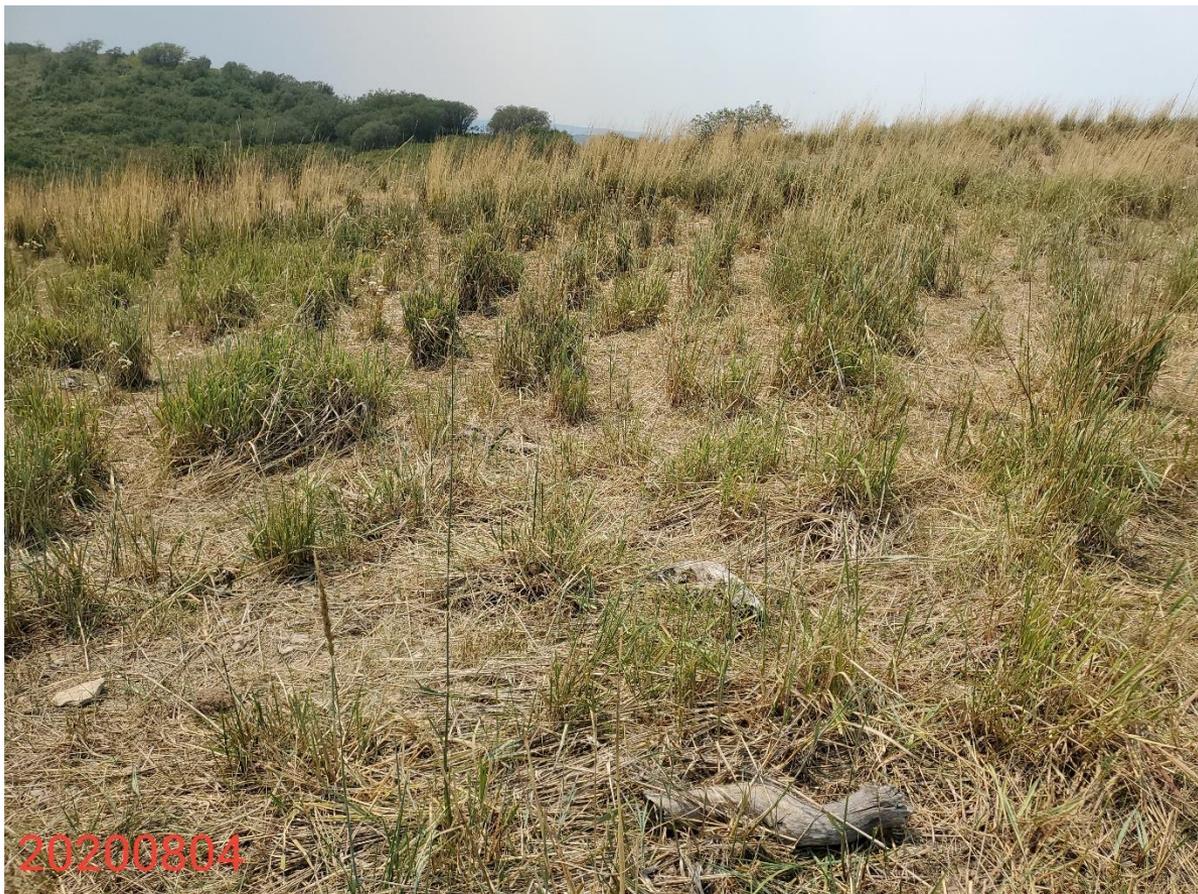
Photo 5: Photo taken from the western interim areas of the Location, facing northwest. Interim reclamation appears to be progressing towards 1003 standards.

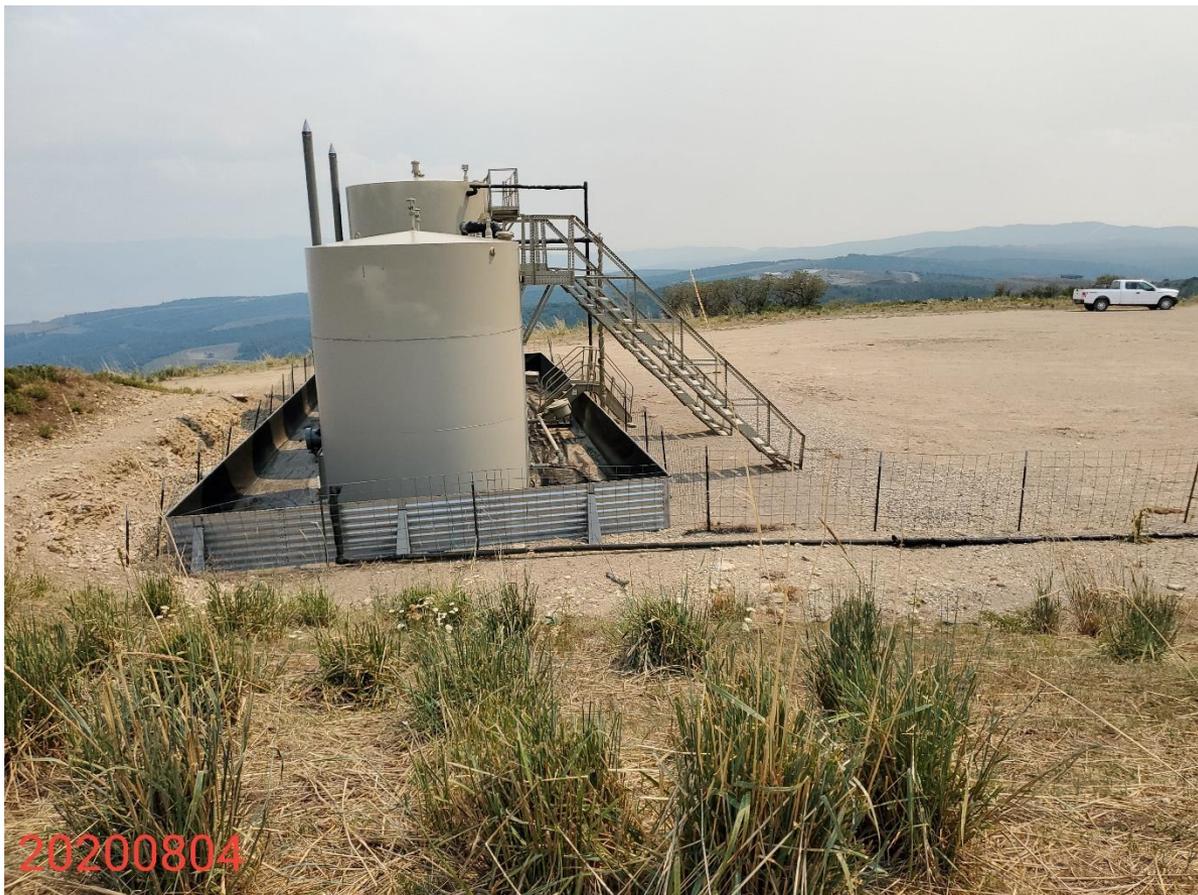
Photo 6: North end of the Location, facing south. Photo provides an overview of the Location.

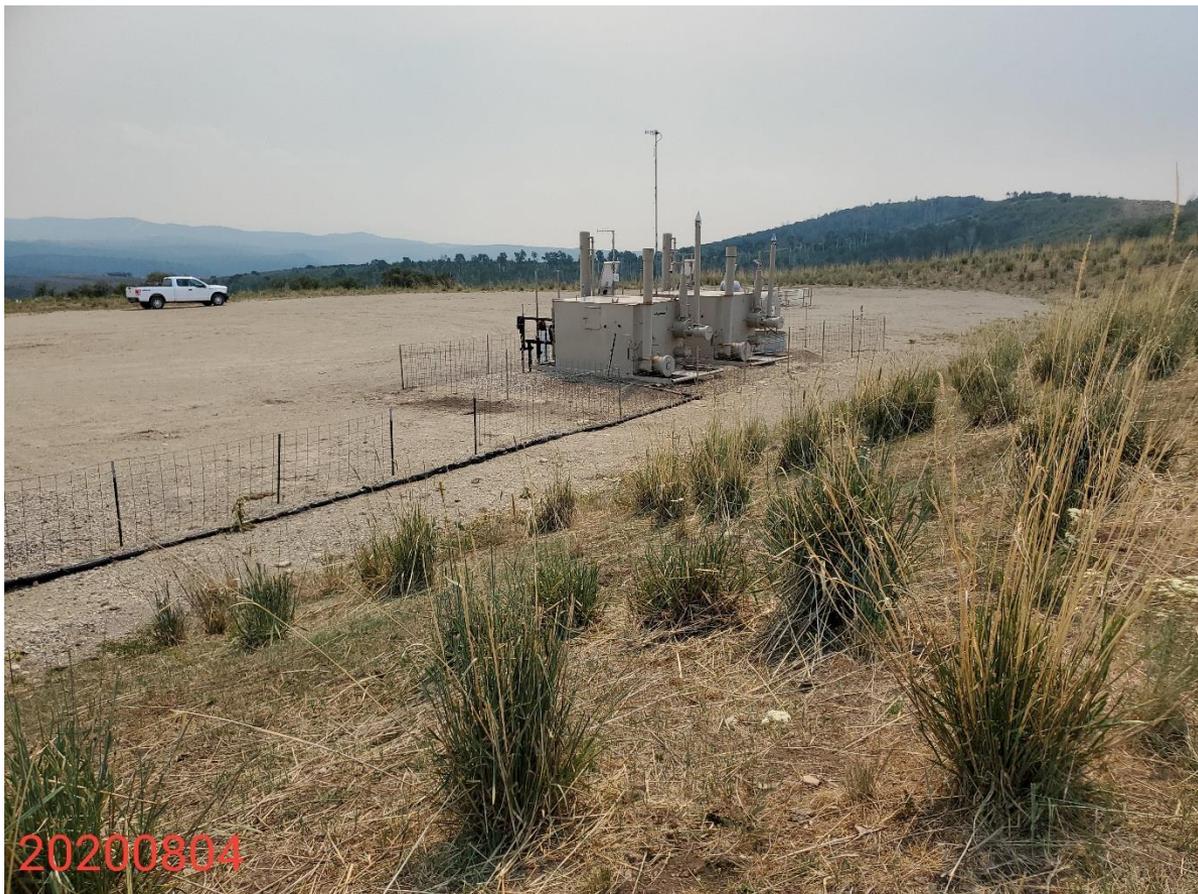
Photo 7: North end of the Location, facing southwest. Photo provides an overview of the Location.

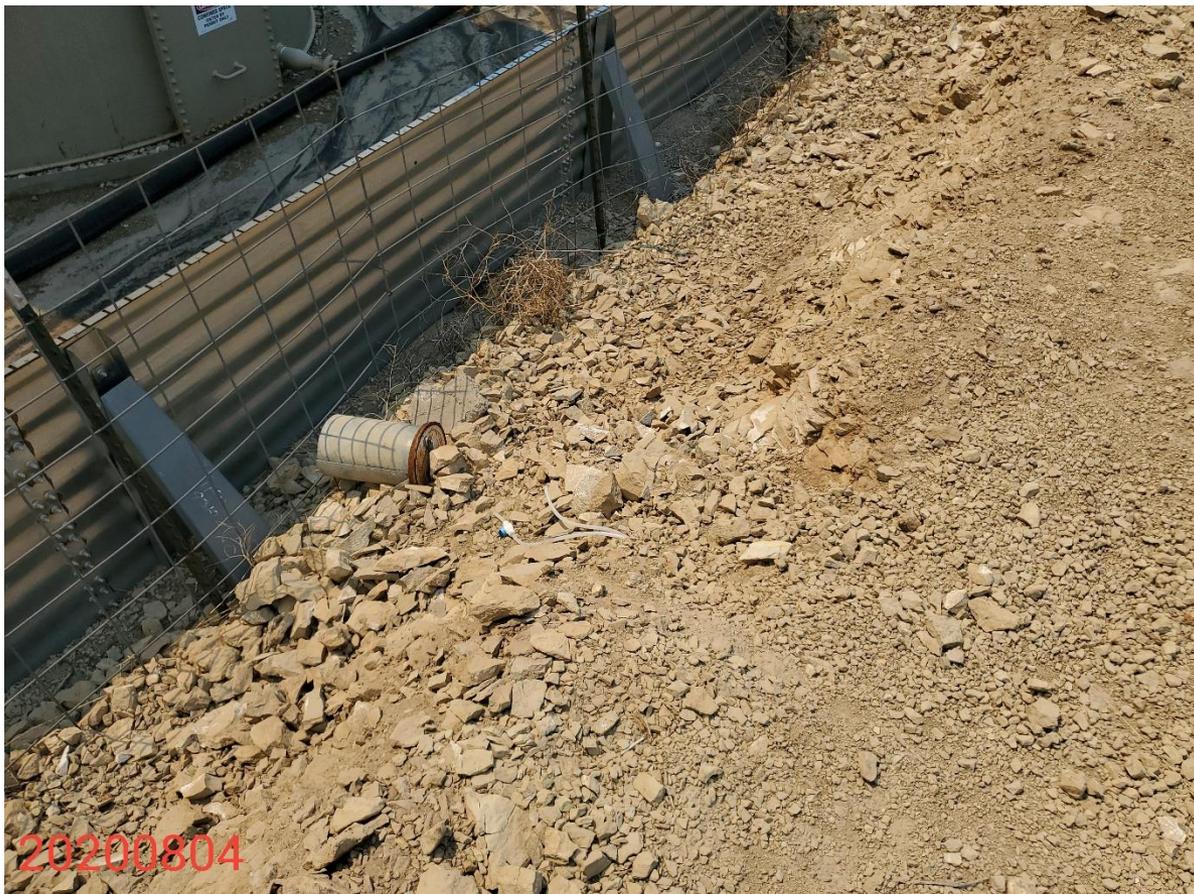
Photo 8: Photo taken from the northeast end of the tank battery. Photo shows what appears to be a part of a monitoring well; Well in disrepair. It is unclear if monitoring wells are needed for the Location and require maintenance to ensure proper functioning condition, or proper abandonment.

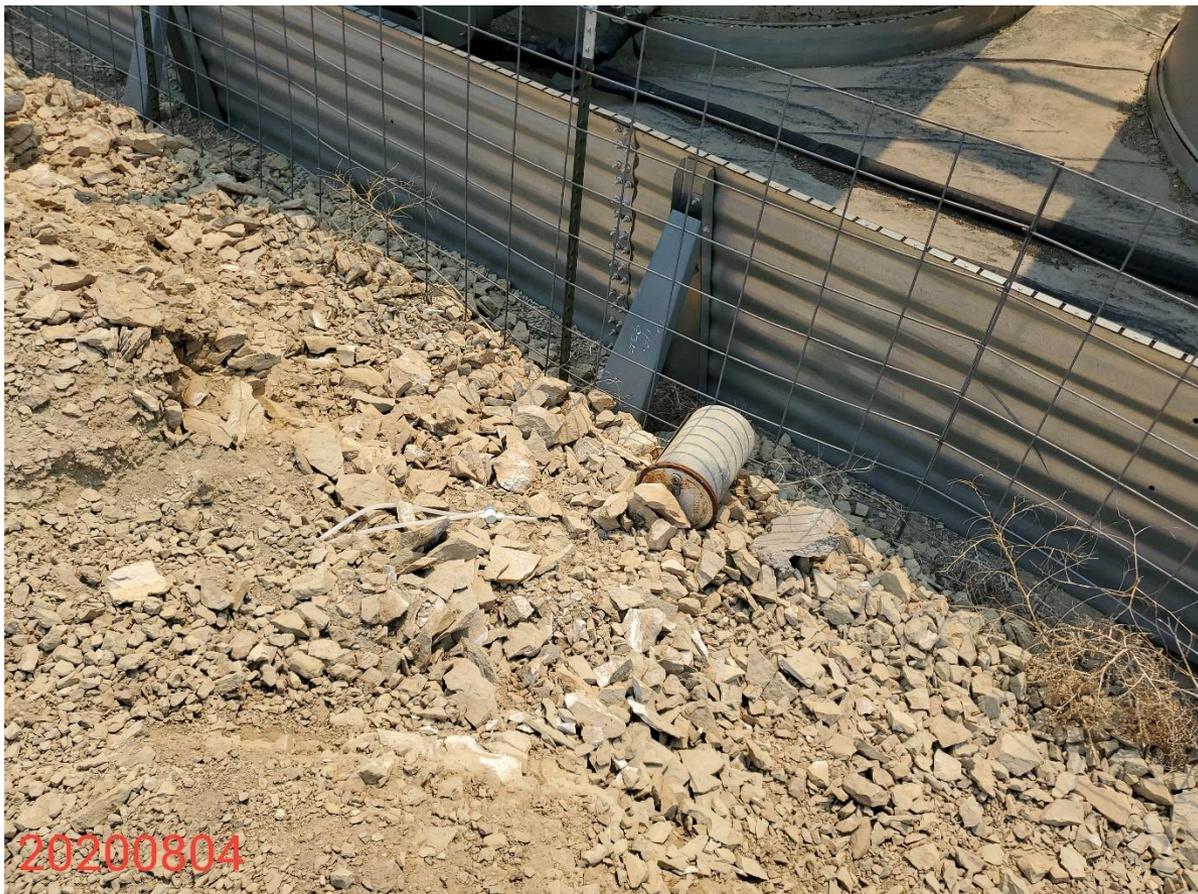
Photo 9: Continued from photo 8. Photo shows topsoil stockpile and drill cuttings. There does not appear to be BMPs in place to segregate cuttings from the topsoil.

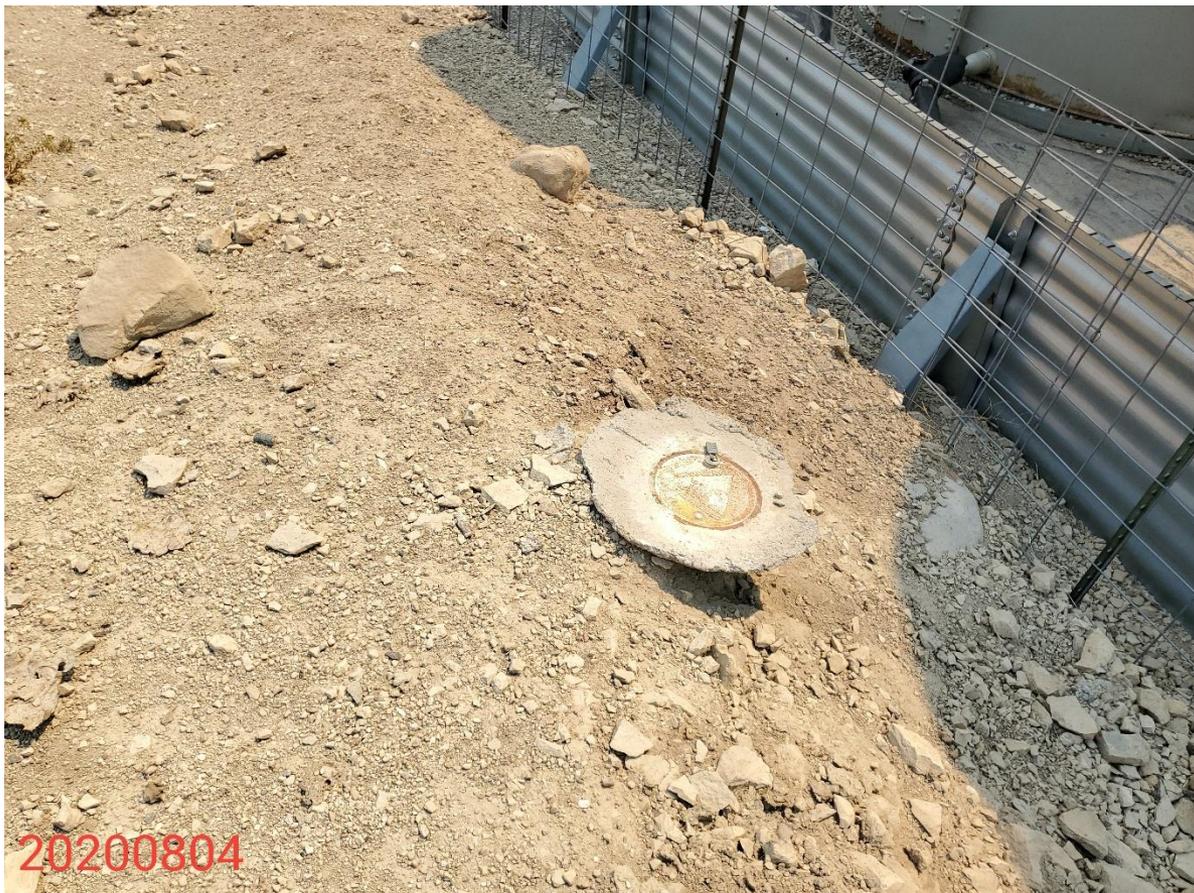
Photo 10: Photo taken from the northeast end of the tank battery. Photo shows second observed monitoring well. It is unclear if monitoring wells are needed for the Location and require maintenance to ensure proper functioning condition, or proper abandonment.
