Inspection Photos

8/10/2020

Operator: CAERUS PICEANCE LLC - 10456

Location ID: 335667

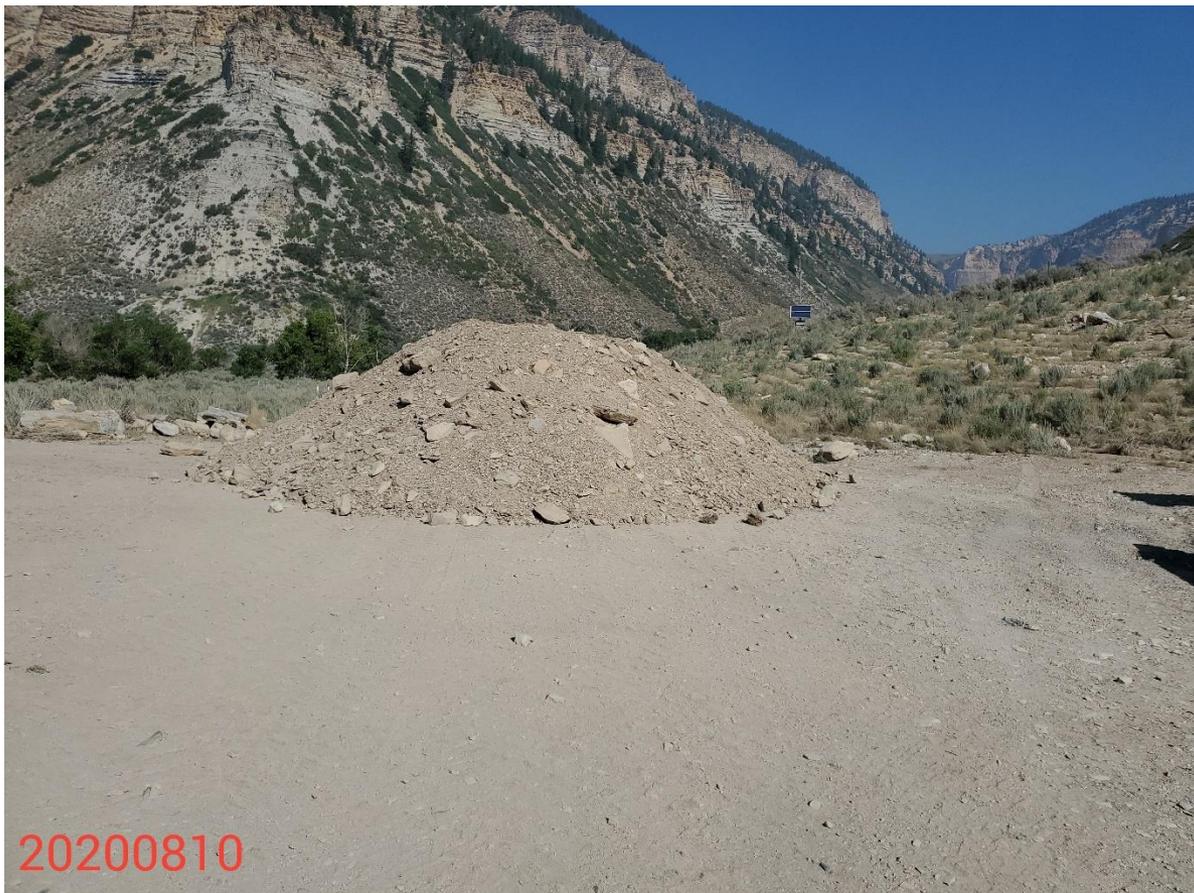
Photo 1: Photo taken from the north end of the Location, facing north. Previous inspection required Operator to relocate excavated soils and to implement BMPs to mitigate transport/discharge of impacted materials pursuant to 1002.f rules. Photo shows soils have been relocated, however no BMPs have been implemented per 1002.f rules and corrective actions.

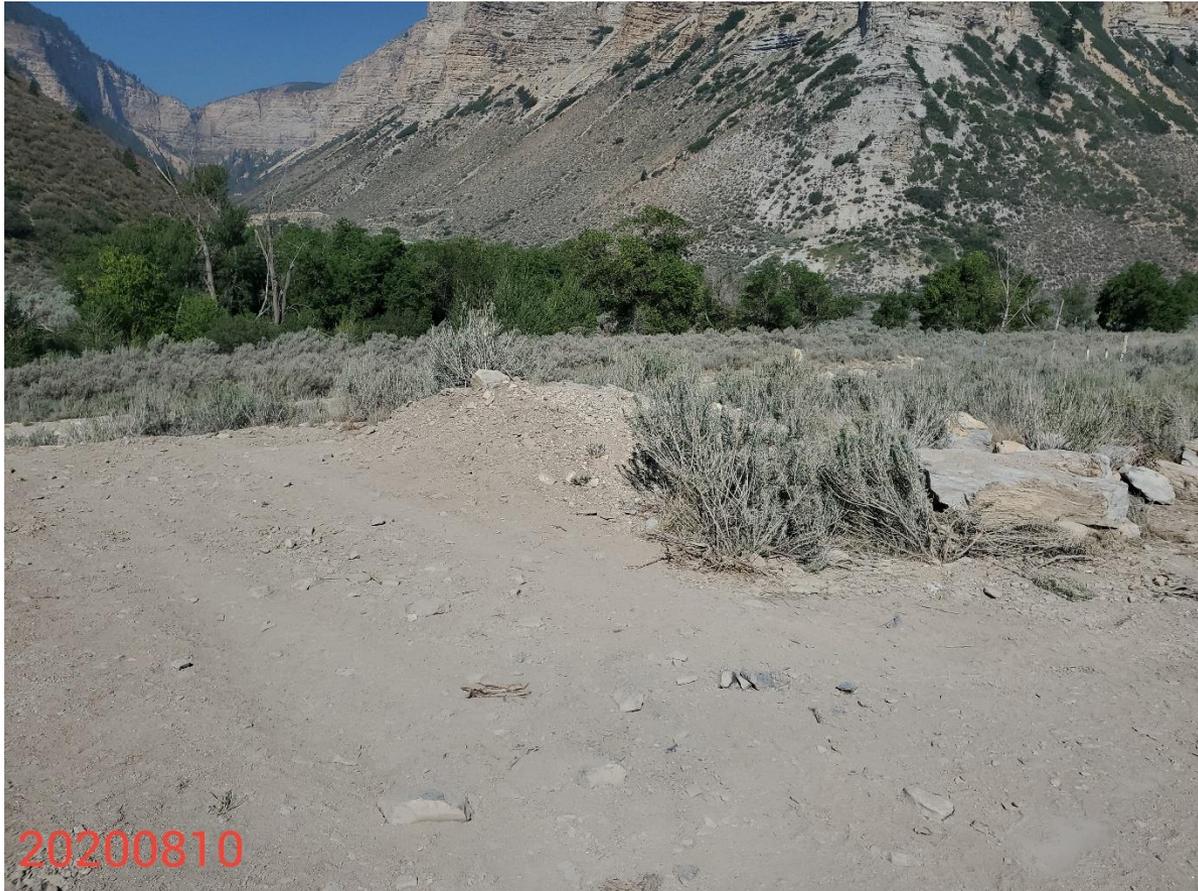
Photo 2: Photo taken from the northwest end of the Location, facing west. See comments under photo 1.

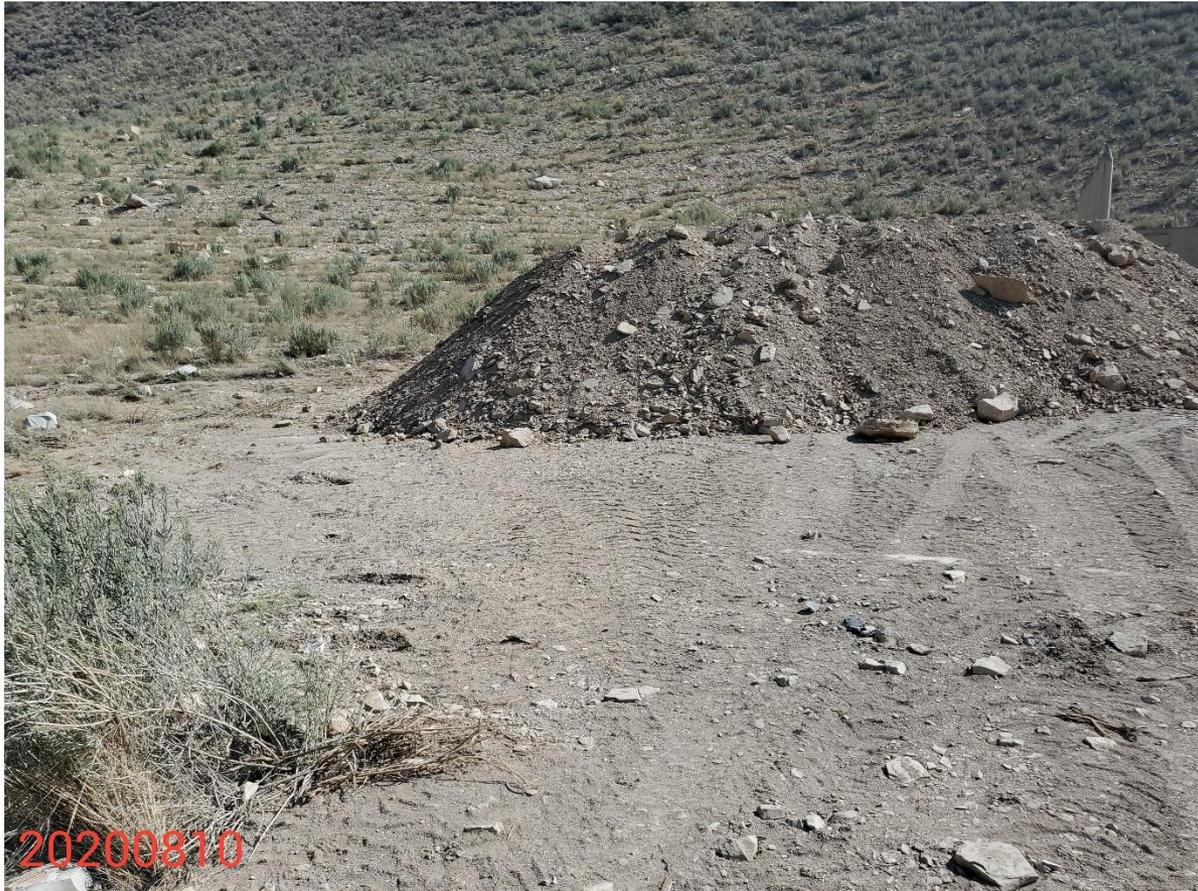
Photo 3: Photo taken from the northwest end of the Location, facing east. See comments under photo 1.

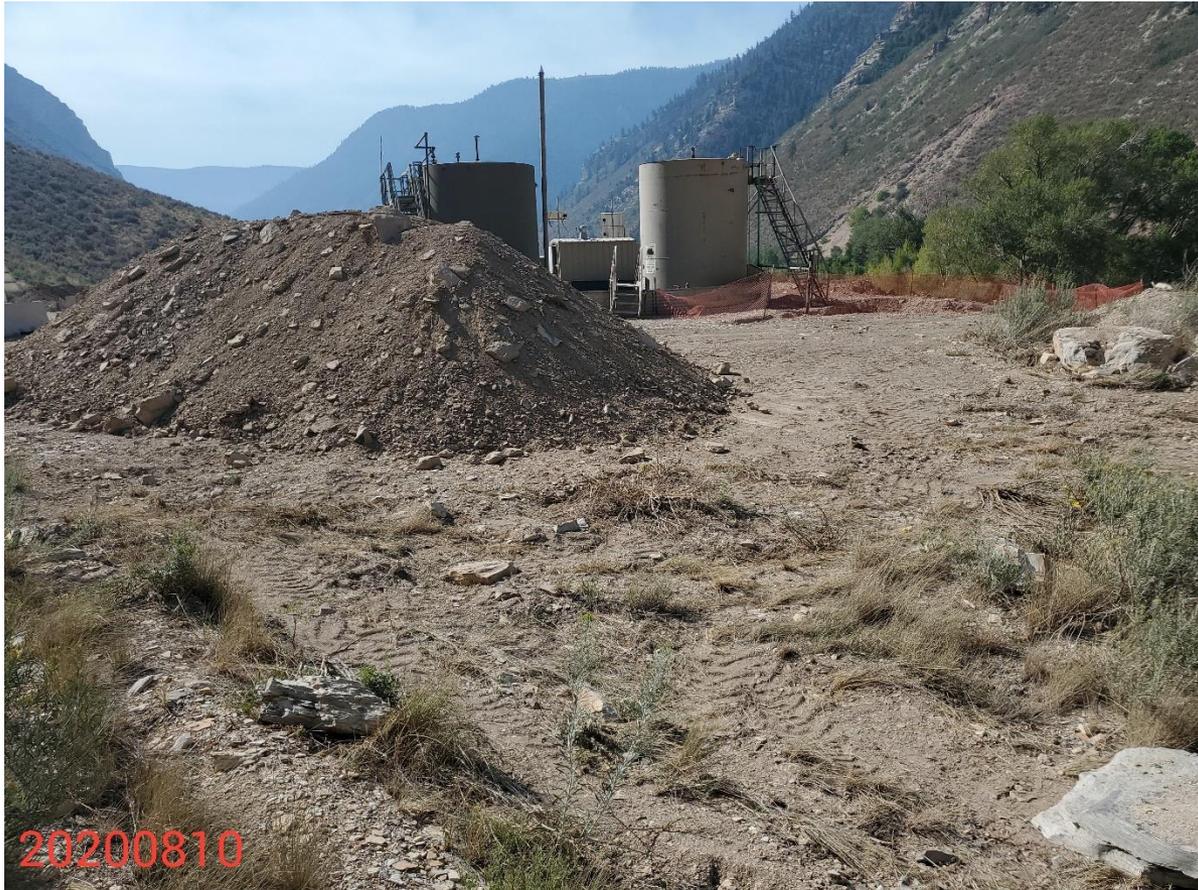
Photo 4: Photo taken from the northern interim areas, facing south. See comments under photo 1.

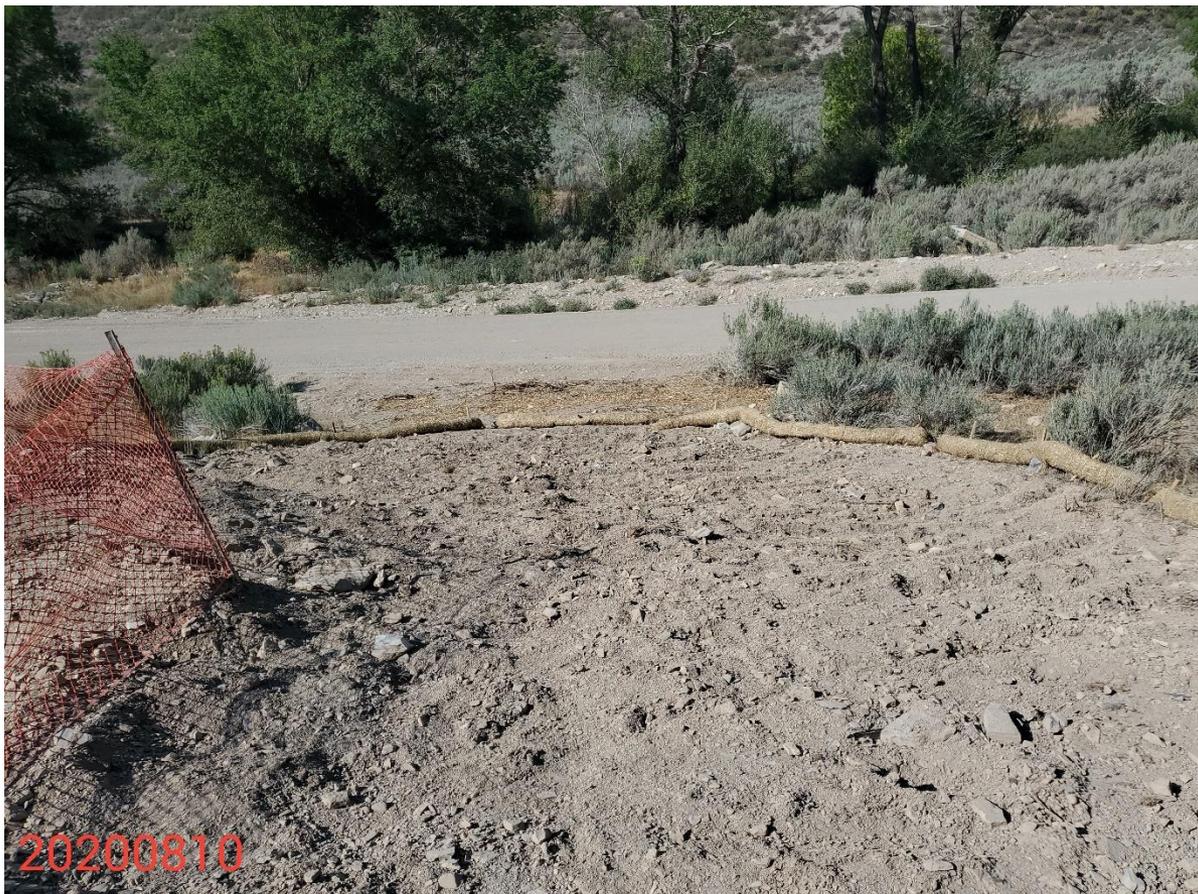
Photo 5: Photo taken from the northwest end of the Location, facing west. Photo shows Operator has implemented straw wattle BMPs; BMPs were observed to not have been installed in accordance with good engineering practices, and are not in proper functioning condition.

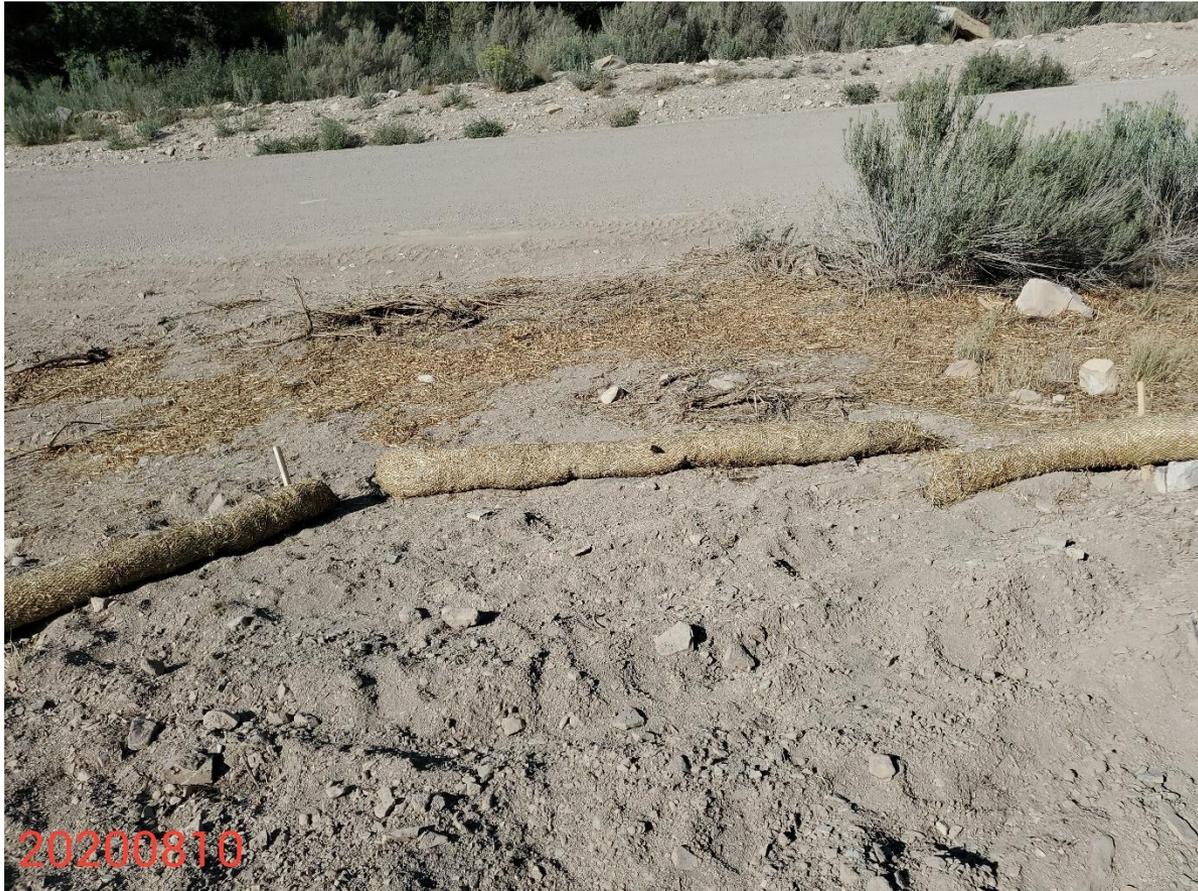
Photo 6: Continued from photo 5. Photo shows BMPs have not been installed in accordance with good engineering practices, and are not in proper functioning condition.

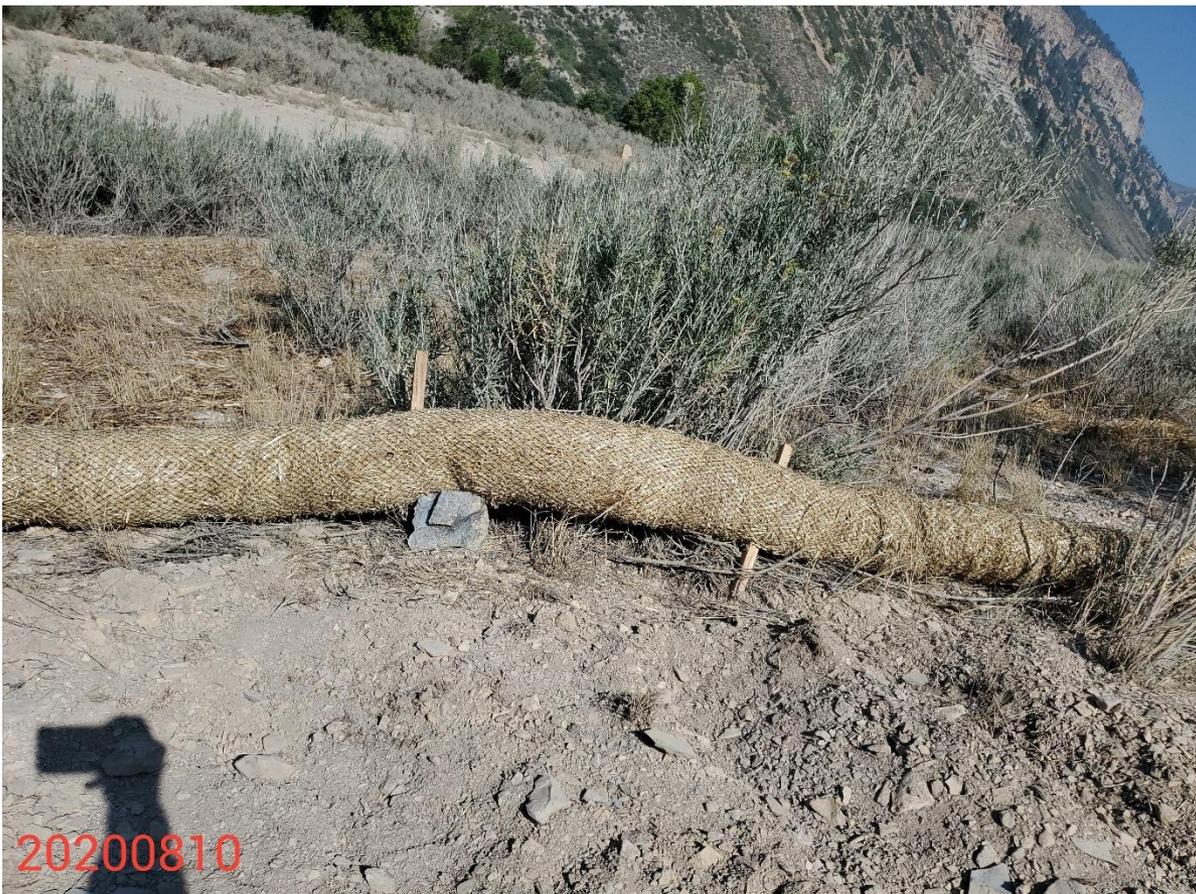
Photo 7: Continued from photo 5. Photo shows BMPs have not been installed in accordance with good engineering practices, and are not in proper functioning condition.

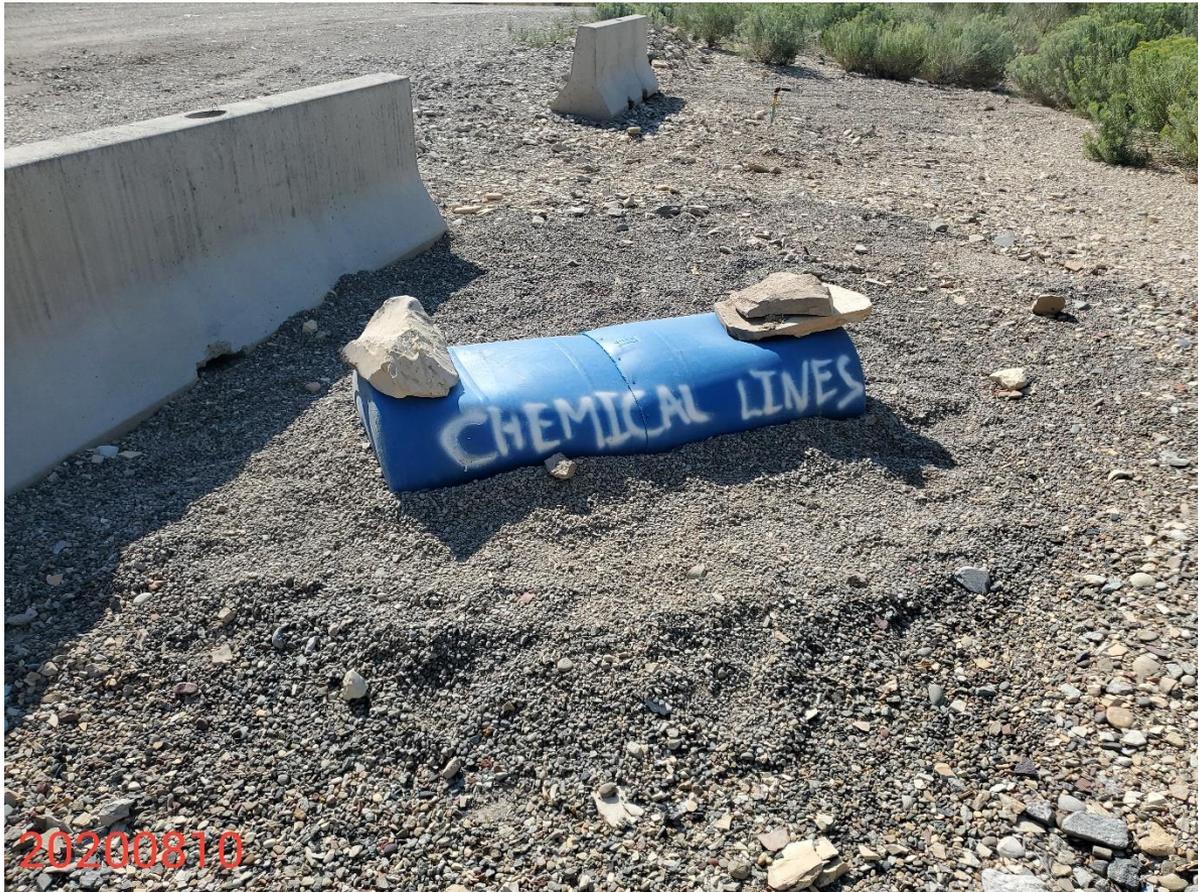
Photo 8: Photo shows a cover has been placed over piping identified as “chemical lines”. Previous inspection required Operator to identify what the equipment is for and its current application for production activities on the Location. No resolution form has been submitted per the corrective action.

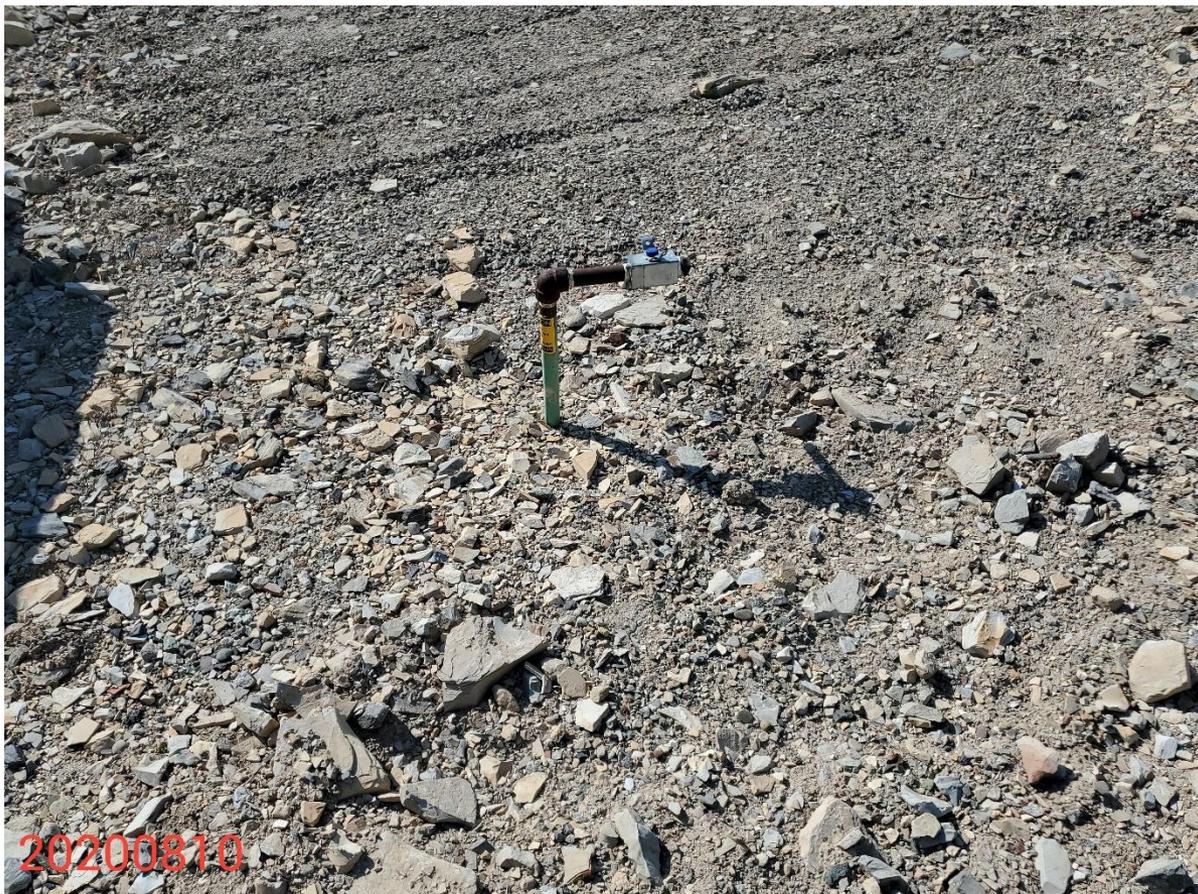
Photo 9: Photo of riser on the west end of the Location. Previous inspection required Operator to identify what the equipment is for and its current application for production activities on the Location. No resolution form has been submitted per the corrective action.
