Final Reclamation Inspection

Operator: CRESTONE PEAK RESOURCES OPERATING LLC - 10633

Location ID: 330822

Inspection Photos
Location Name: HINGLEY FARMS #32-18
Location ID: 330822

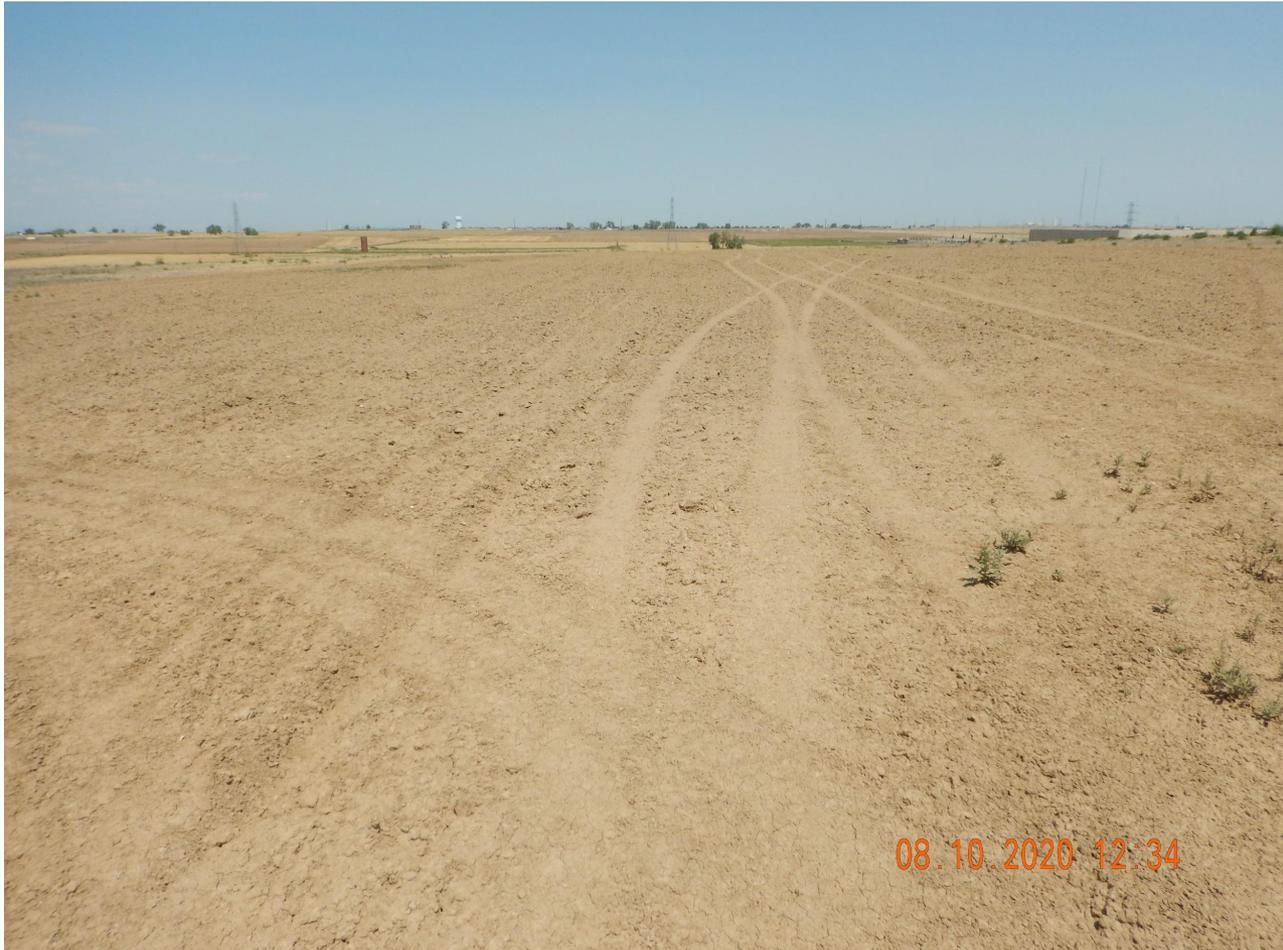
Photo 1. Photo taken from the southern location, facing North. Photo illustrates all equipment has been removed and it appears seedbed prep has been performed.

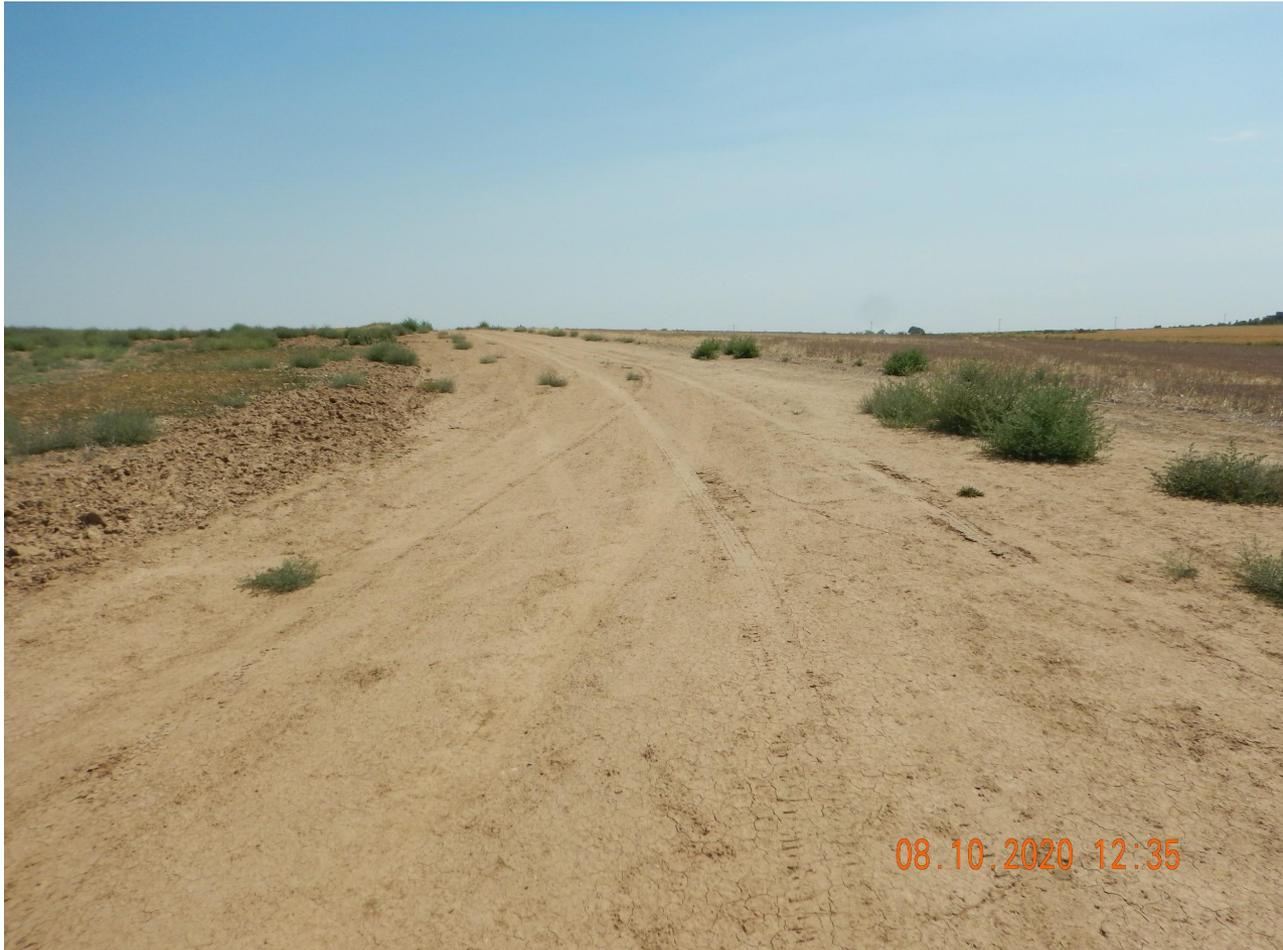
Photo 2. Photo taken from the southern location, facing East. Photo illustrates a portion of the access road may have been decompacted. Operator will remain responsible for complying with Rule 1004 for all disturbance areas - refer to Photo 3.

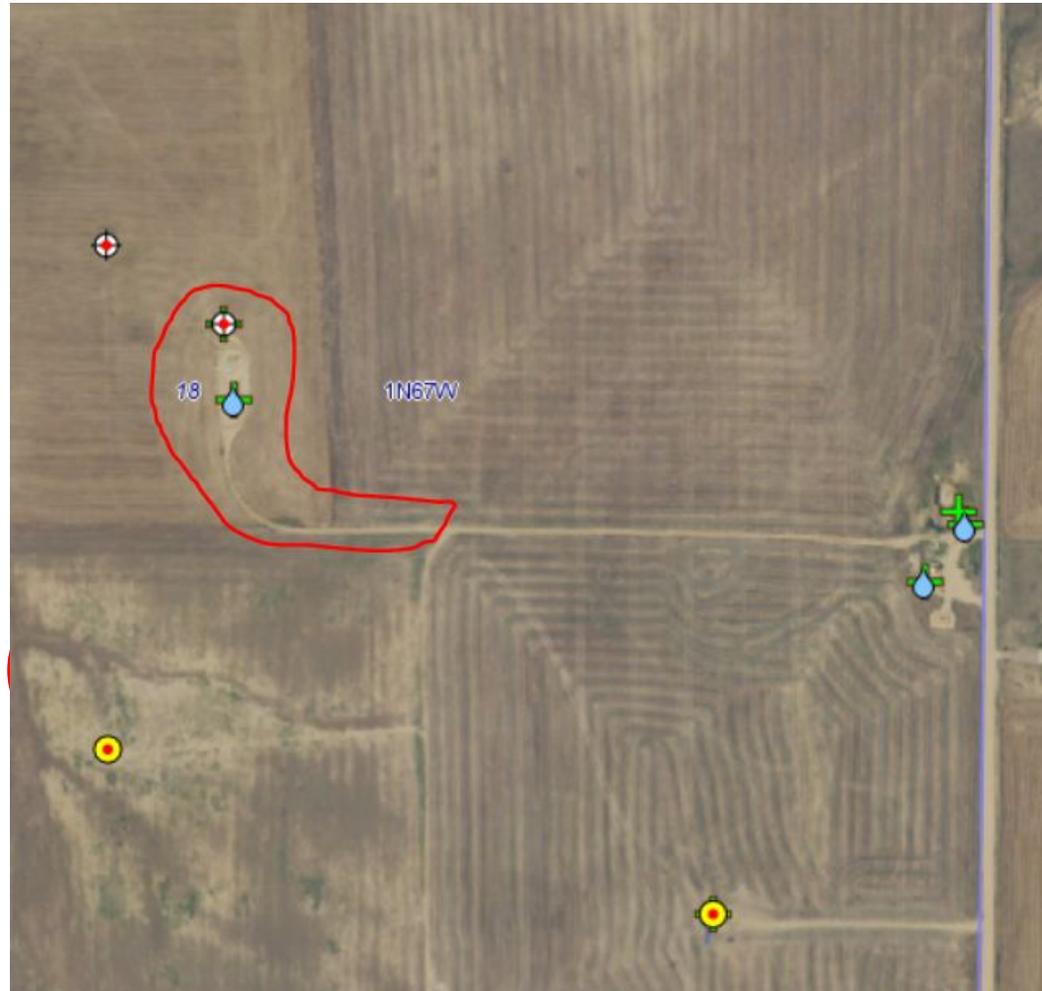
Photo 3. 2017 aerial imagery illustrates the area of disturbance that the Operator is responsible for. Note: there are other active nearby wells which are using other portions of the shared access road.
