**RE: Tiffany Gathering  
July 2020 Vegetation Monitoring**

**Tiffany Gathering**  
**July 2020**  
**Vegetation Monitoring Map**  
**BP America Production Co.**

**Tiffany Gathering  
Vegetation Monitoring  
Photographic Log  
BP America Production Co.**

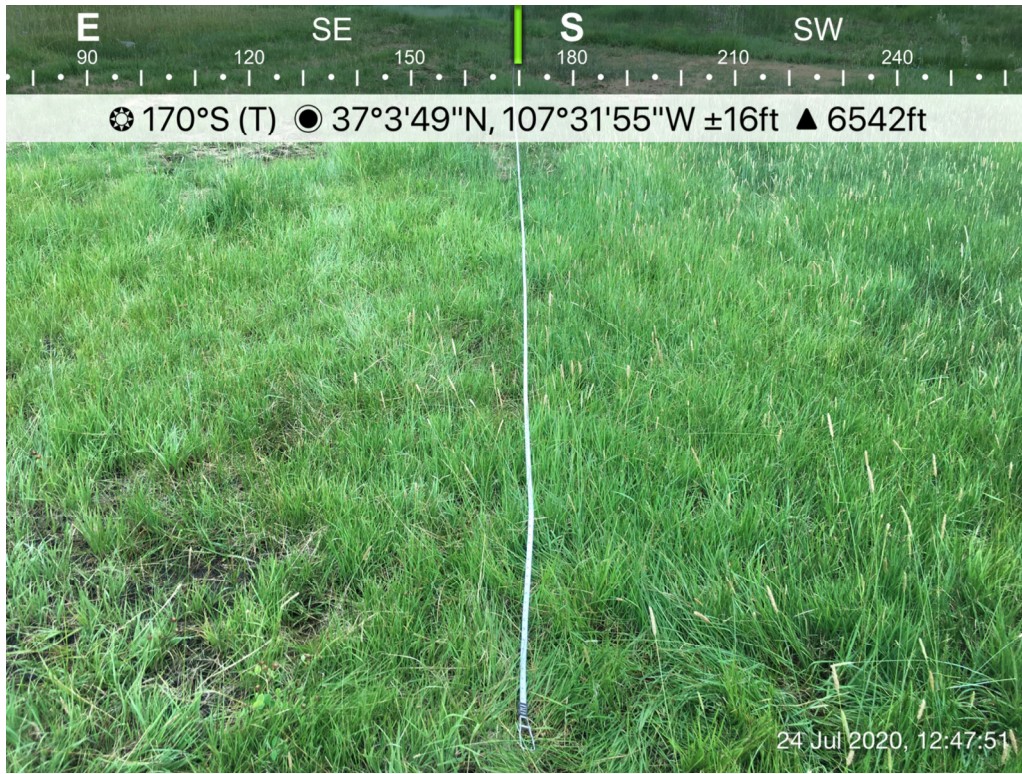
Photo 1: Start of Transect 1, 7/24/2020.

Vegetation cover was 68% in Transect 1 and 100% in Transect 2 in the July 2020 vegetation monitoring event, which is a 26% increase in vegetation cover in Transect 1 and a 10% increase in vegetation cover in Transect 2 from the June 2020 monitoring event. Bare ground made up 18% of Transect 1 and there was no bare ground observed in Transect 2, which is consistent with the June 2020 monitoring event. Transect 1 was saturated due to flood irrigation. Transect 2 was located within an irrigation-influenced wetland area with flowing water.

% Vegetation Cover (top canopy intercepts) = 68%

% Bare Ground\* = 18%

Vegetation along the transect was consistent with seasonal and surrounding conditions.

Soil was saturated due to flood irrigation.

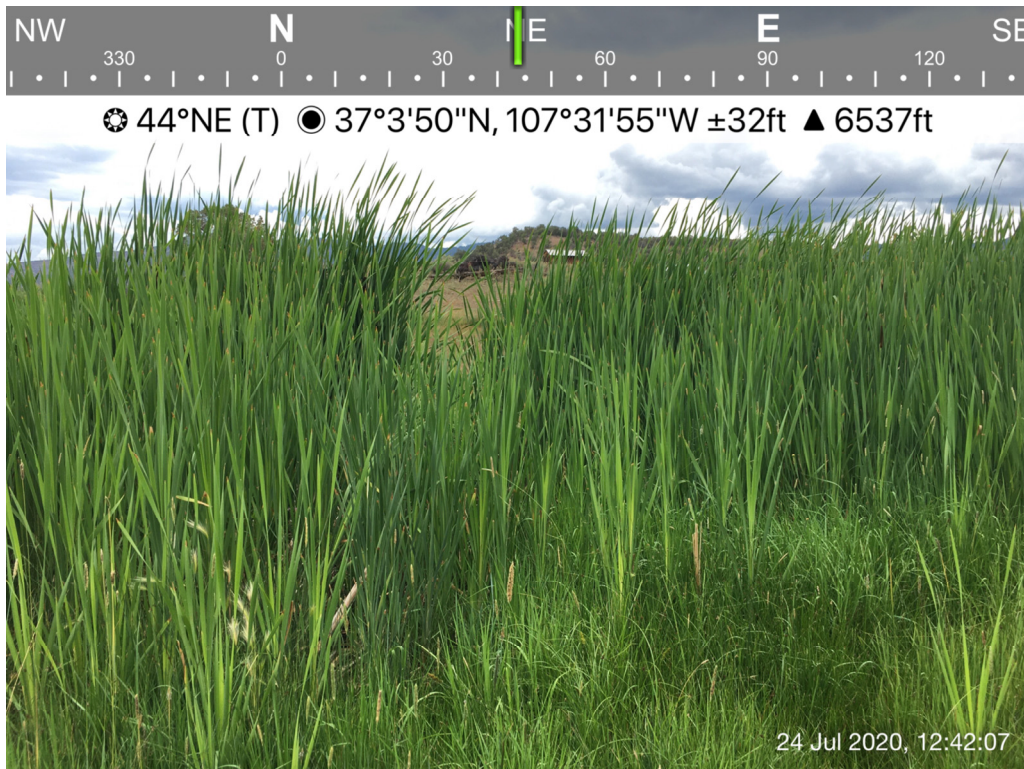
Photo 2: Start of Transect 2, 7/24/2020.

% Vegetation Cover (top canopy intercepts) = 100%

% Bare Ground\* = 0%

Vegetation along the transect was consistent with seasonal and surrounding conditions.

Transect is located in an irrigation-influenced wetland with flowing water.
