Inspection Photos
Operator: BP America
API: 067-07204
Date: 8/11/2020

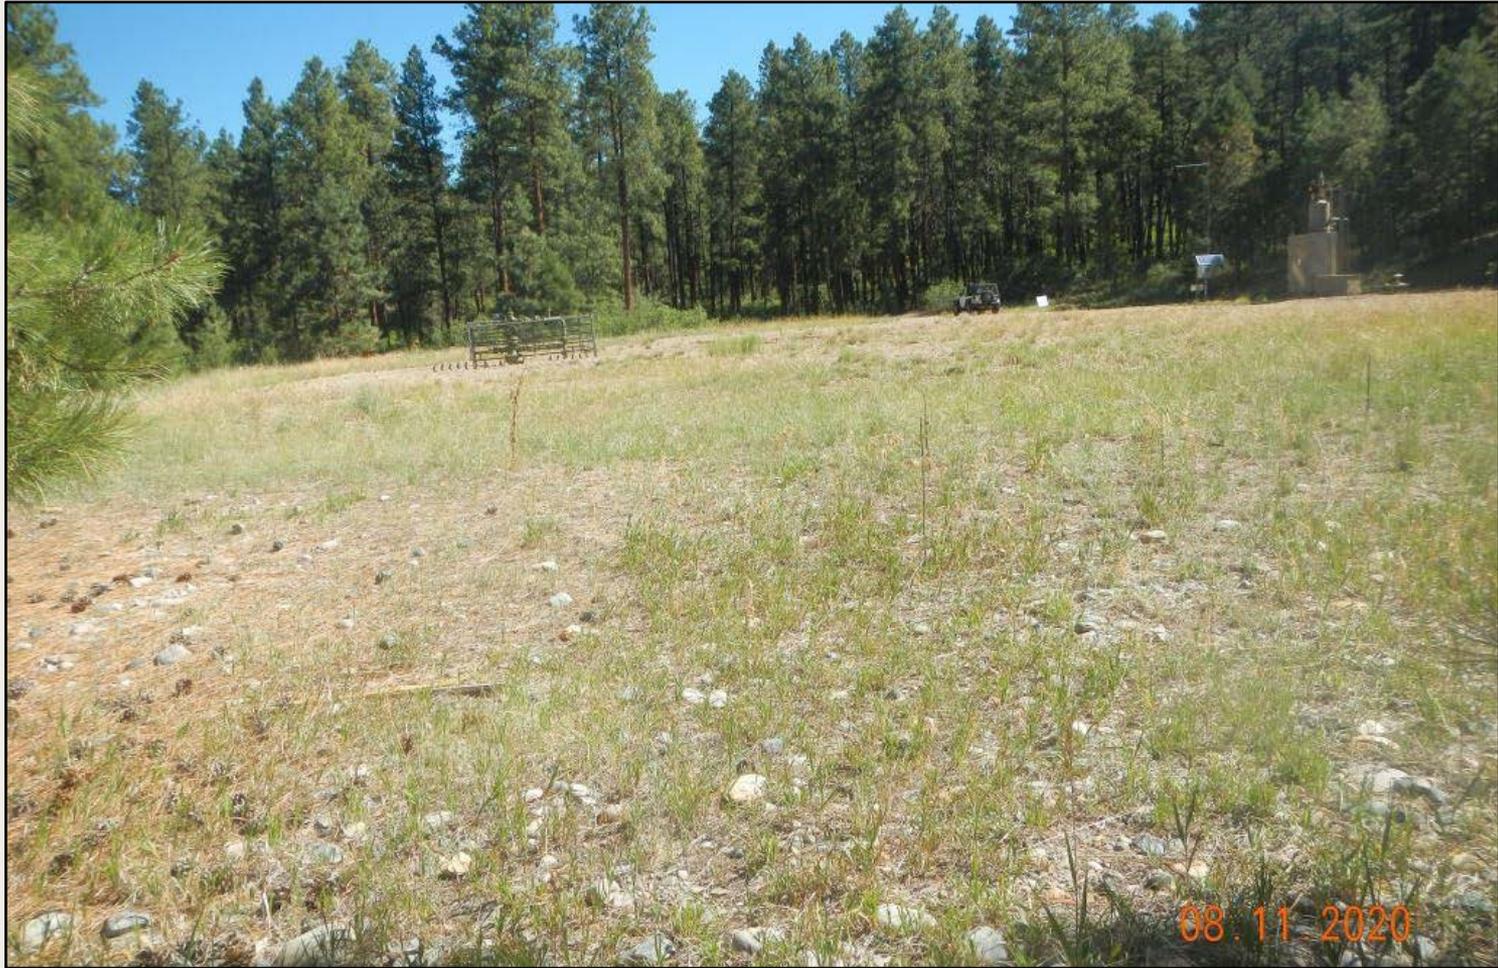
Photo 1. View of the project area from the southwestern corner facing center.

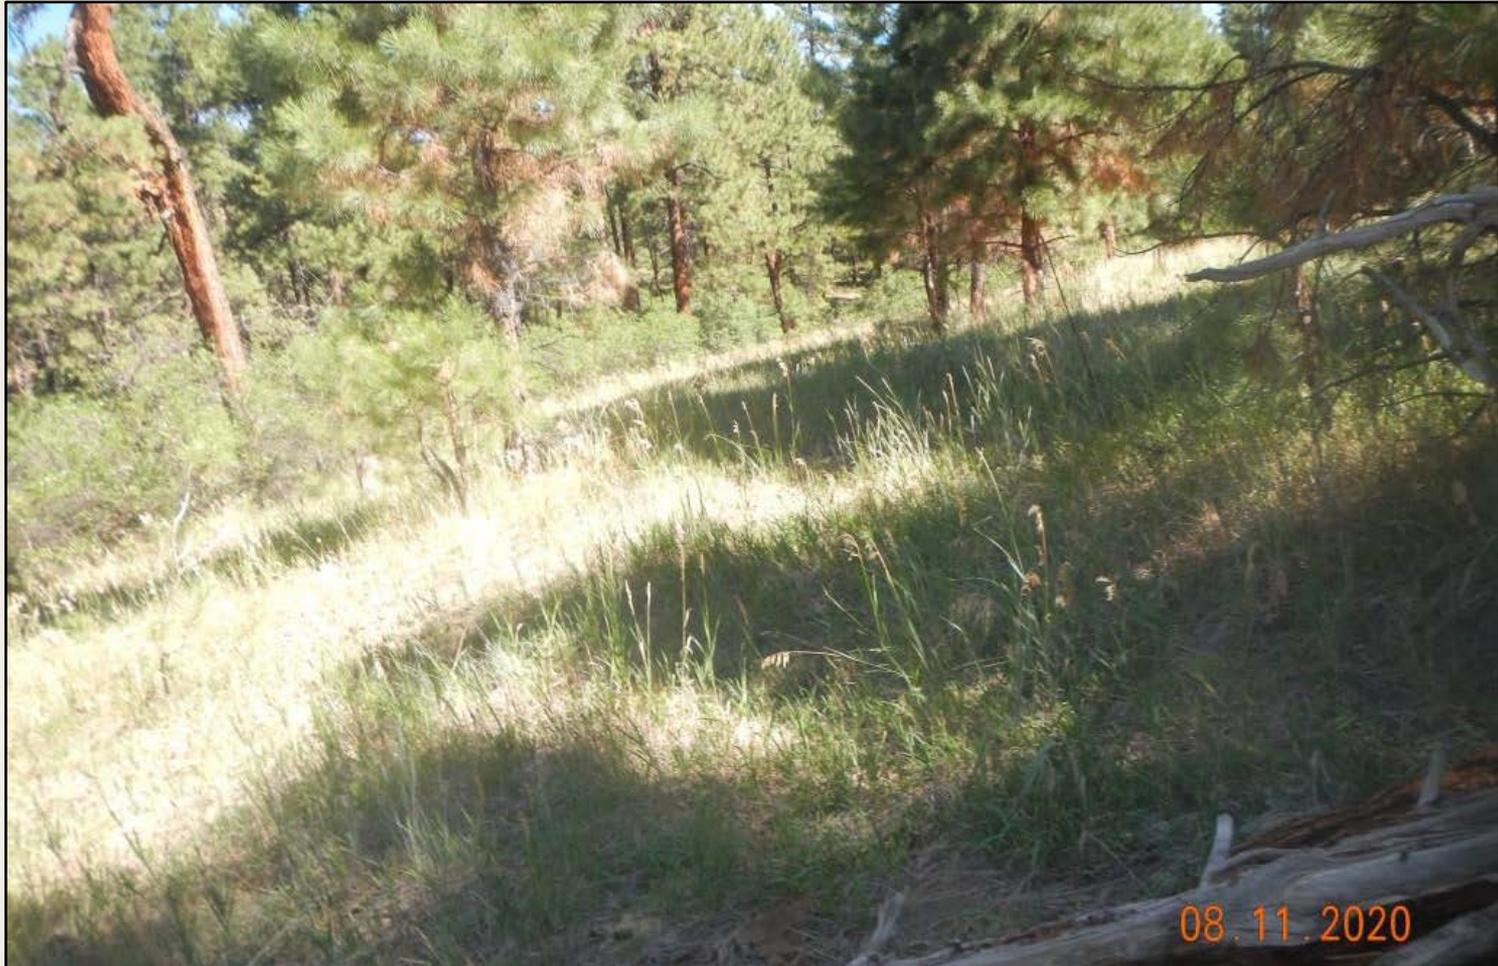
Photo 2. View of the western portion of the project area from the southwestern corner facing northward. Revegetation is progressing with western wheatgrass, smooth brome, sand dropseed, and scattered ponderosa pine trees.

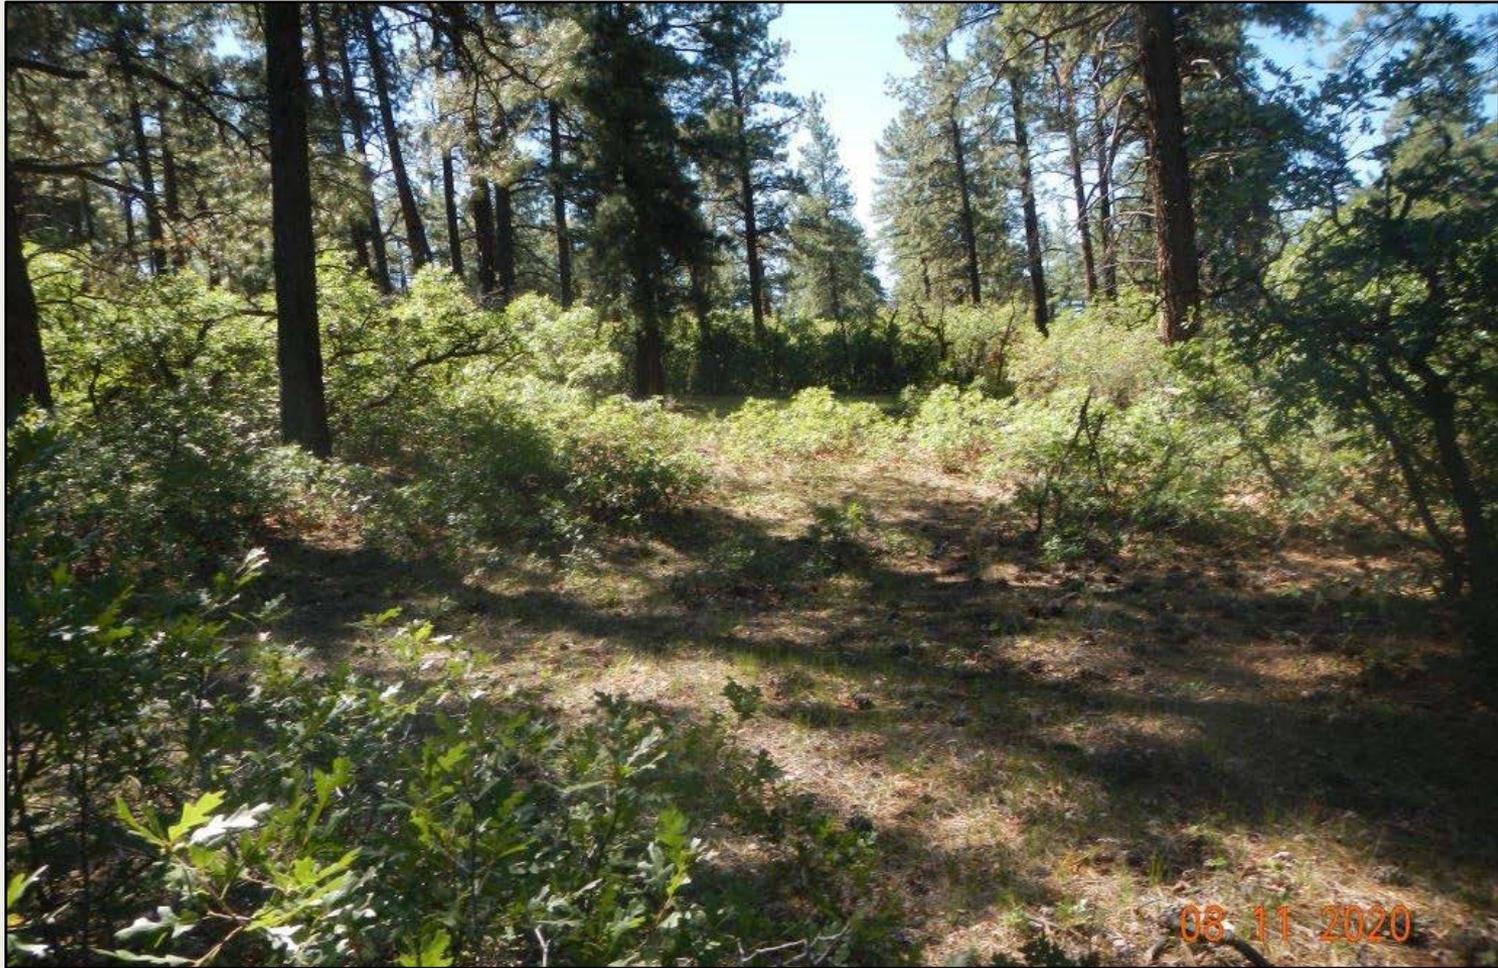
Photo 3. View of reference area comprised of ponderosa pine woodland with gambel oak understory, along with grasses and forbs such as sandberg bluegrass and yarrow.
