**Inspection Photos**  
**Operator: BP America**  
**API: 067-06507**  
**Date: 8/11/2020**

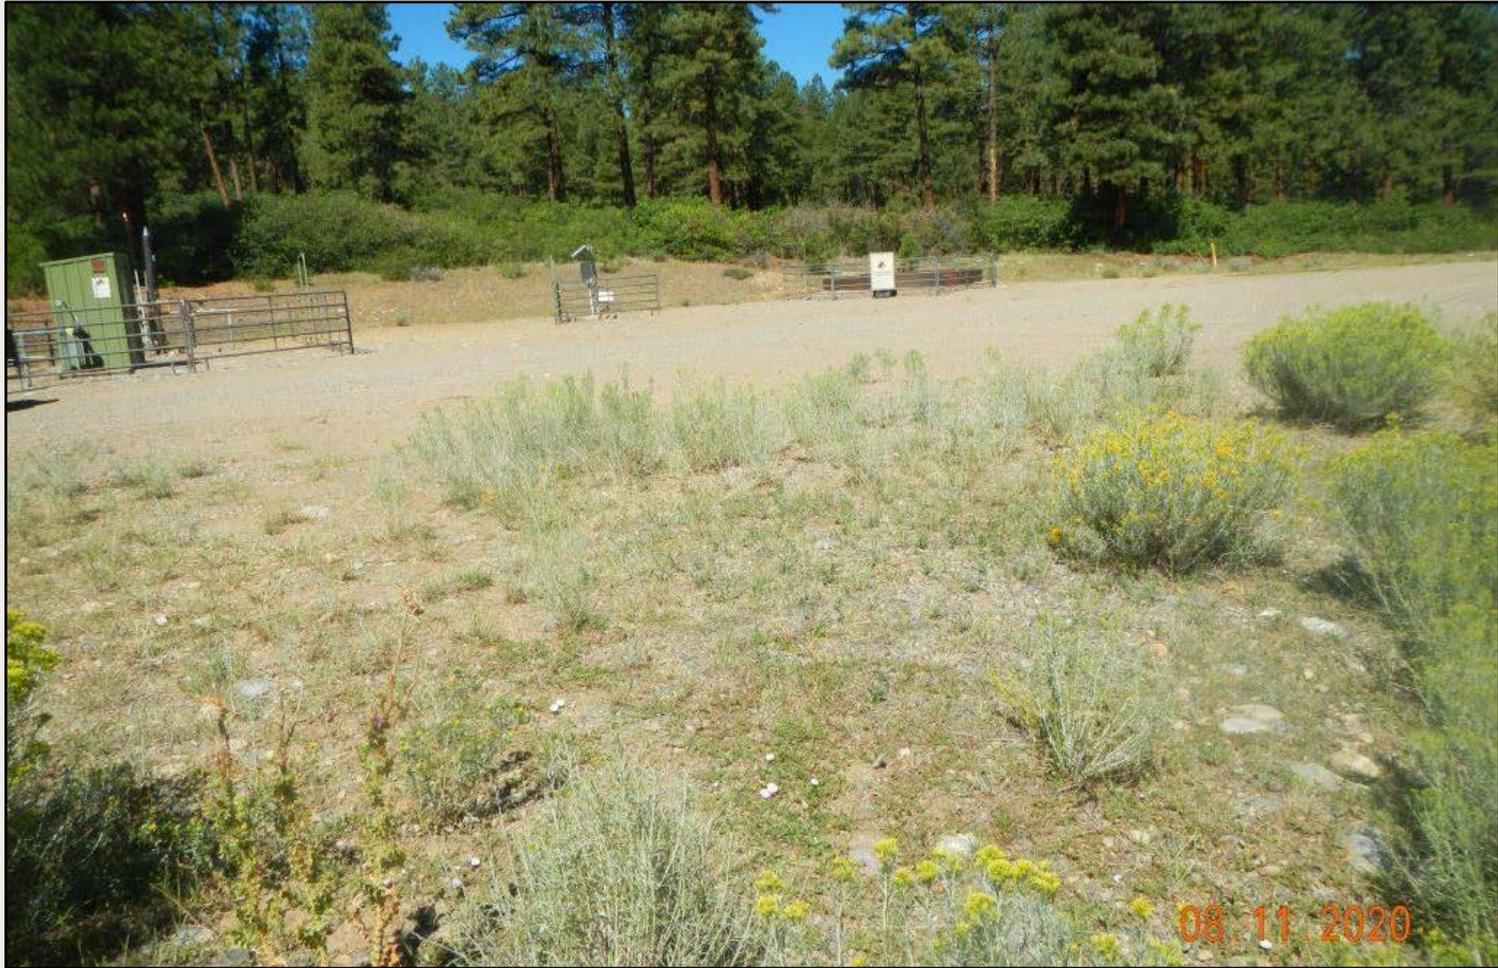
Photo 1. View of the project area from the southeastern corner facing center.

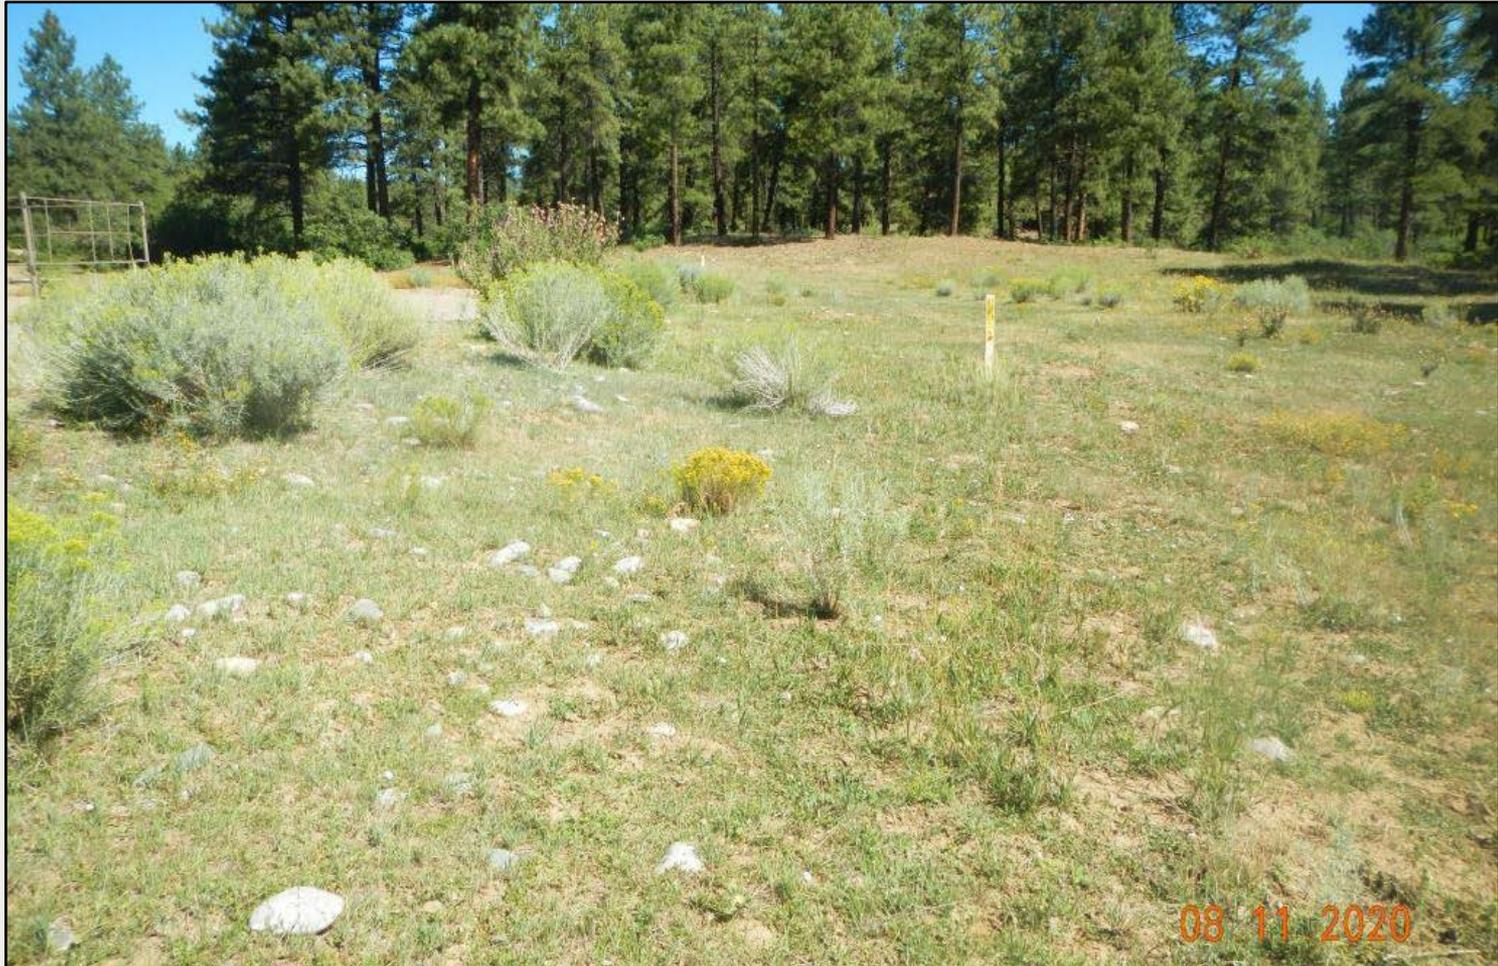
Photo 2. View of the eastern portion of the project area from the southeastern corner facing northward. Revegetation is progressing with western wheatgrass, smooth brome, and rubber rabbitbrush.

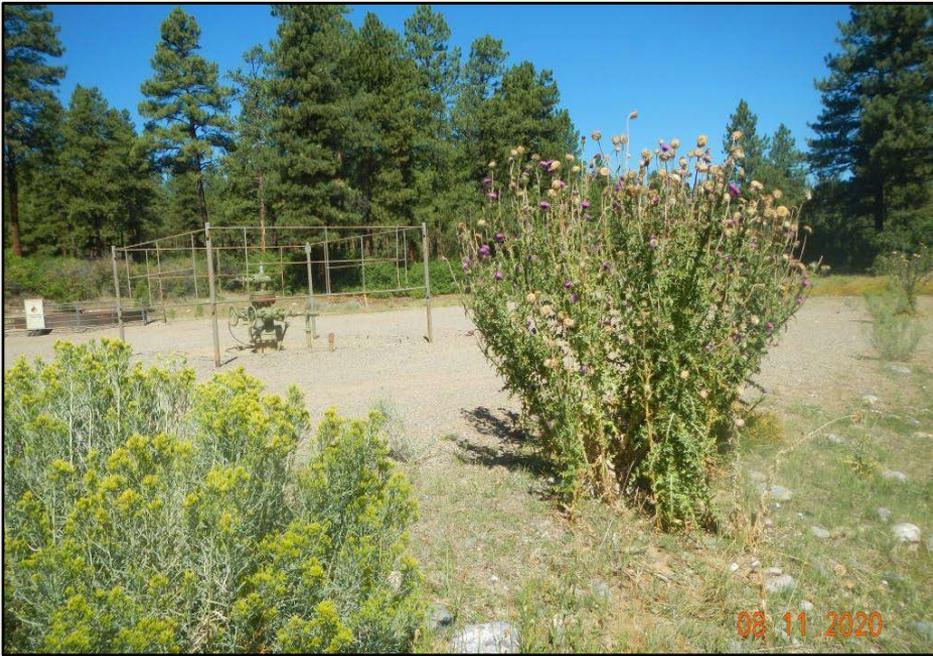
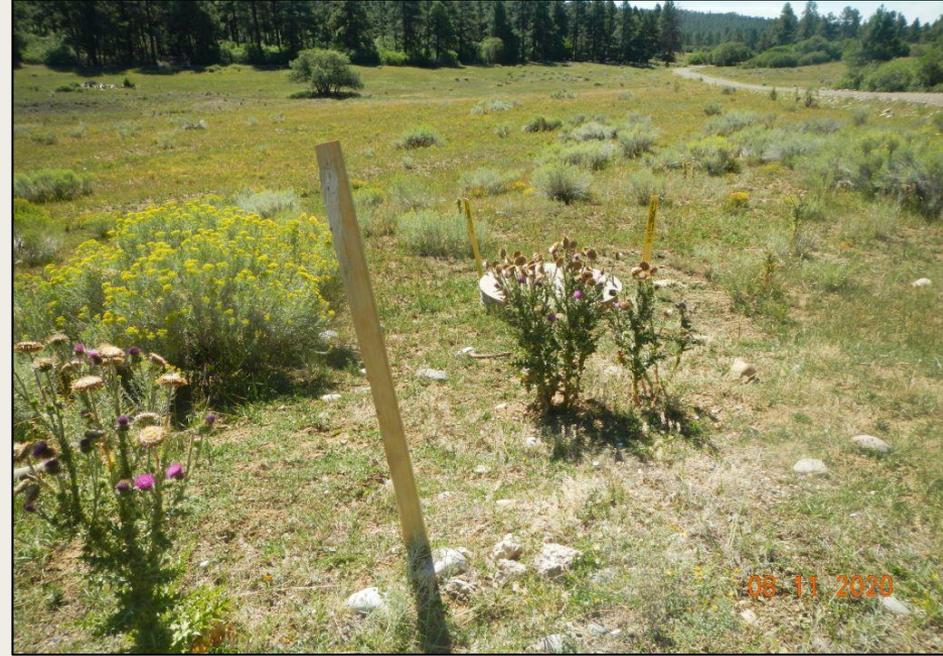
Photos 3/4. View of musk thistles within the project area in flowering/seedling vegetative condition.

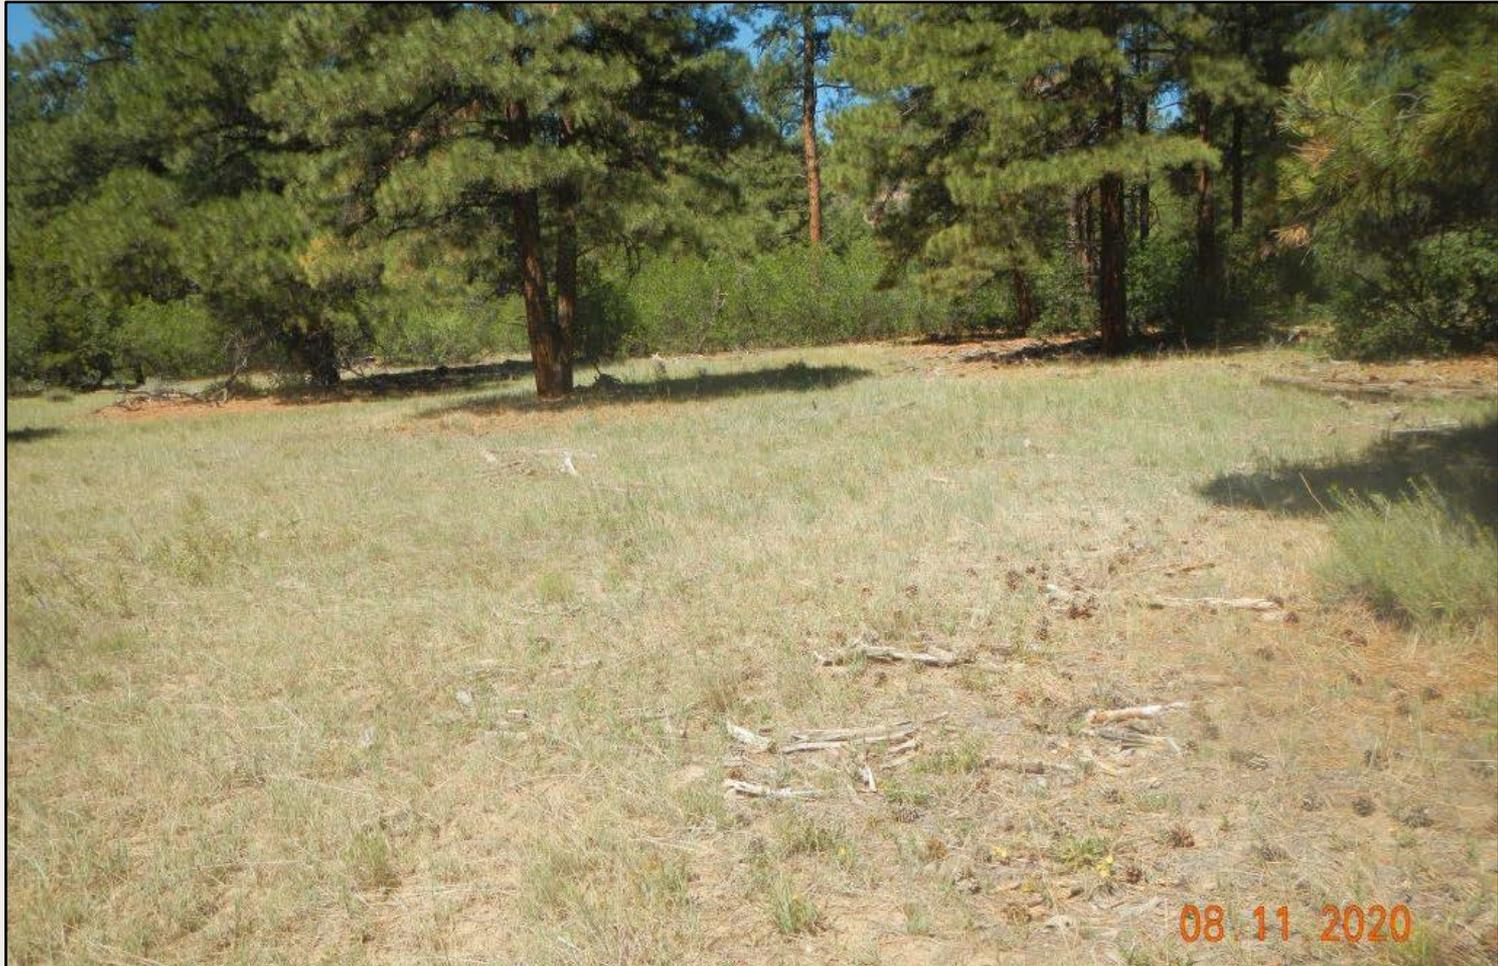
Photo 5. View of reference area comprised of ponderosa pine woodland and gambel oak shrubland, with a mosaic of sagebrush shrubland and open grassland comprised of fringed sage, black sage, smooth brome, and western wheatgrass.
