# Inspection Photos

API: 063-06045

Operator: CITATION OIL & GAS CORP

Inspection Date: 8/11/2020

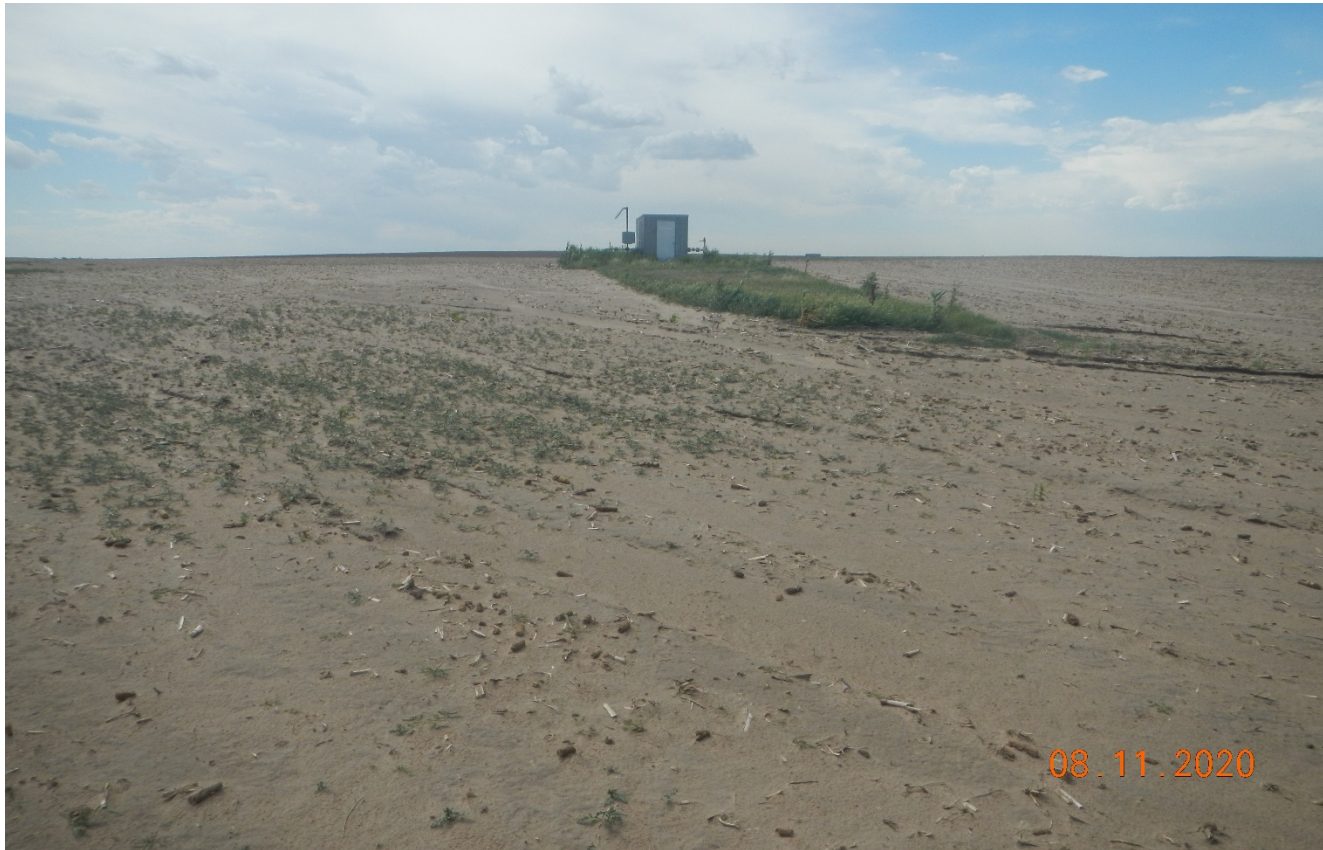
**Photo 1.** Facing northwest toward the location. The meter shed still remains at the location and the area is being farmed around where equipment remains.

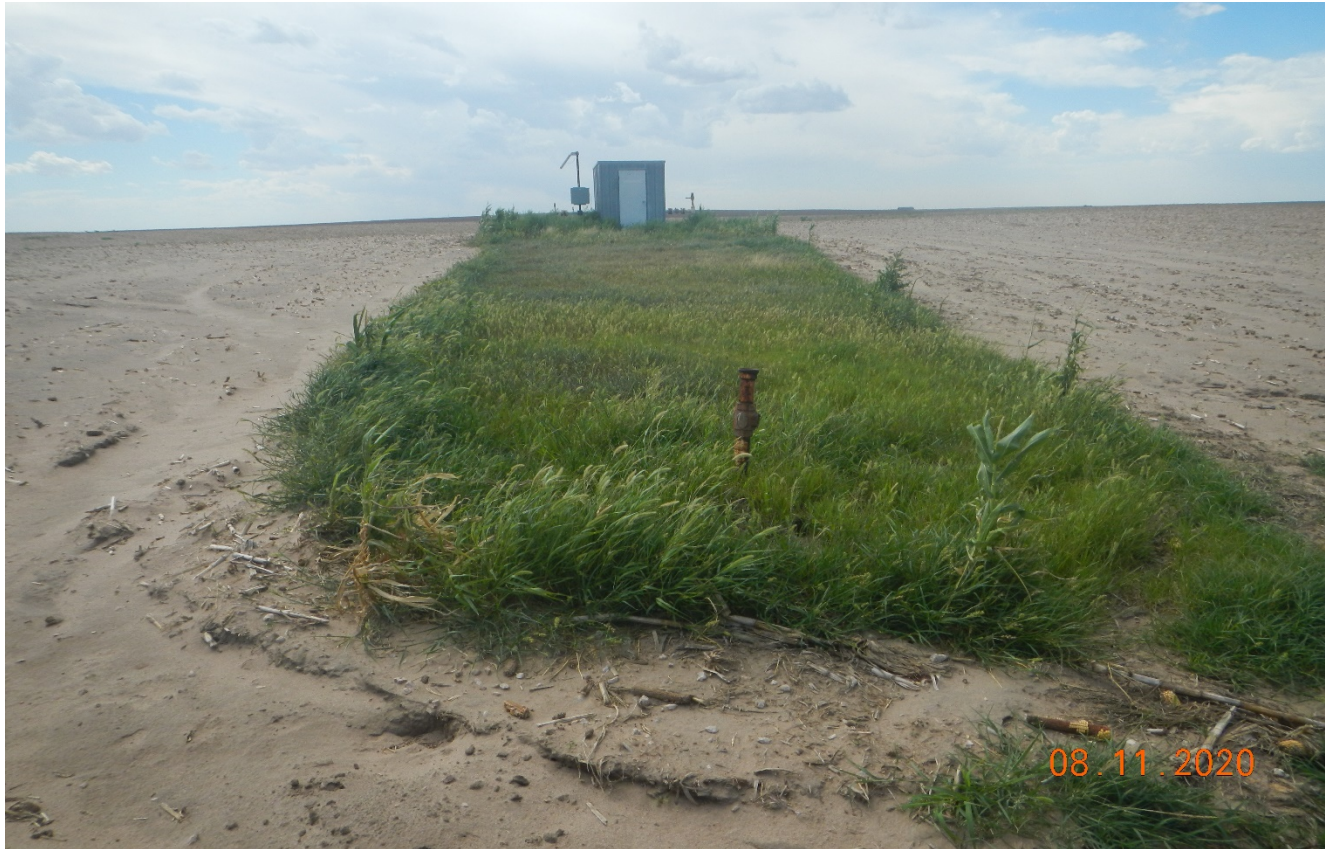
**Photo 2.** Facing west toward the location. The meter shed and pipe riser still remain which is interfering with farming operations.

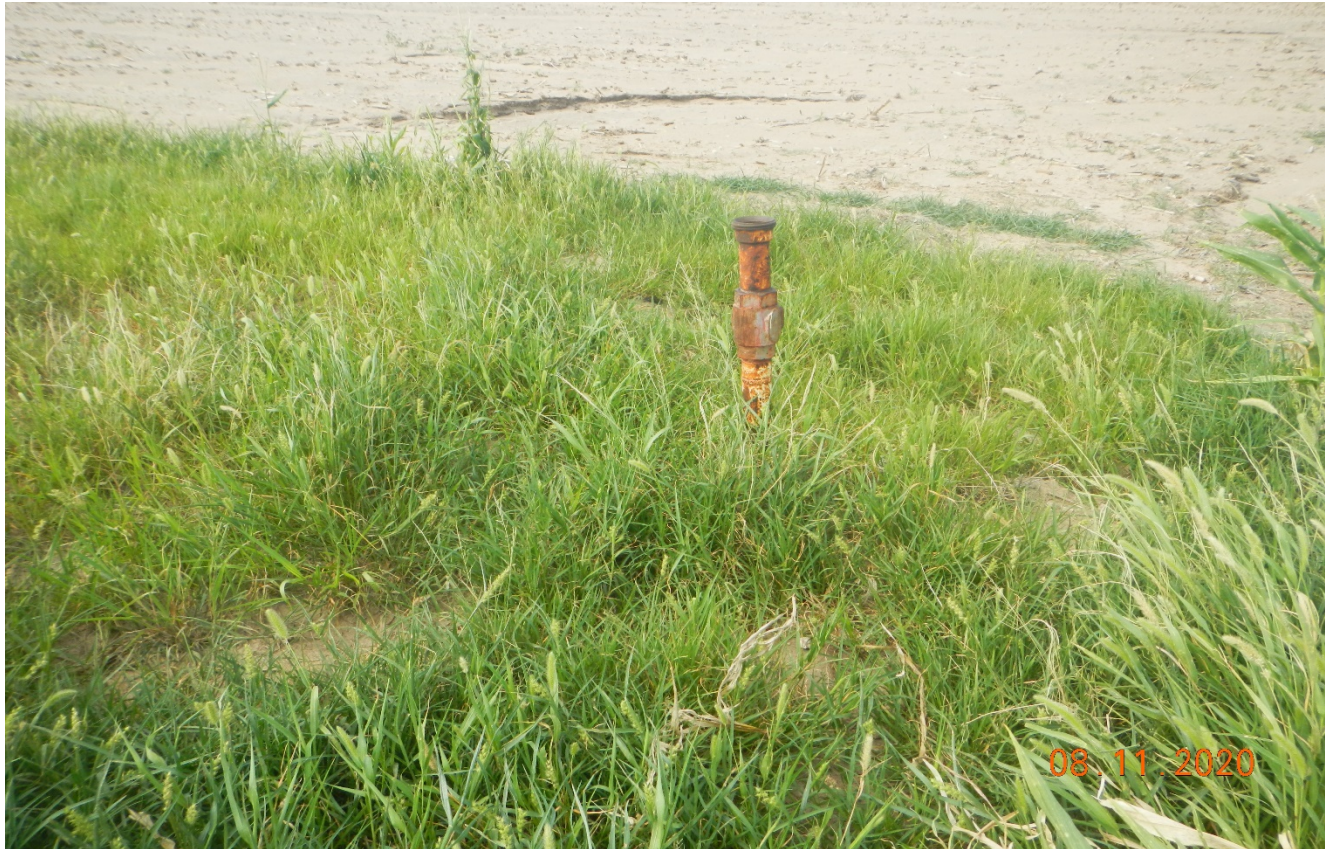
**Photo 3.** A pipe riser remains at Lat/Long:39.07978,-102.38848.

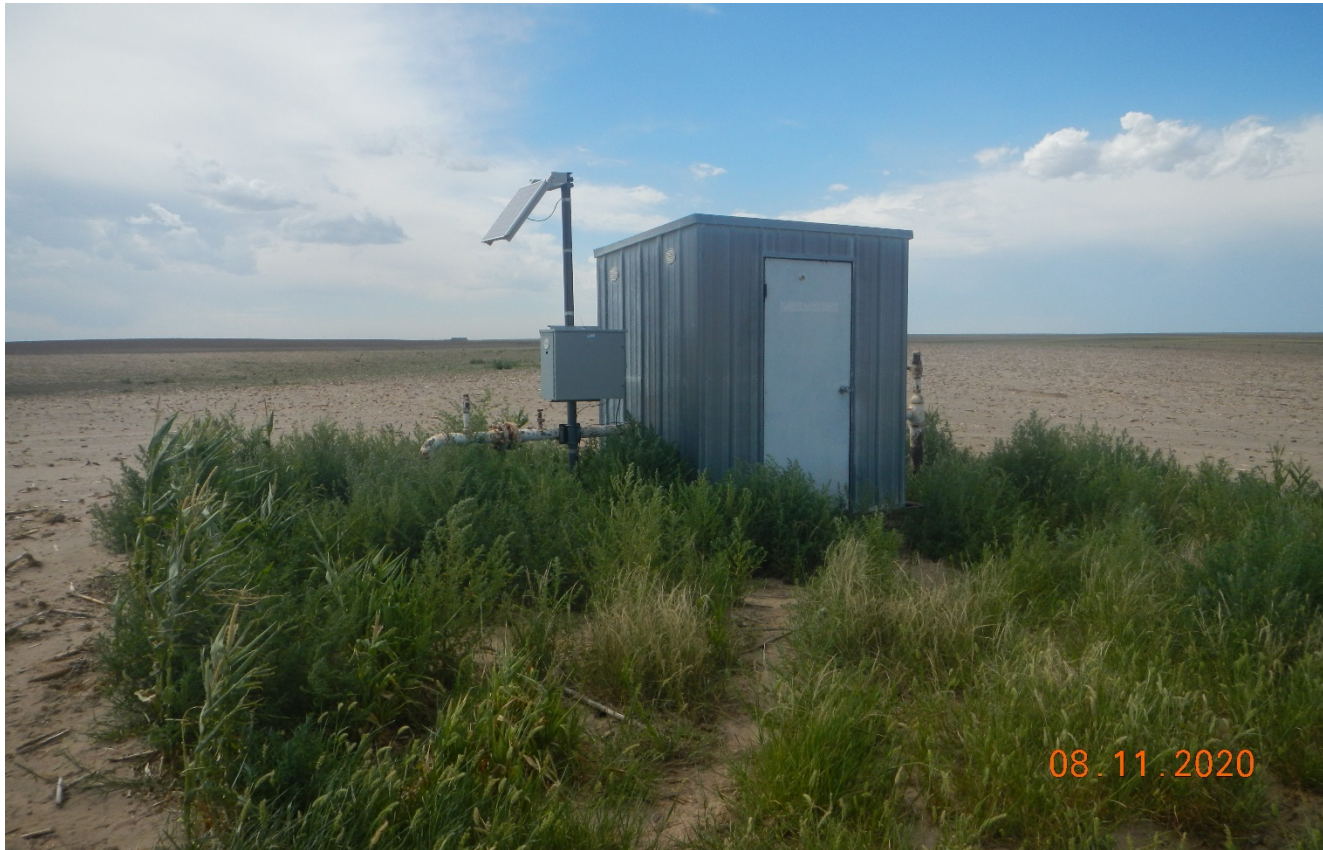
**Photo 4.** The meter shed remains at the location which is interfering with farming operations.

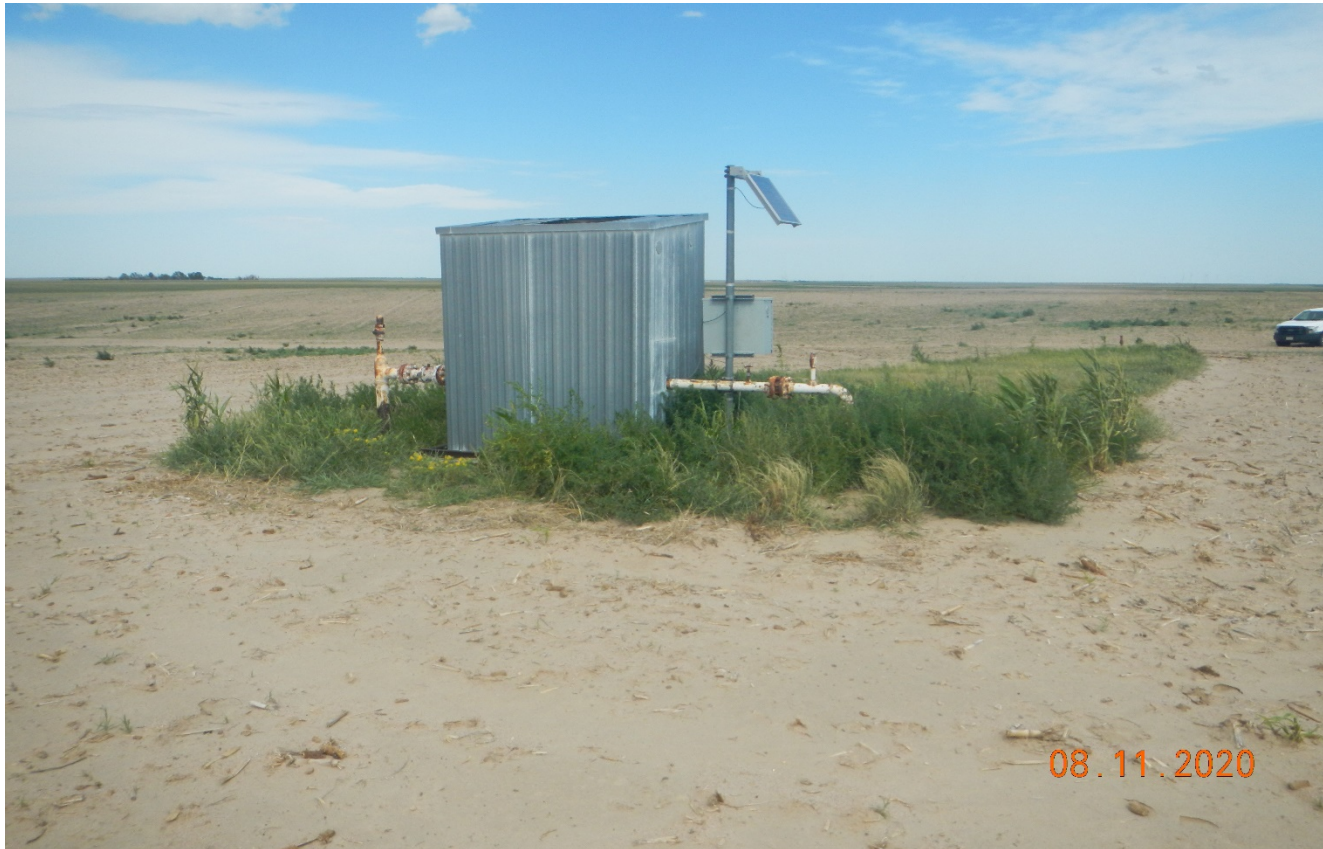
**Photo 5.** Facing northeast toward the meter shed. All equipment should have been removed within 3 months of plugging the well.
