Interim Reclamation and Stormwater Inspection

Operator: EXTRACTION OIL & GAS INC - #10459

Location ID: 428627

Inspection Photos
Location Name: BROMLEY /32-32
Location ID: 428627

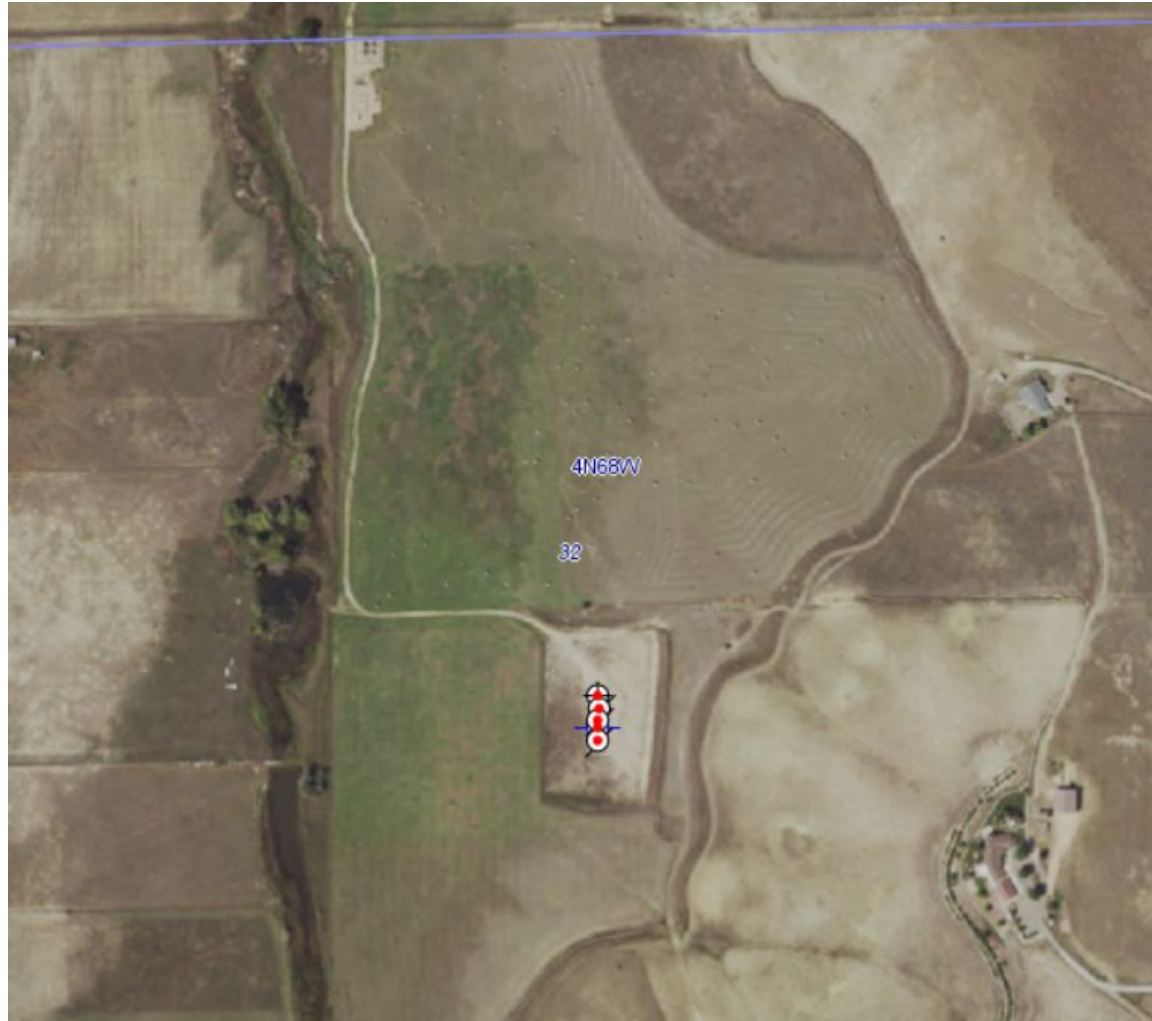
Photo 2. COGCC GISOnline aerial imagery taken 2017. Imagery illustrates the Operator has failed to perform interim reclamation at the well location. Refer to Photos 3-5 confirming interim reclamation has never been performed.

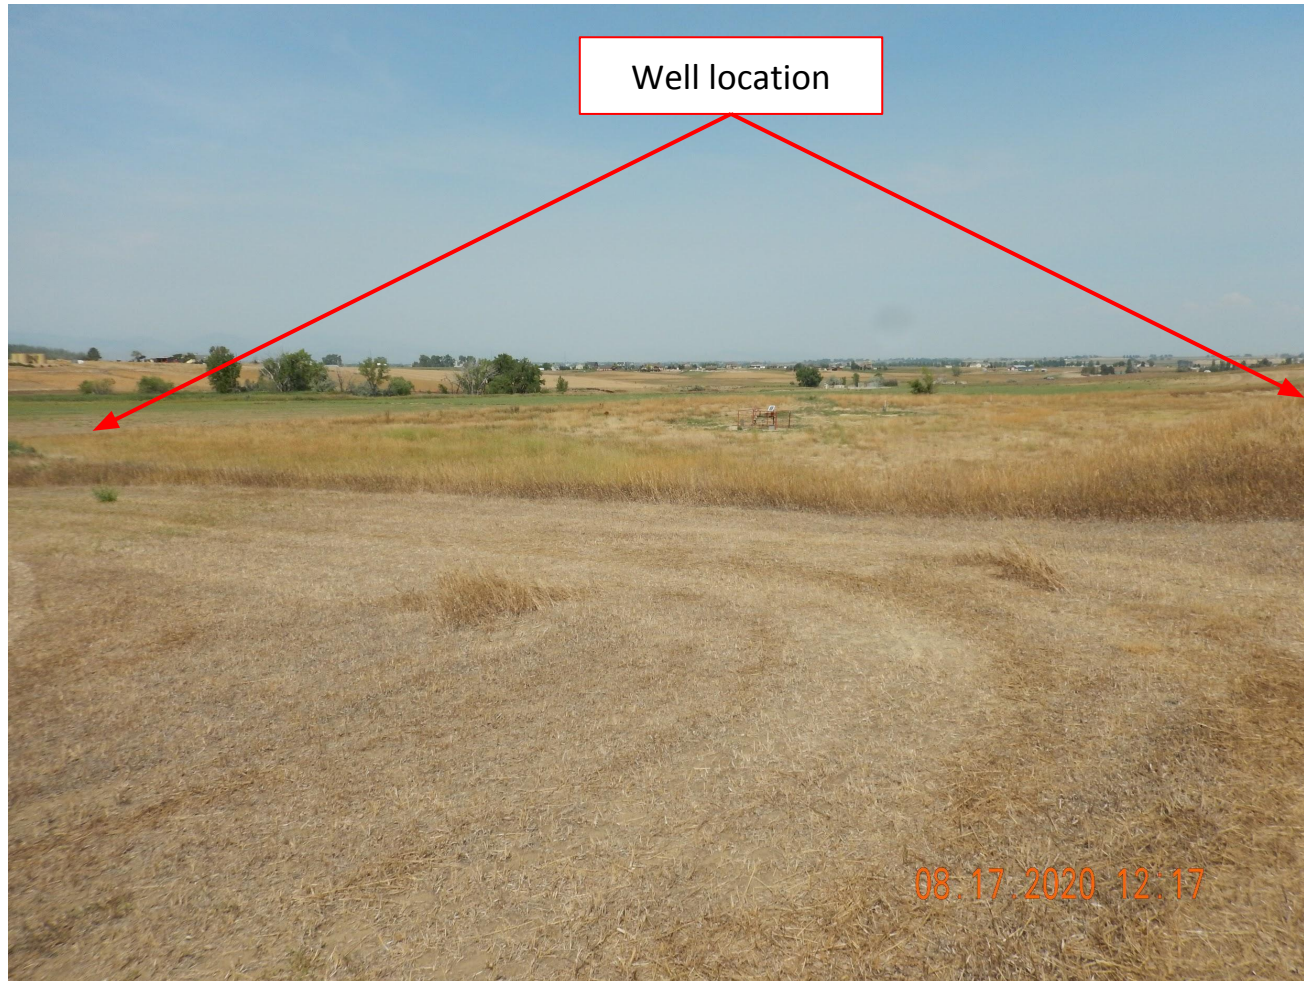
Photo 3. Photo taken south of the well location, facing North. Photo illustrates the Operator has failed to perform interim reclamation activities.

Photo 4. Photo taken south of the well location, facing Northwest. See comments under Photo 3.

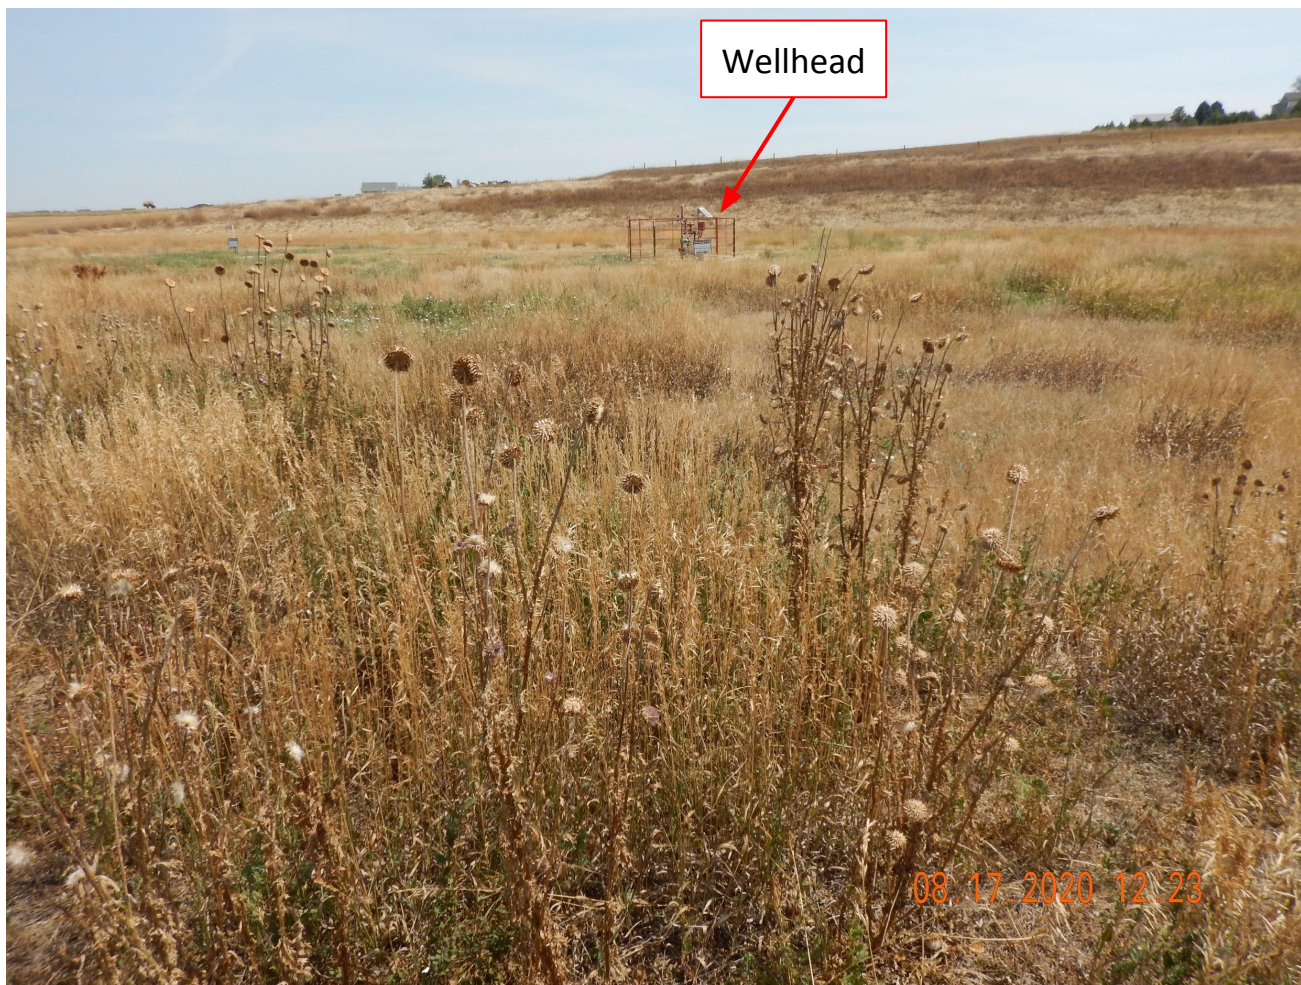
Photo 6. Photo taken from the western well location, facing East. Photo illustrates an unmanaged List B Colorado noxious weed, Musk thistle, which has already flowered and has mostly all set seed.

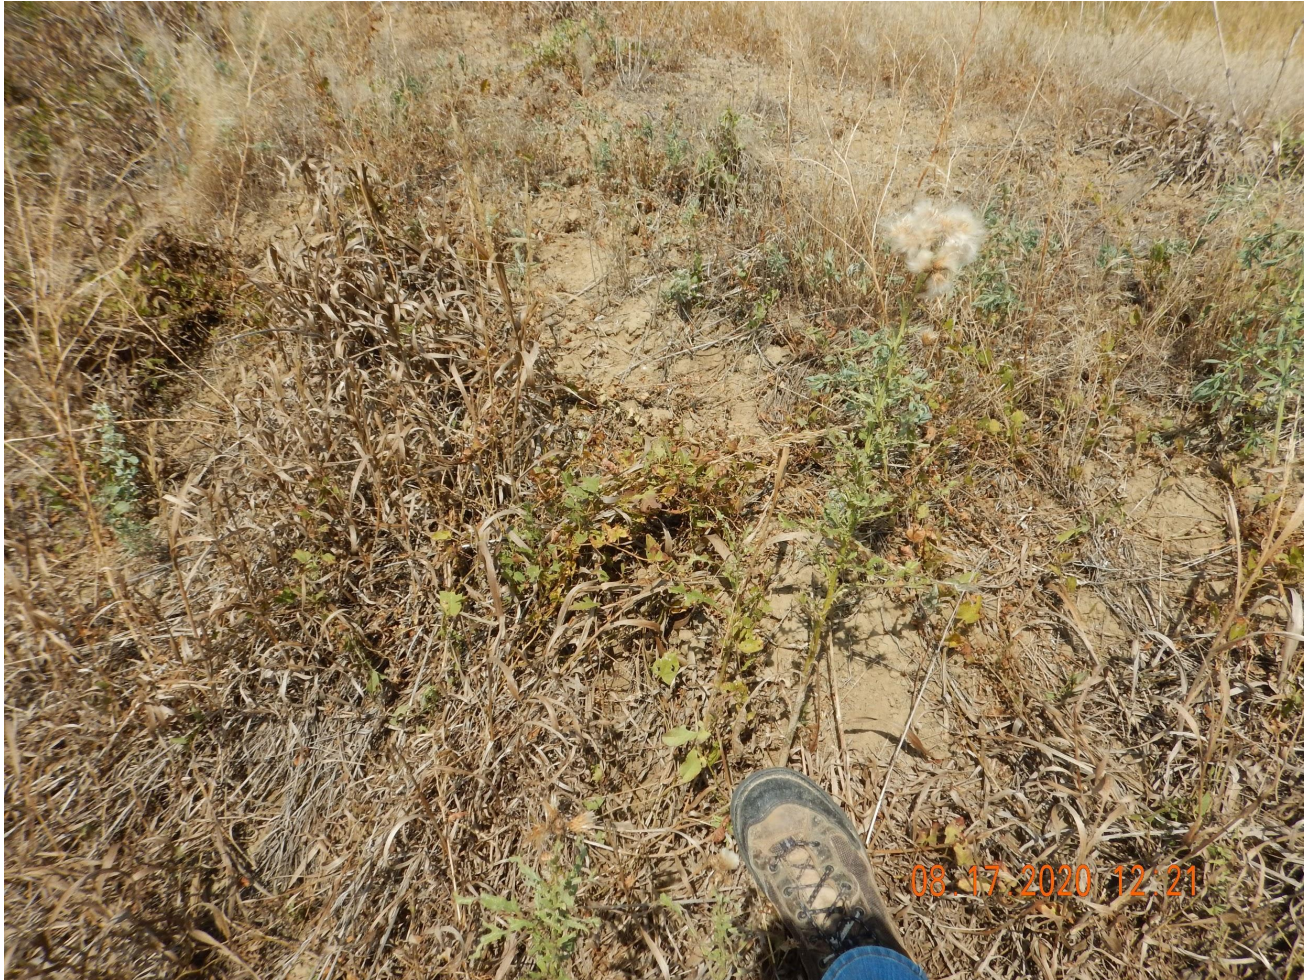
Photo 7. Photo taken from the northern well location. Photo illustrates an unmanaged List B Colorado noxious weed, Canada thistle, which has already flowered and has set seed.

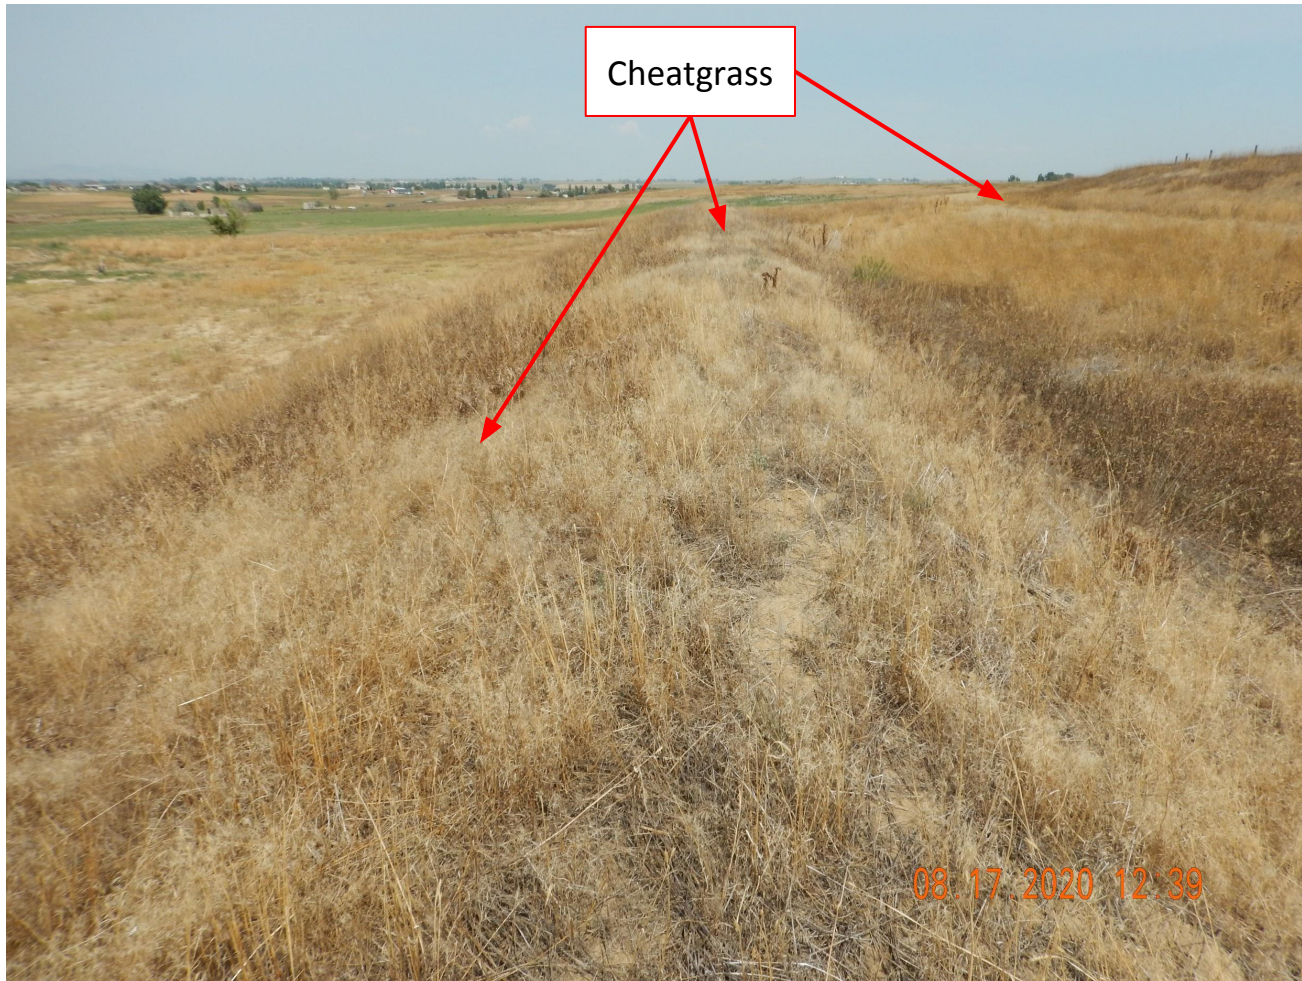
Photo 8. Photo taken from the southeastern well location, facing North. Photo illustrates an unmanaged List C Colorado noxious weed, cheatgrass, which appears to be spreading off location and onto the adjacent land.

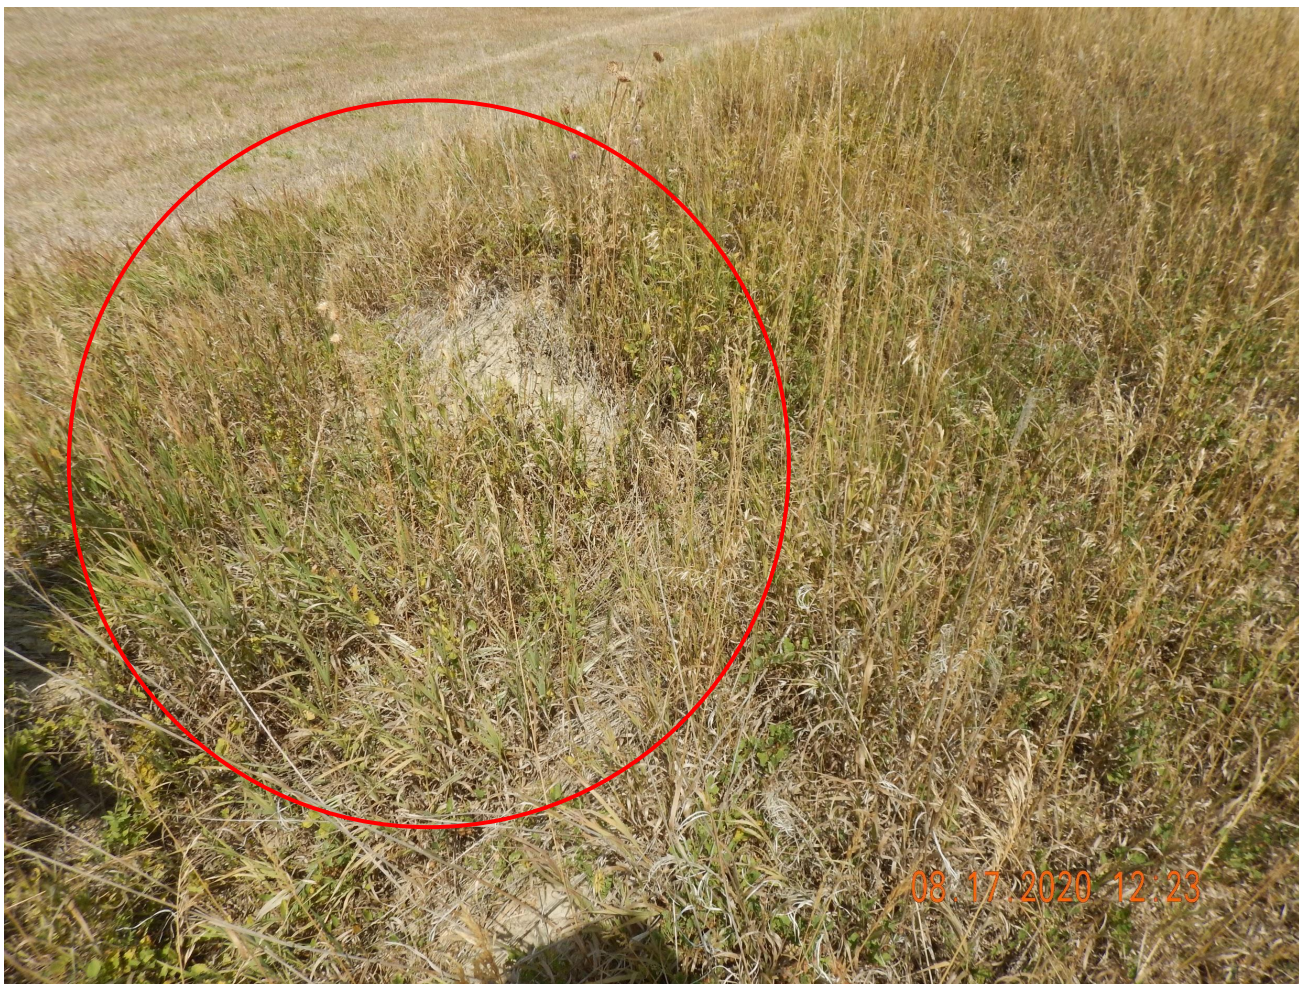
Photo 9. Photo taken from the western well location, facing Northwest. Photo illustrates gully erosion along the western fill slope. There were other areas of erosion observed along the western fill slope.

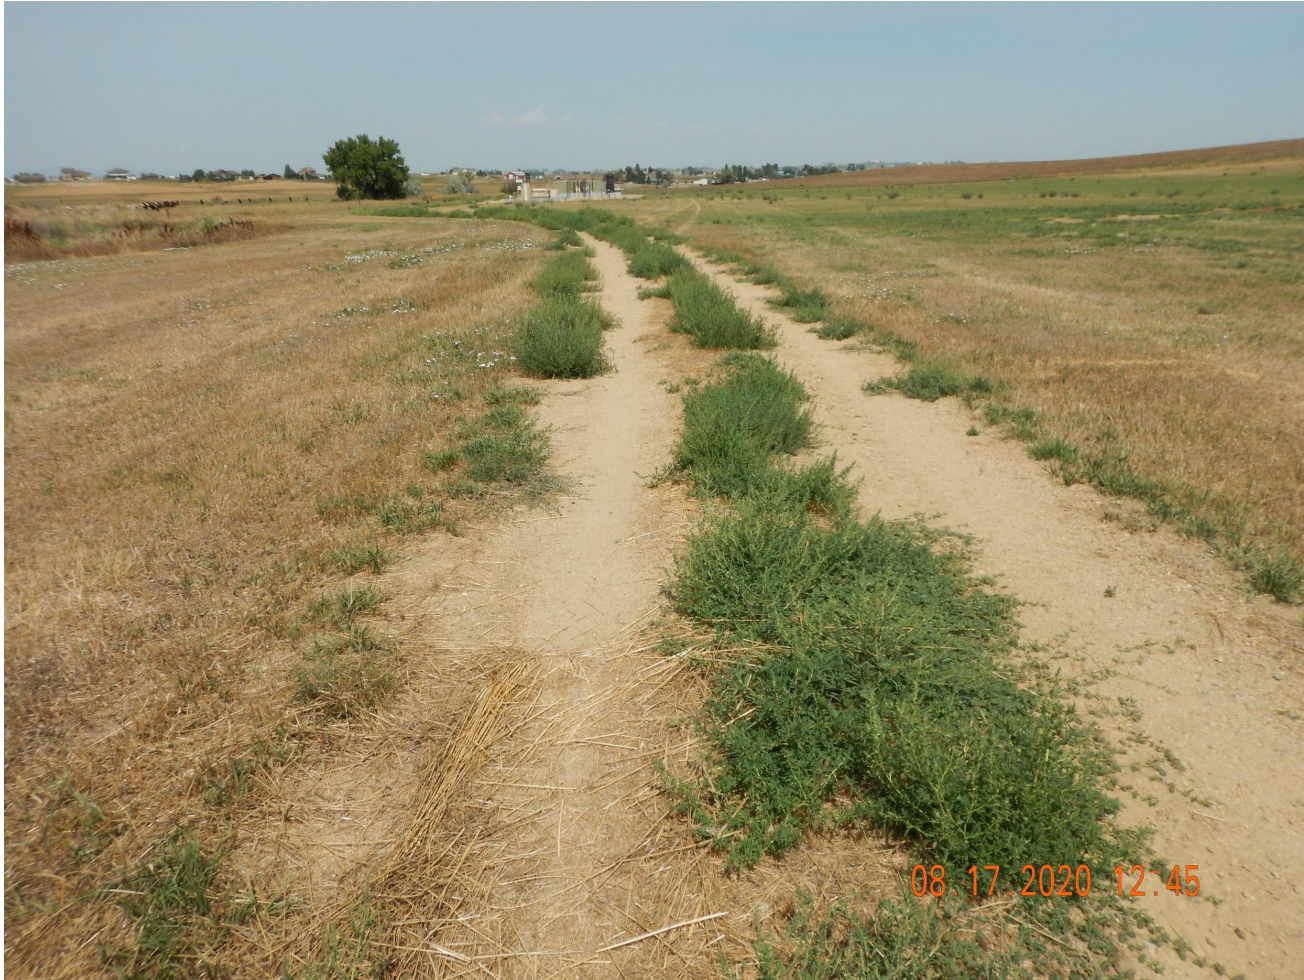
Photo 10. Photo taken from a portion of the access road, facing North. Photo illustrates unmanaged weeds along the access road.

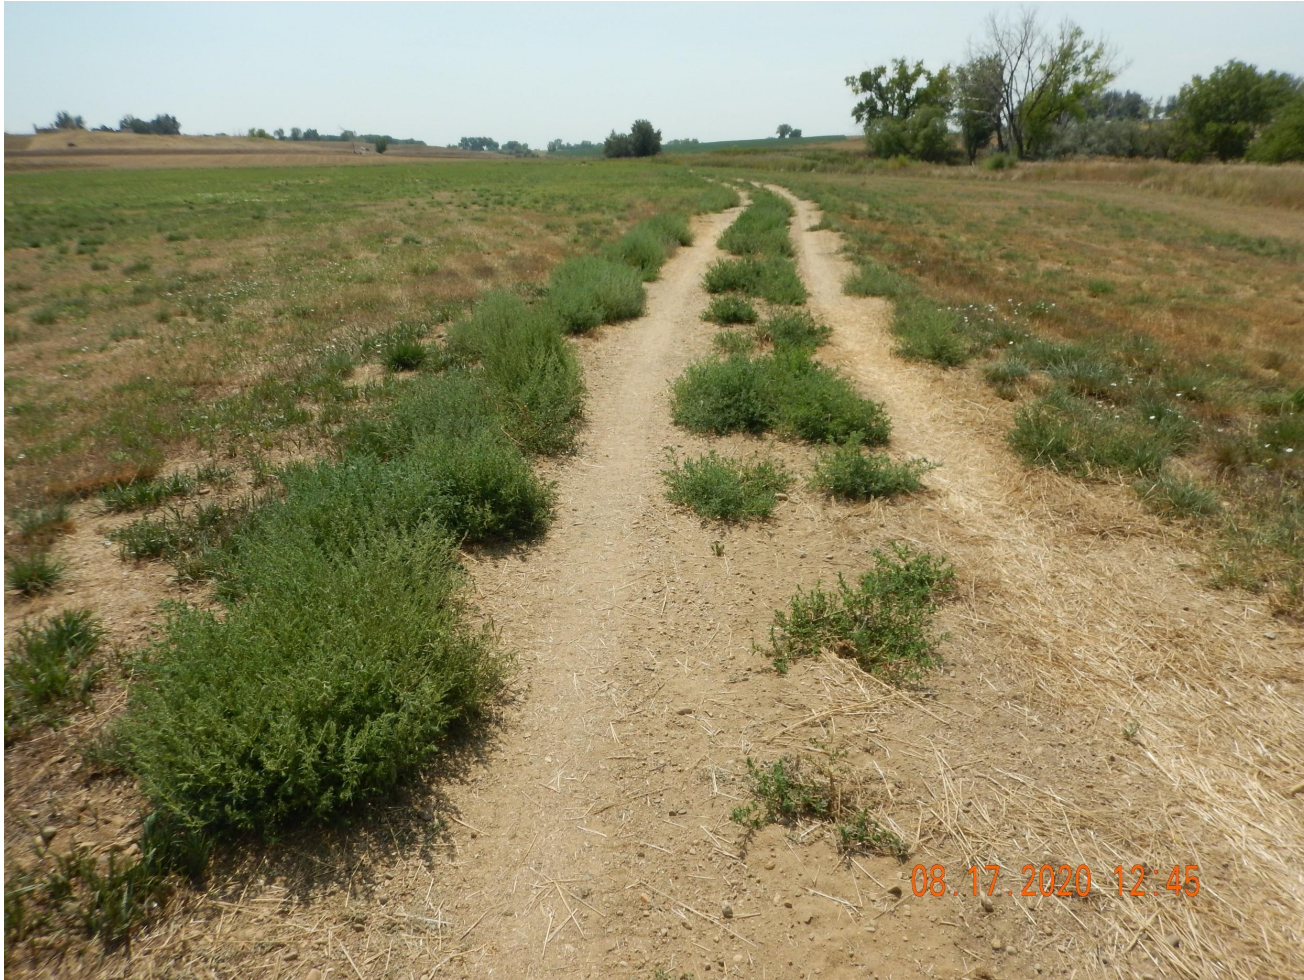
Photo 11. Photo taken from a portion of the access road, facing South. See comments under Photo 10.
