Interim Reclamation and Stormwater Inspection

Operator: CUB CREEK ENERGY- #10542

Location ID: 446104

Inspection Document #: 697501906

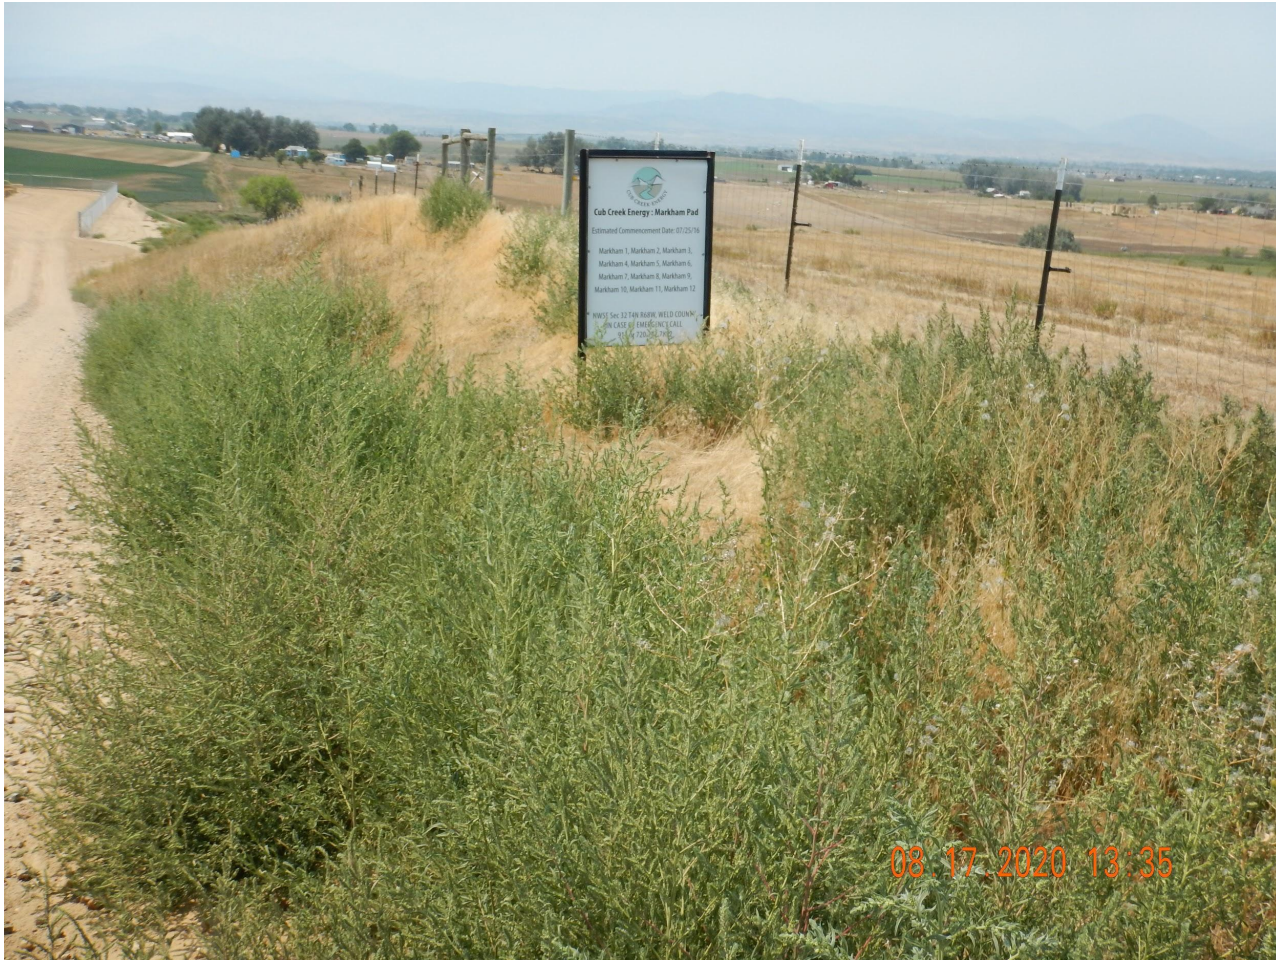
Photo 1. Photo taken from the northeastern location, facing West. Photo illustrates the Operator sign with unmanaged weeds (Kochia and cheatgrass).

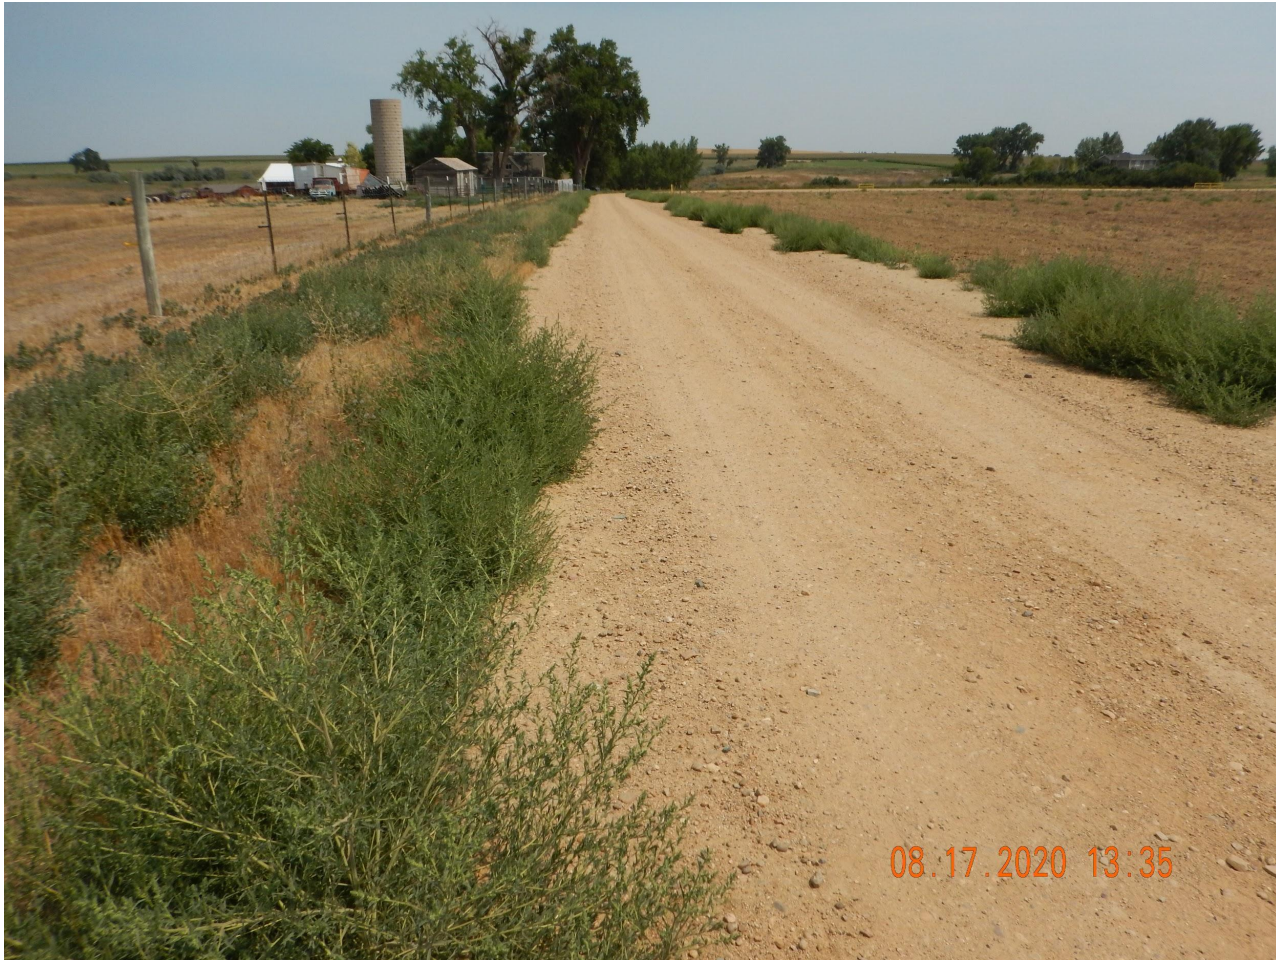
Photo 2. Photo taken from the northeastern location, facing East. Photo illustrates unmanaged weeds (Kochia and cheatgrass) on either side of the main access road.

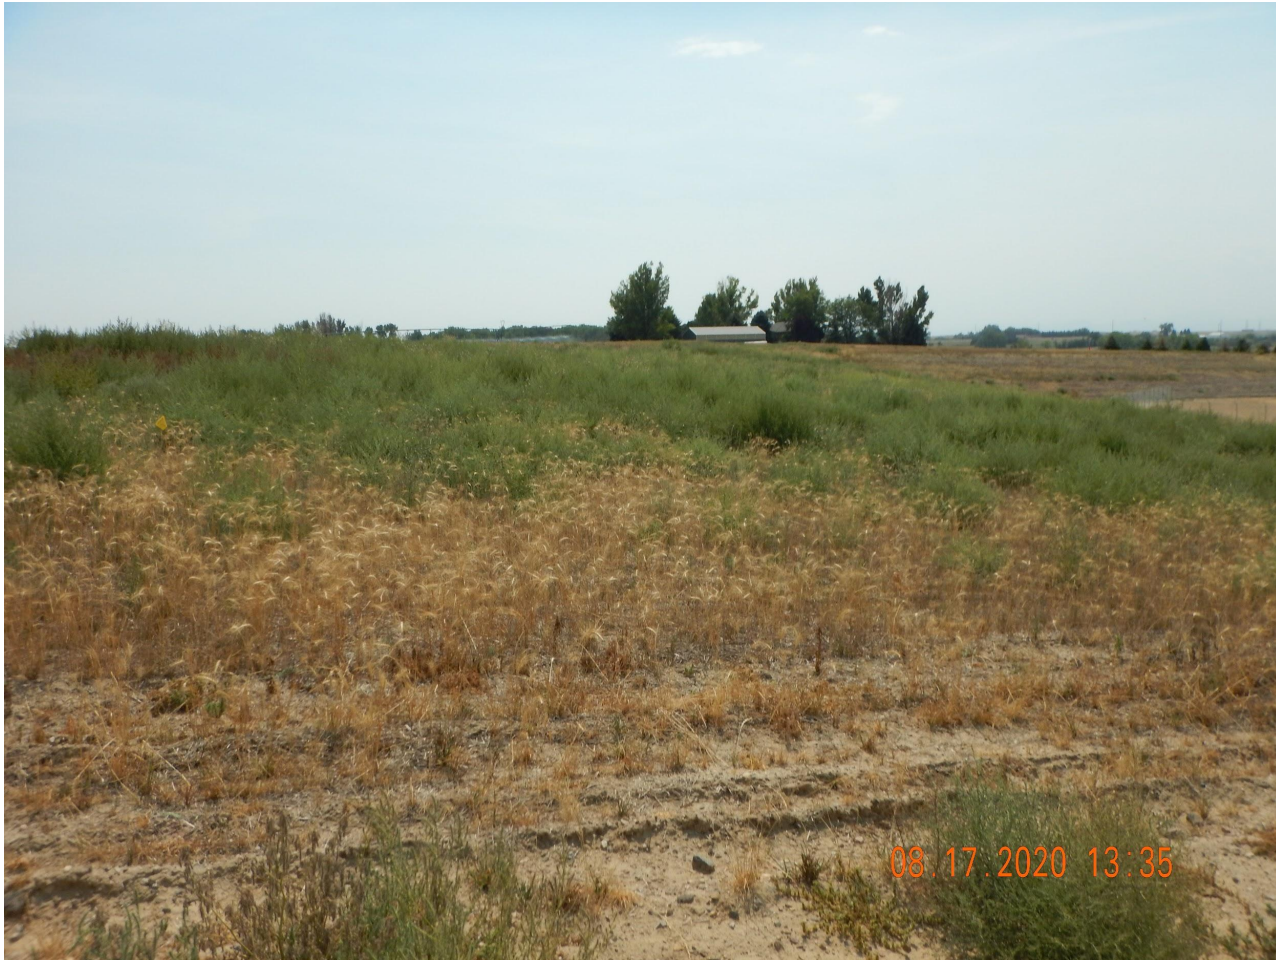
Photo 3. Photo taken from the northeastern location, facing South. Photo illustrates unmanaged weeds (Kochia) throughout the interim areas.

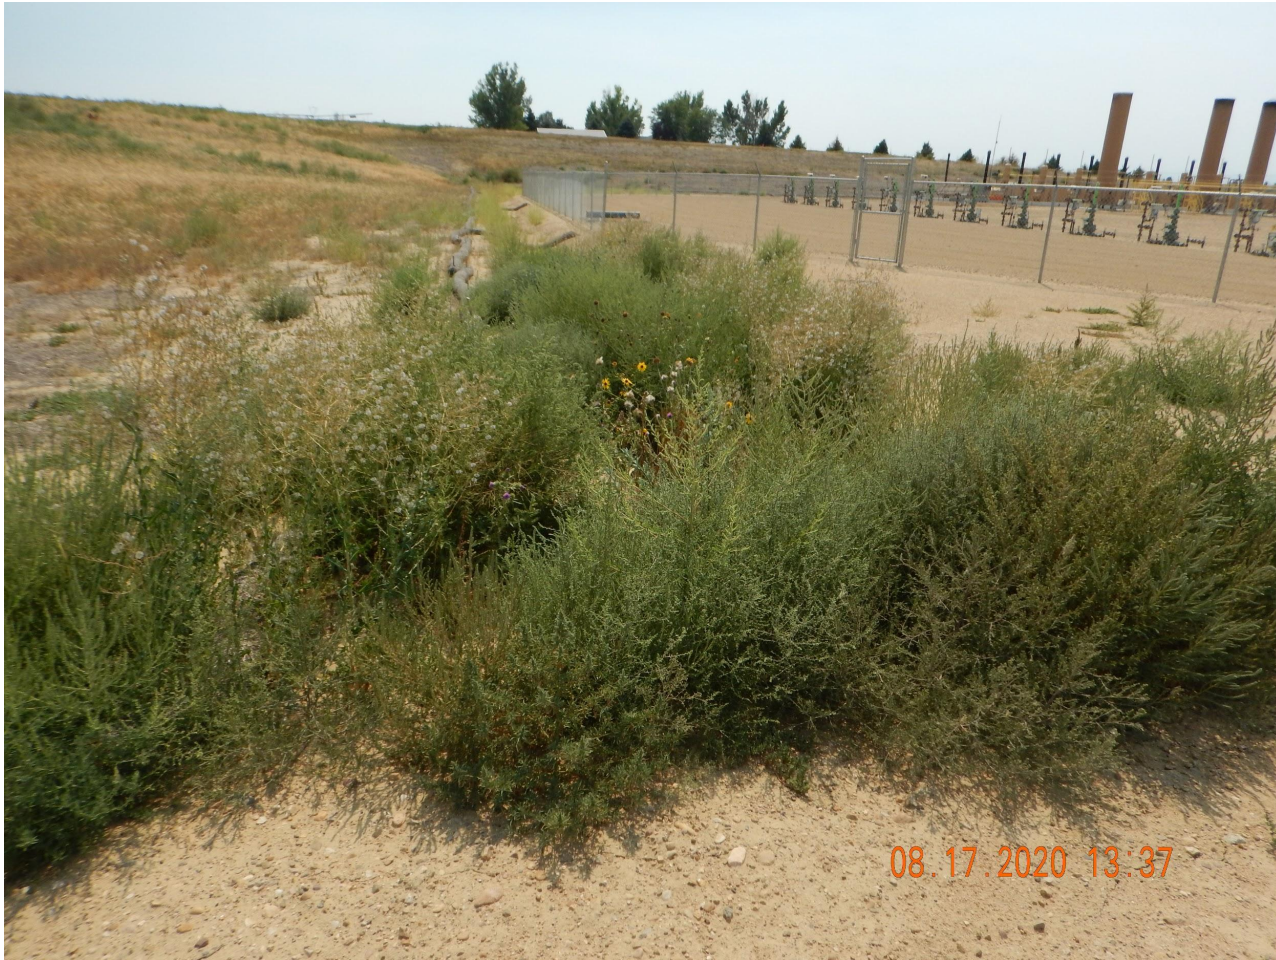
Photo 4. Photo taken from the northeastern well pad, facing South. See comments under Photo 3.

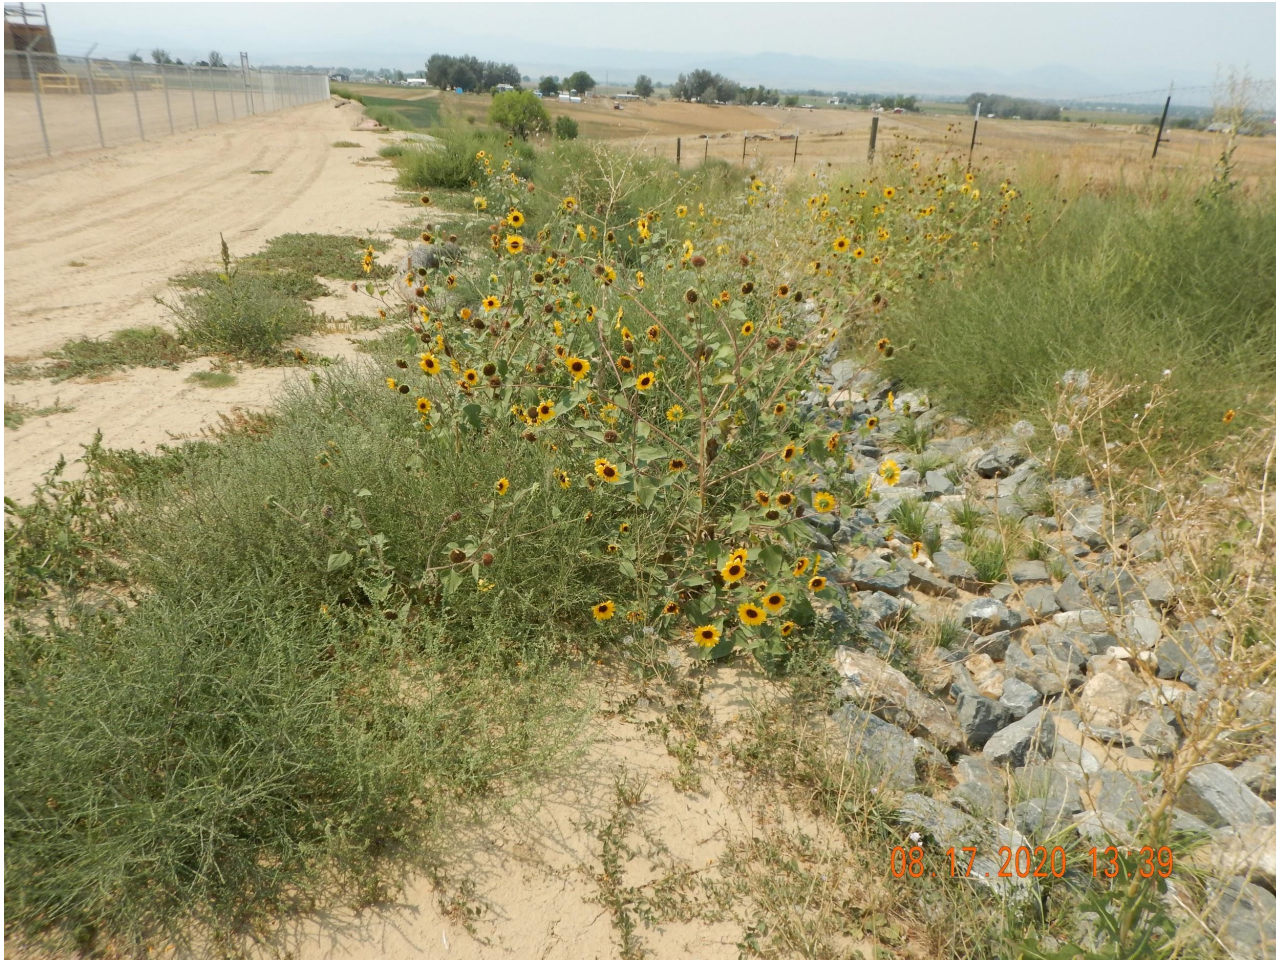
Photo 5. Photo taken from the northeastern well pad, facing West. See comments under Photo 3.

Note: stormwater BMPs appear to be in proper functioning condition.

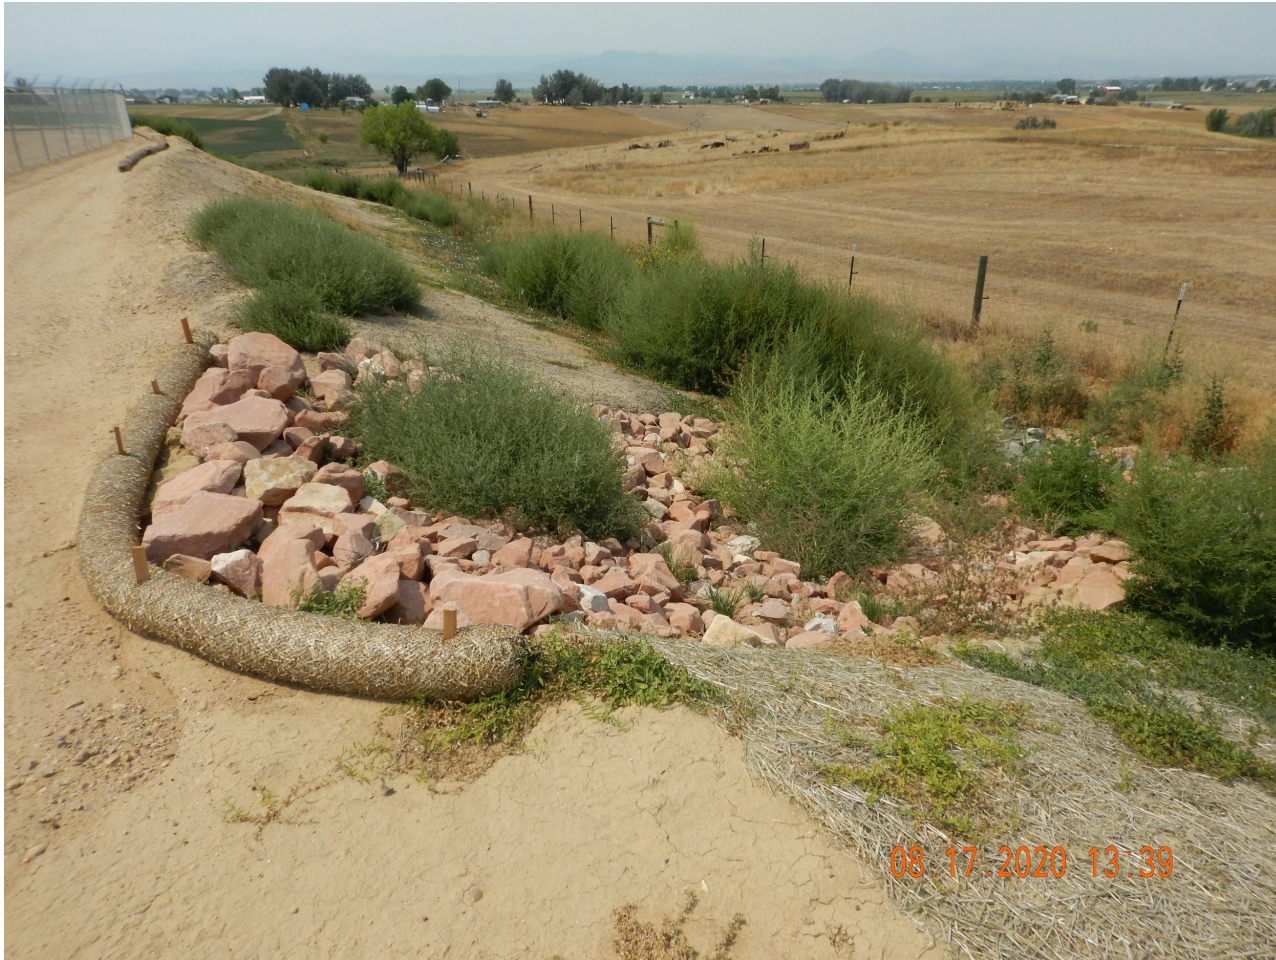
Photo 6. Photo taken from the northern well pad, facing West. See comments under Photo 5.
