**Inspection Photos**  
**Operator: BP America**  
**API: 067-07153**  
**Date: 8/25/2020**

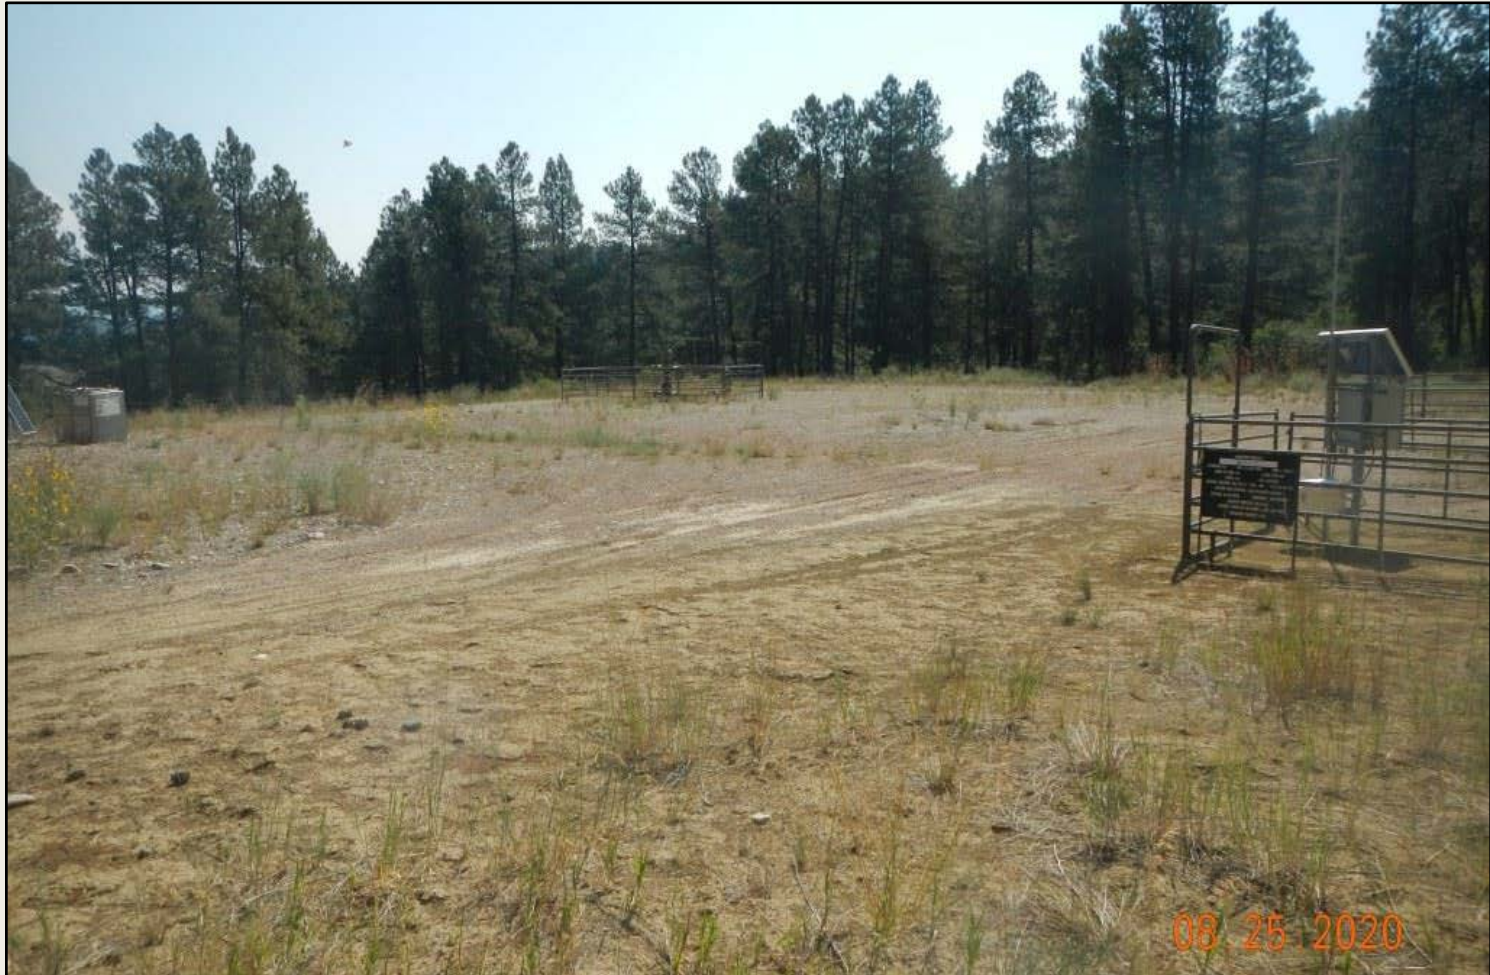
Photo 1. View of the project area from the southwestern corner facing center.

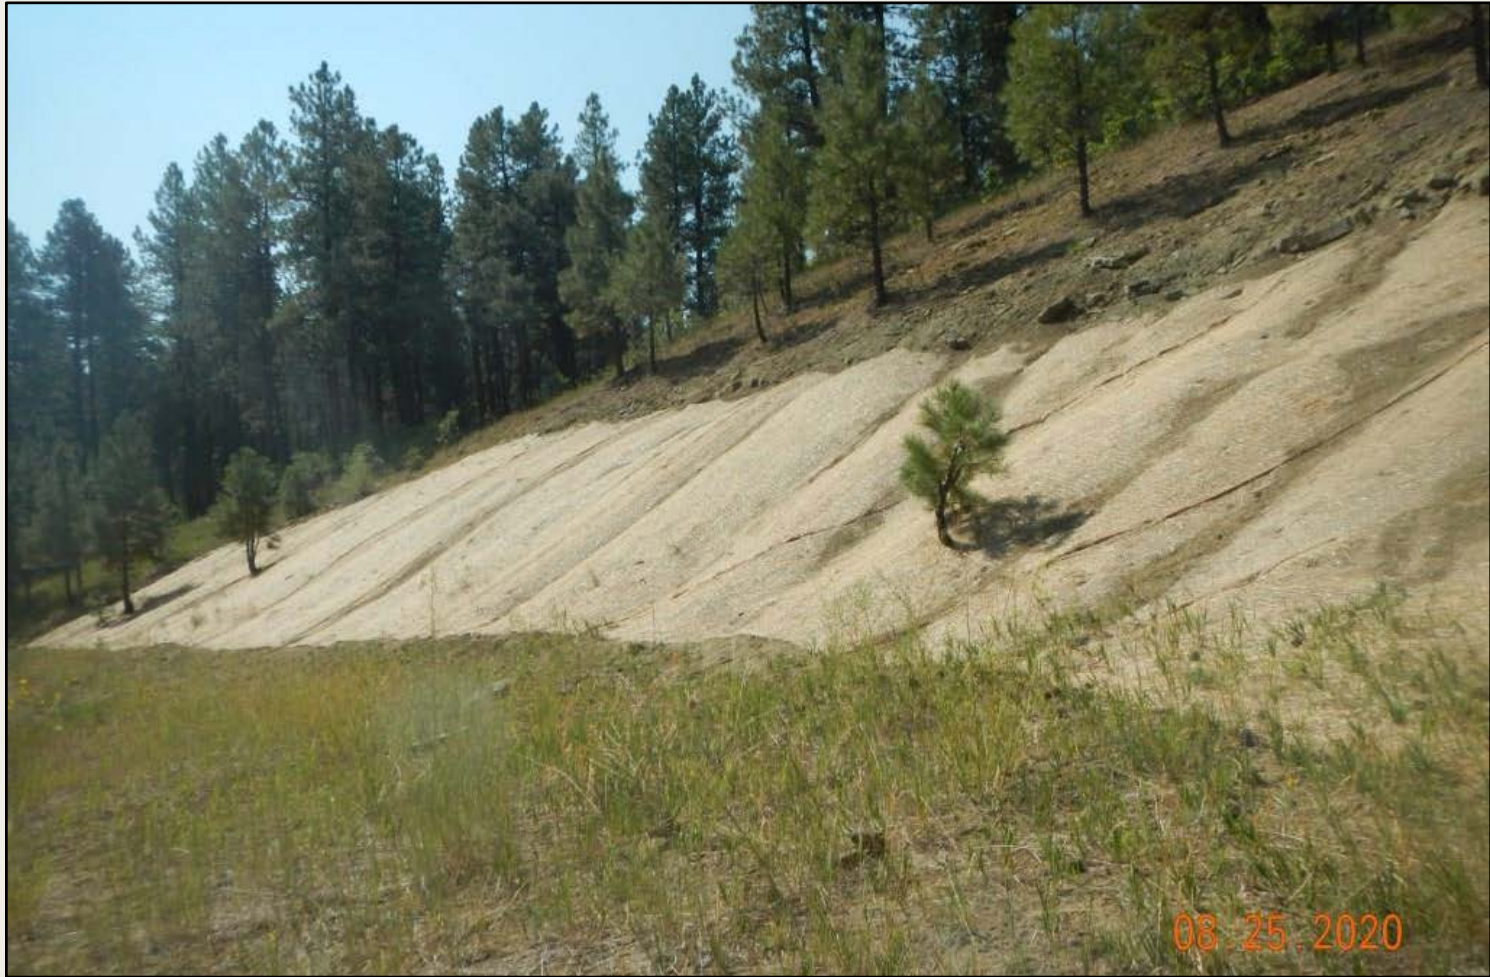
Photo 2. View of erosion control blankets installed on the southern cut-slope. Blankets appear to be properly installed.

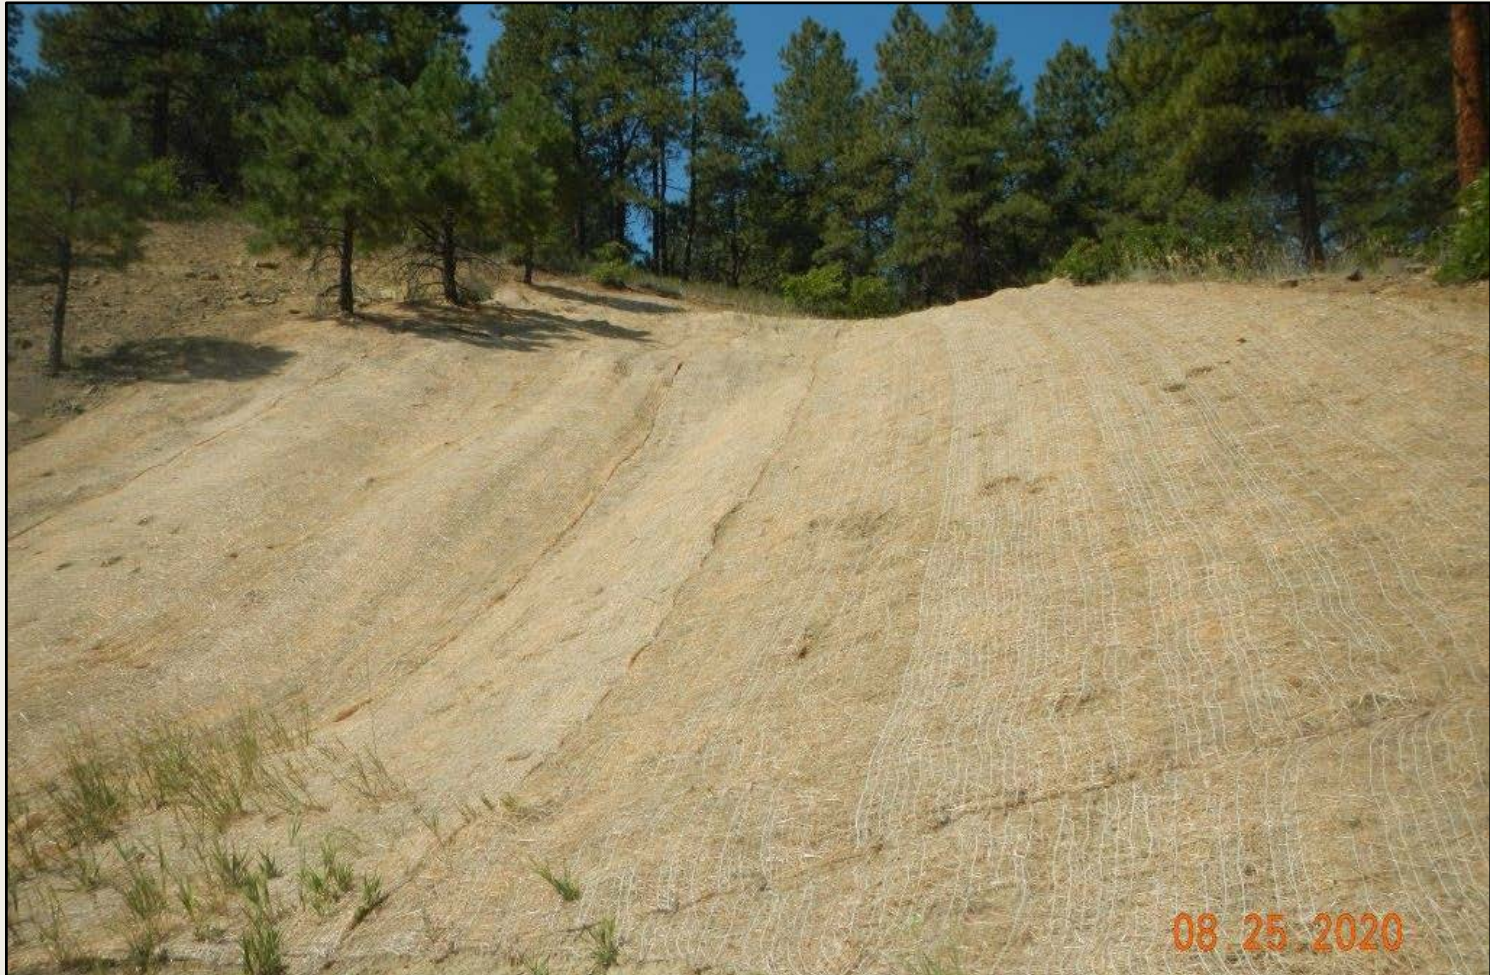
Photo 3. View of erosion control blanket installed in the southwestern project area. Small smooth brome plants observed near the toe of the slope.

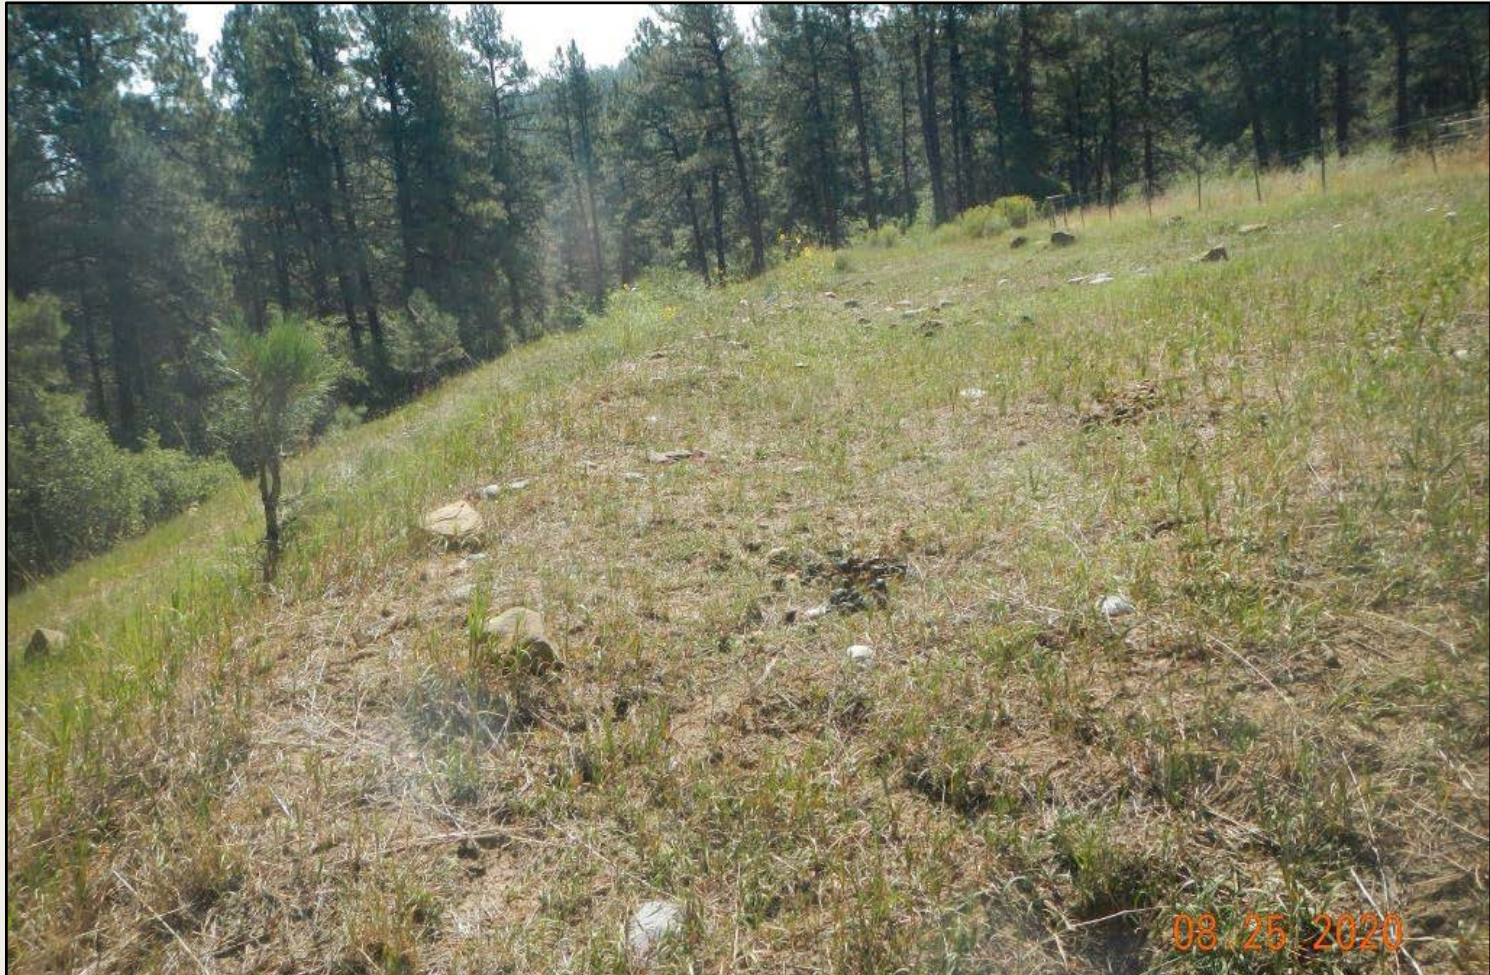
Photo 4. View of the northern project area from the northwestern corner facing eastward. Vegetation is well established here with smooth brome and western wheatgrass.

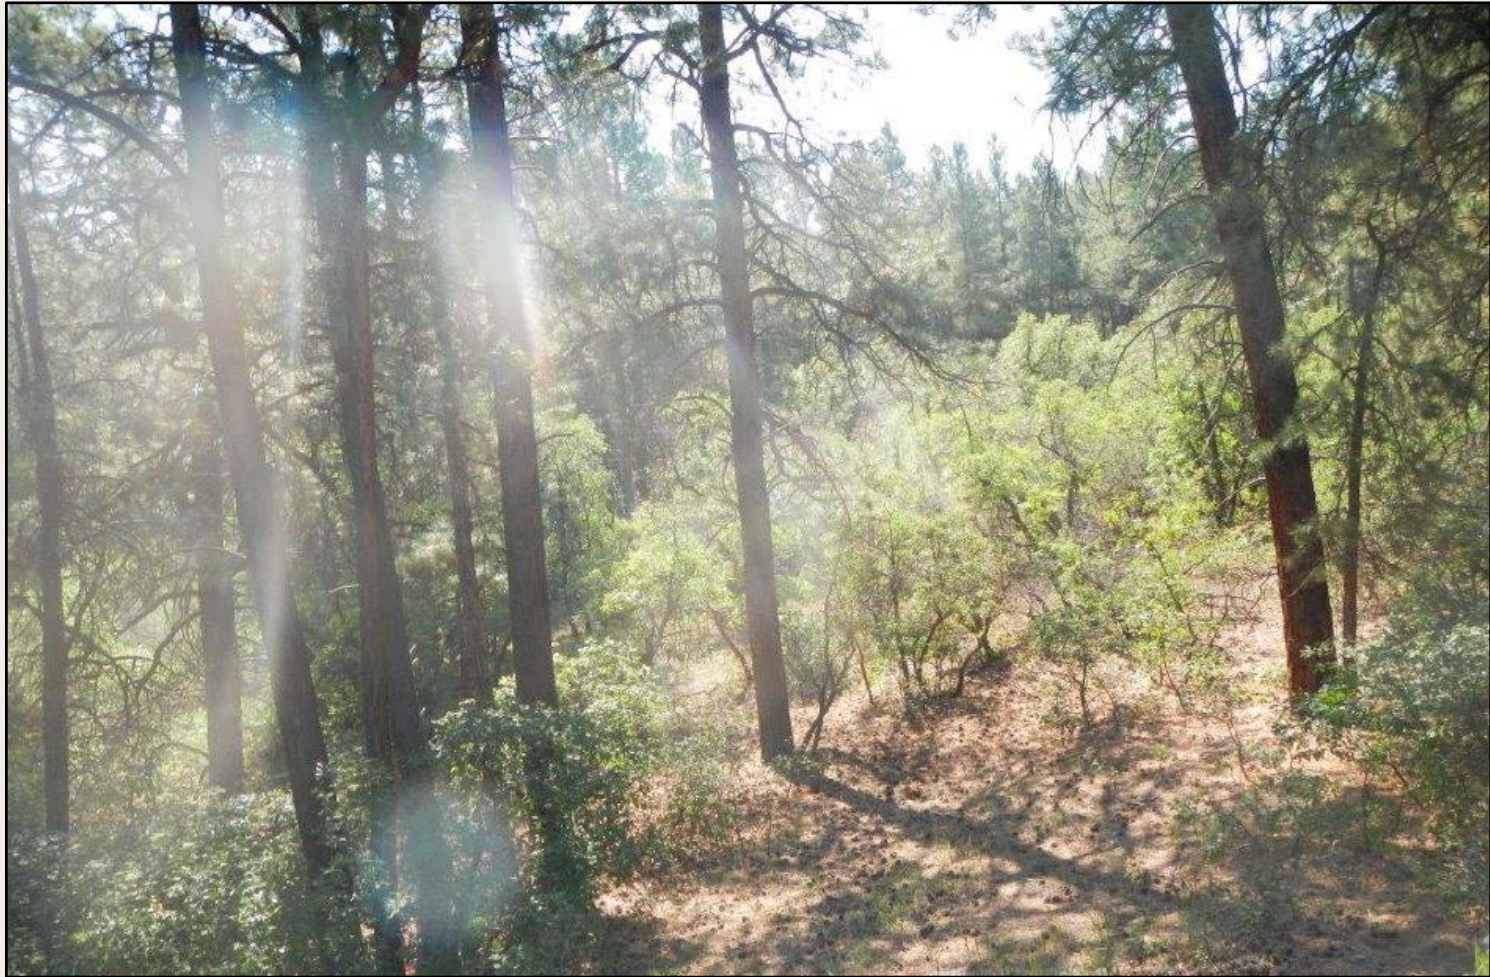
Photo 5. View of reference area comprised of ponderosa pine woodland with understory of gambel oak, Sandberg bluegrass, and forbs such as purple aster.
