Inspection Photos
Operator: BP America
API: 067-07174
Date: 8/25/2020

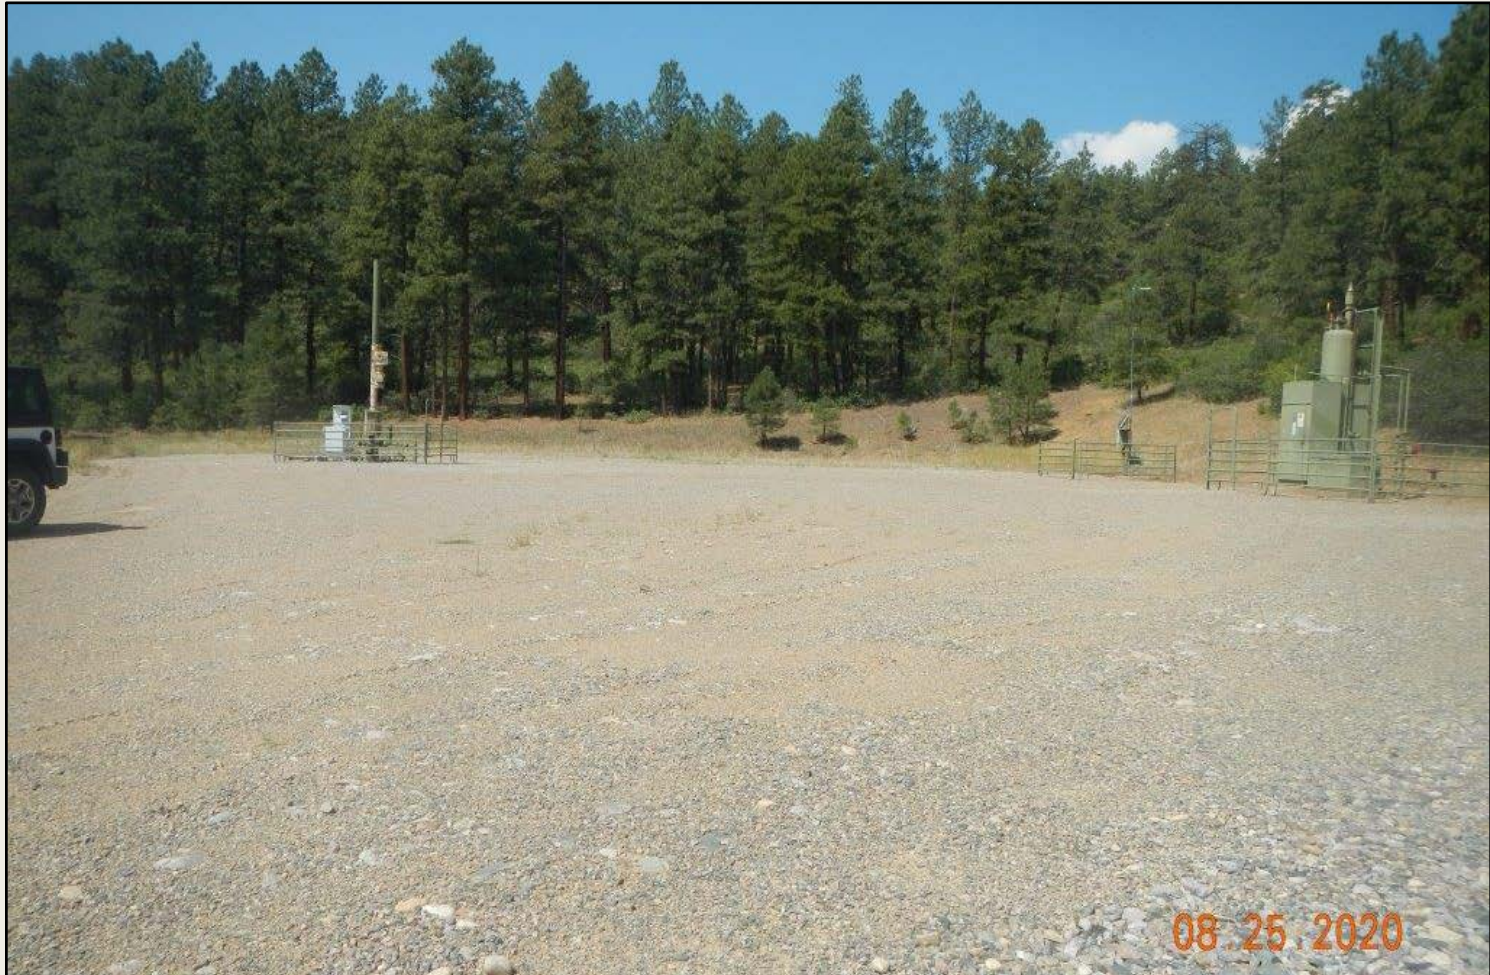
Photo 1. View of the project area from the well pad entrance facing center.

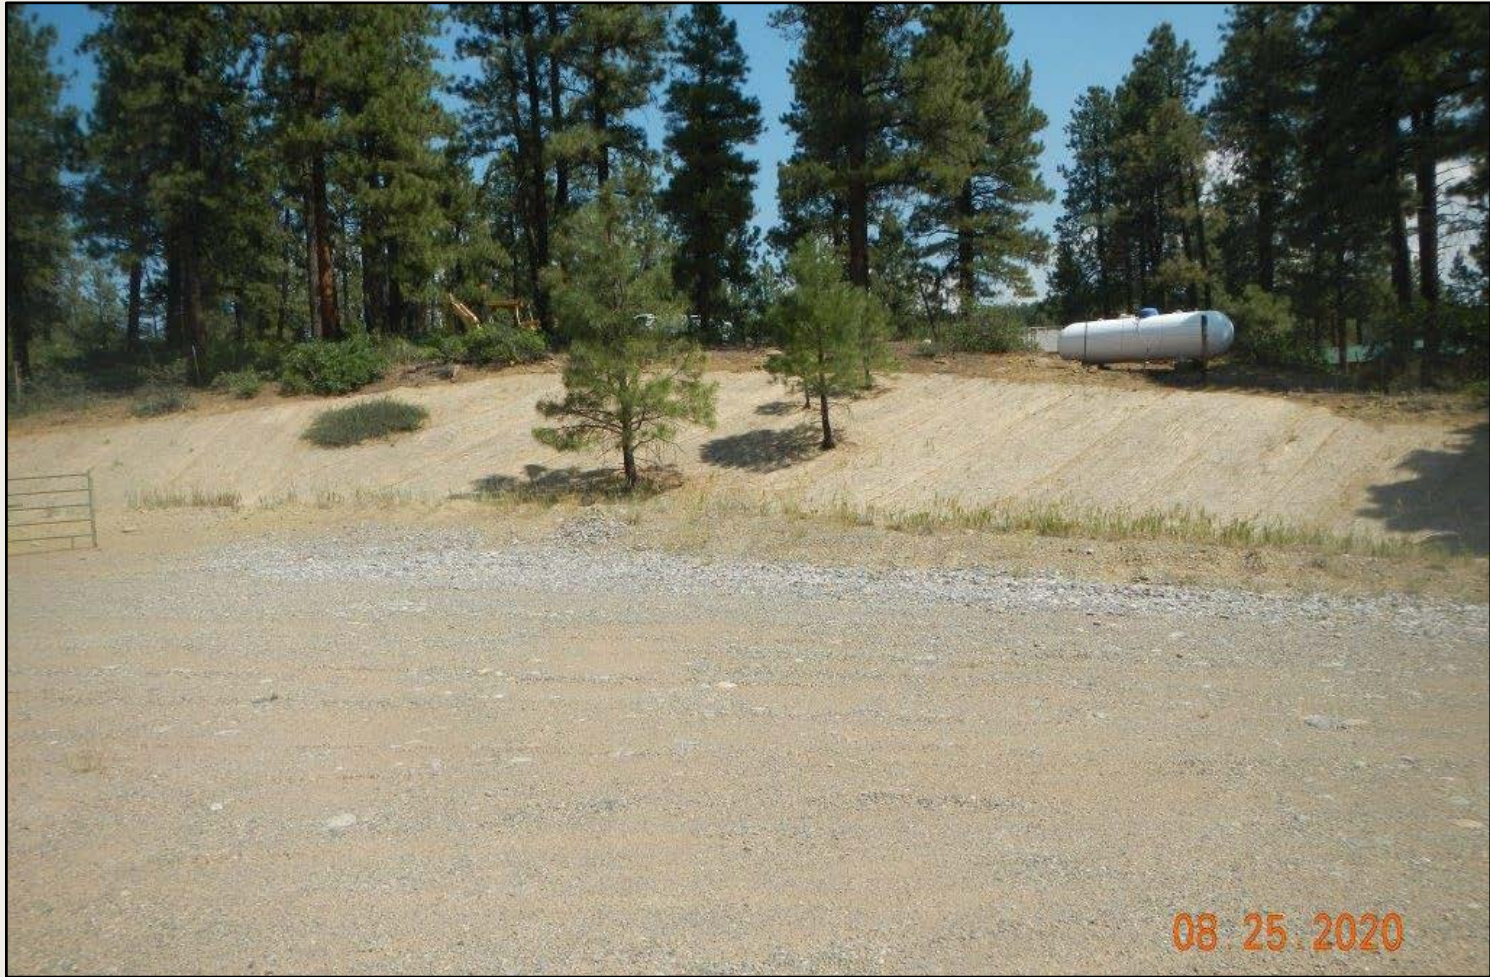
Photo 2. View of the northern cut-slope. Erosion control blanket installed along the slope.

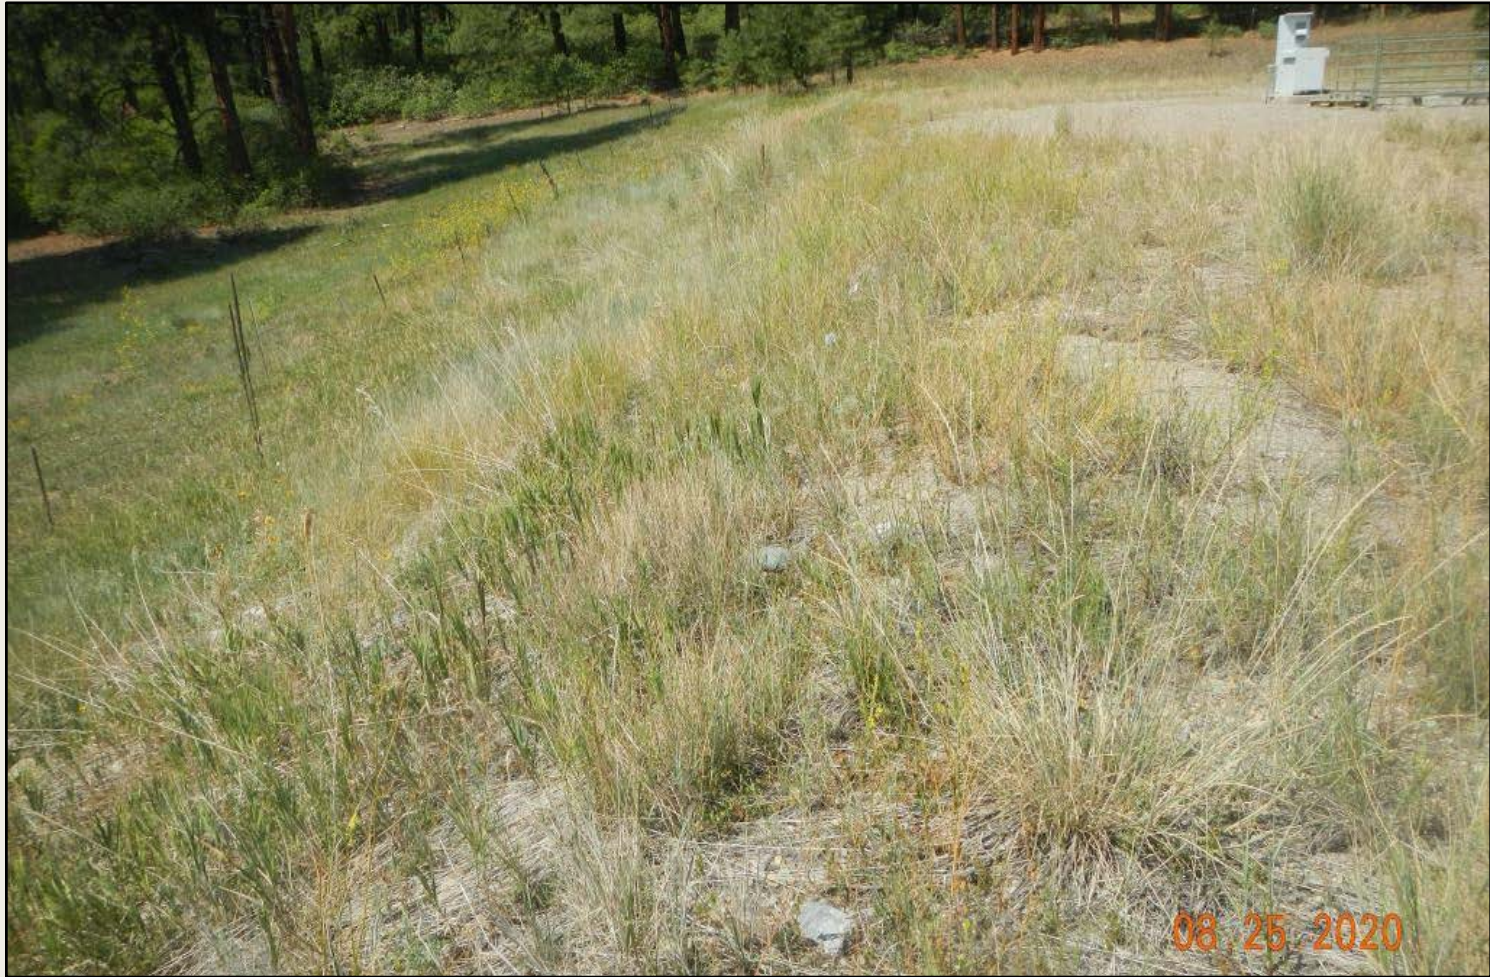
Photo 3. View of the southern project area from the southeastern project area facing westward. Revegetation is progressing with smooth brome, western wheatgrass, and sand dropseed.
