# Interim Reclamation and Stormwater Inspection

Operator: NOBLE ENERGY INC - #100322

Location ID: 432544

Inspection Photos  
Location Name: Wahlert /AC23-69HN Pad  
Location ID: 432544

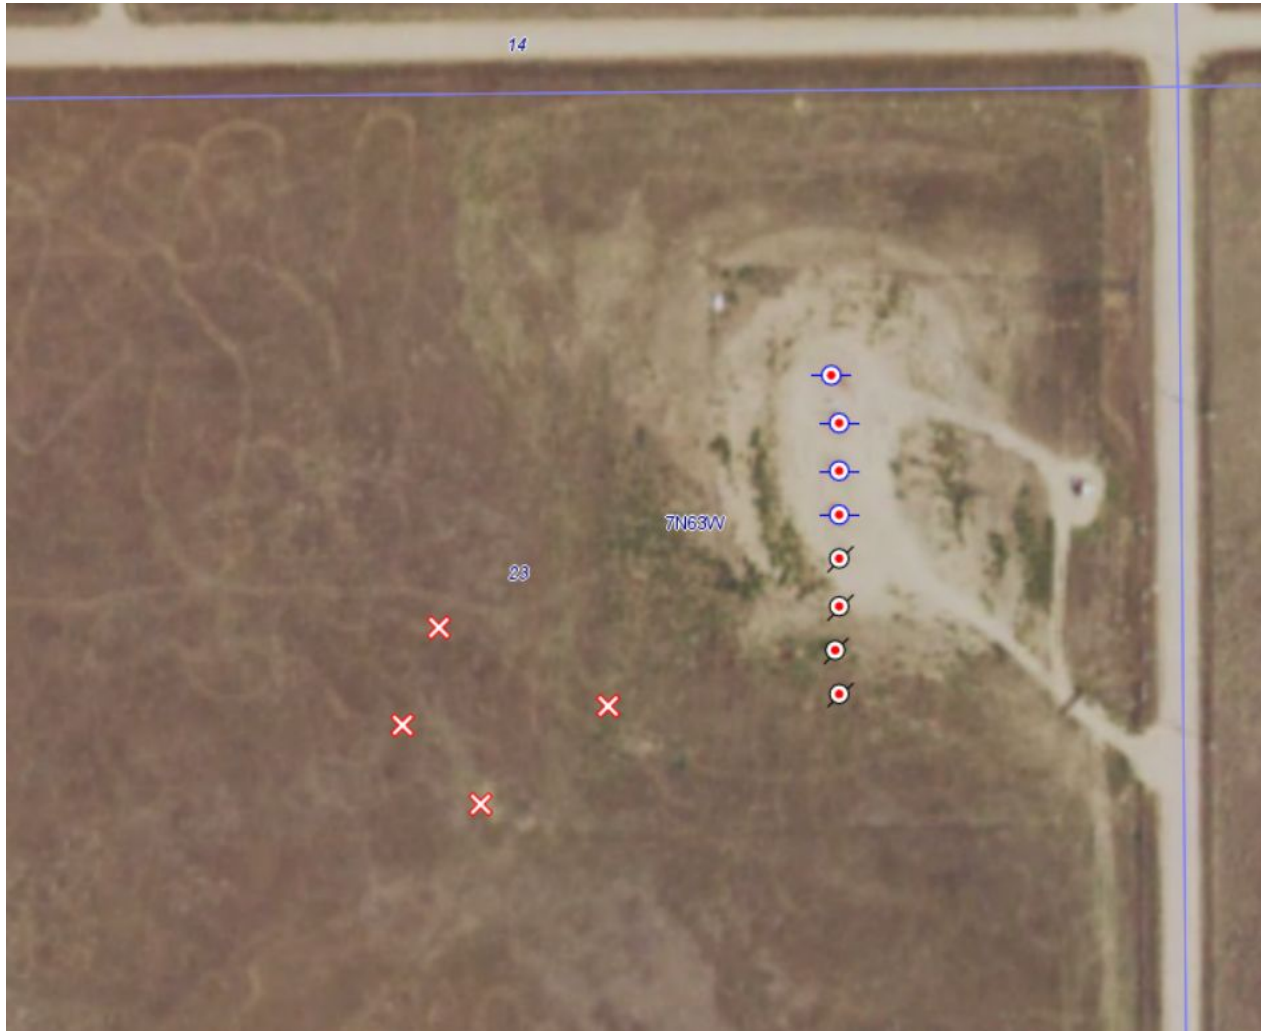
**Photo 2.** Aerial imagery from 2017 using COGCC database illustrates the location and surface disturbance after interim reclamation. The “red x’s” are locations of a List B Colorado noxious weed, Scotch thistle, which has spread off location.

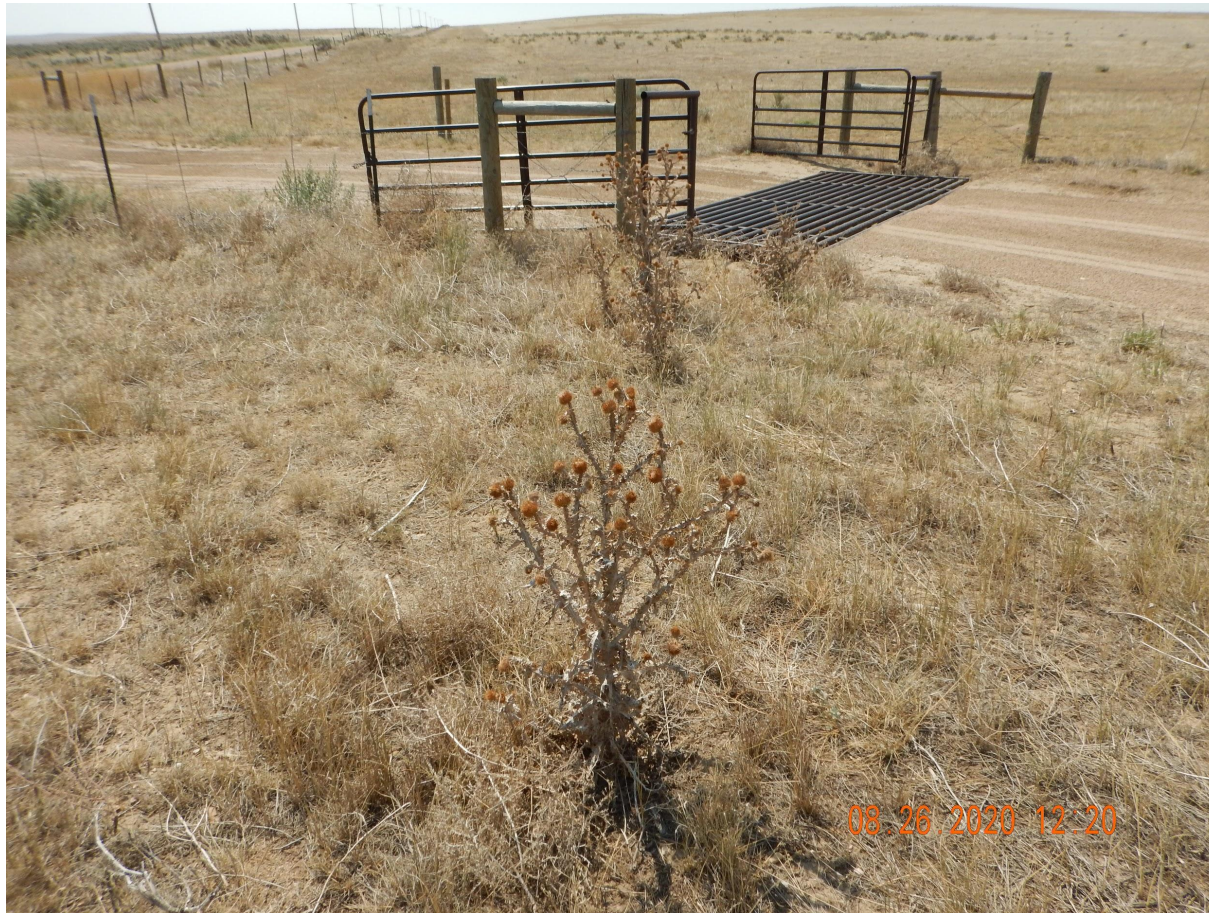
**Photo 3.** Photo taken from the entrance of the location, facing South. Photo illustrates unmanaged List B Colorado noxious weeds, Scotch thistle, which has spread off location.

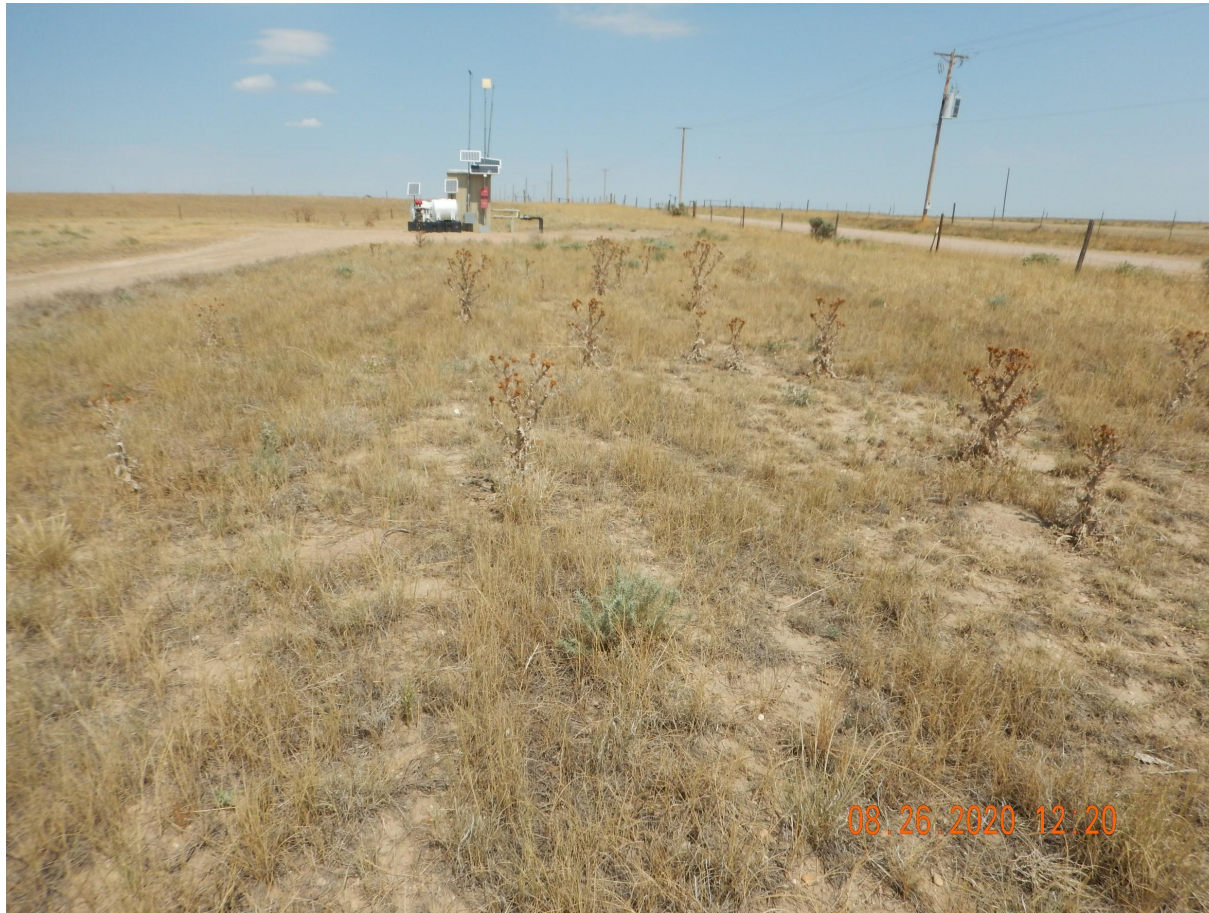
**Photo 4.** Photo taken from the entrance of the location, facing North. See comments under Photo 3.

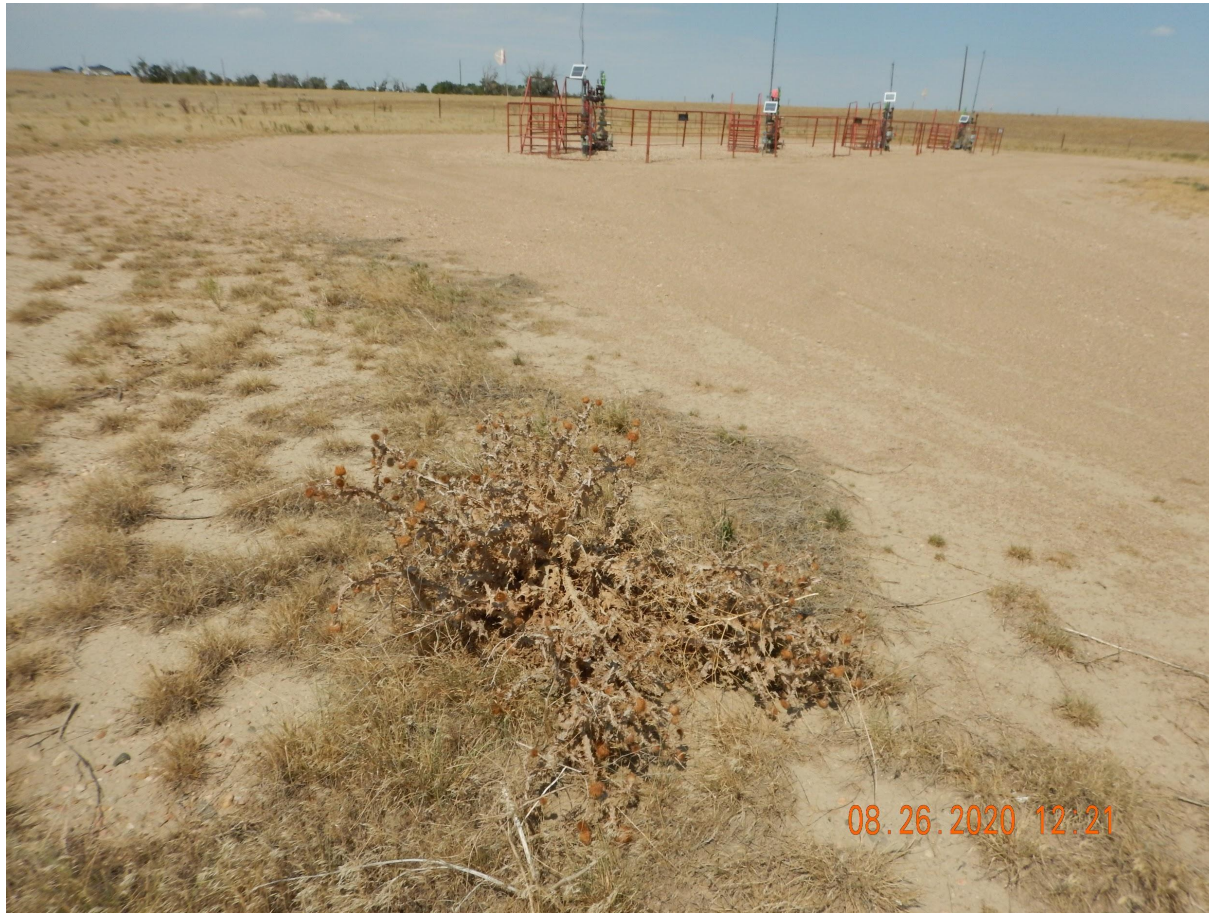
**Photo 5.** Photo taken from the southern well pad, facing West. See comments under Photo 3.

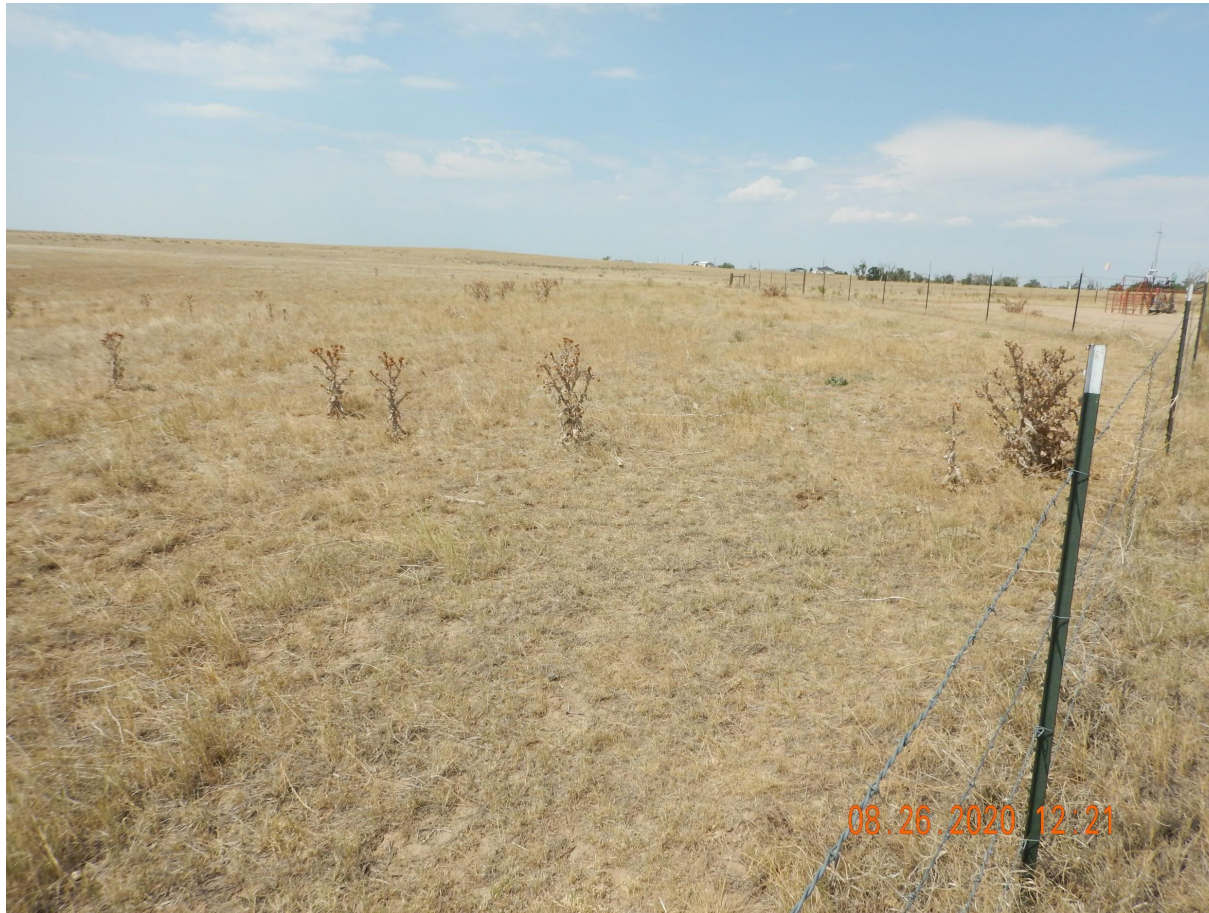
**Photo 7.** Photo taken from the southeastern well pad, facing West. Photo illustrates unmanaged List B Colorado noxious weeds, Scotch thistle, within the southern interim area.

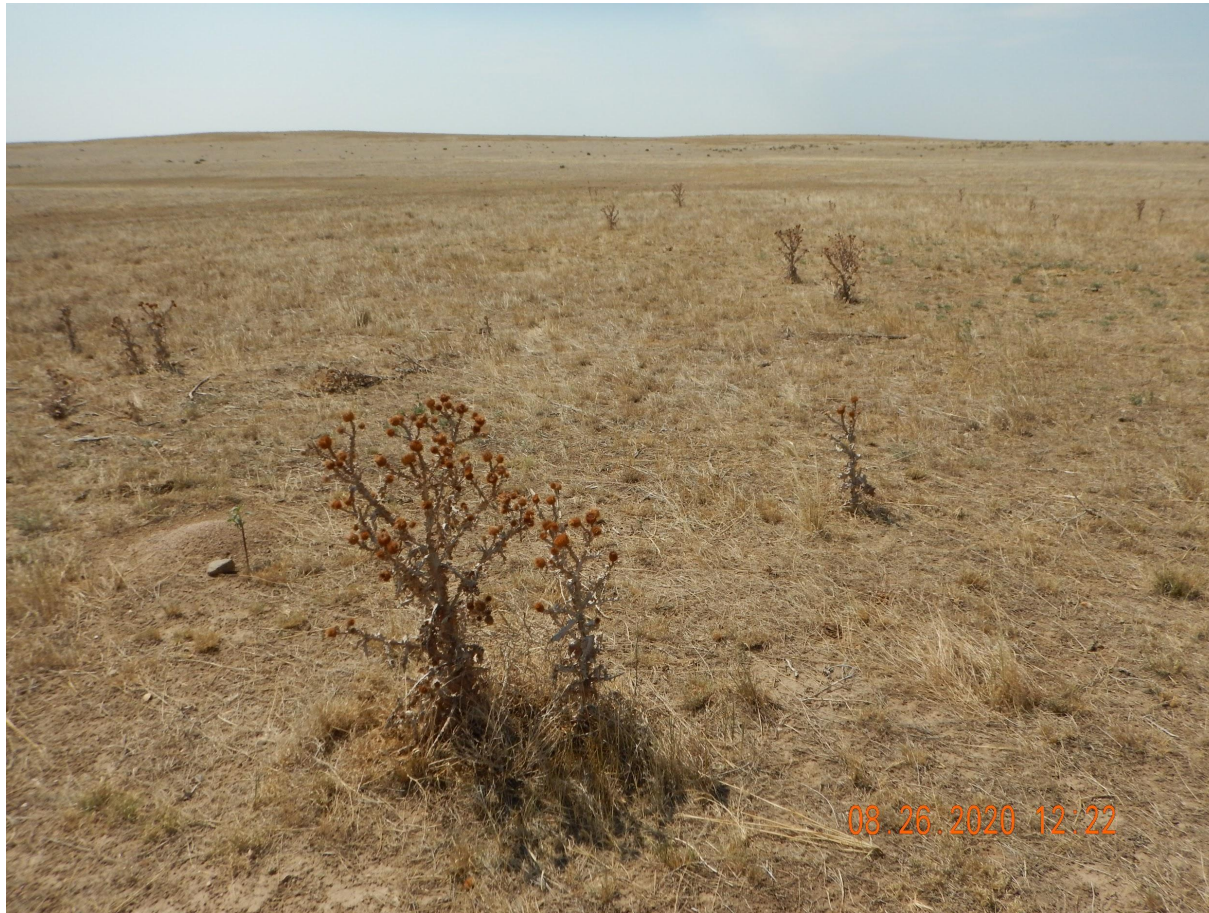
**Photo 8.** Photo taken from the southern interim area, facing South. Photo illustrates unmanaged List B Colorado noxious weeds, Scotch thistle, which have spread off location and beyond the interim reclamation areas.

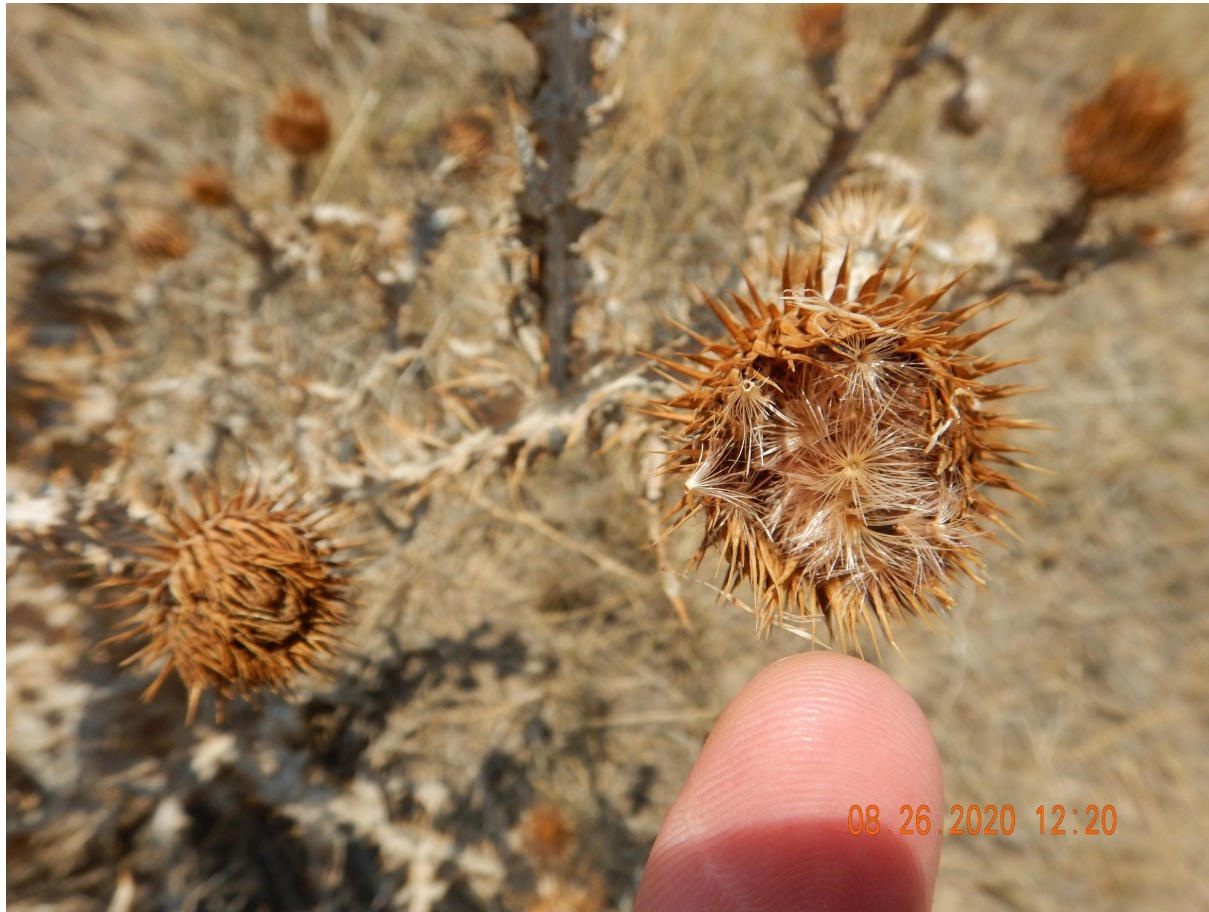
**Photo 9.** Close up photo taken from an unmanaged List B Colorado noxious weed, Scotch thistle. Most of the Scotch thistle has already flowered and set seed. Photo illustrates viable seeds which remain within the flowering head.

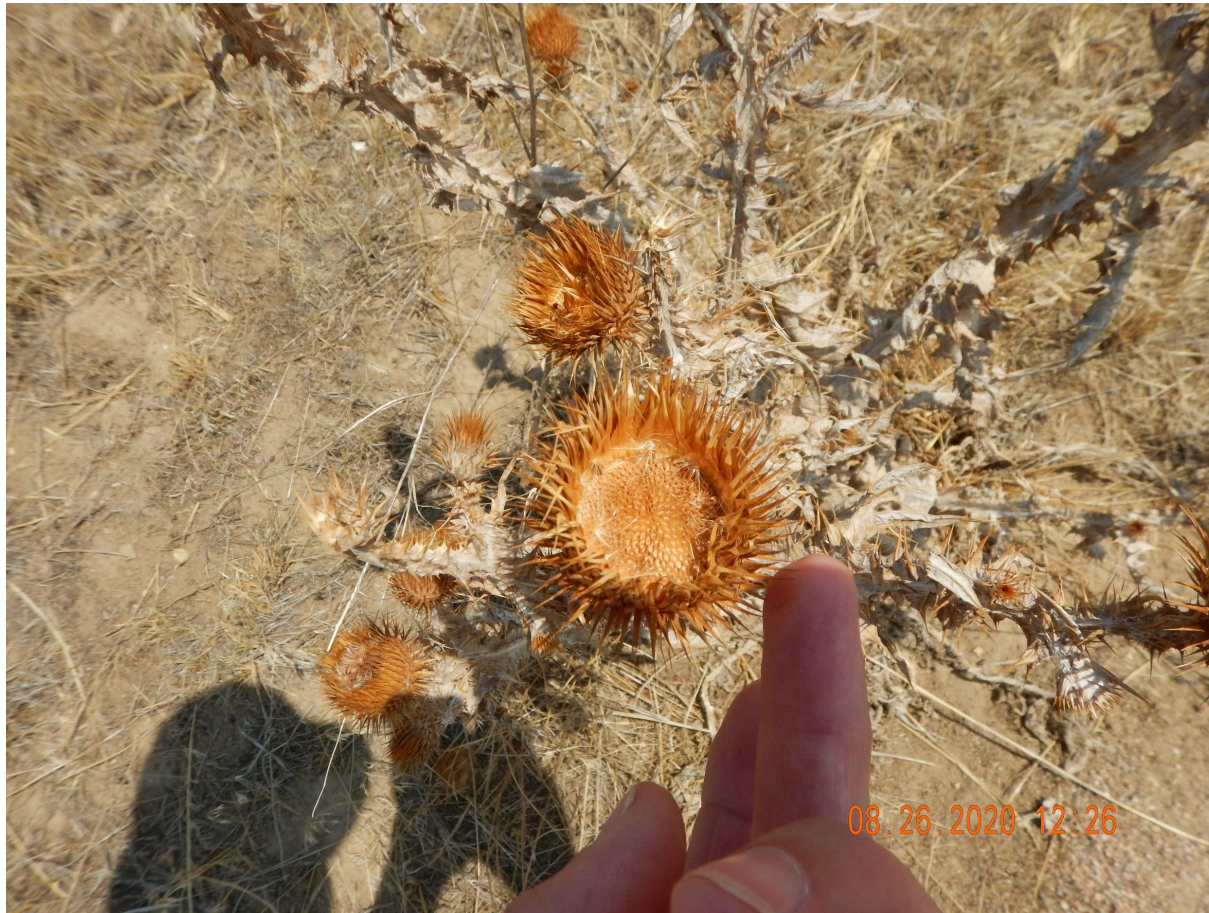
**Photo 10.** Close up photo taken from an unmanaged List B Colorado noxious weed, Scotch thistle. Most of the Scotch thistle has already flowered and set seed. Photo illustrates all seeds have been dispersed.
