Final Reclamation Inspection

Operator: CRESTONE PEAK RESOURCES OPERATING LLC - 10633

Location ID: 431823

Inspection Photos
Location Name: JO Farms #0-4-17
Location ID: 431823

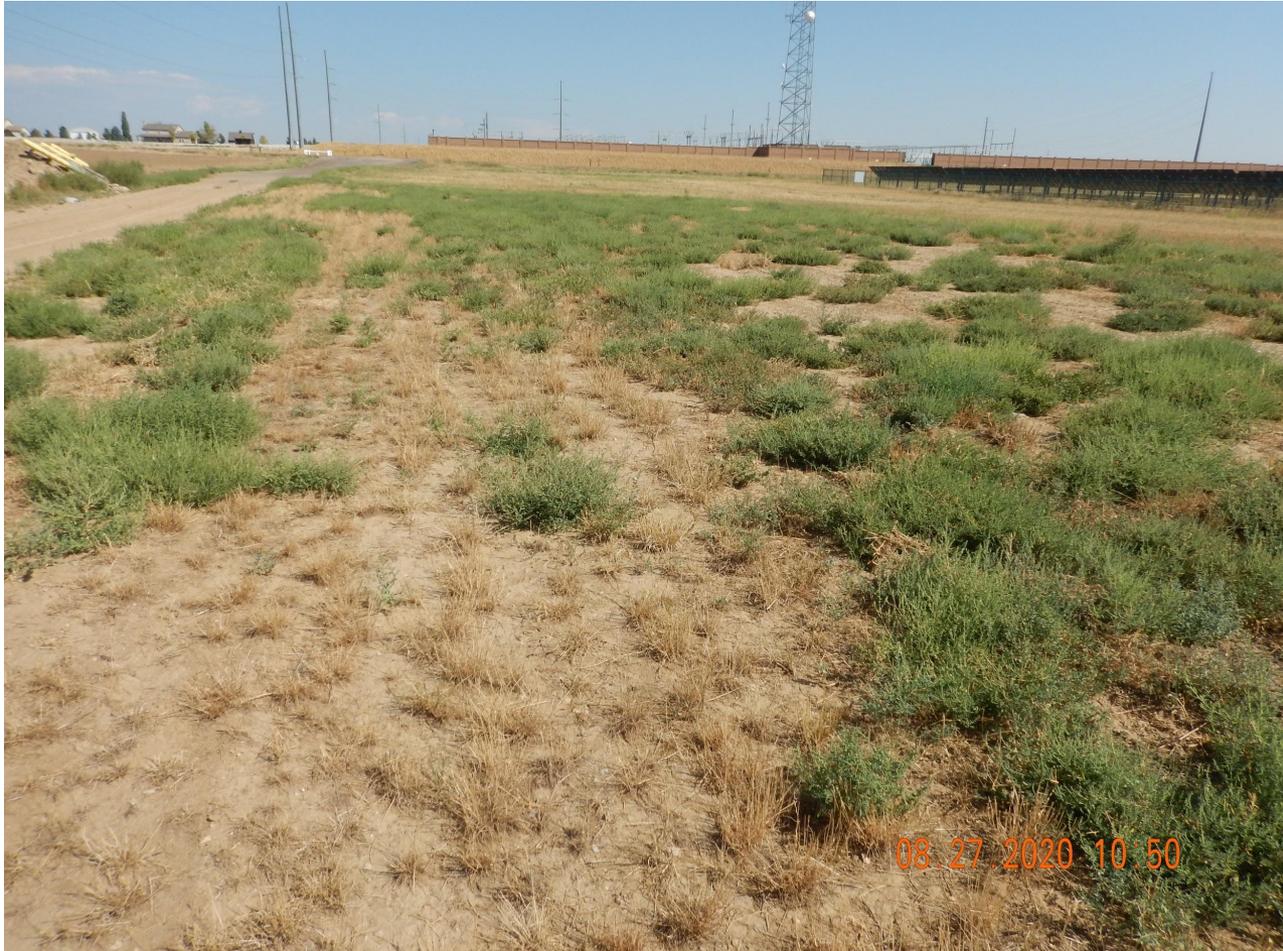
Photo 2. Photo taken from the associated offsite tank battery, facing North. Photo illustrates Operator has removed all equipment and has performed final reclamation activities. Reference area species, crested wheatgrass, were observed throughout the tank battery. The green foliage is Kochia/Russian thistle which appears to be recently mowed.

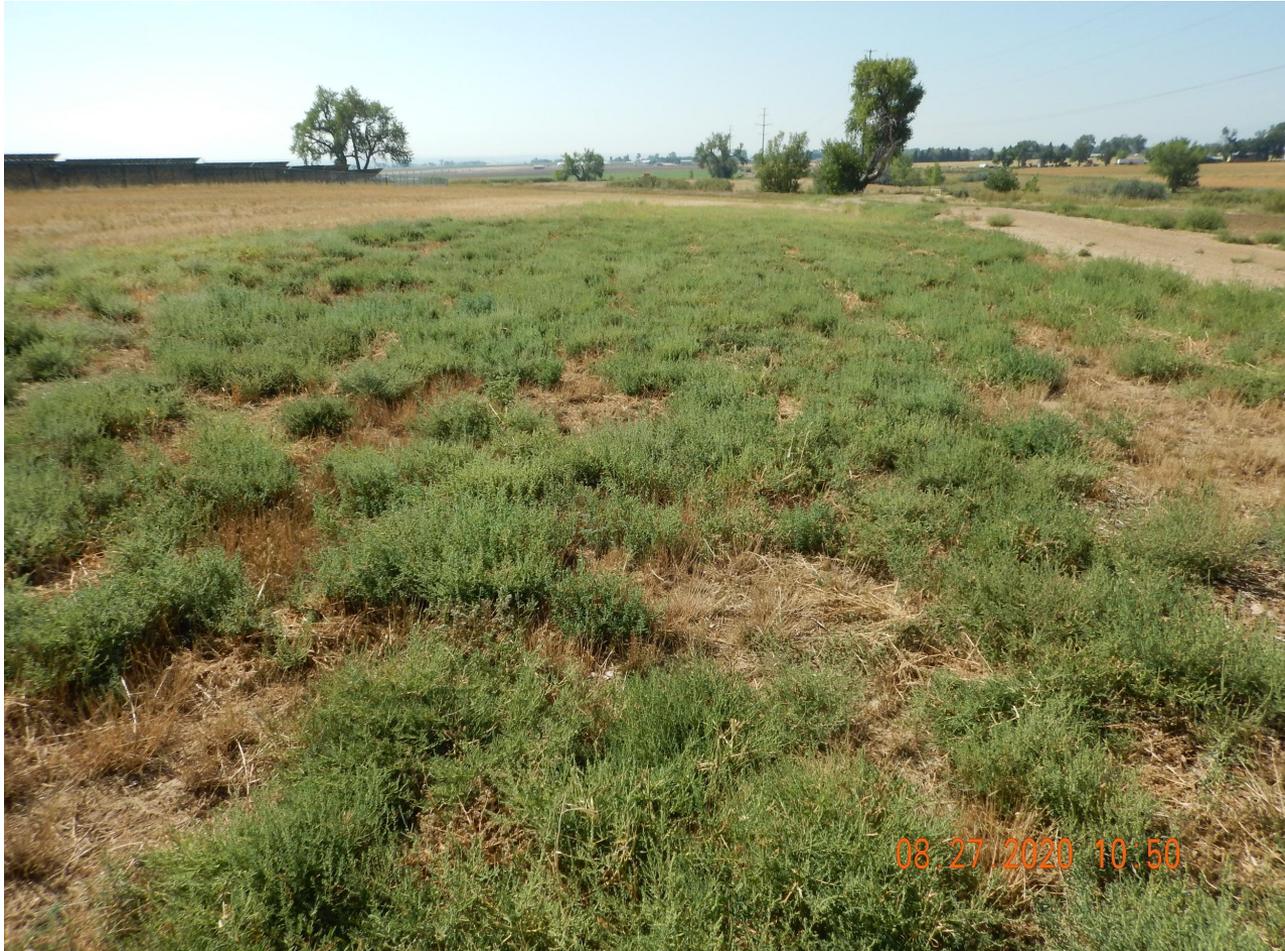
Photo 3. Photo taken from the associated offsite tank battery, facing South. See comments under Photo 2.

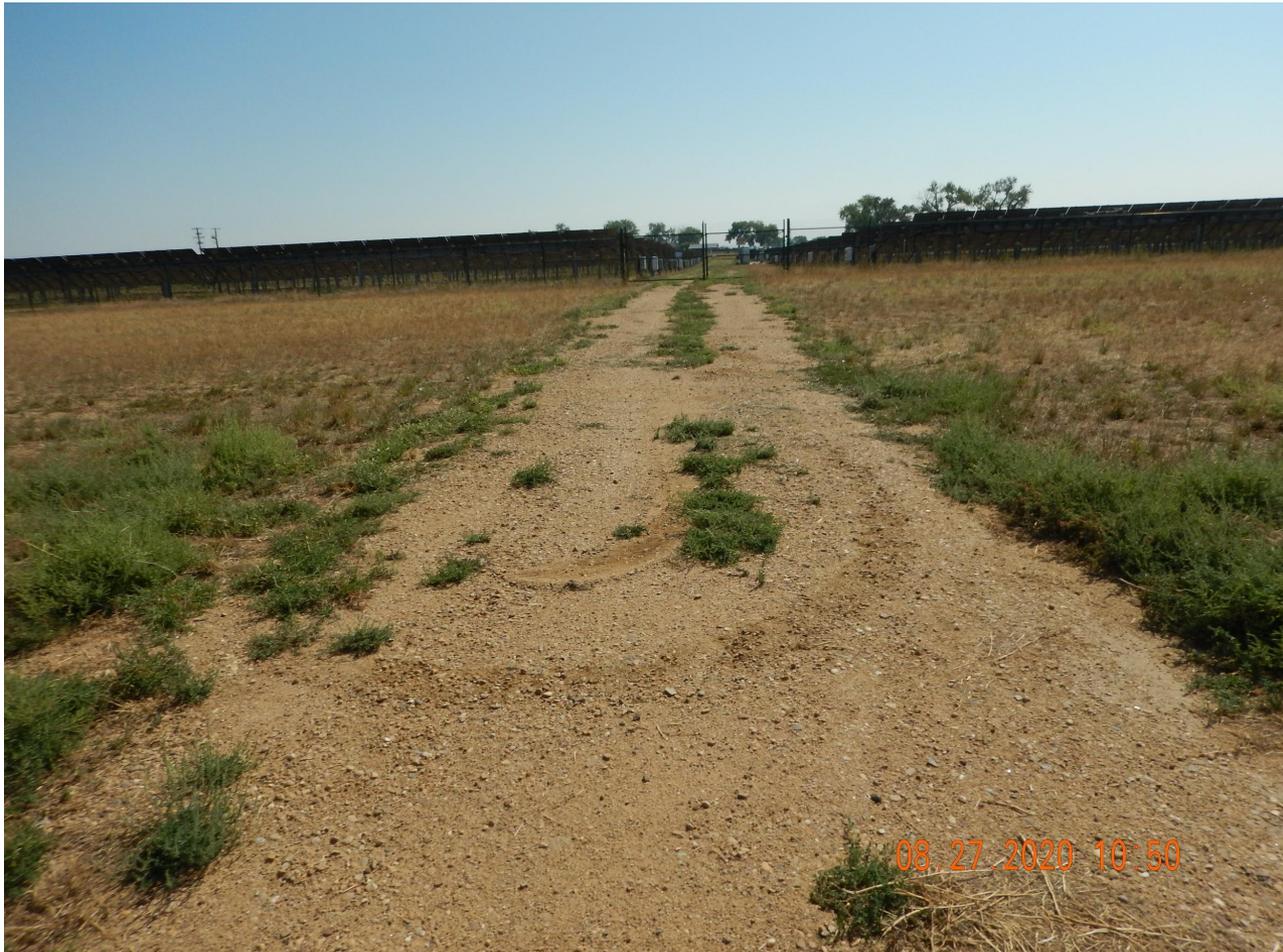
Photo 4. Photo taken from the associated offsite tank battery, facing East. Photo illustrates there is a new access road which is used to access the nearby solar farm.

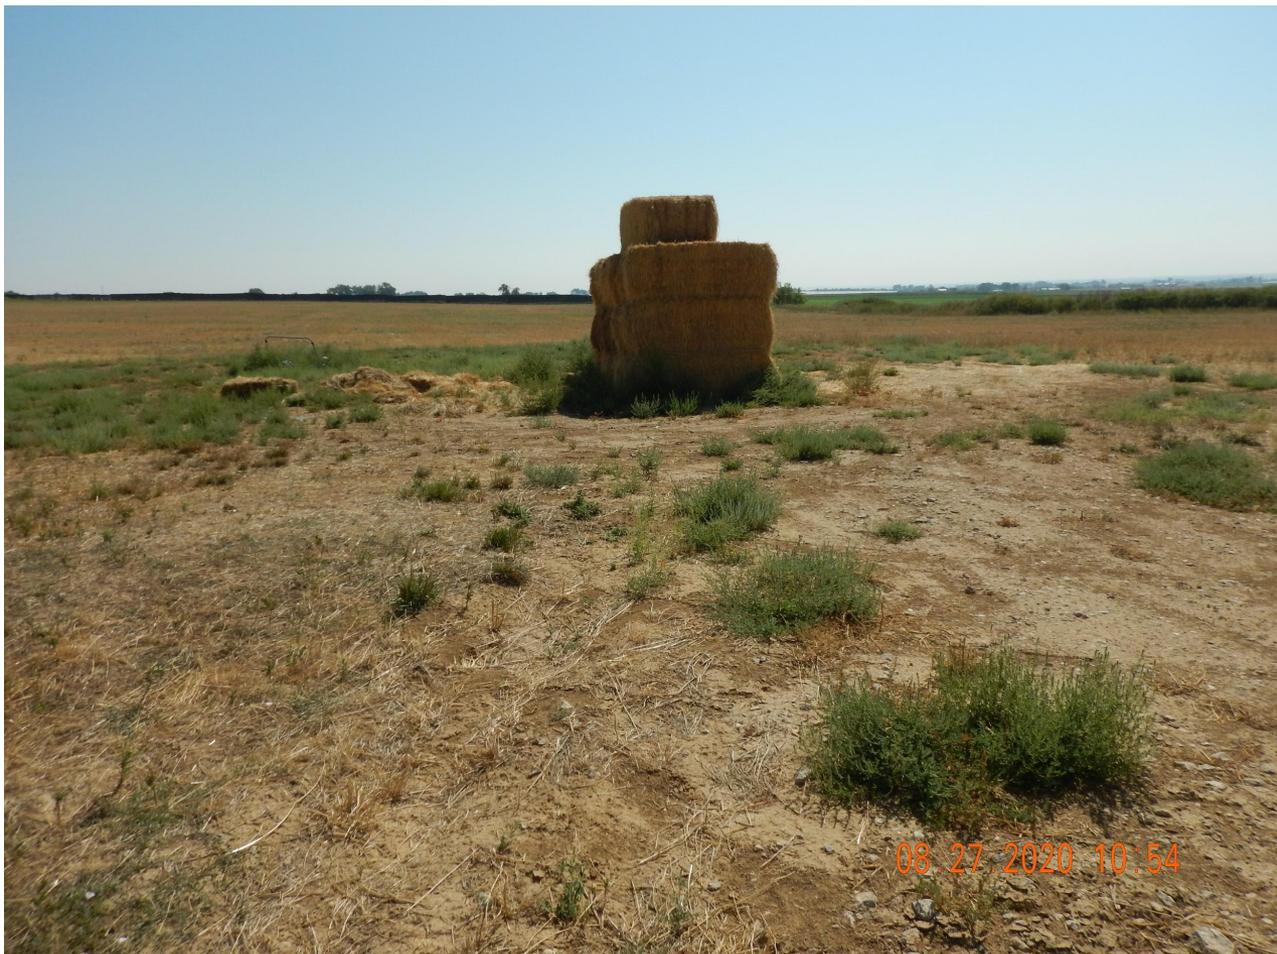
Photo 5. Photo taken from the well location, facing East. Photo illustrates all equipment has been removed. Surface owner appears to be using portions of the well location for hay storage.

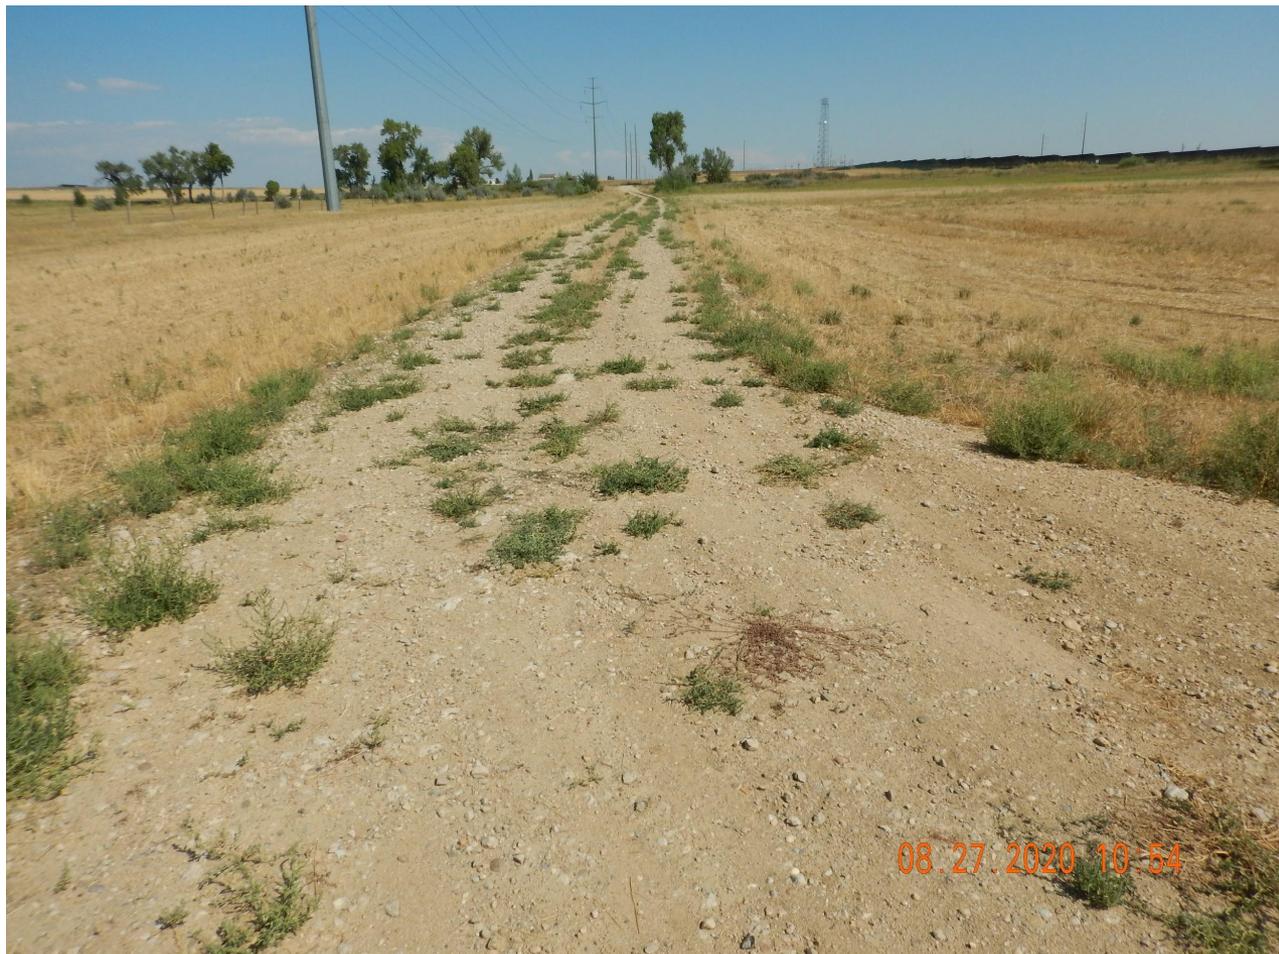
Photo 6. Photo taken from the well location, facing North. Photo illustrates the access road has not been reclaimed. Note: portion appear to be utilized to access two different solar farms.
