Inspection Photos
Location Name: HILL RANCH 06-04
API#: 05-071-07432
INSP. #: 695103250

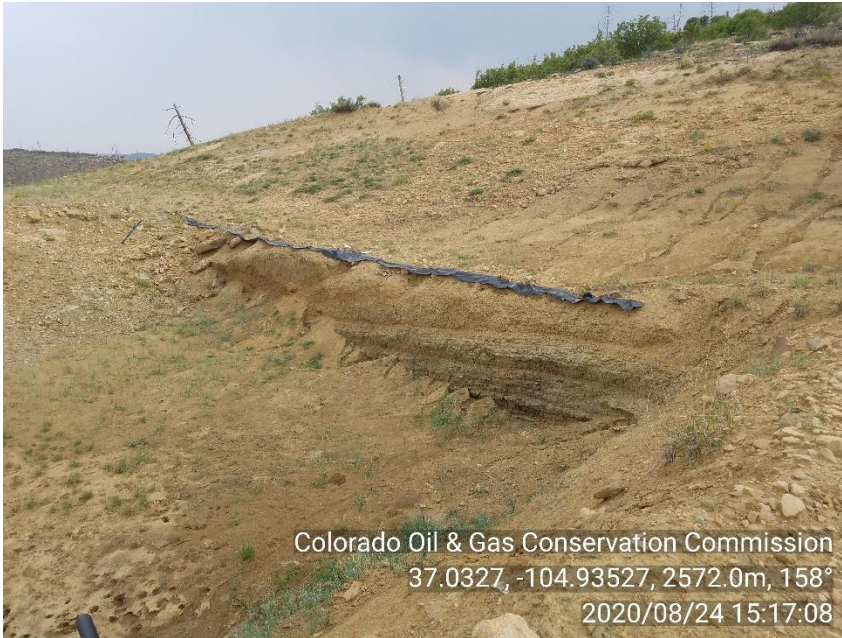
PHOTO 3: TRASH IN EARTH PIT. REMOVE REMINENCE OF PIT LINER THAT WAS LEFT AFTER REMOVING PIT LINER, COMPLY WITH RULE 603.f. CA DATE 9-8-20.

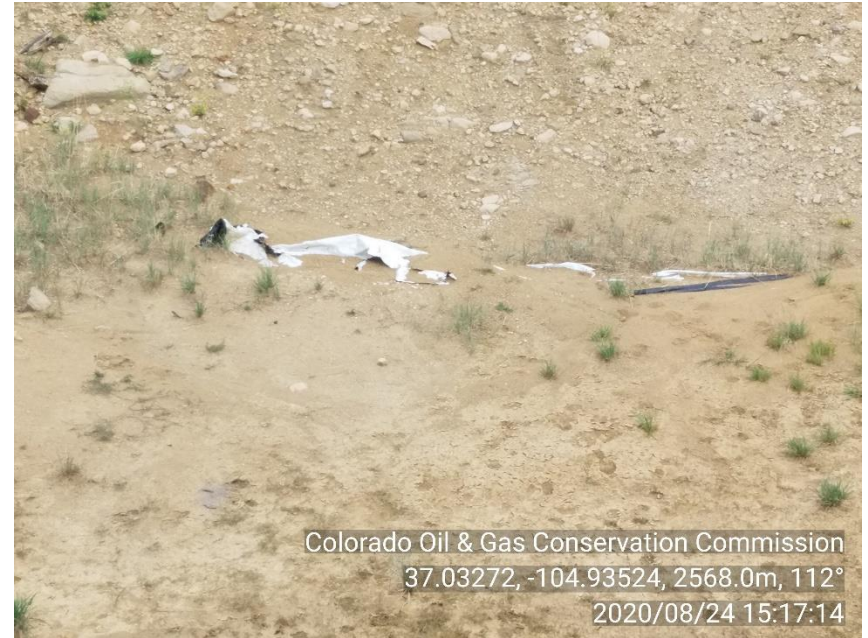
PHOTO 4: IMAGE OF MORE TRASH IN EARTH PIT.
