Inspection Photos
Location Name: HILL RANCH 31-14
API#: 05-071-09567
INSP. #: 695103252

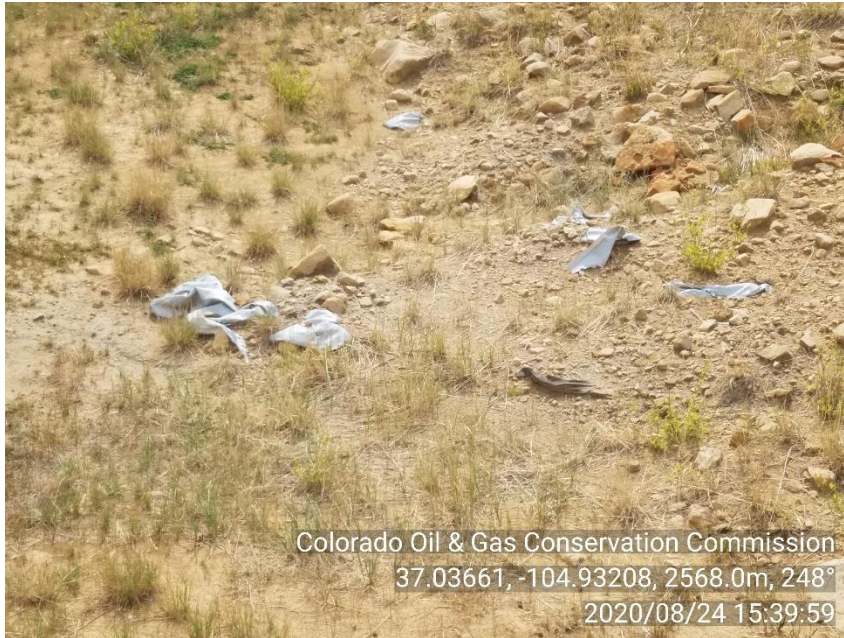
PHOTO 3: TRASH IN EARTH PIT (PIECES OF PIT LINER LEFT IN PIT). REMOVE ALL TRASH IN AND AROUND PIT, COMPLY WITH RULE 603.f. CA DATE 9-8-20.

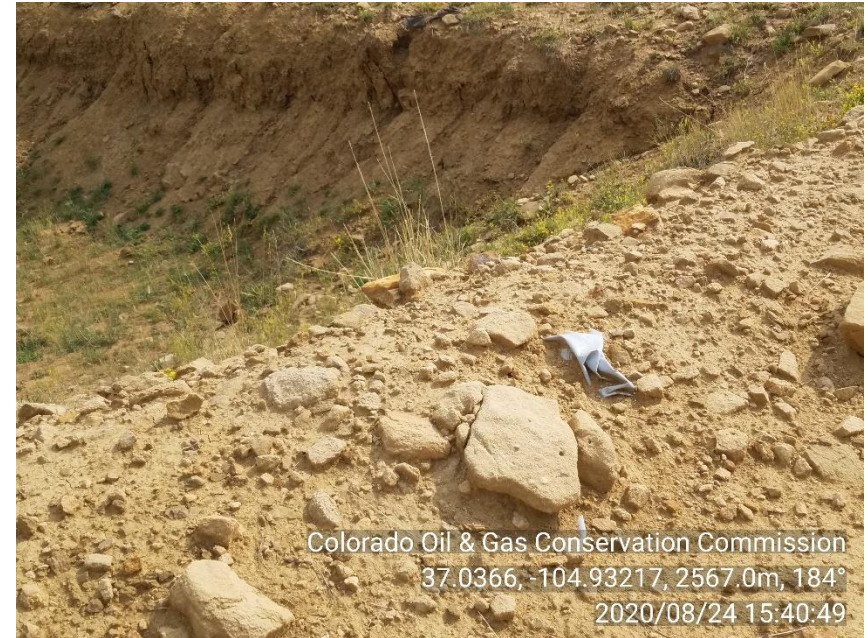
PHOTO 4: MORE IMAGES OF PIT LINER ON TOP EDGE OF PIT. REMOVE ALL TRASH IN AND AROUND PIT, COMPLY WITH RULE 603.f. CA DATE 9-8-20.

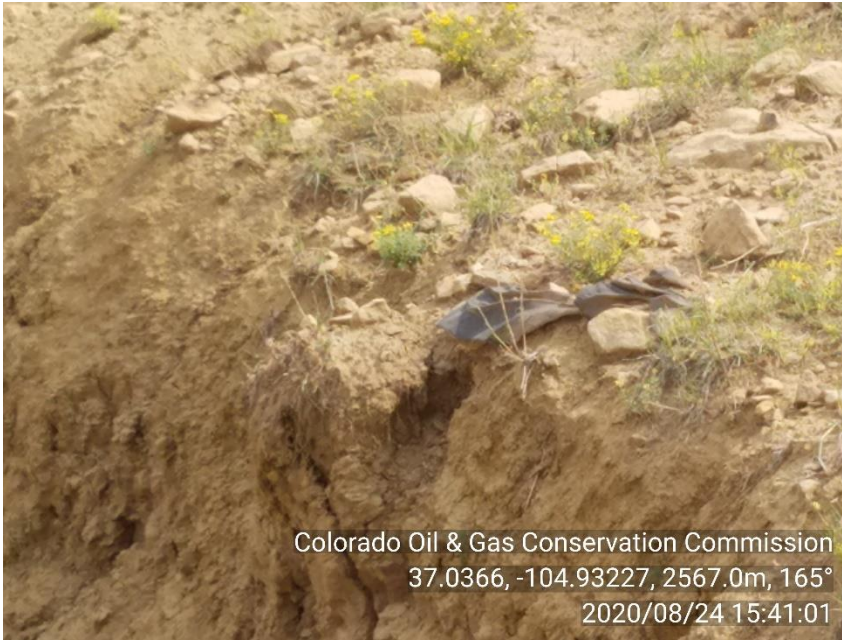
**PHOTO 5: MORE IMAGES OF PIT LINER ON TOP EDGE OF PIT.
REMOVE ALL TRASH IN AND AROUND PIT, COMPLY WITH
RULE 603.f. CA DATE 9-8-20.**

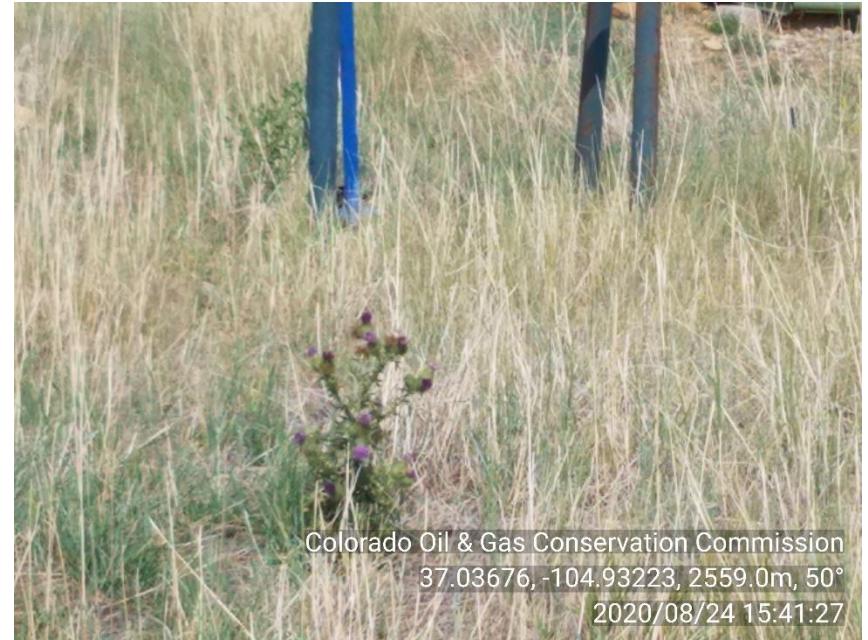
**PHOTO 6: NOXIOUS WEED NEAR ENTRANCE OF LOCATION.
CONTROL WEEDS.**
