Inspection Photos  
Location Name: AP 09-07  
API#: 05-071-06190  
INSP. #: 695103254

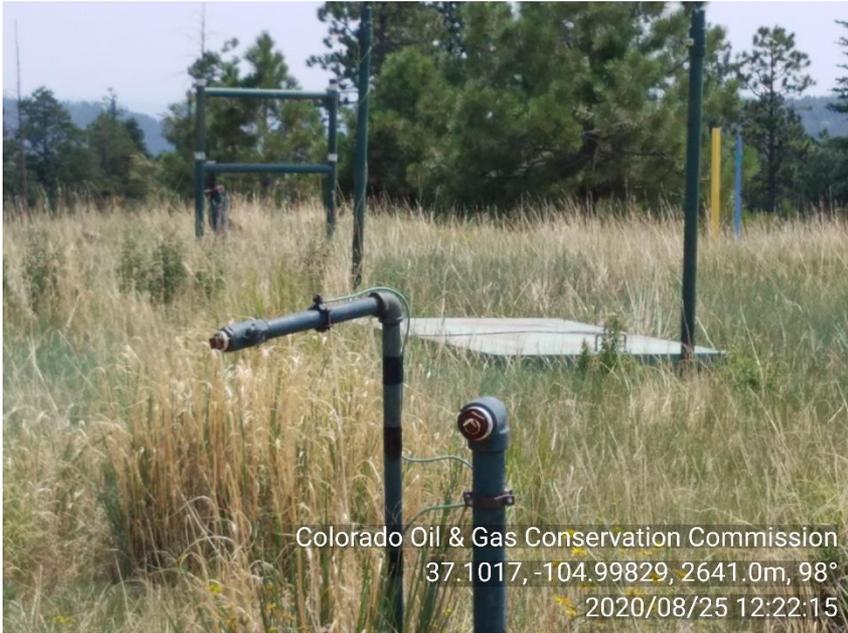
**PHOTO 3: UNMARKED UNUSED RISERS ON NORTHWEST  
EDGE OF LOCATION. REMOVE OR MARK RISERS, COMPLY  
WITH RULE 603.f. CA DATE 11-26-20.**
