Inspection Photos  
Location Name: APACHE CANYON 10-01  
API#: 05-071-08277  
INSP. #: 695103256

Location Name: APACHE CANYON 10-01

API#: 05-071-08277

INSP. #: 695103256

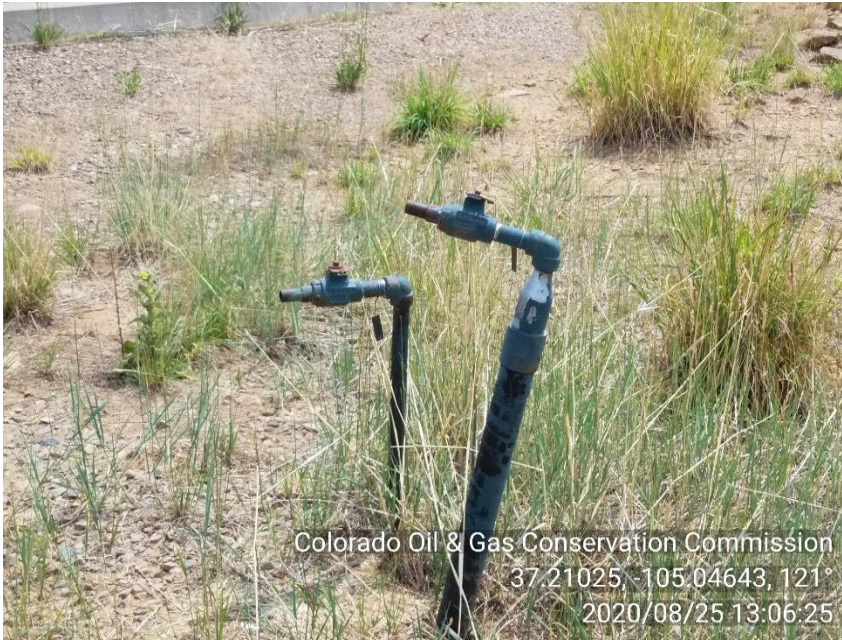
**PHOTO 3: UNMARKED UNUSED RISERS NOT LO/TO. REMOVE OR MARK AND LOCKOUT/TAGOUT RISERS, COMPLY WITH RULE 603.f. CA DATE 11-25-20.**

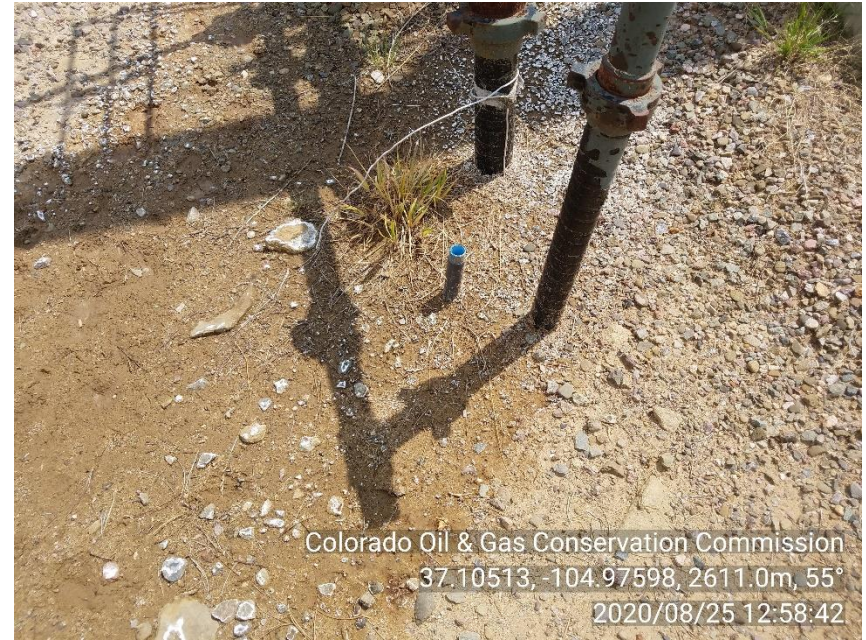
**PHOTO 4: UNMARKED UNUSED RISERS NOT LO/TO. REMOVE OR MARK AND LOCKOUT/TAGOUT RISERS, COMPLY WITH RULE 603.f. CA DATE 11-25-20.**

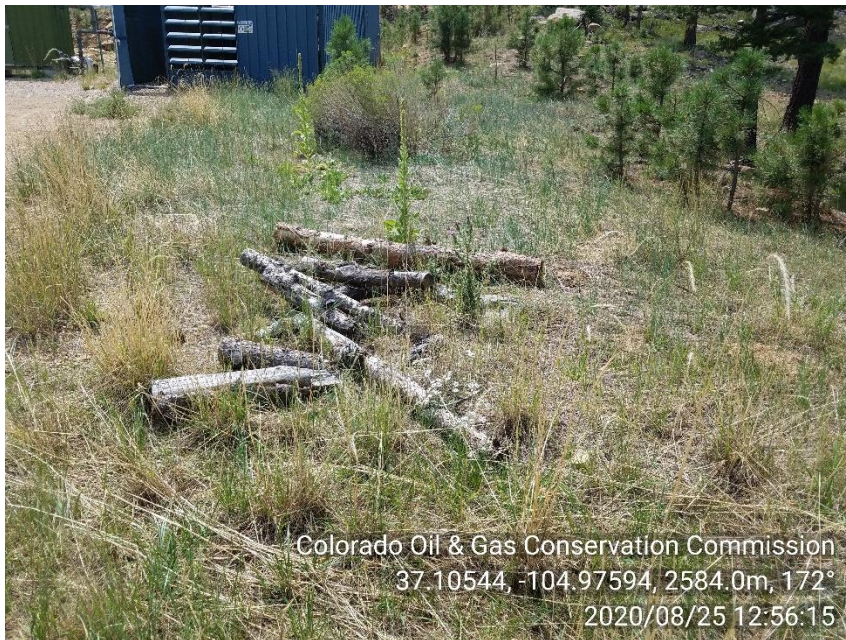
**PHOTO 5: TRASH/DEBREE ON WEST SIDE OF LOCATION.**  
**REMOVE ALL TRASH ON AND AROUND LOCATION, COMPLY**  
**WITH RULE 603.f. CA DATE 11-25-20.**

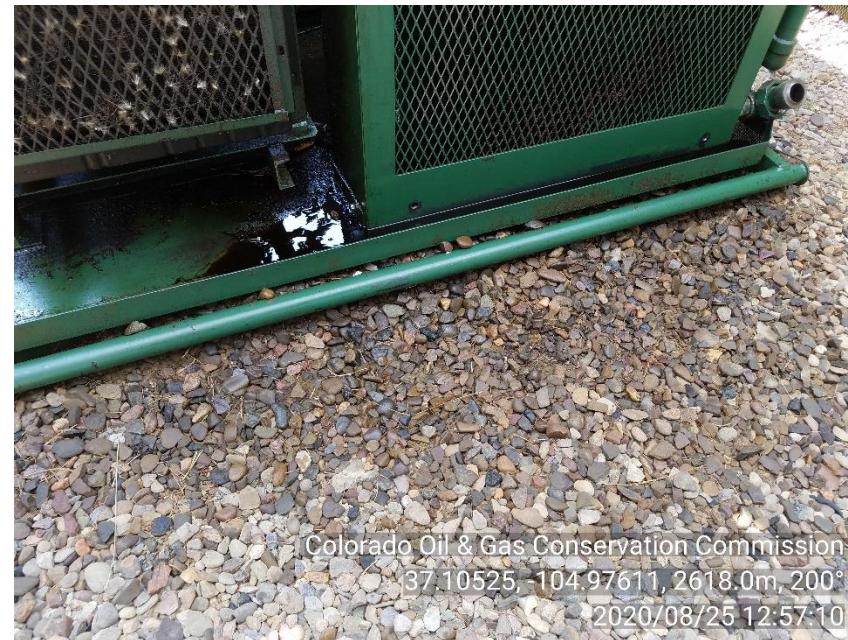
**PHOTO 6: IMPACTED SOIL NEAR COMPRESSOR INSIDE**  
**SOUNDWALLS. "Properly dispose of oily waste in accordance**  
**with 907.e." CA DATE 11-25-20.**

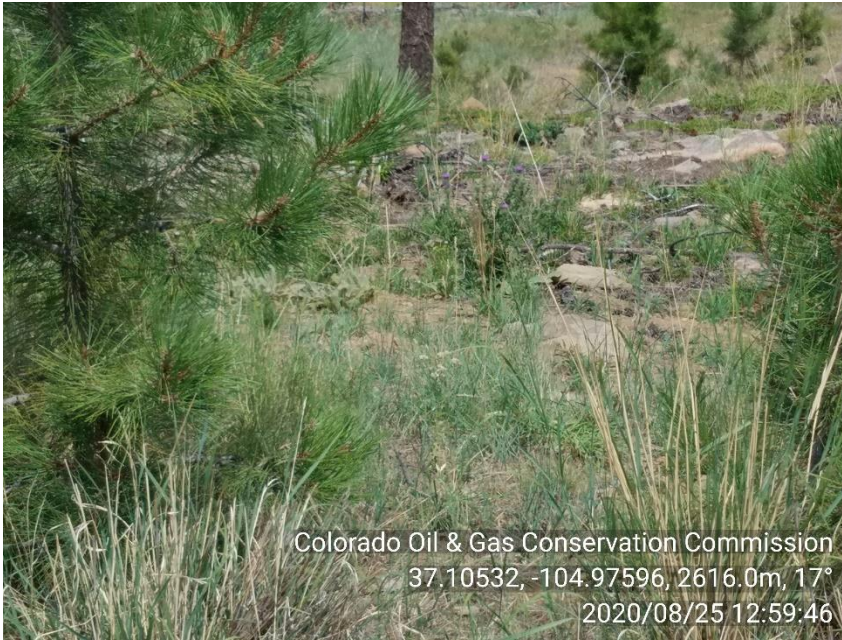
**PHOTO 7: NOXIOUS WEEDS ON EDGE OF LOCATION AND ON INTERIM RECLAMATION AREA ALSO ALL ALONG THE ROW GOING TO THE WEST OF LOCATION. **CONTROL WEEDS.****

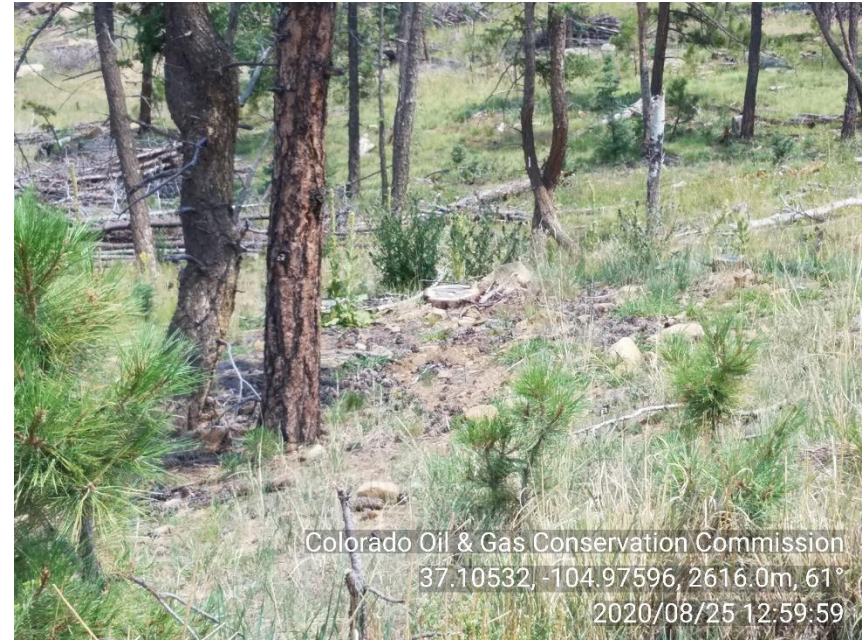
**PHOTO 8: MORE IMAGES OF NOXIOUS WEEDS.**

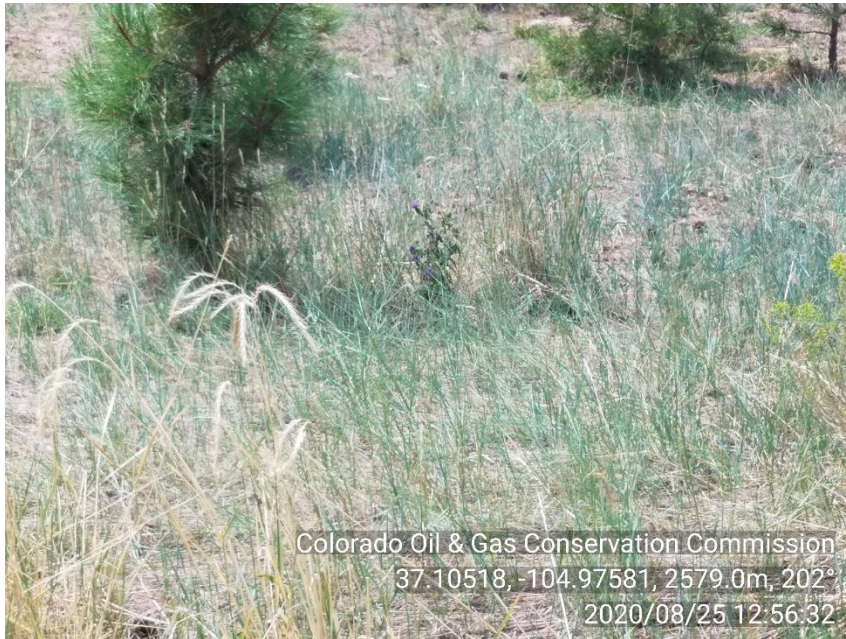
**PHOTO 9: NOXIOUS WEEDS NORTH OF LOCATION.**
