# Inspection Photos

Operator: SG INTERESTS I LTD - 77330

Location ID: 422990

Gunnison County, CO

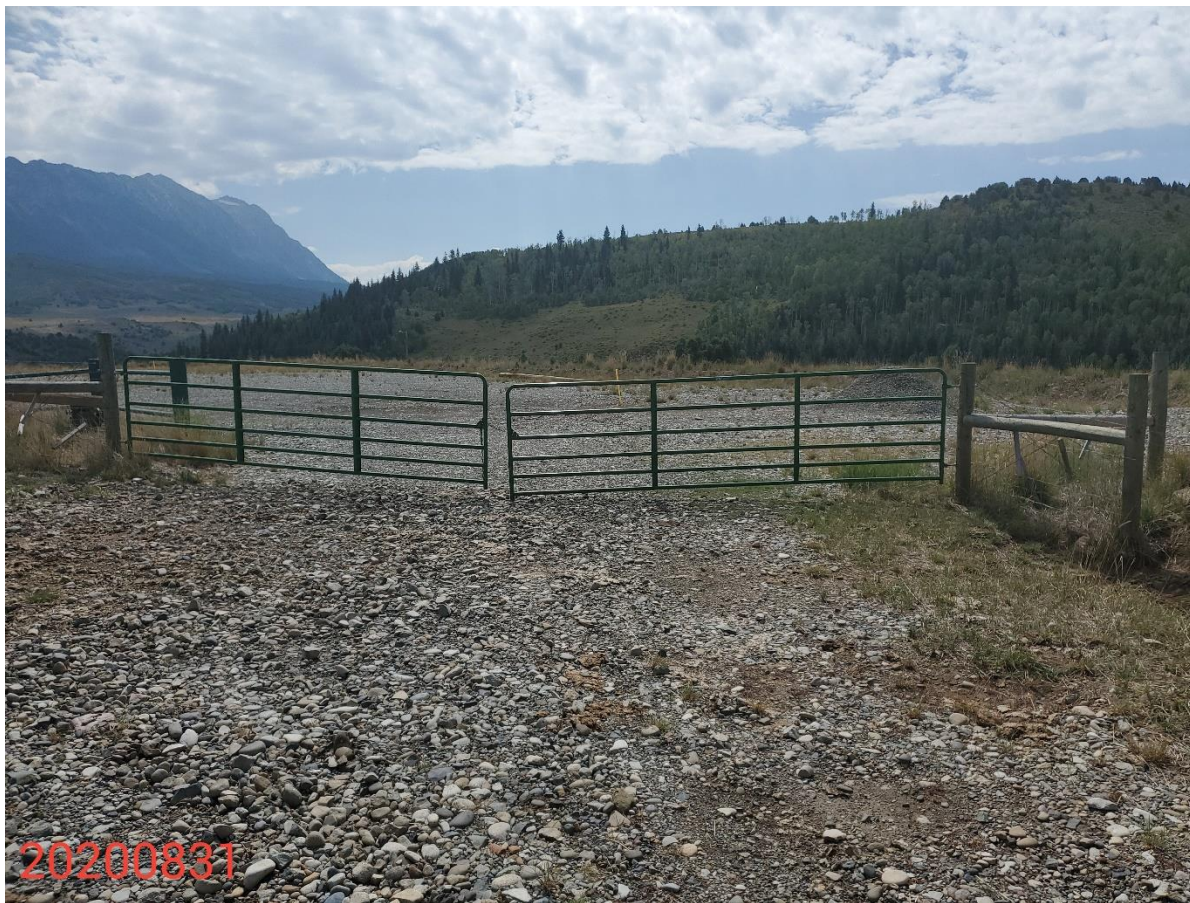
**Photo 1:** Photo taken from the Location entrance, facing south. Photo shows signage required per the Delayed IR NTO, and per COAs, has not been installed.

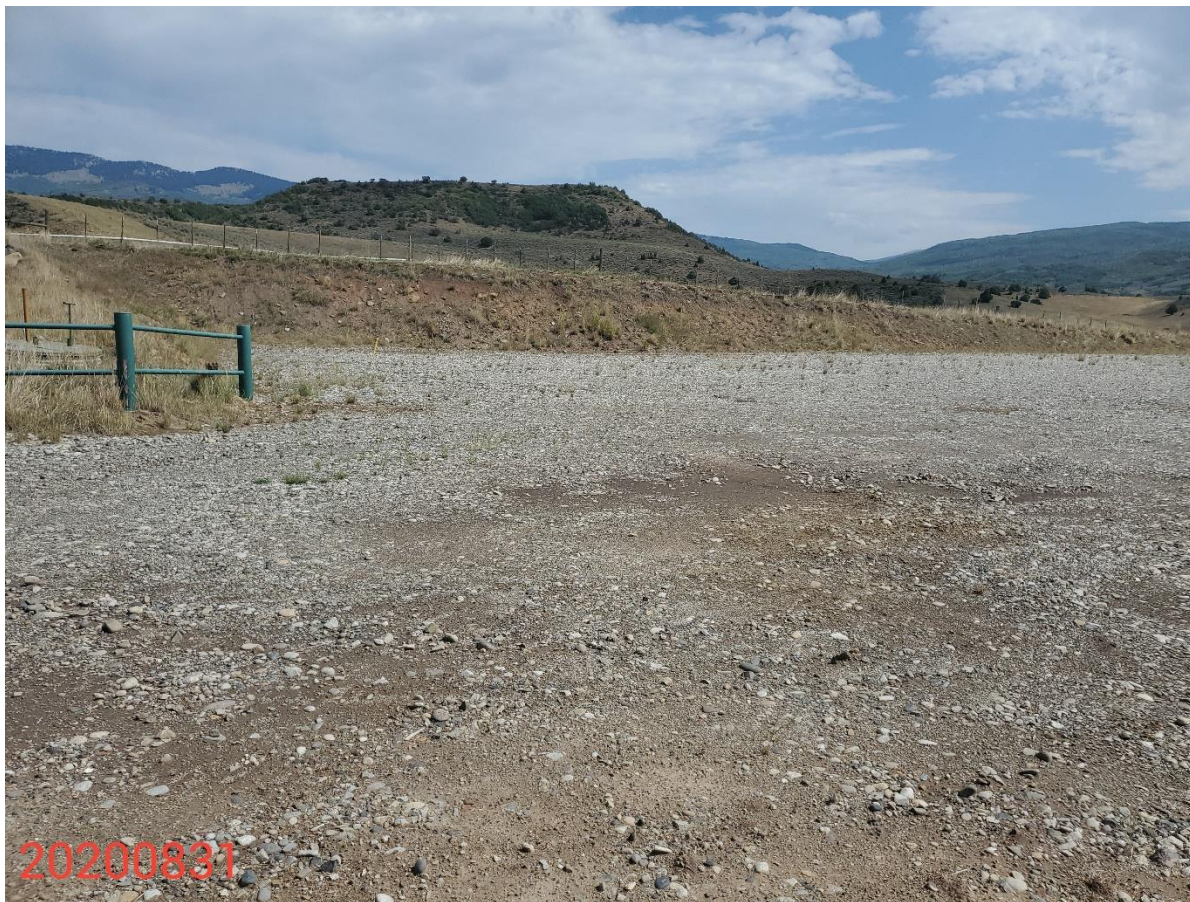
**Photo 2:** Photo taken from west end of the Location, facing north east. Photo provides an overview of the location.

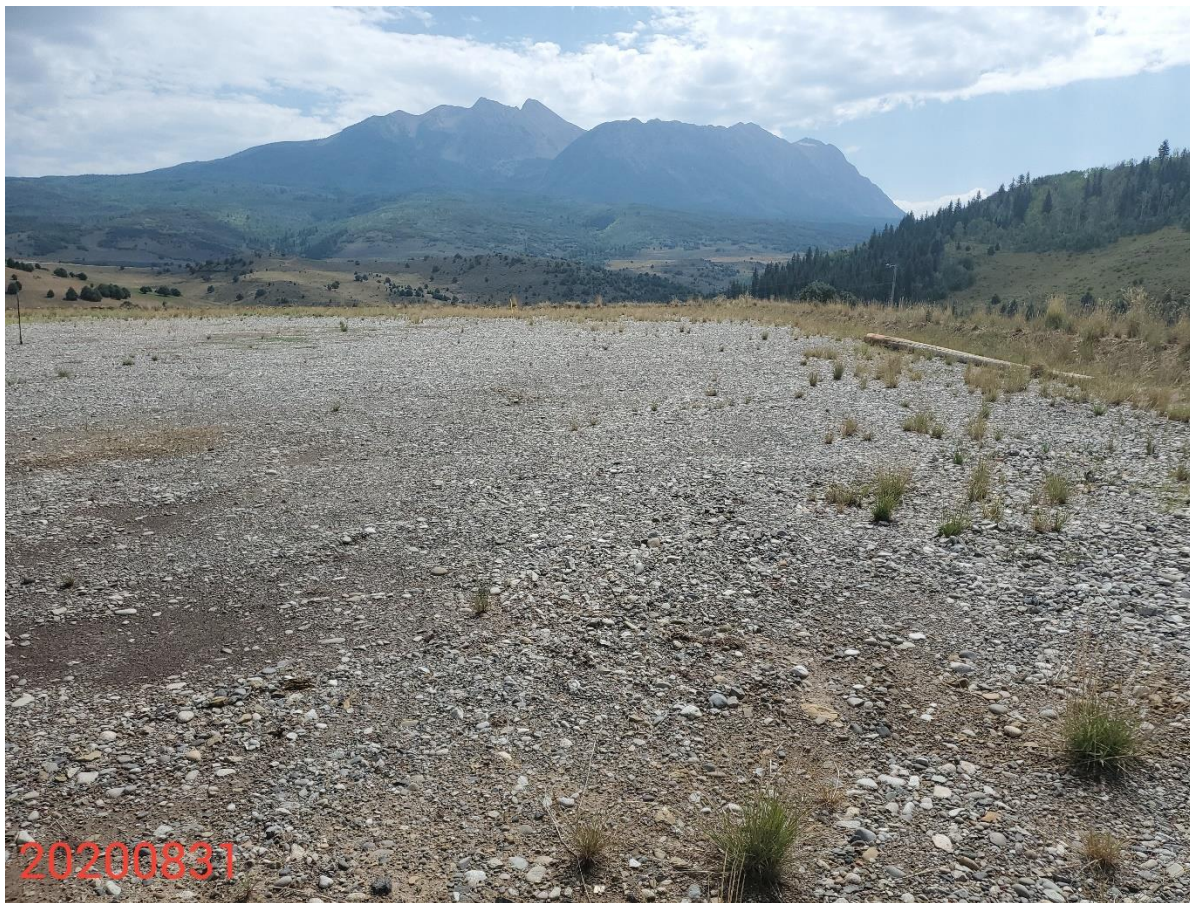
**Photo 3:** Photo taken from west end of the Location, facing south. Photo provides an overview of the location.

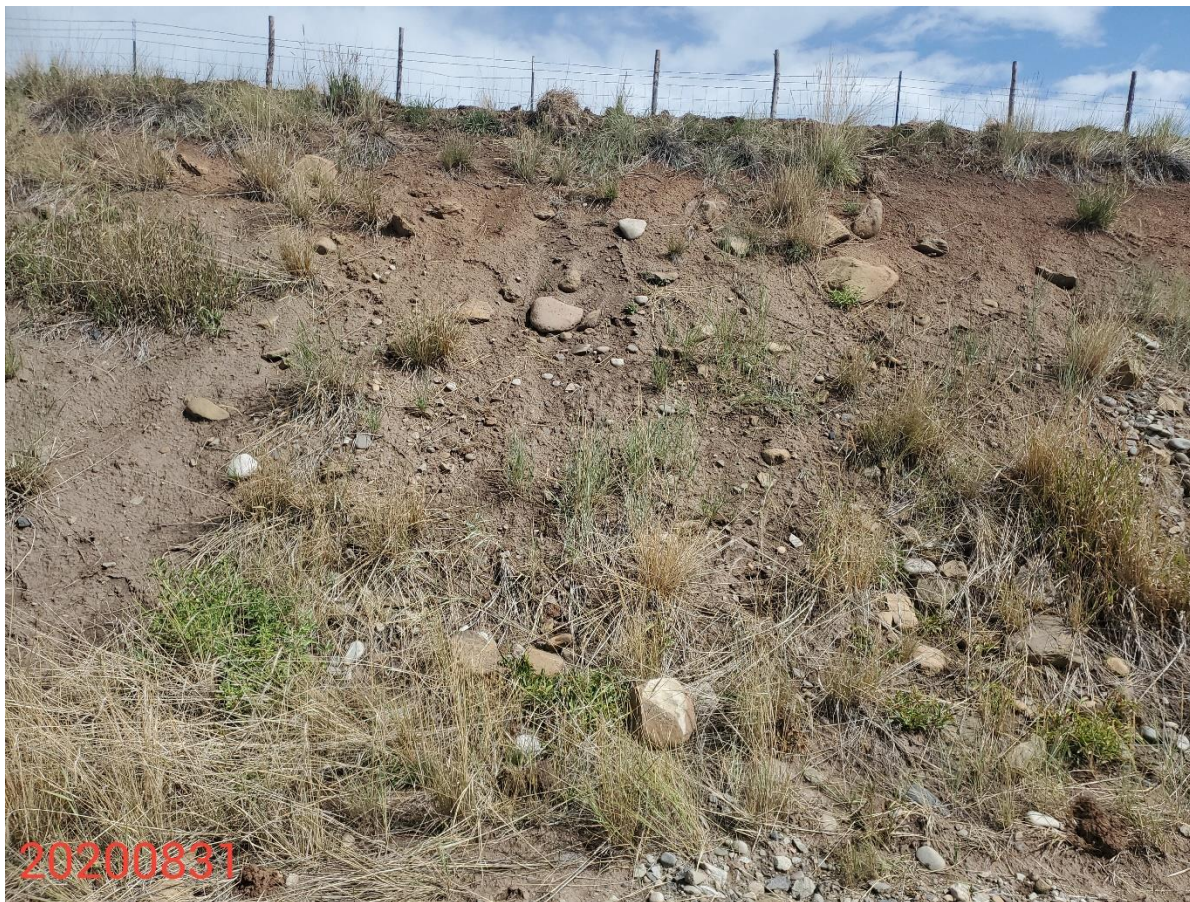
**Photo 4:** Photo taken from the cut slope on the north end of the Location. Photo shows BMPs to protect and stabilize the slopes remain missing or insufficient.

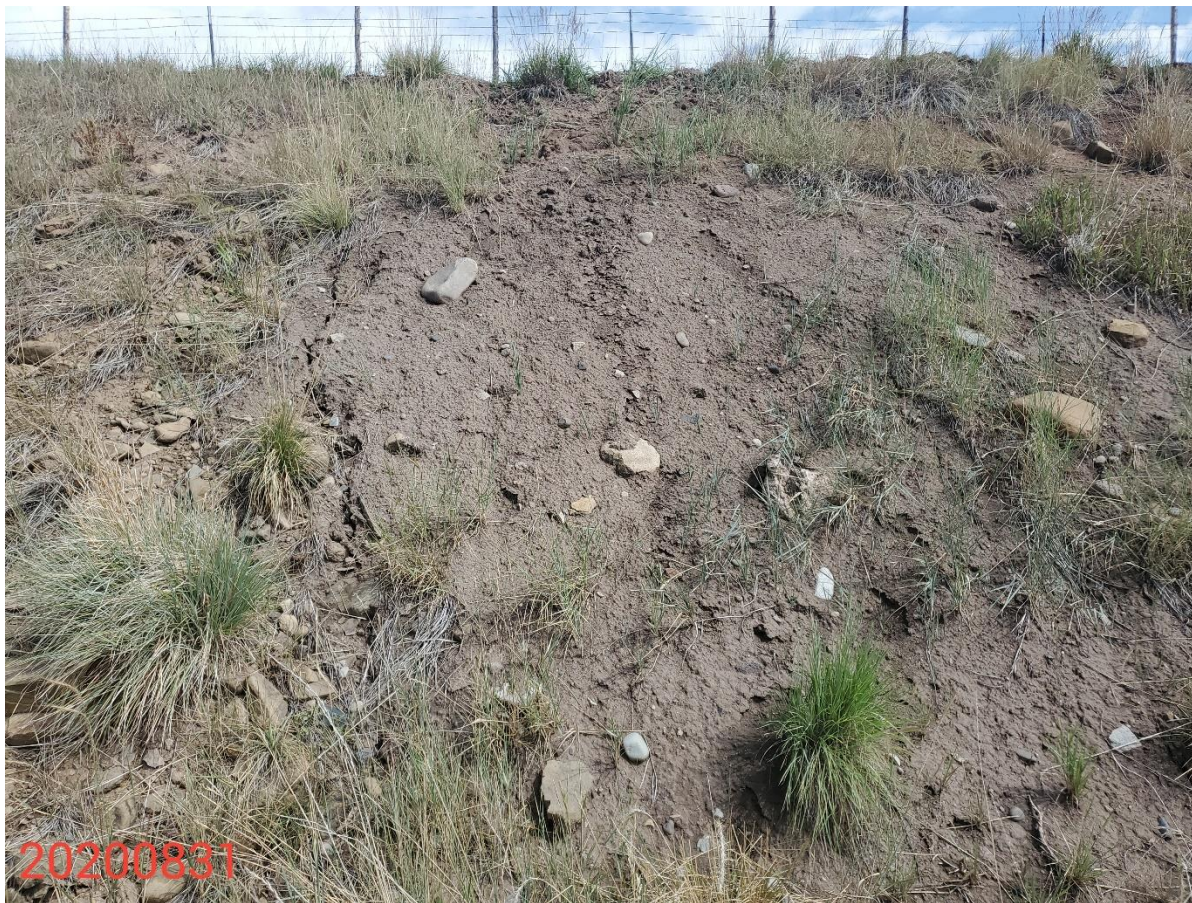
**Photo 5:** Photo taken from the cut slope on the north end of the Location. Photo shows BMPs to protect and stabilize the slopes remain missing or insufficient. Erosion degradation is recurring.

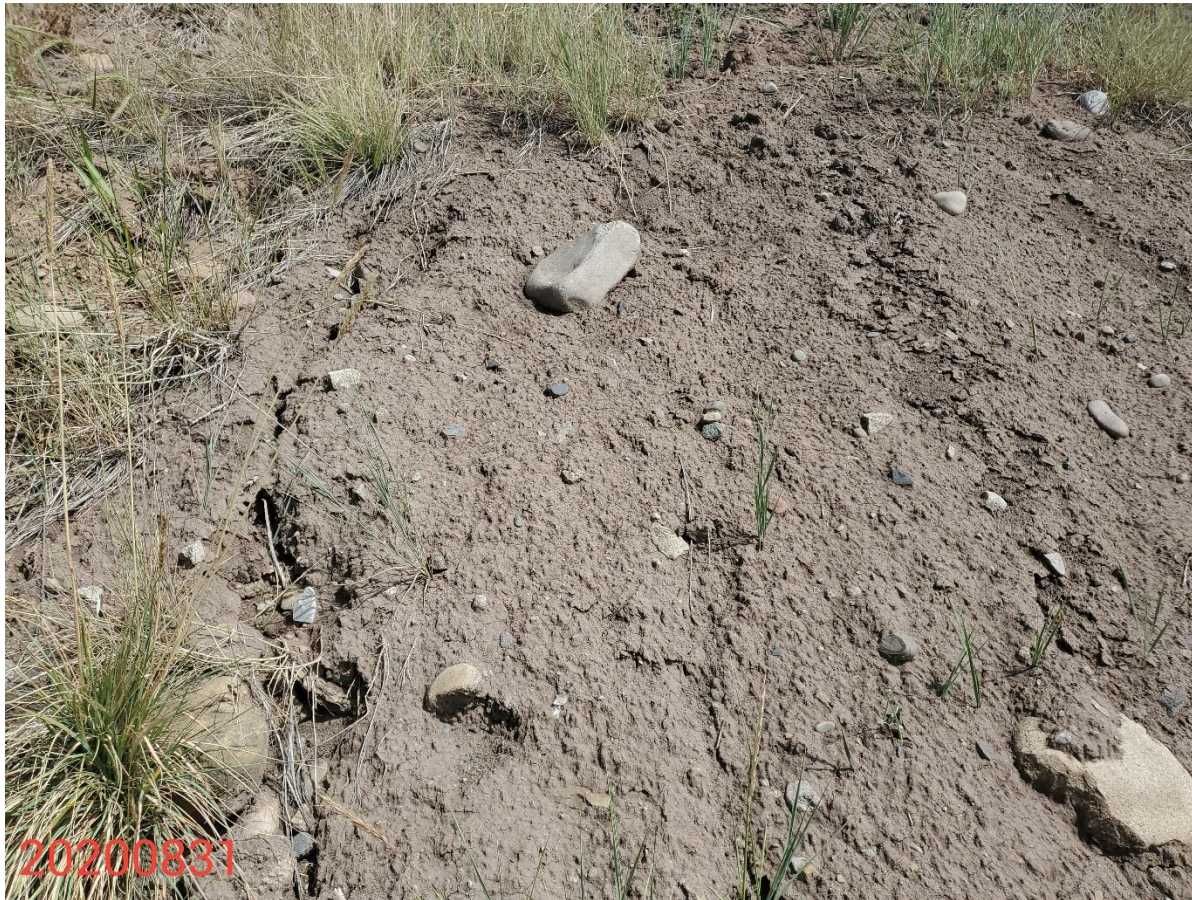
**Photo 6:** Photo taken from the cut slope on the north end of the Location. Photo shows BMPs to protect and stabilize the slopes remain missing or insufficient. Erosion degradation is recurring.

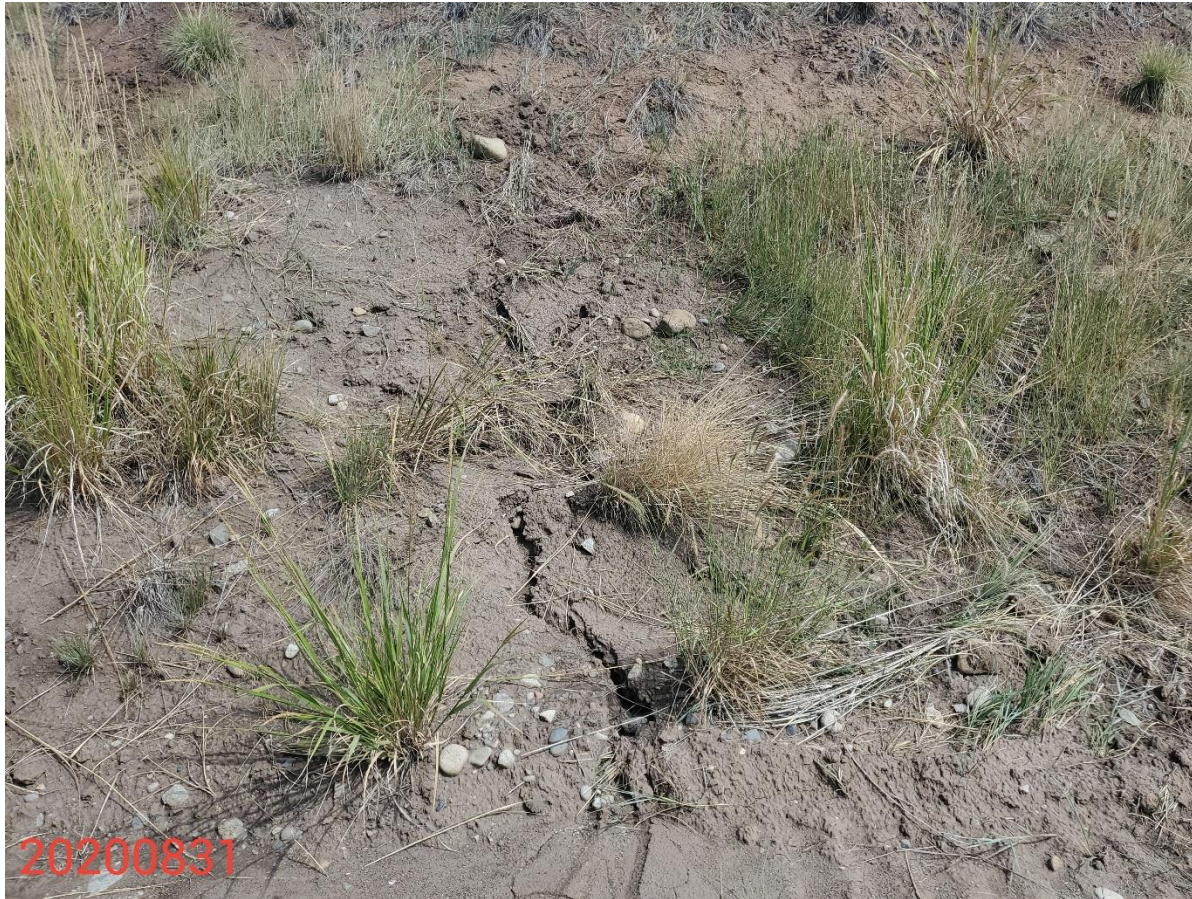
**Photo 7:** Photo shows sediment deposition and erosion from the cutslope.

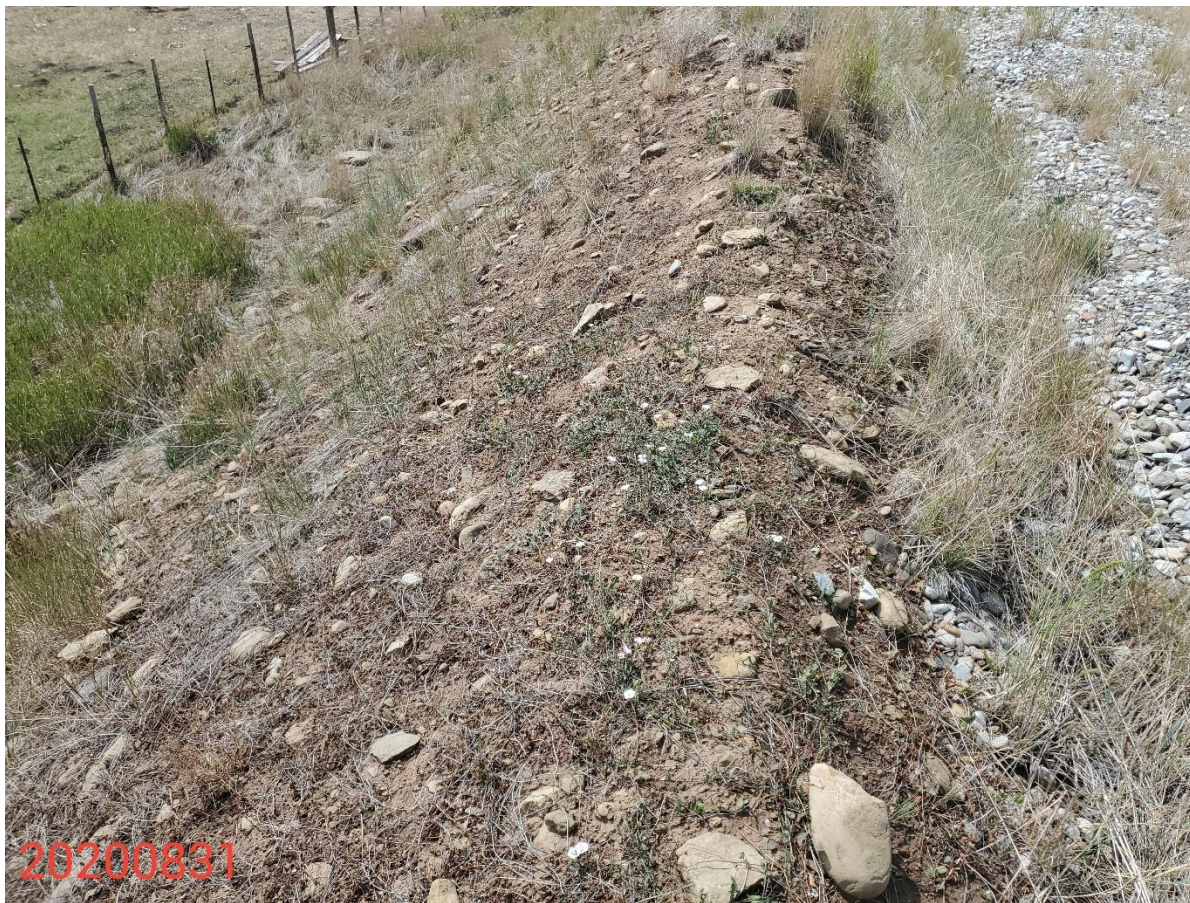
**Photo 8:** Photo shows bindweed establishment on the east end of the Location. This is a Colorado State listed noxious weed.

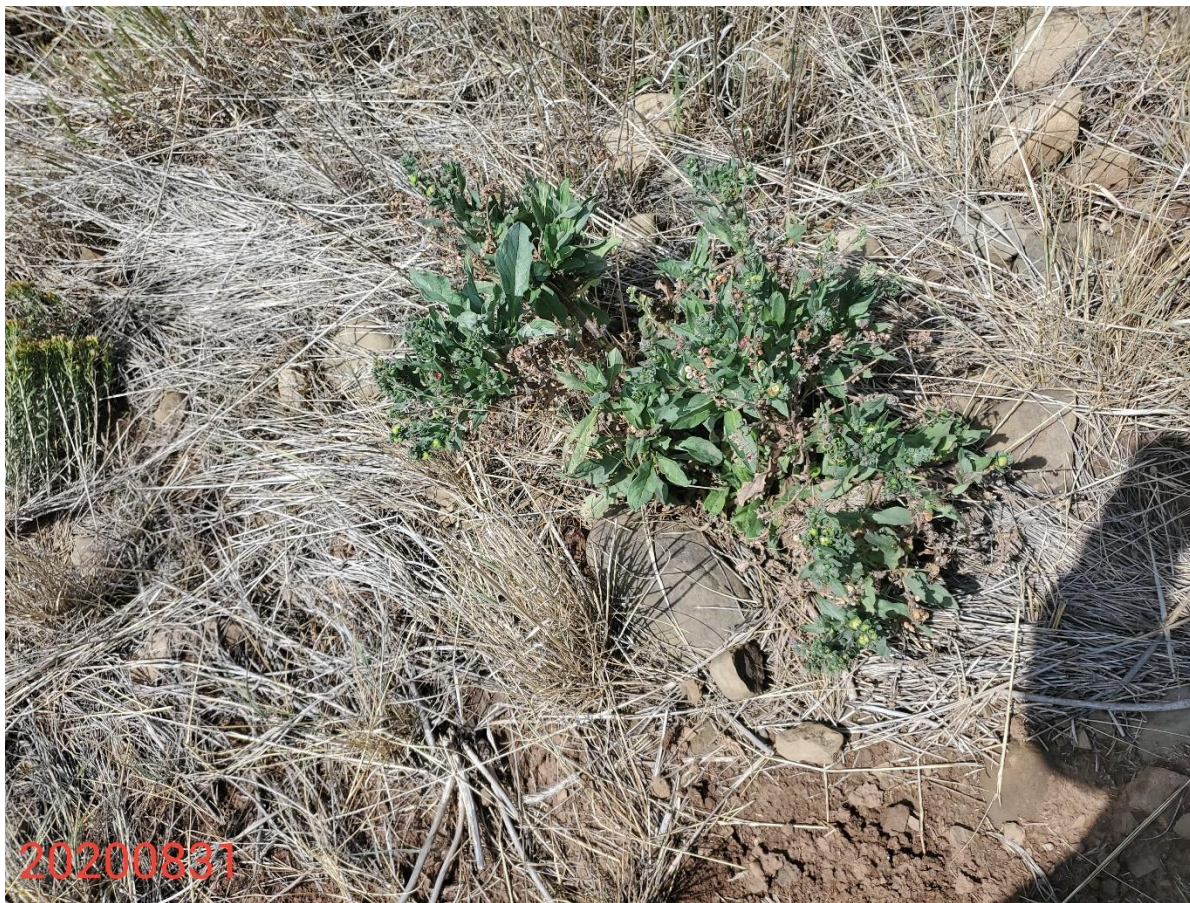
**Photo 9:** Photo shows bindweed establishment on the south end of the Location. This is a Colorado State listed noxious weed.

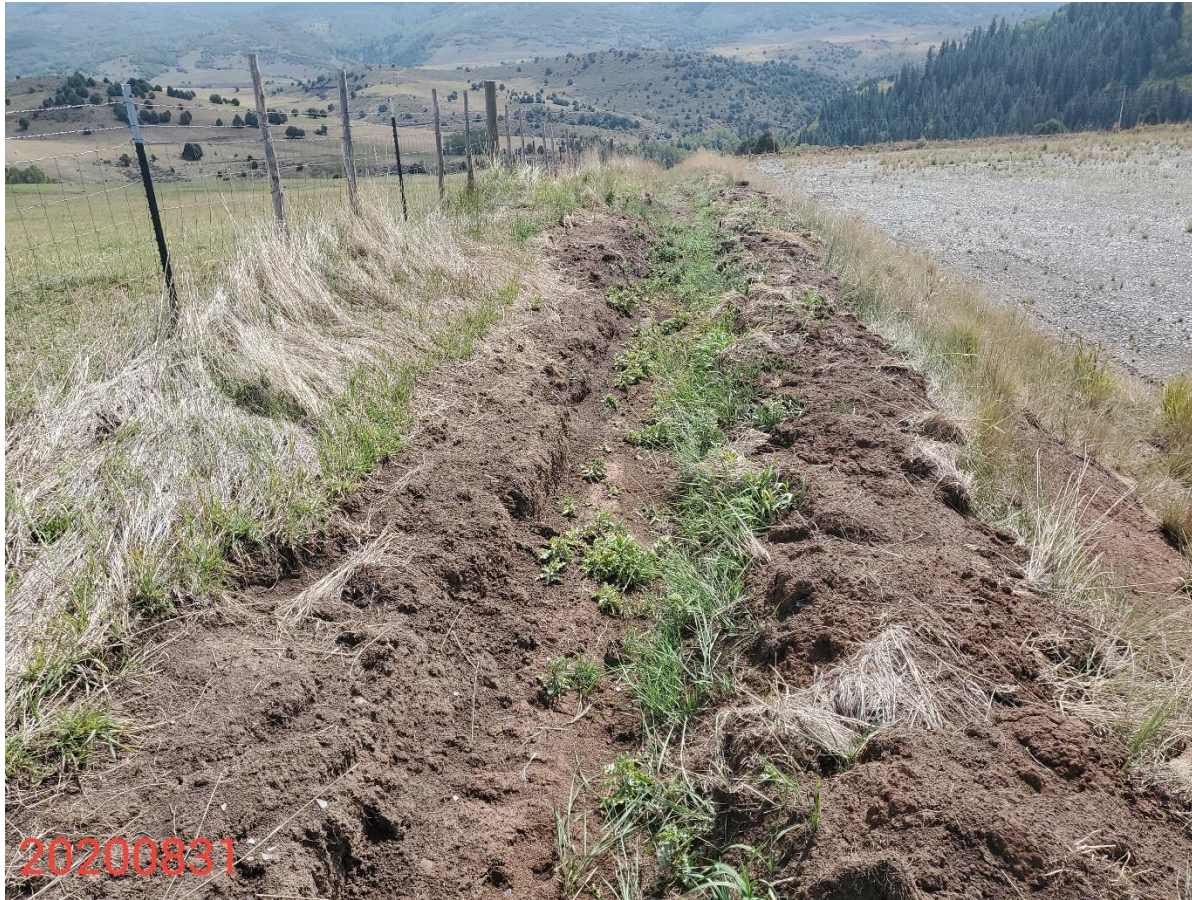
**Photo 10:** Photo taken from the stormwater ditch on the north end of the Location. Previous inspection observed Canada thistle establishing within ditch. Photo shows Canada thistle establishment remains evident within ditch. Previous weed management efforts appear insufficient.

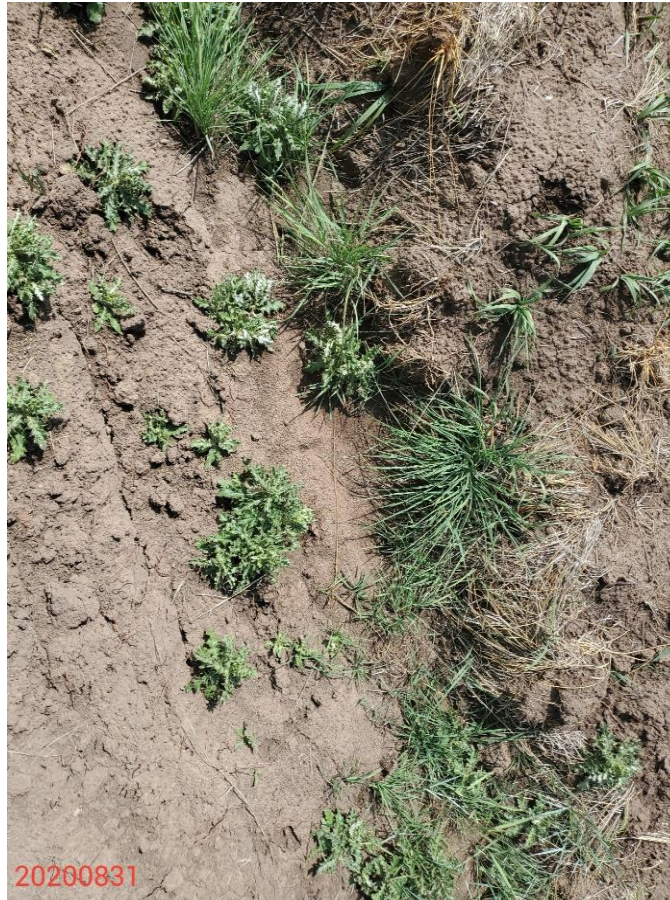
**Photo 11:** Photo shows Canada thistle establishment within ditch. Previous weed management efforts appear insufficient.
