# Inspection Photos

8/31/2020

Operator: SG INTERESTS I LTD - 77330

Location ID: 414132

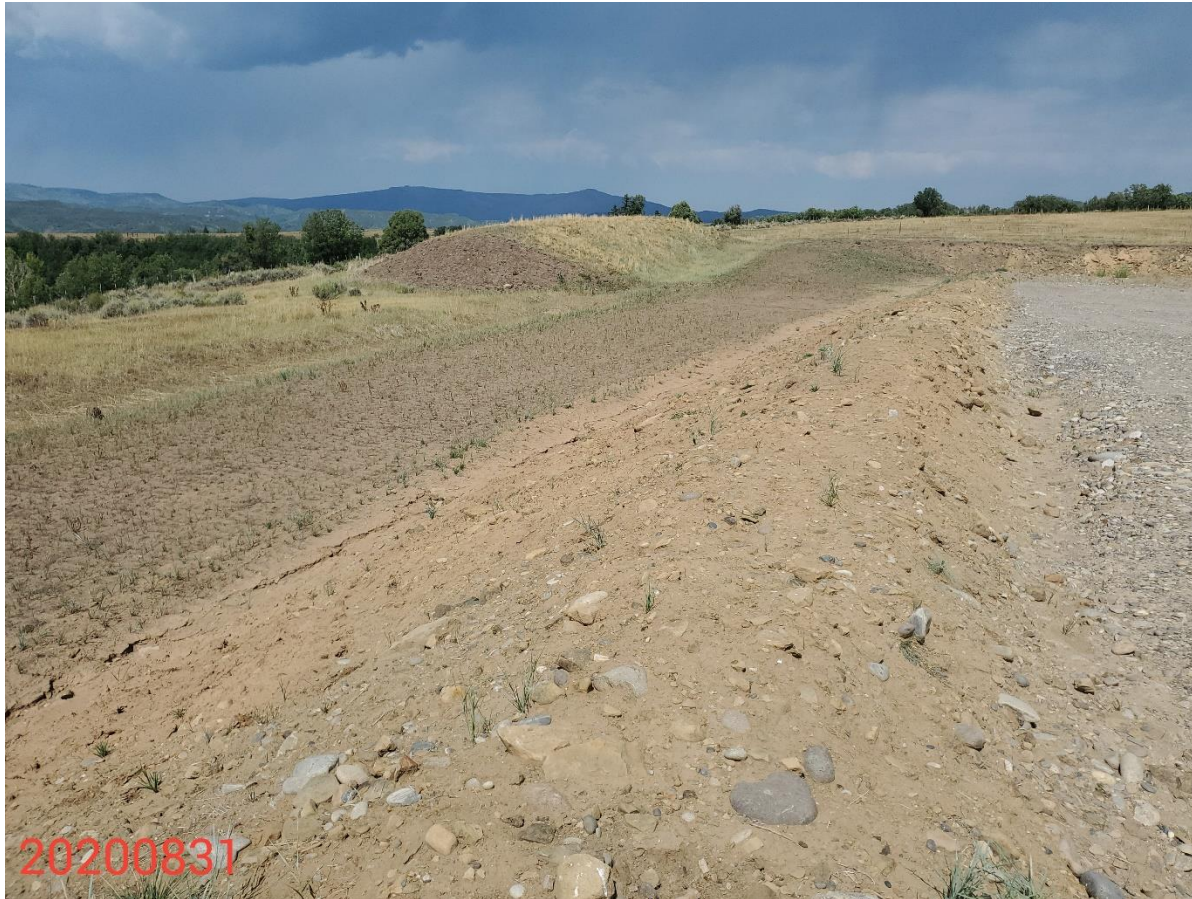
**Photo 1:** Photo taken from the west end of the Location, facing northwest. Photo shows interim areas and stormwater ditch.

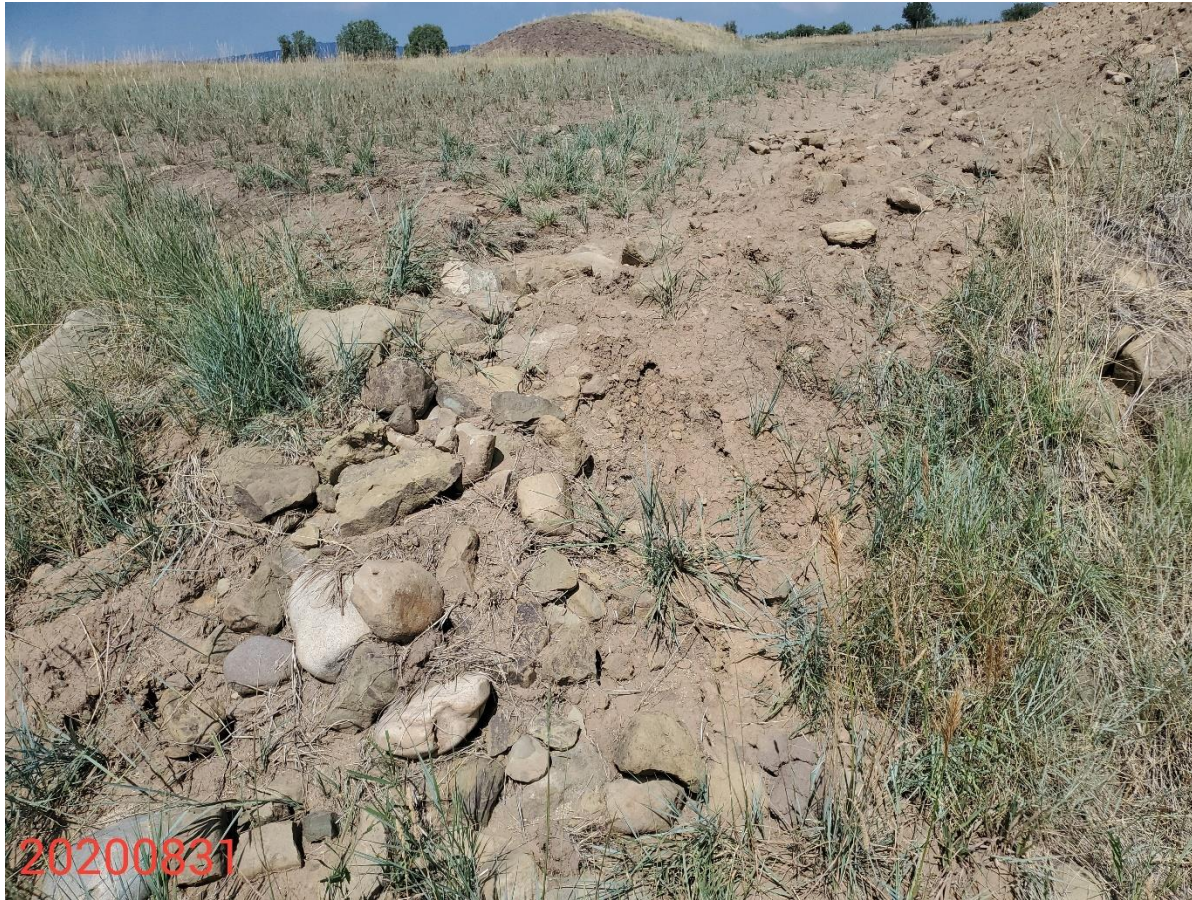
**Photo 2:** Photo taken from the outlet of the western stormwater ditch. Photo shows outlet/ditch has not been constructed in accordance with good engineering practices; Outlet remains insufficient to stabilize slopes and allow sediment laden-free stormwater discharge.

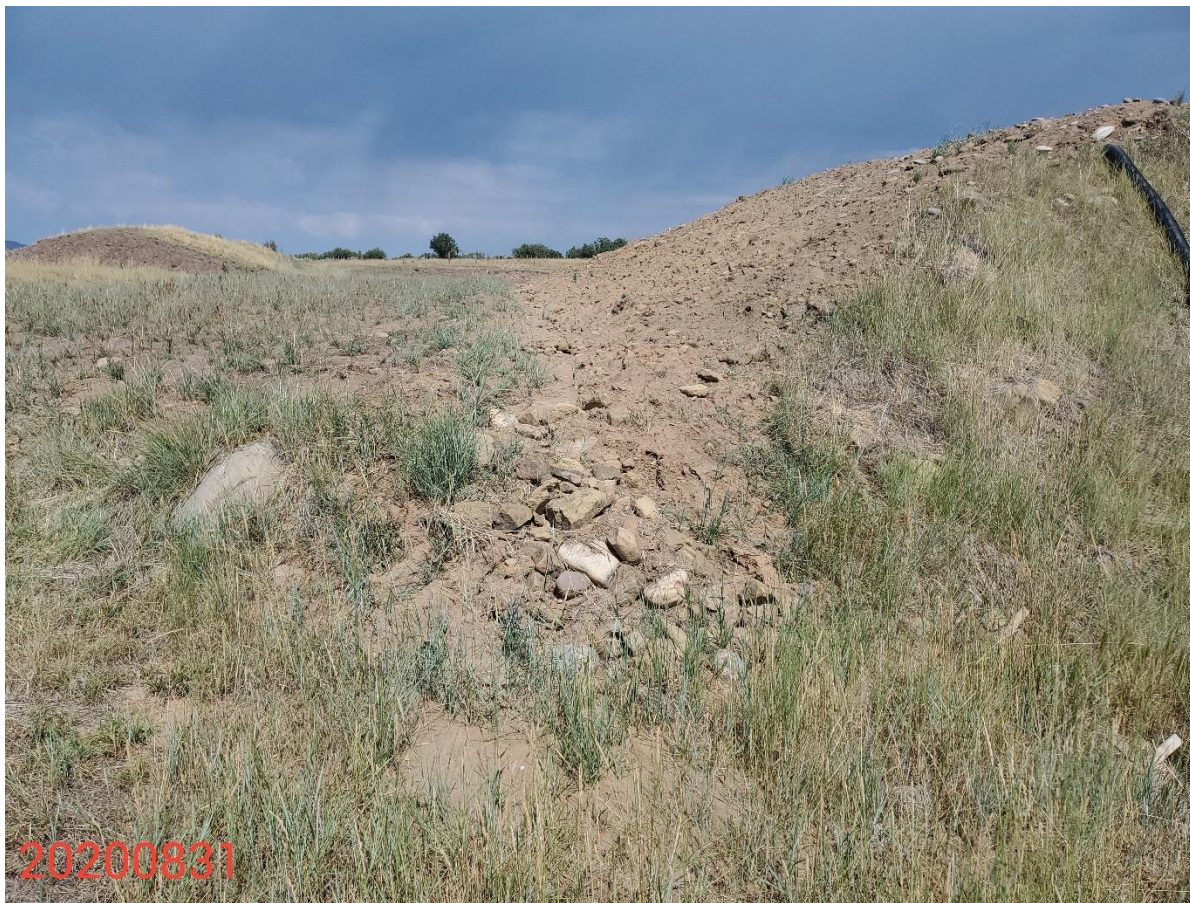
**Photo 3:** See comments under photo 2. Off-site sediment deposition evident.

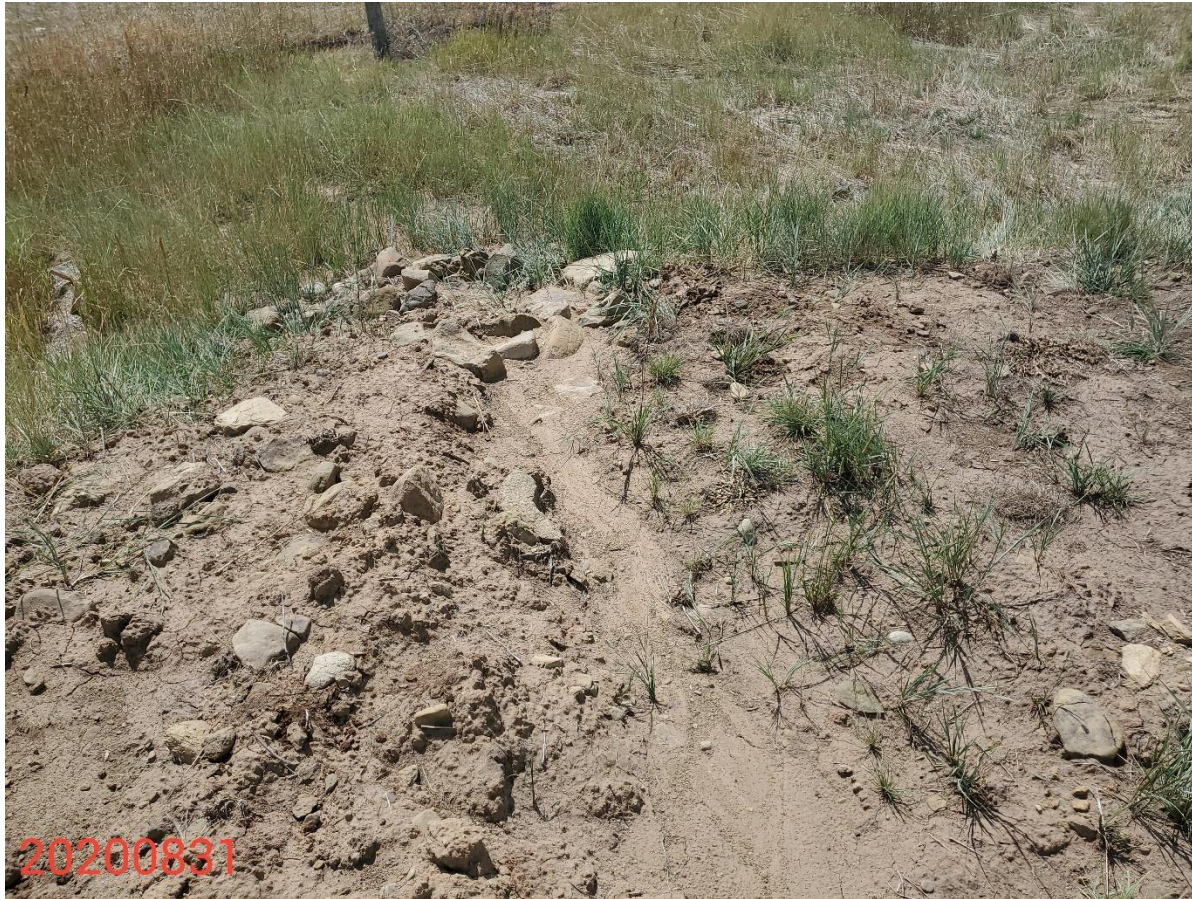
**Photo 4:** See comments under photo 2.

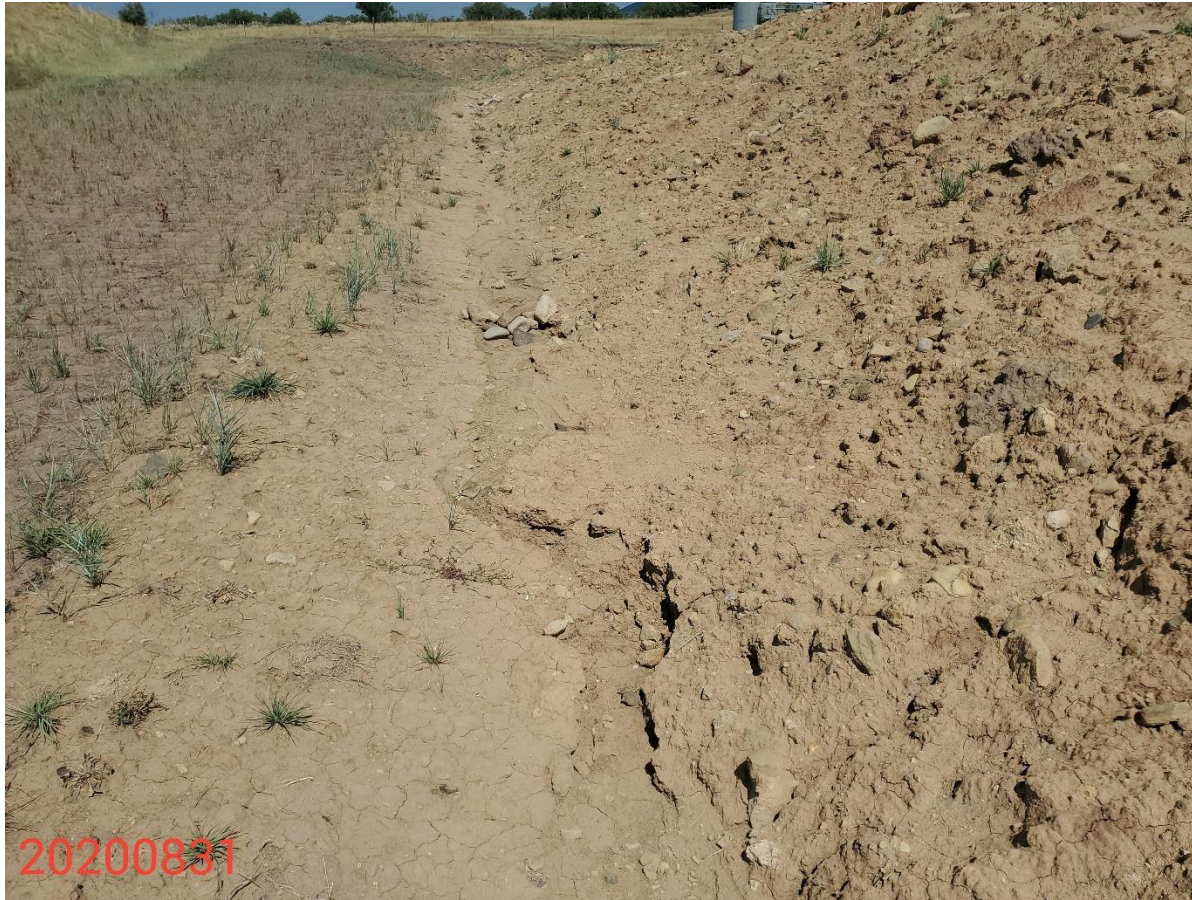
**Photo 5:** Photo taken from the western stormwater ditch. Photo shows Channel incision/erosion evident. Operator has implemented rock checks/velocity check within ditch. BMP appears insufficient and has not been installed in accordance with good engineering practices.

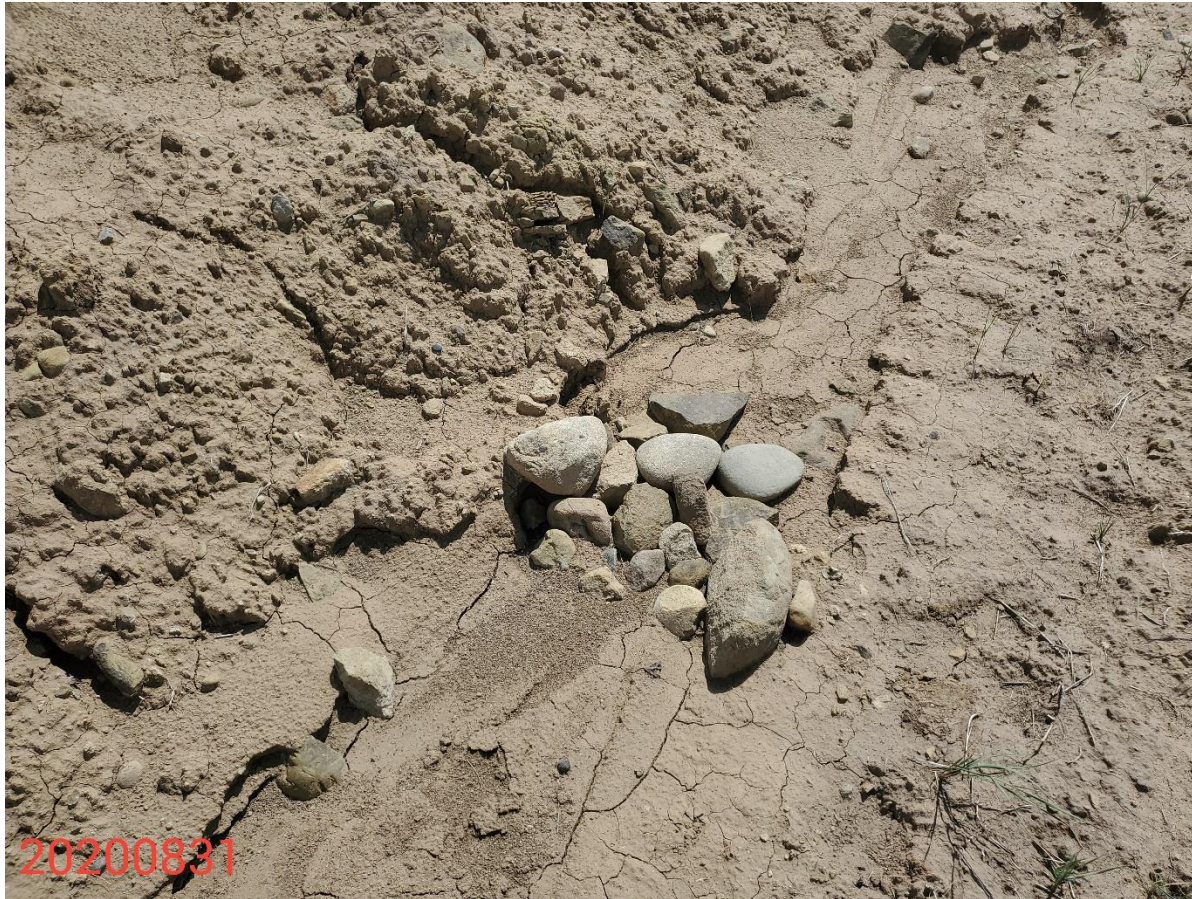
**Photo 6:** Photo of rock check/velocity check within ditch. See comments under photo 5.
