Inspection Photos

Spill ID 476917

Remediation Project 15805

Pits; 446048 and 446049

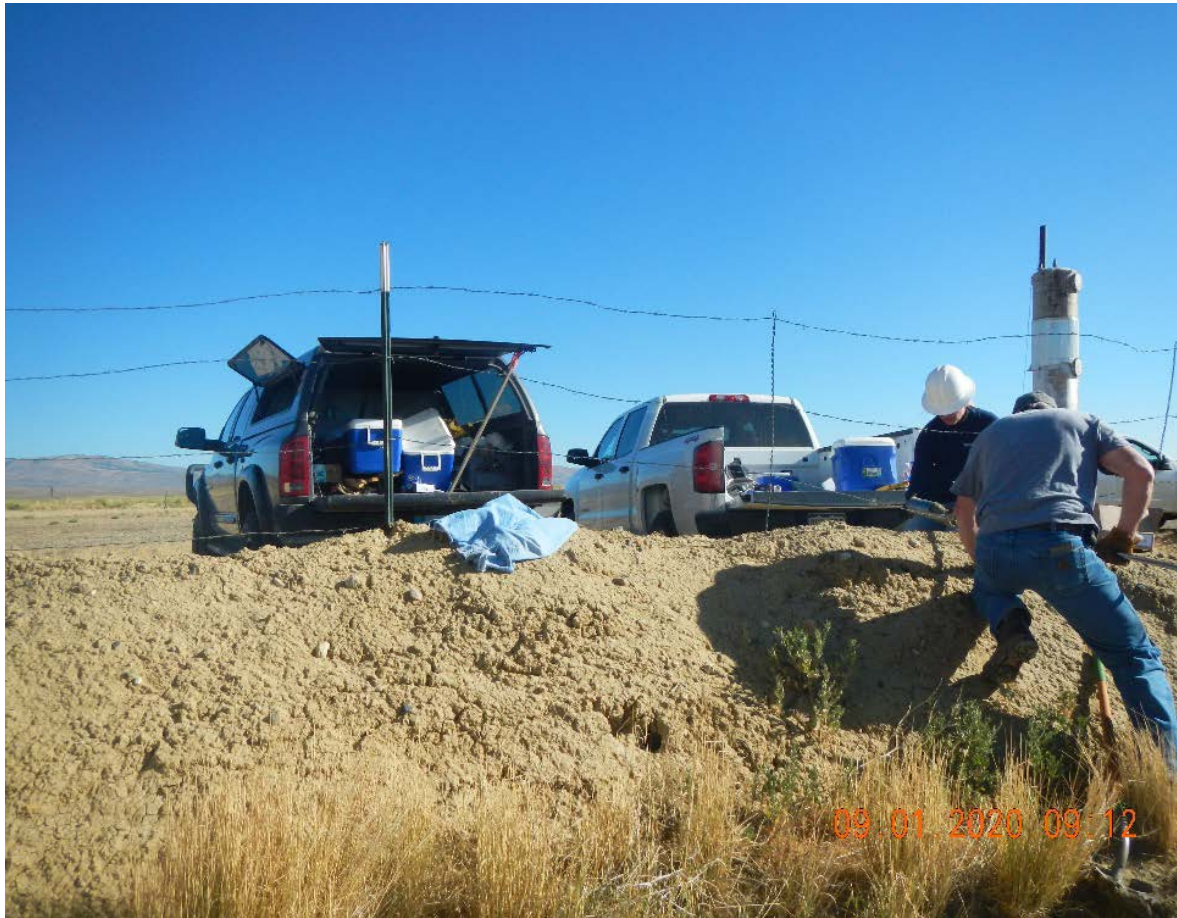
Photo #1 sampling in pit 446049. Pit was dry at time of sampling. Soil was dense clay. No observable hydrocarbon in pit or odor detectable in soil. Soil samples were collected via hand auger to a depth of 18" below pit bottom/wall.

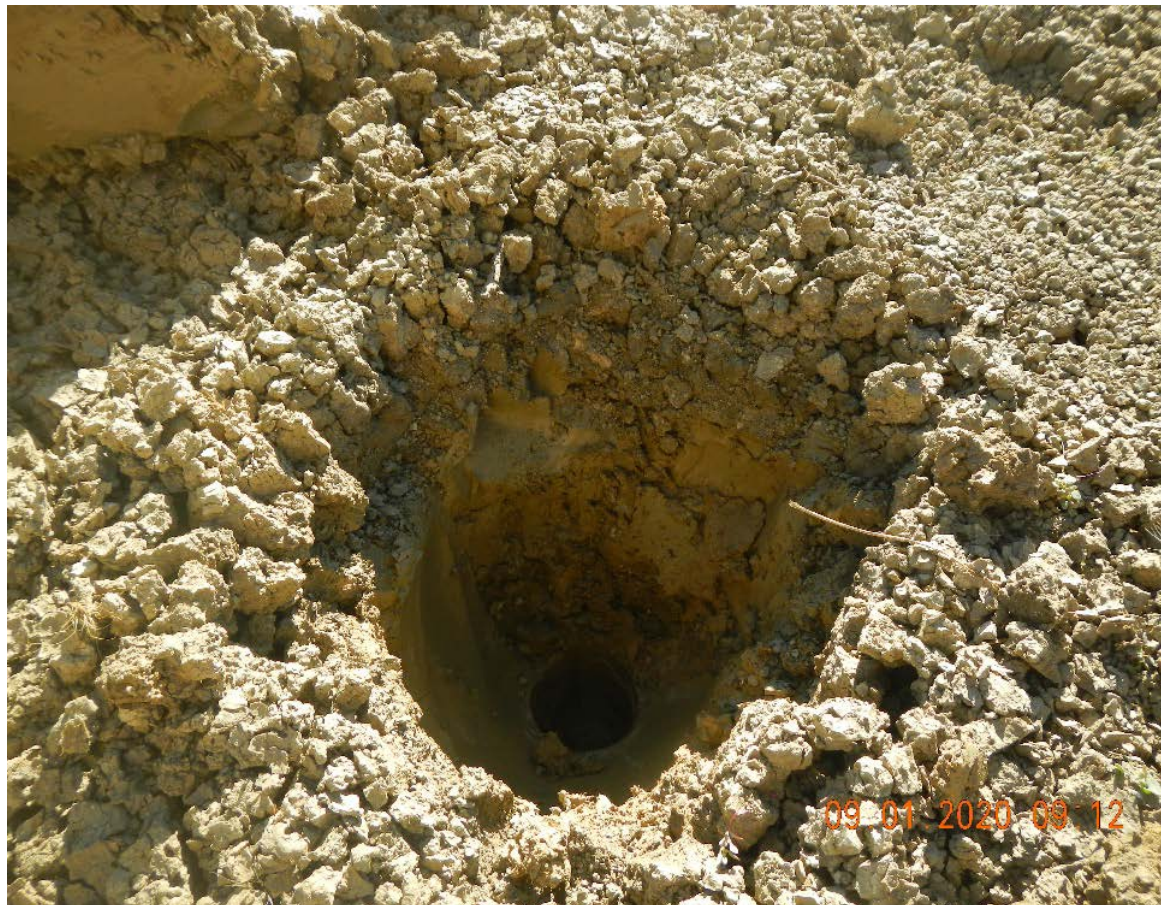
Photo #2 Close up of sample hole. Some holes were dug to 1 foot with a shovel then advanced with a hand auger.

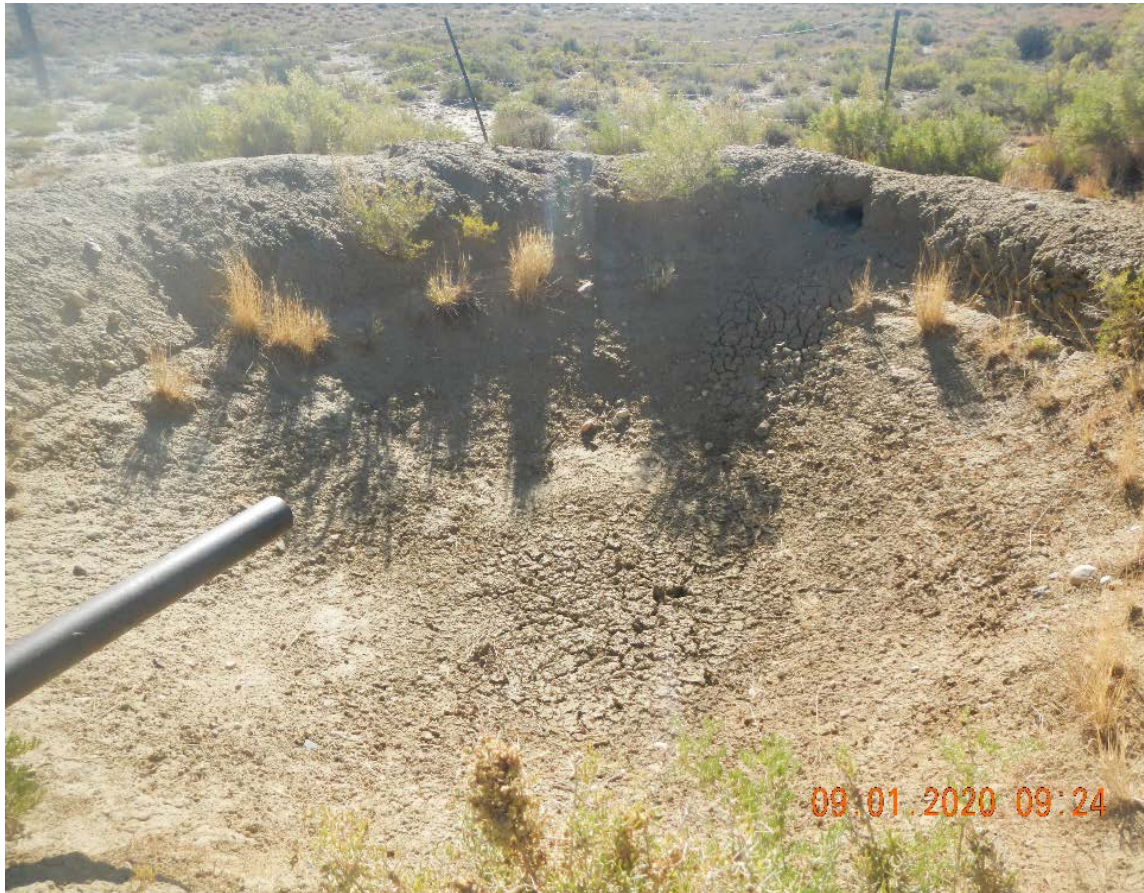
Photo #3 Pit location 446048. Pit was dry at time of sampling. Soil was dense clay. No observable hydrocarbon in pit or odor detectable in soil. Soil samples were collected via hand auger to a depth of 18" below pit bottom/wall.
