Inspection Photos

Location Name: APACHE CANYON 02-03

API#: 05-071-08347

INSP. #: 695103276

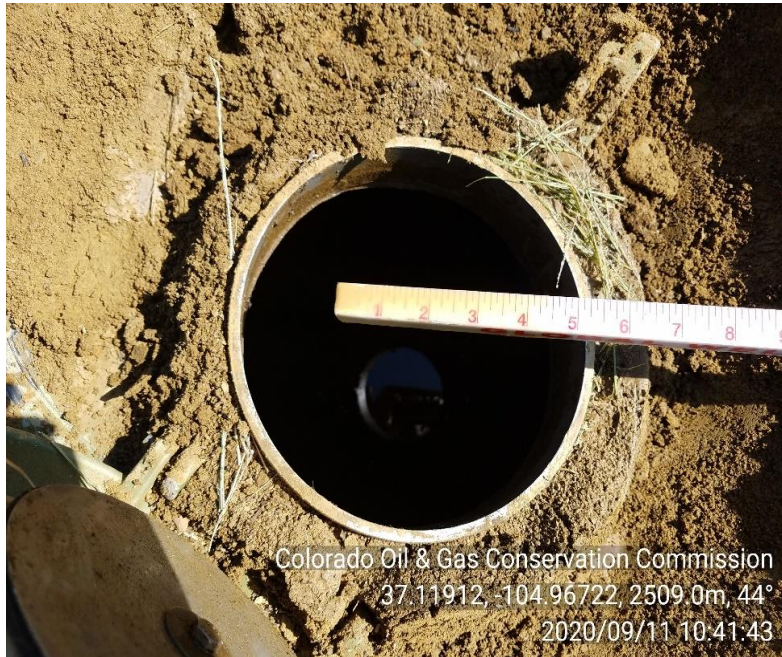
PHOTO 3: APPEARS TO BE OIL IN PRODUCED WATER TANK. Pursuant to Rule 907A. Operator shall properly identify and dispose of non-E&P. Wastes in accordance with state and federal regulations, including storing, treating, and disposing of hazardous waste in accordance with 6 C.C.R. 1007-3. All non-hazardous/non-E&P wastes are considered solid waste which require storage, treatment, and disposal in accordance with 6 C.C.R. 1007-2. Rule 907.b.(2) - provide all transportation and disposal documentation required by Rule 907.b.(2)

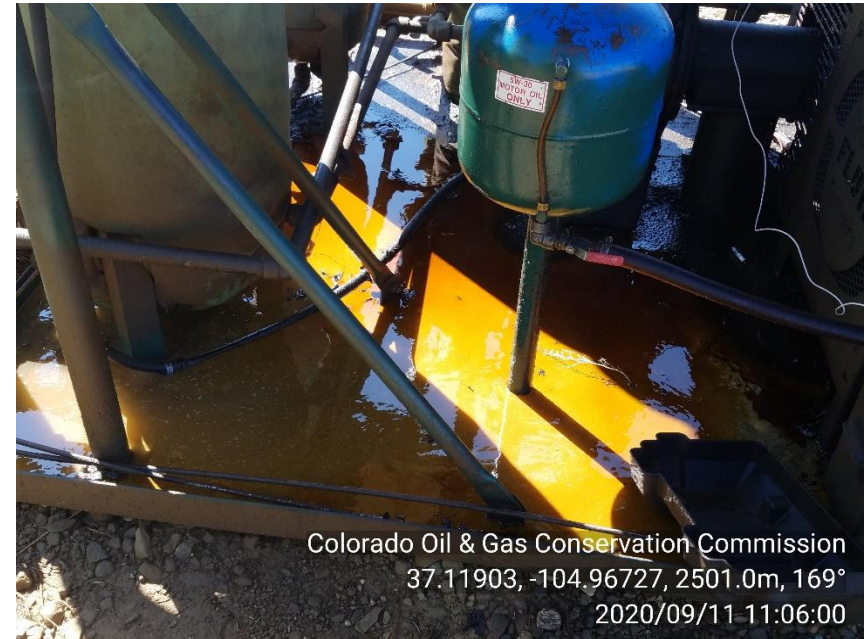
PHOTO 4: OIL WATER MIXTURE IN COMPRESSOR SKID. Comply with general provisions of the oil and gas act for wildlife protection. CA DATE 9-23-20.

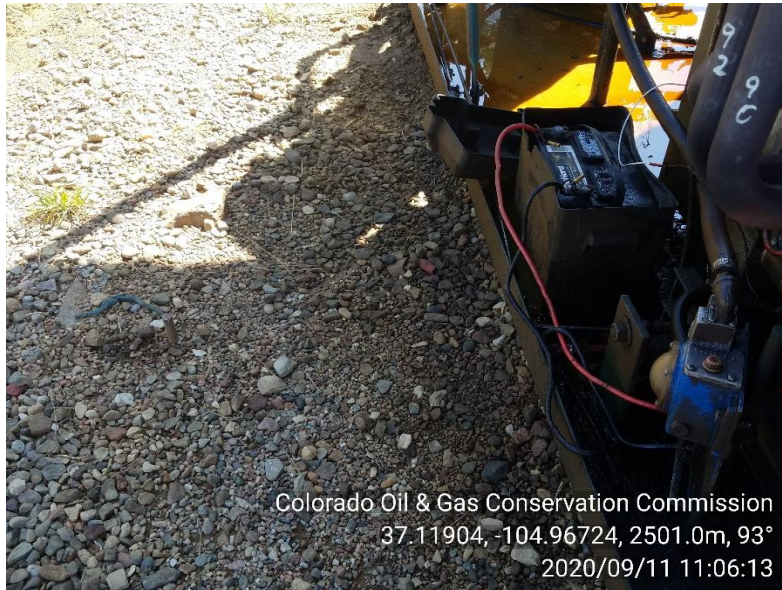
PHOTO 5: AREA OF IMPACTED SOIL AROUND COMPRESSOR SKID. Properly dispose of oily waste in accordance with 907.e. CA DATE 10-16-20.

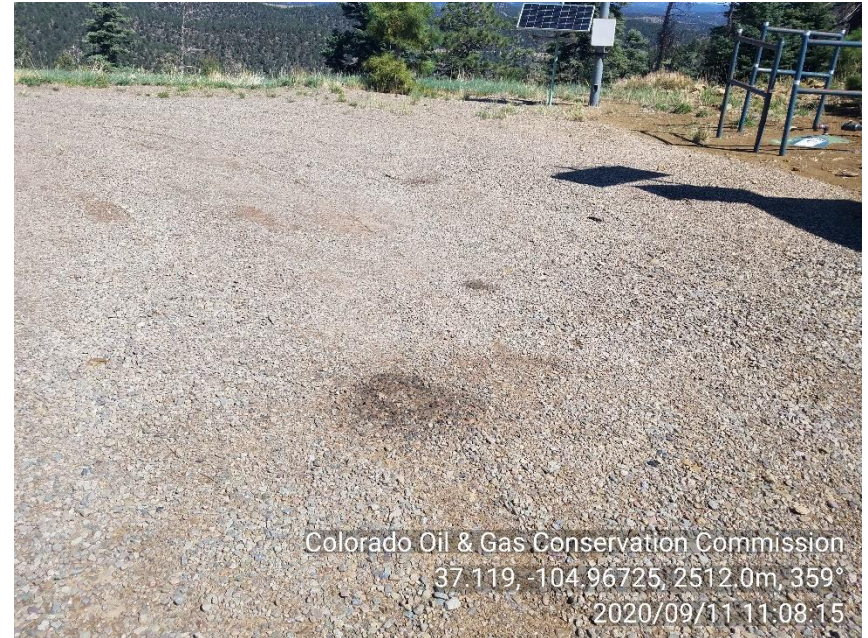
PHOTO 6: SEVERAL AREAS OF IMPACTED SOIL AROUND LOCATION. Properly dispose of oily waste in accordance with 907.e. CA DATE 10-16-20.

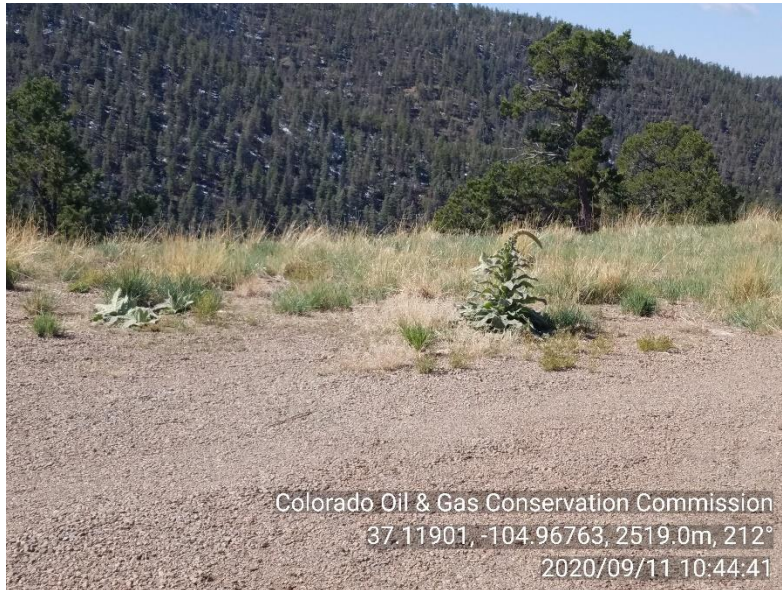
PHOTO 7: CLASS C NOXIOUS WEEDS ON AROUND LOCATION INCLUDING THE INTERIM RECLAMATION AREA. COMPLY WITH RULE 1003.f. CA DATE 9-23-20.

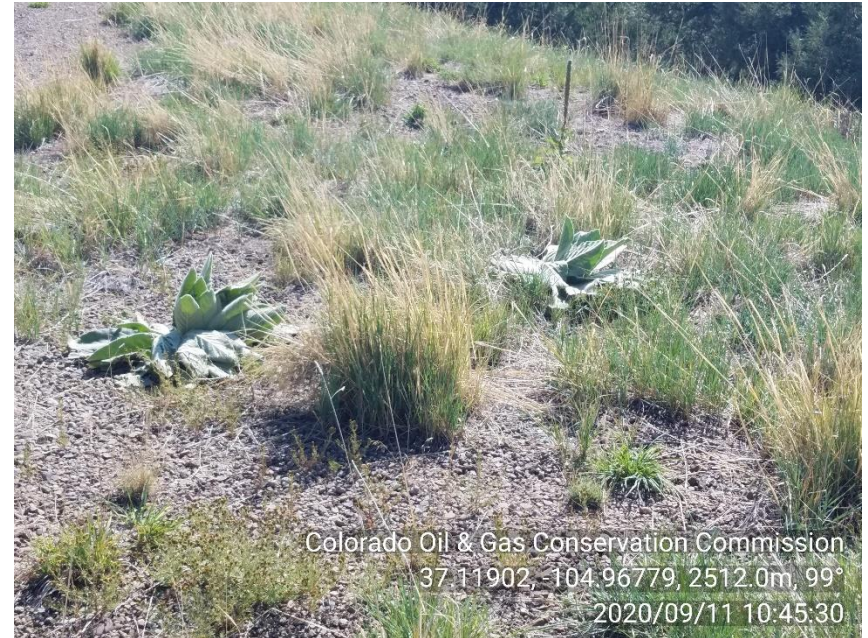
PHOTO 8: CLASS C NOXIOUS WEEDS ON AROUND LOCATION INCLUDING THE INTERIM RECLAMATION AREA. COMPLY WITH RULE 1003.f. CA DATE 9-23-20.

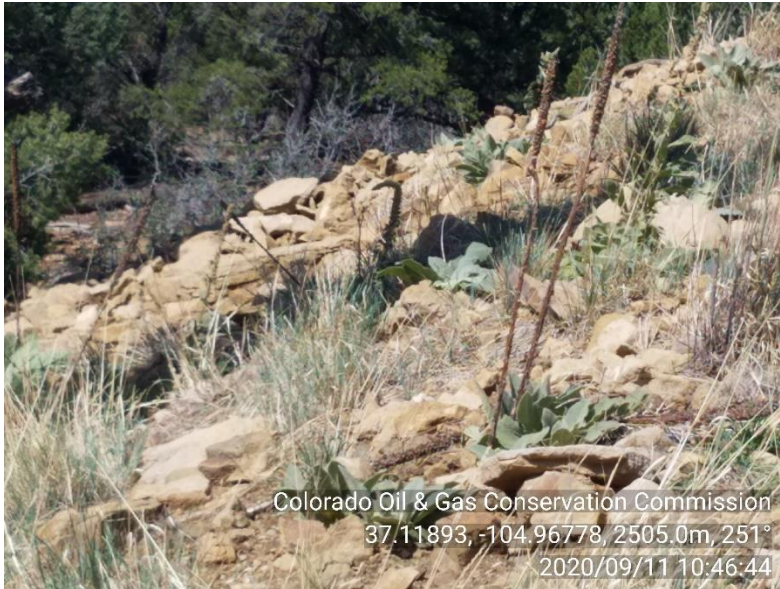
PHOTO 9: CLASS C NOXIOUS WEEDS ON AROUND LOCATION INCLUDING THE INTERIM RECLAMATION AREA. **COMPLY WITH RULE 1003.f. CA DATE 9-23-20.**

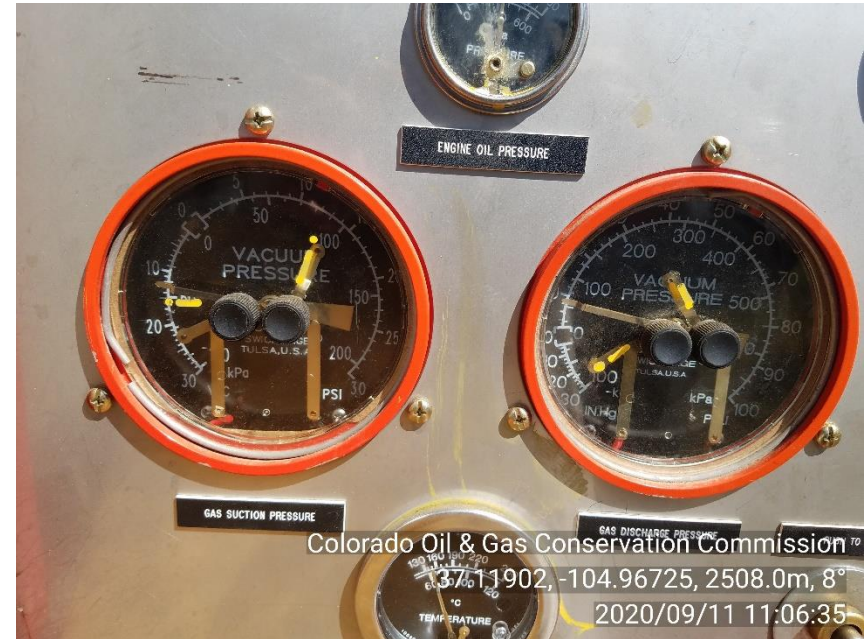
PHOTO 10: WELL IS BEING PRODUCED ON A VACUUM. FORM 4 SUNDRY APPROVED 6-8-06
