# Inspection Photos

9/17/2020

Operator: NONSUCH NATURAL GAS INC -  
10163

Location ID: 324169  
Garfield County, CO

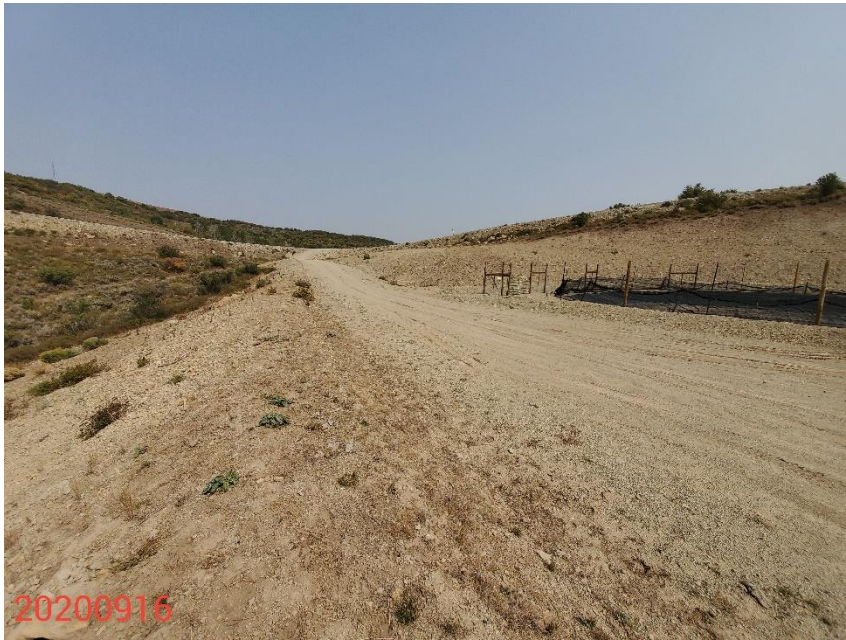
**Photo 1:** Photo taken from the west end of the Location, facing north. Photos 1-3 provide an overview of the Location from north, west to south.

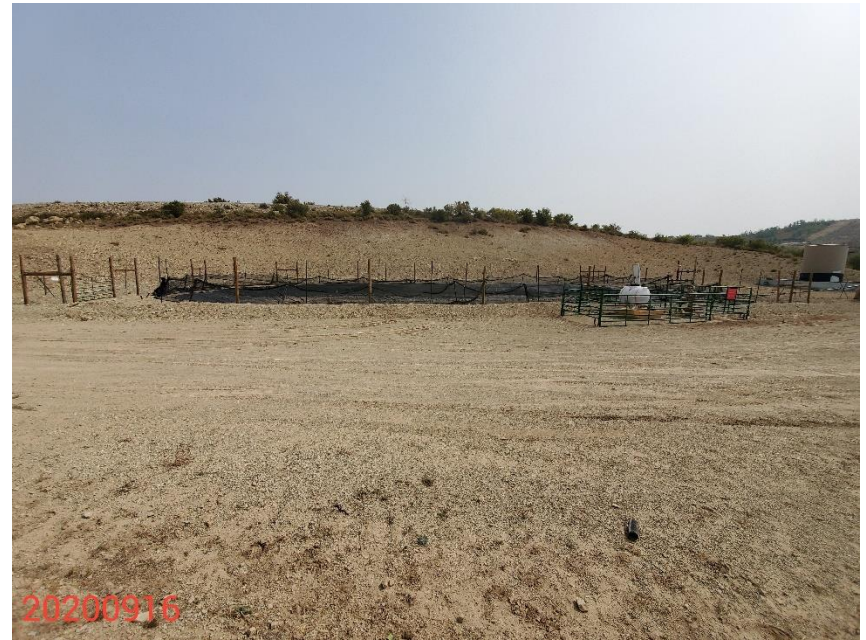
**Photo 2:** See comments under photo 1.

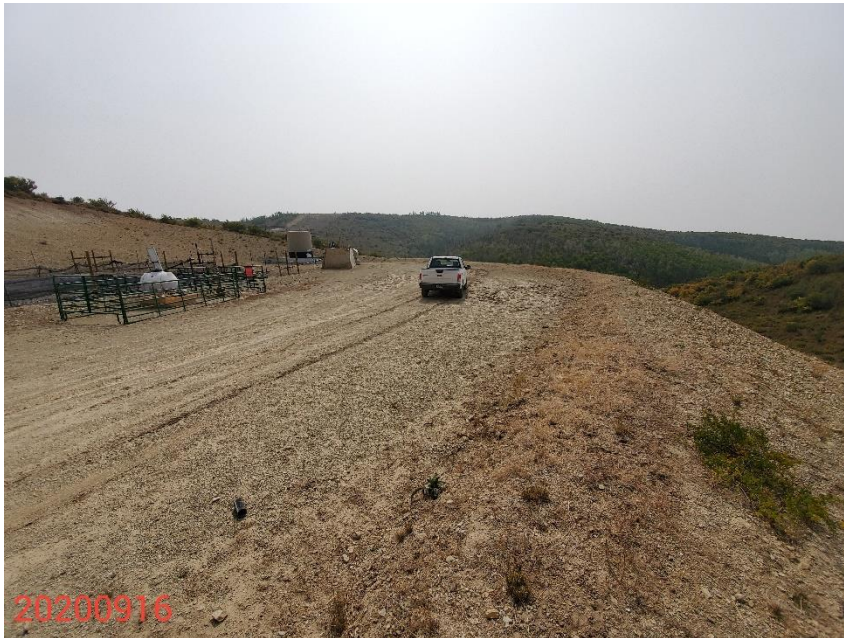
**Photo 3:** See comments under photo 1.

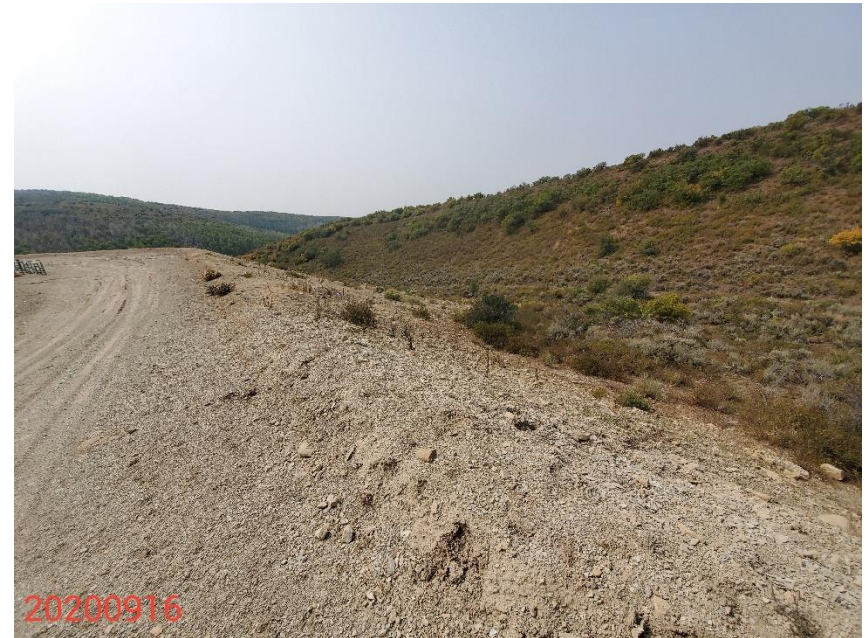
**Photo 4:** Photo taken from the west end of the Location, facing south. Photo shows BMPs on the Location remain missing or insufficient to stabilize soils on the slope. Photo also shows additional interim reclamation does not appear to have been conducted.

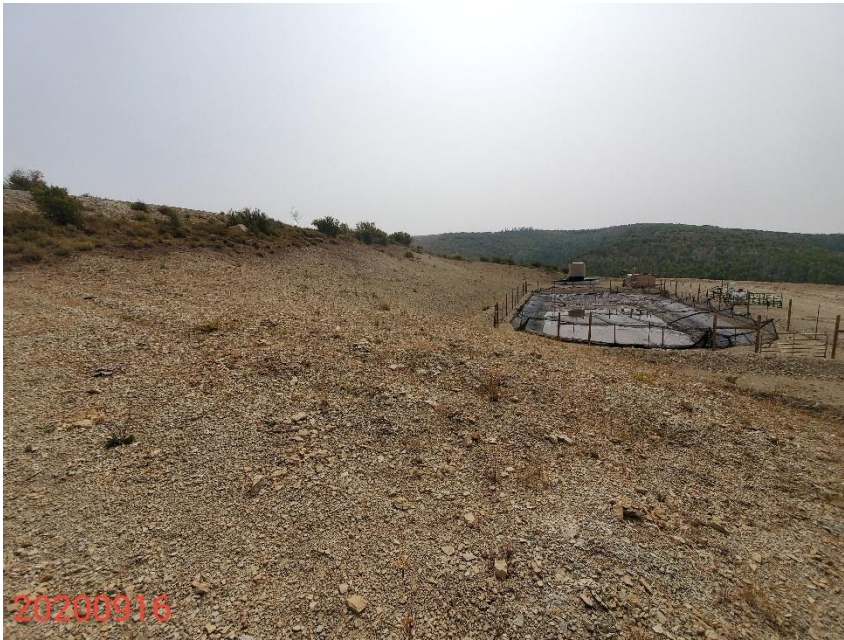
**Photo 5:** Photo taken from the east end of the Location, facing south. Photo shows BMPs on the Location remain missing or insufficient to stabilize soils on the slope. Photo also shows additional interim reclamation does not appear to have been conducted.

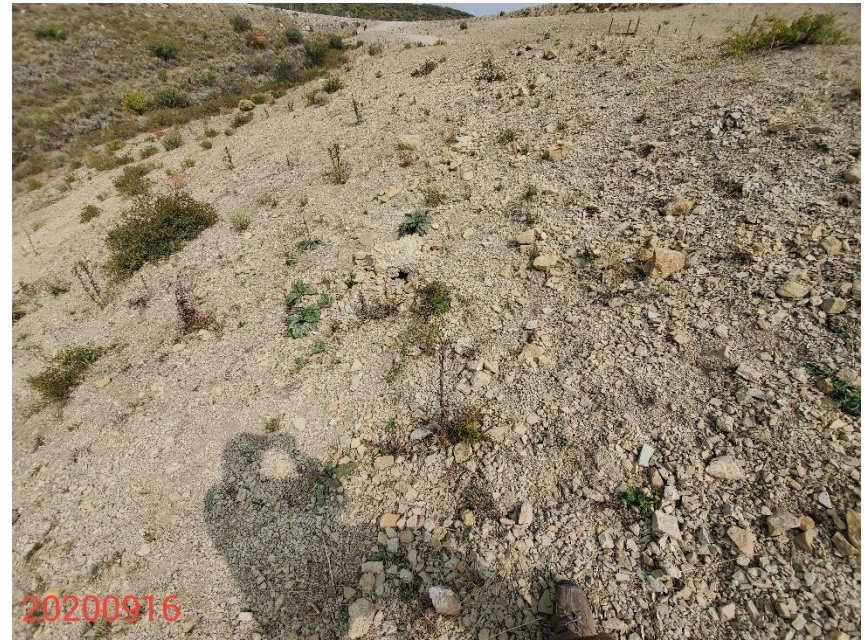
**Photo 6:** Photo taken from the interim areas. Photo shows weed management appears to have been conducted.
