# Inspection Photos

9/16/2020

Operator: NONSUCH NATURAL GAS INC -  
10163

Location ID: 453726  
Garfield County, CO

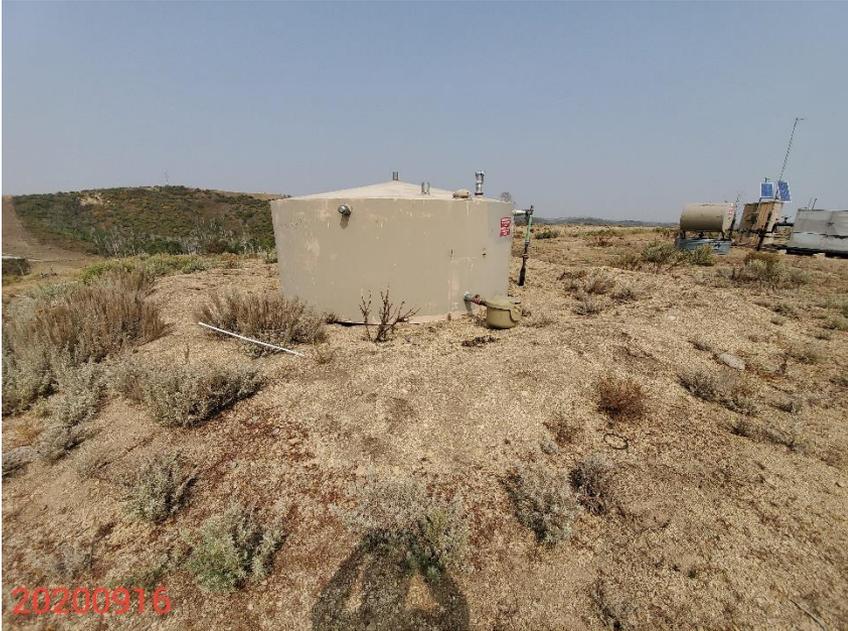
**Photo 1:** Photo of 200 bbl condensate tank on the southern end of the Location. Photo shows secondary containment remains out of compliance with Rule 906.d.(1); Vegetation remains established within BMP compromising the imperviability of the containment; BMP insufficient to contain contents of tank and sufficient freeboard to contain precipitation.

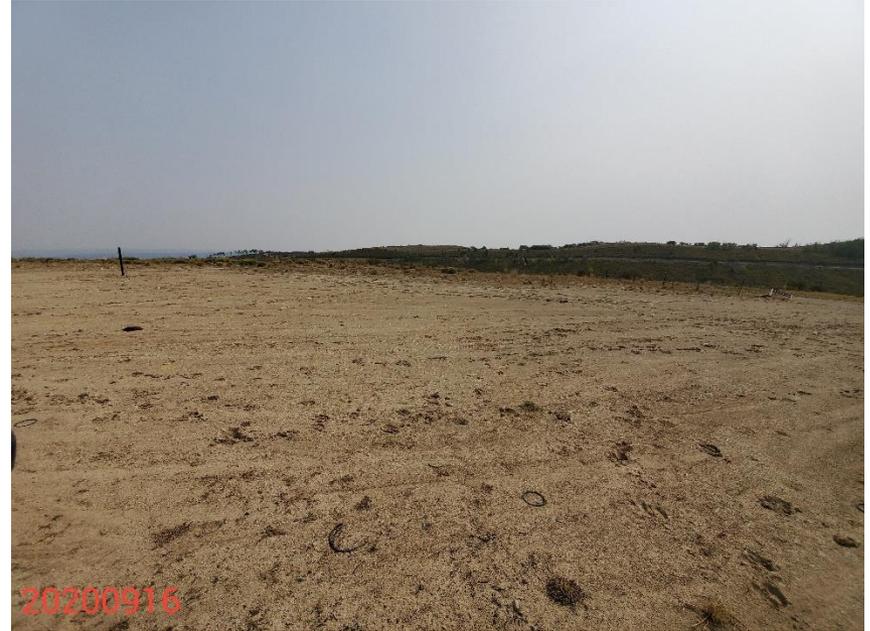
**Photo 2:** Photo taken from the Location facing northeast. Photo shows equipment not needed for production has been removed.
