KP Kauffman - COGCC Inspection Photos
Location: H. Huett Consolidation OLF Release
Spill ID # 478005 Date 9/21/2020

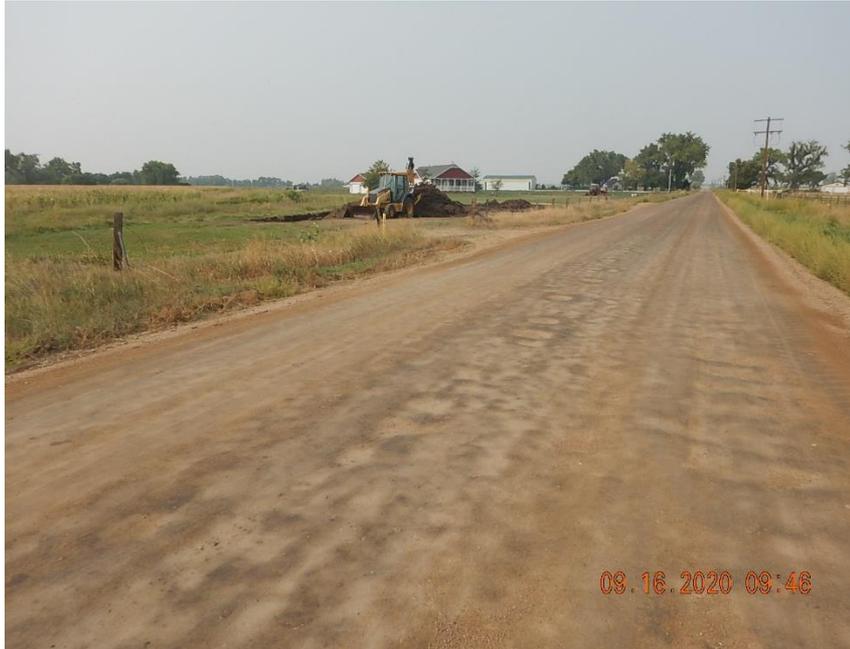
View of spill response and excavation activity on the south side of WCR 8; view west.

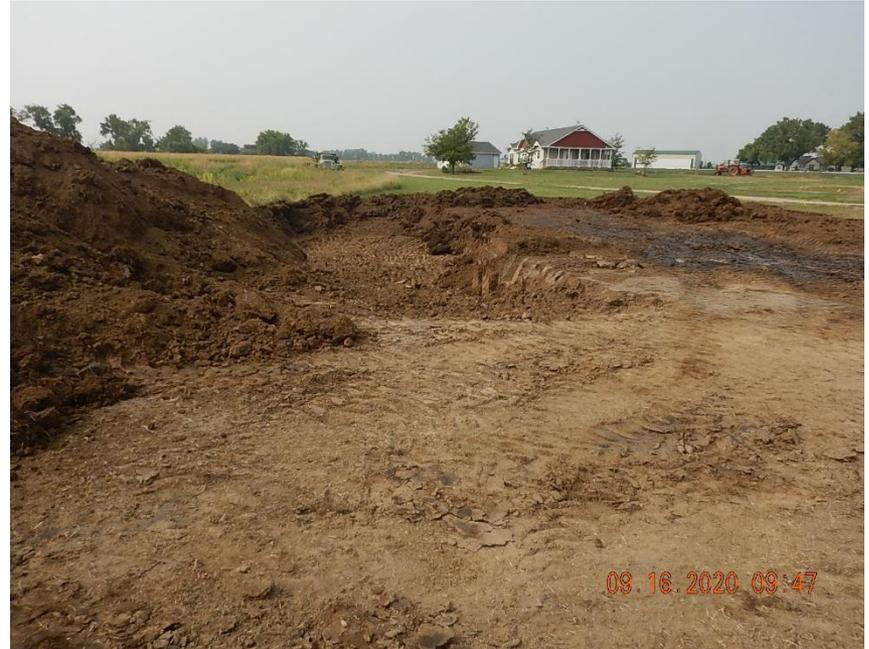
Closer view of area of release and hydrocarbon stained soils; view west.

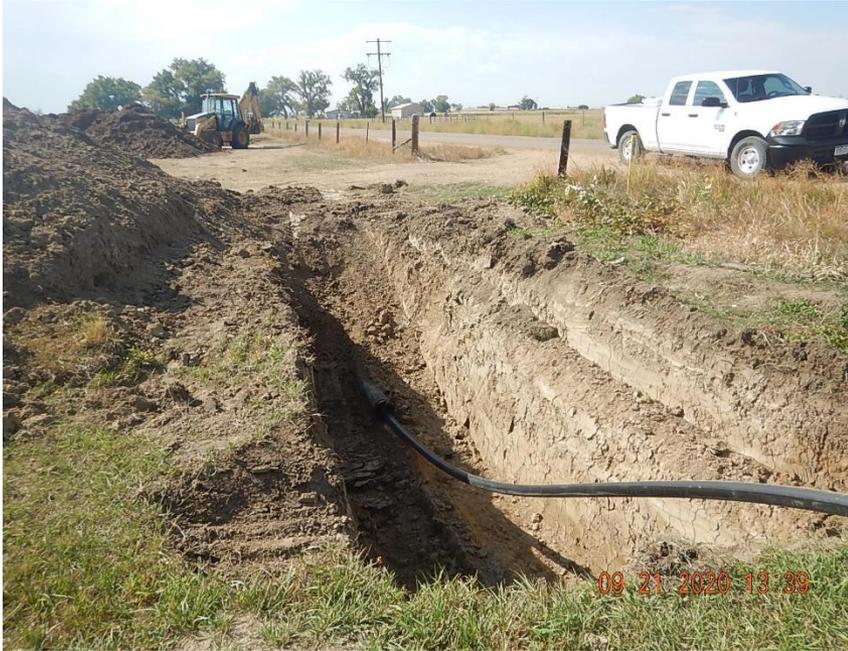
East bellhole excavation; 6" CS H Huett Consolidation OLF exposed and cut with 3" OD DR 11 HDPE pipe being slip lined through failed section of pipe.

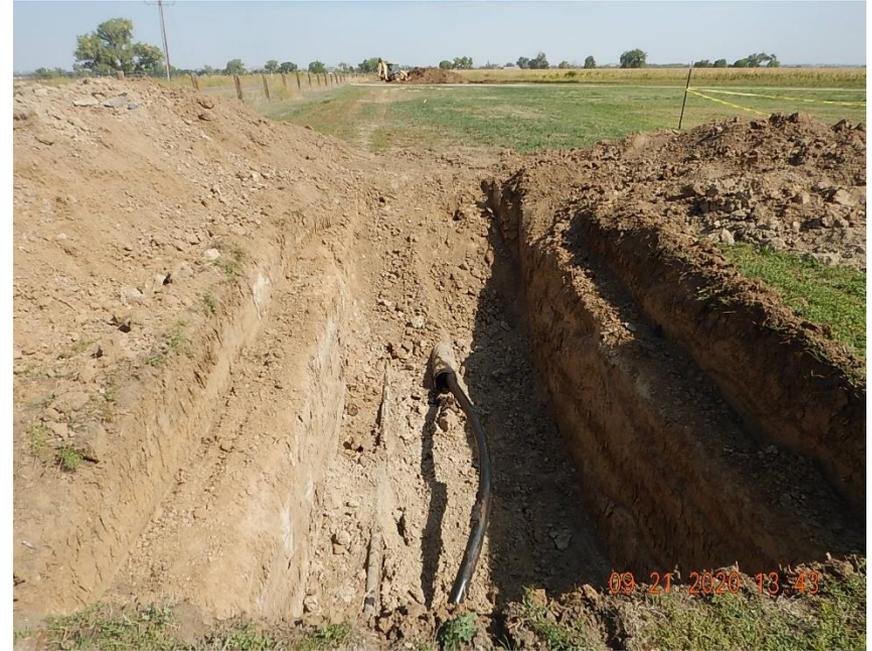
West bellhole excavation; 6" CS H Huett Consolidation OLF exposed and cut with 3" OD DR 11 HDPE pipe being slip lined through failed section of pipe. A 2" CS OLF is also exposed in the excavation.
