# Inspection Photos

9/24/2020

Operator: NONSUCH NATURAL GAS INC -  
10163

Location ID: 453726  
Garfield County, CO

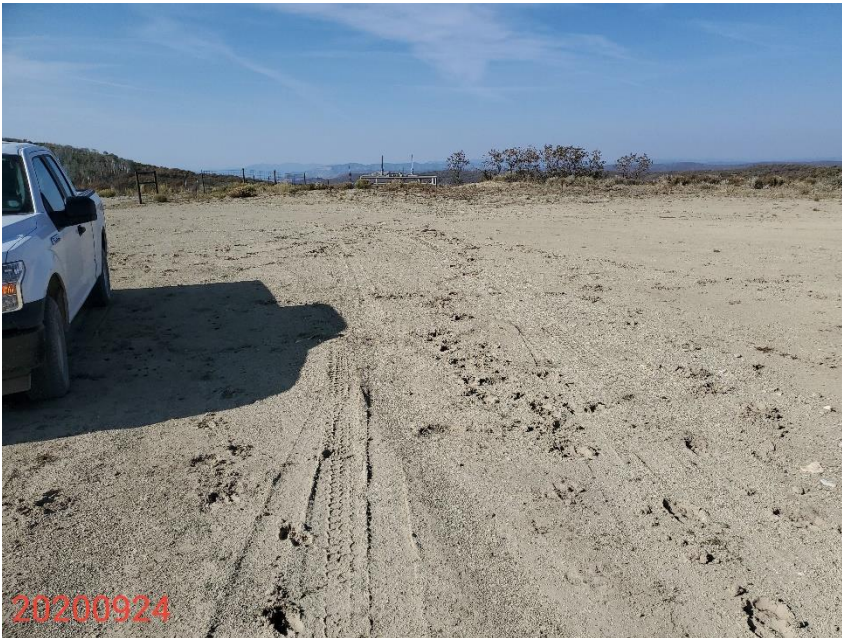
**Photo 1:** Photo taken from the east end of the Location, facing south. Photos 1-3 provide an overview of the production area of the tank battery facility, from south, west to north.

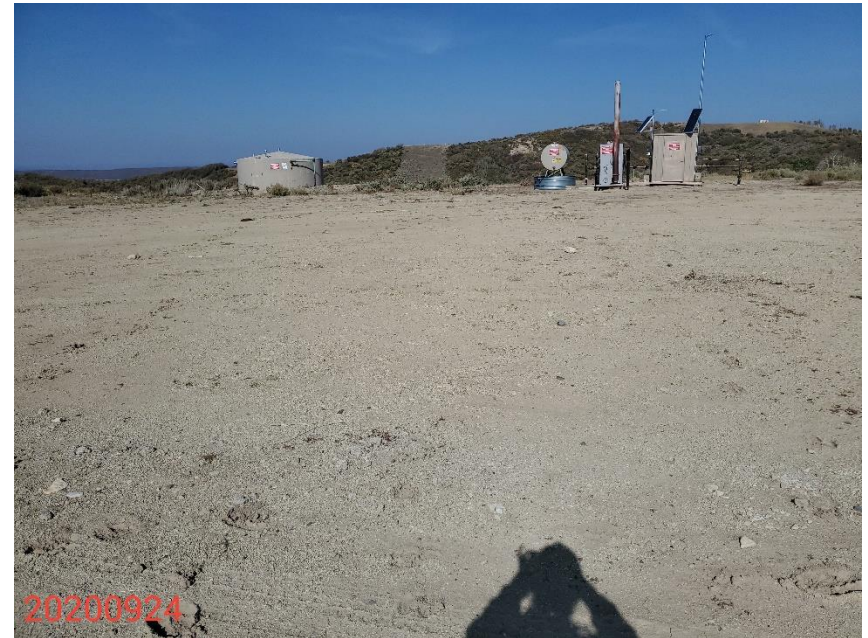
**Photo:** See comments under photo 1.

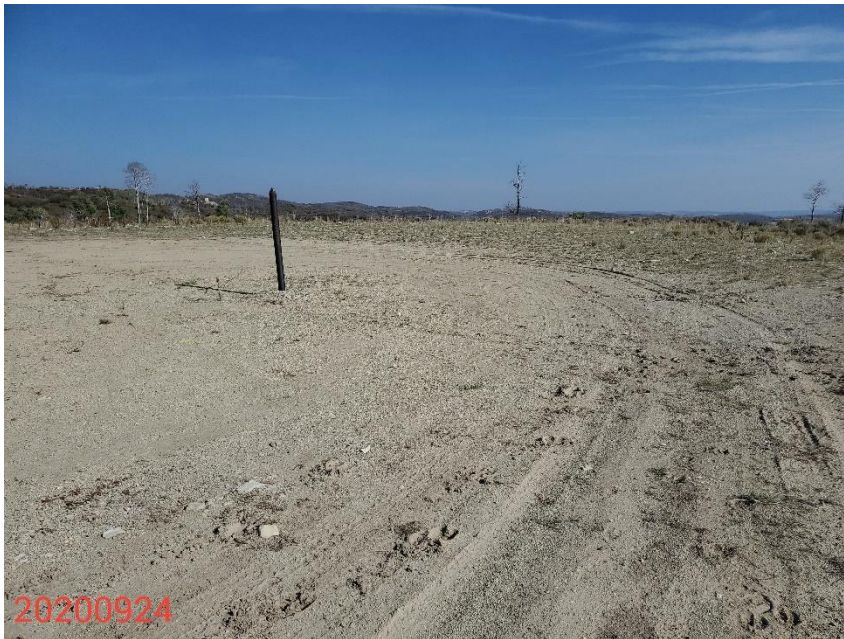
**Photo 3:** See comments under photo 1.

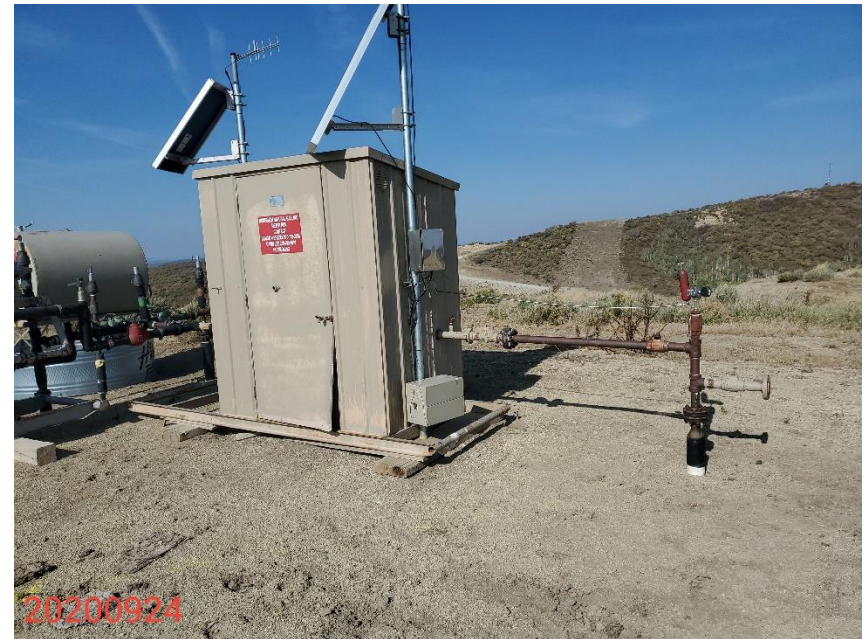
**Photo 4:** Photo of meter shed. COGCC Records show meter shed is active and associated with the CSOC 697-14 1 well, API #045-07948.

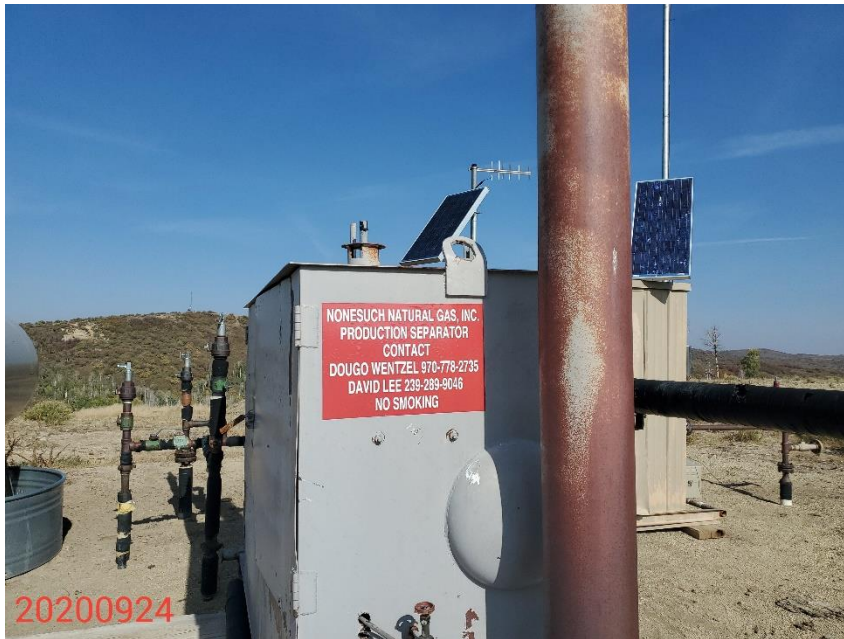
**Photo 5:** Photo shows separator equipment on the Location. It is unclear to the COGCC as to what the equipment's current use is on the Location, and if equipment is considered active.

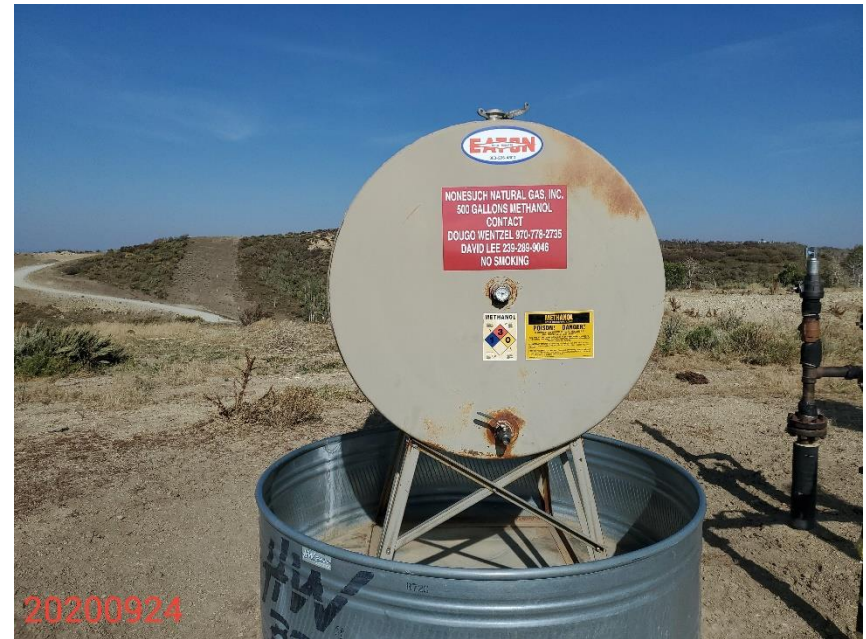
**Photo 6:** Photo shows methanol tank on the Location. It is unclear to the COGCC as to what the equipment's current use is on the Location, and if equipment is considered active.

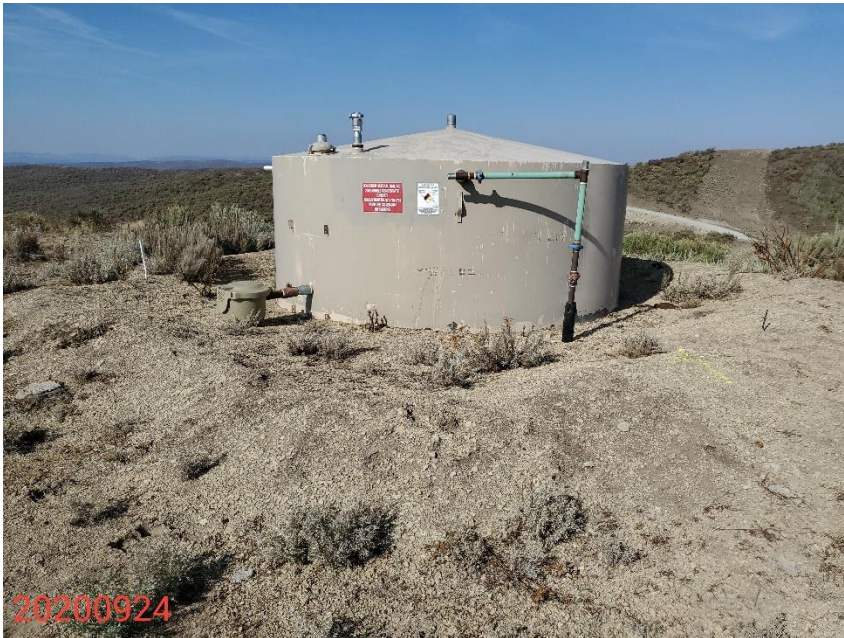
**Photo 7:** Photo shows 200bbl tank. It is unclear to the COGCC as to what the equipment's current use is on the Location, and if equipment is considered active. Secondary containment remains out of compliance with Rule 906.d.(1). See inspection #696201797 for additional details.
