# Inspection Photos

ID: 412295

Operator: RENCO GAS PIPELINE INC

Inspection Date: 9/24/2020

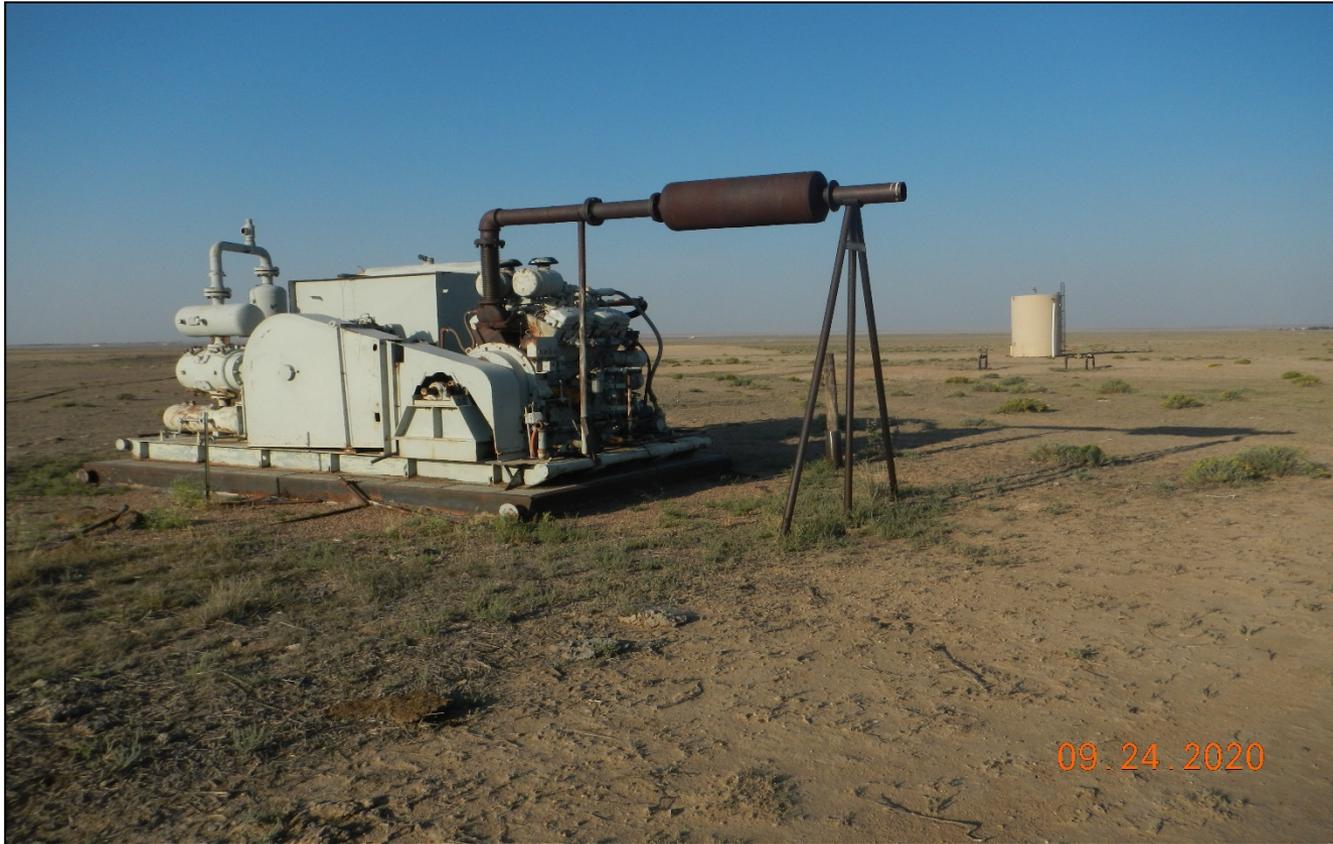
**Photo 1.** Facing southwest. There is an unused compressor engine that appears to be abandoned. This equipment needs to be removed.

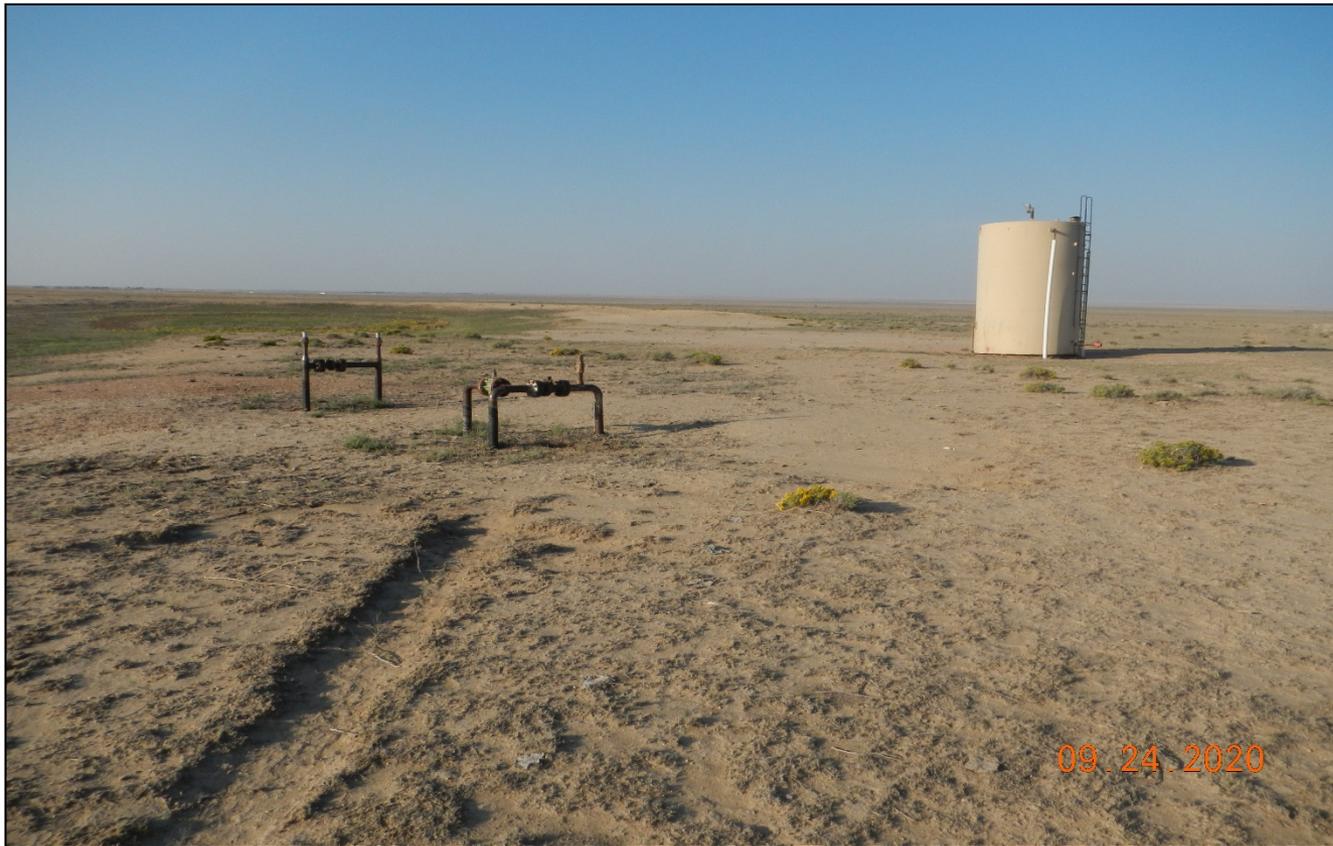
**Photo 2.** There is pipe risers that remain at the location and a steel tank. Does not appear to be in use. Unused equipment needs to be removed.

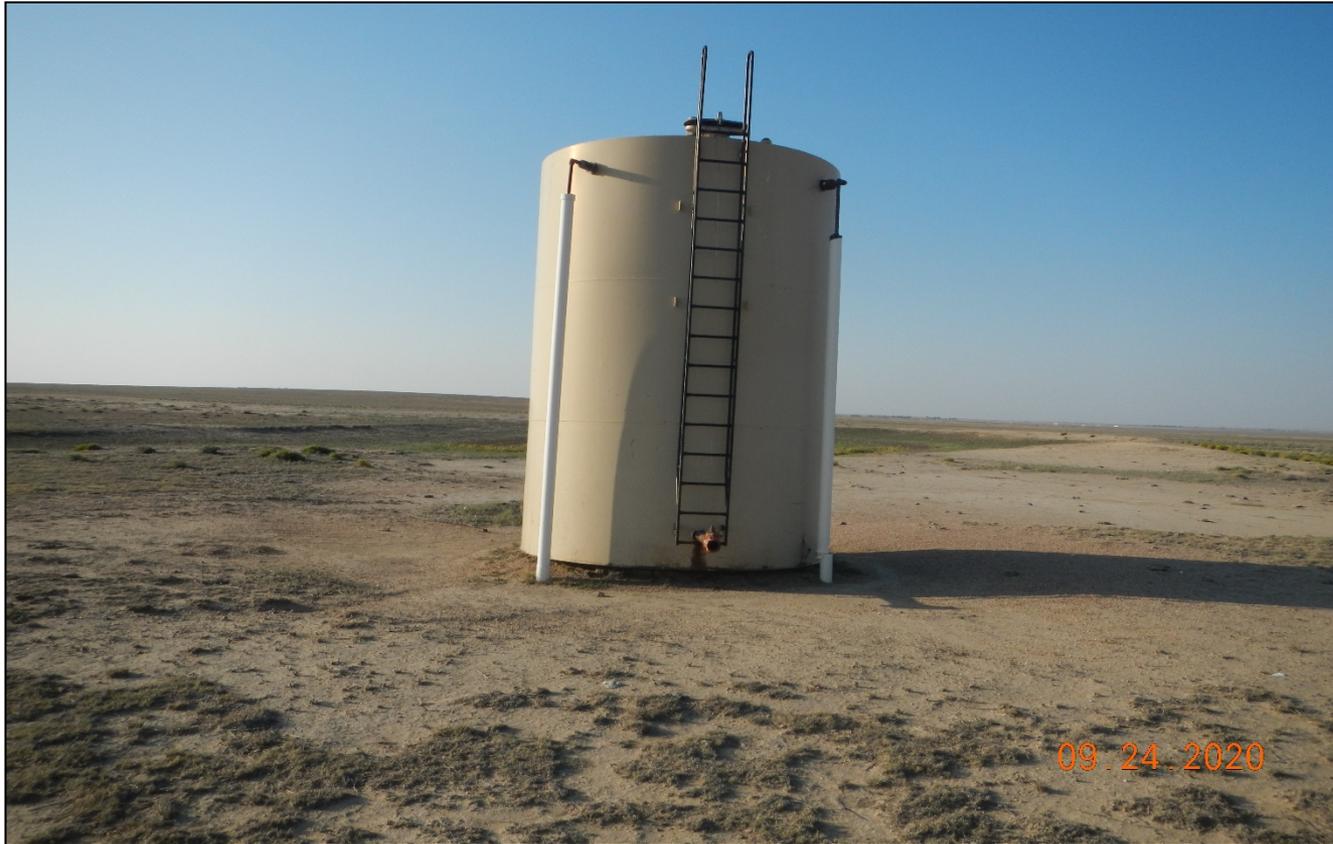
**Photo 3.** A steel tank appears to be unused with no secondary containment. There is no vegetation growth around the tank which indicates impacted soil.
