Inspection Photos

API: 05-011-06094

Operator: THOMAS L SPRING LLC

Inspection Date: 9/24/2020

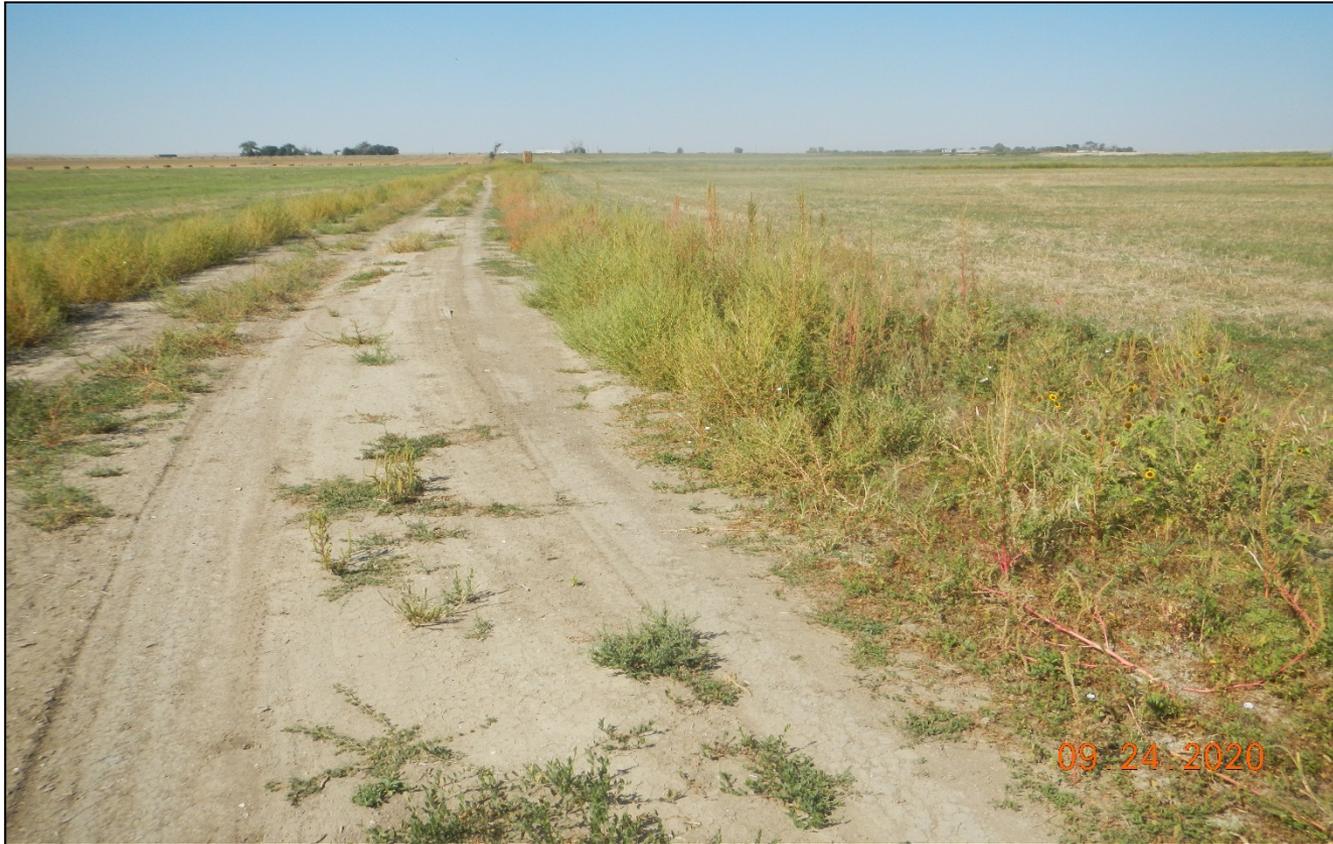
Photo 1. Facing west along the access road. The access road has not been reclaimed and there is undesirable weeds along the roadside.

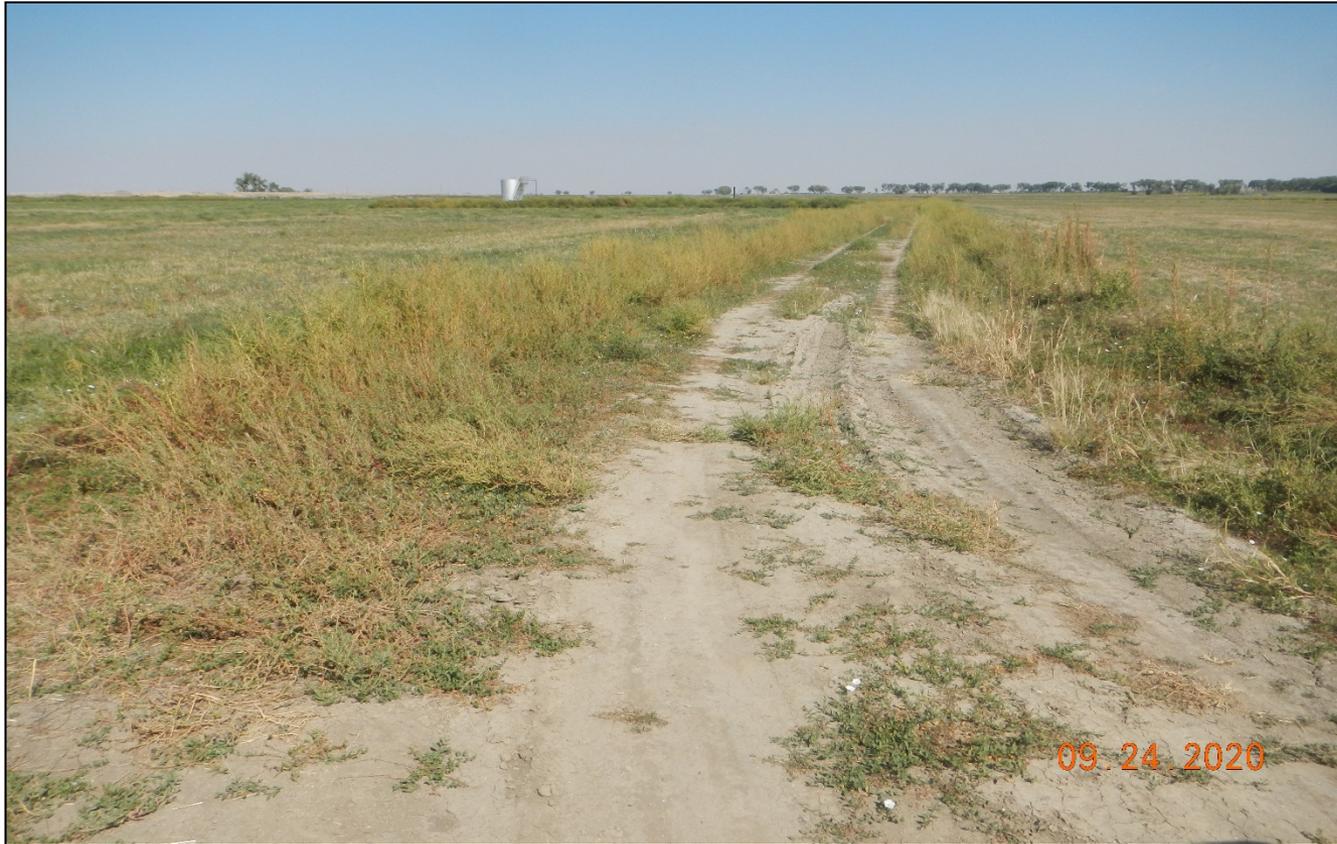
Photo 2. Facing north along the access road. The access road has not been reclaimed and there is undesirable weeds along the roadside.

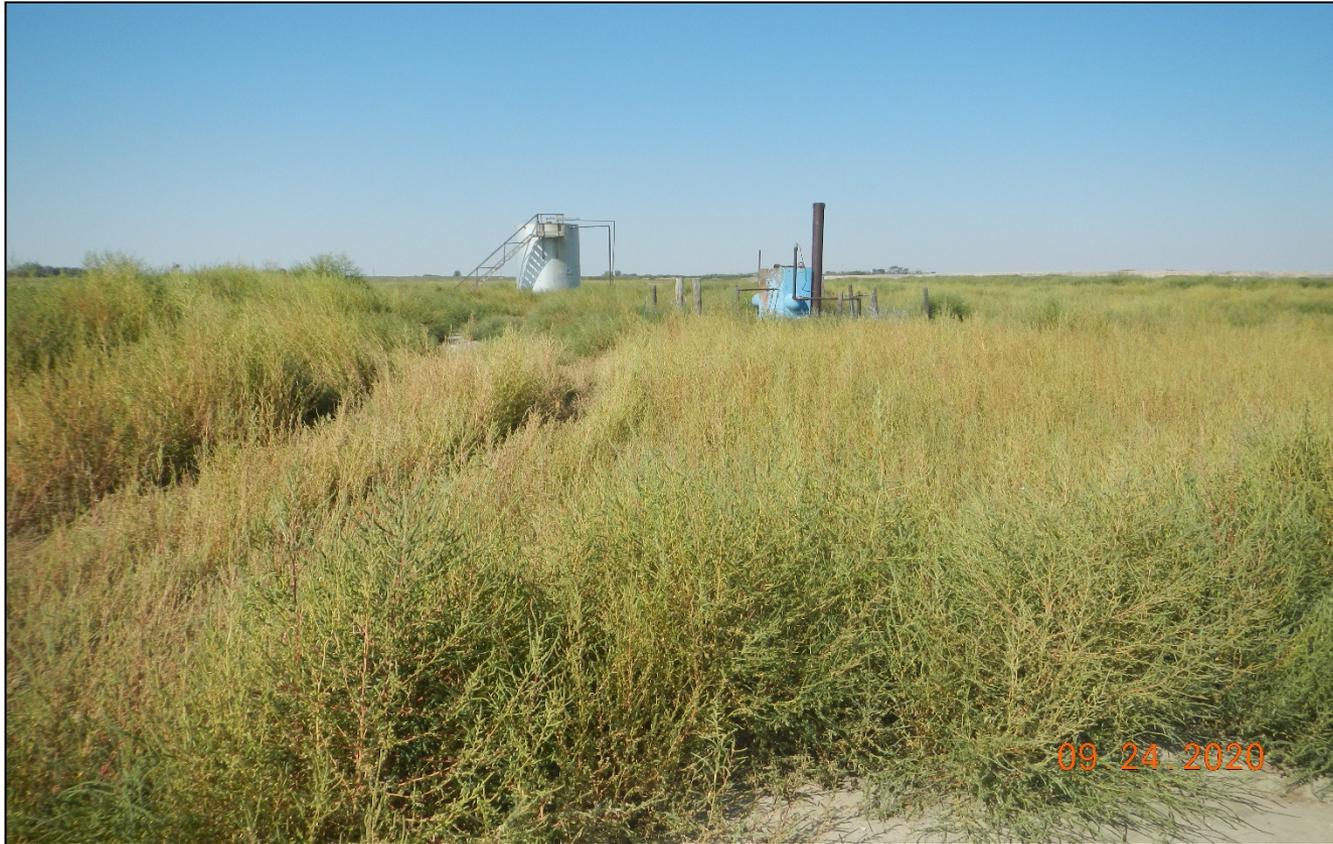
Photo 3. Facing northwest toward the location. There is undesirable weeds (Kochia) throughout the entire location which has grown to 4-6 feet tall.

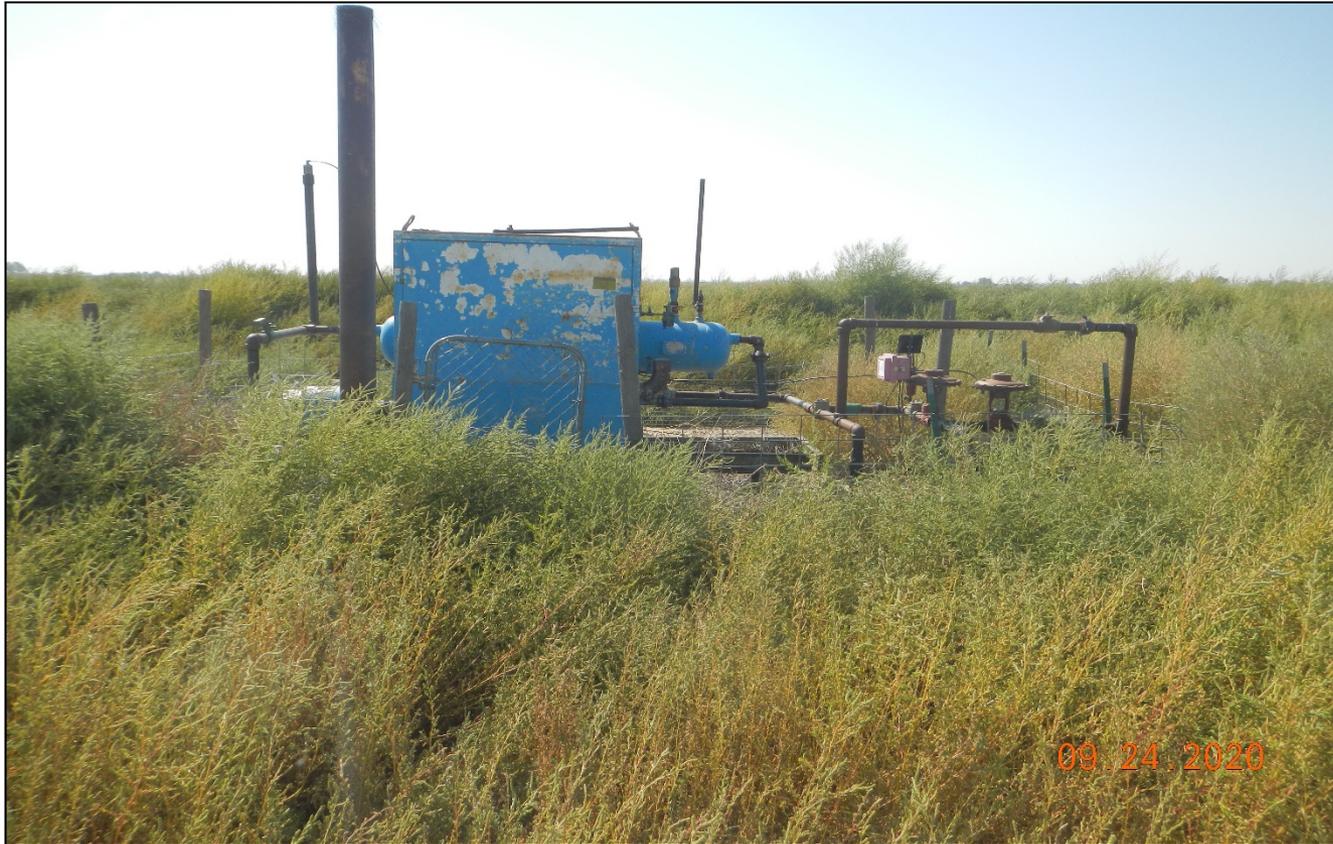
Photo 4. There is equipment that remains at the location that has not been removed. The weeds have grown around the equipment and are a fire hazard.

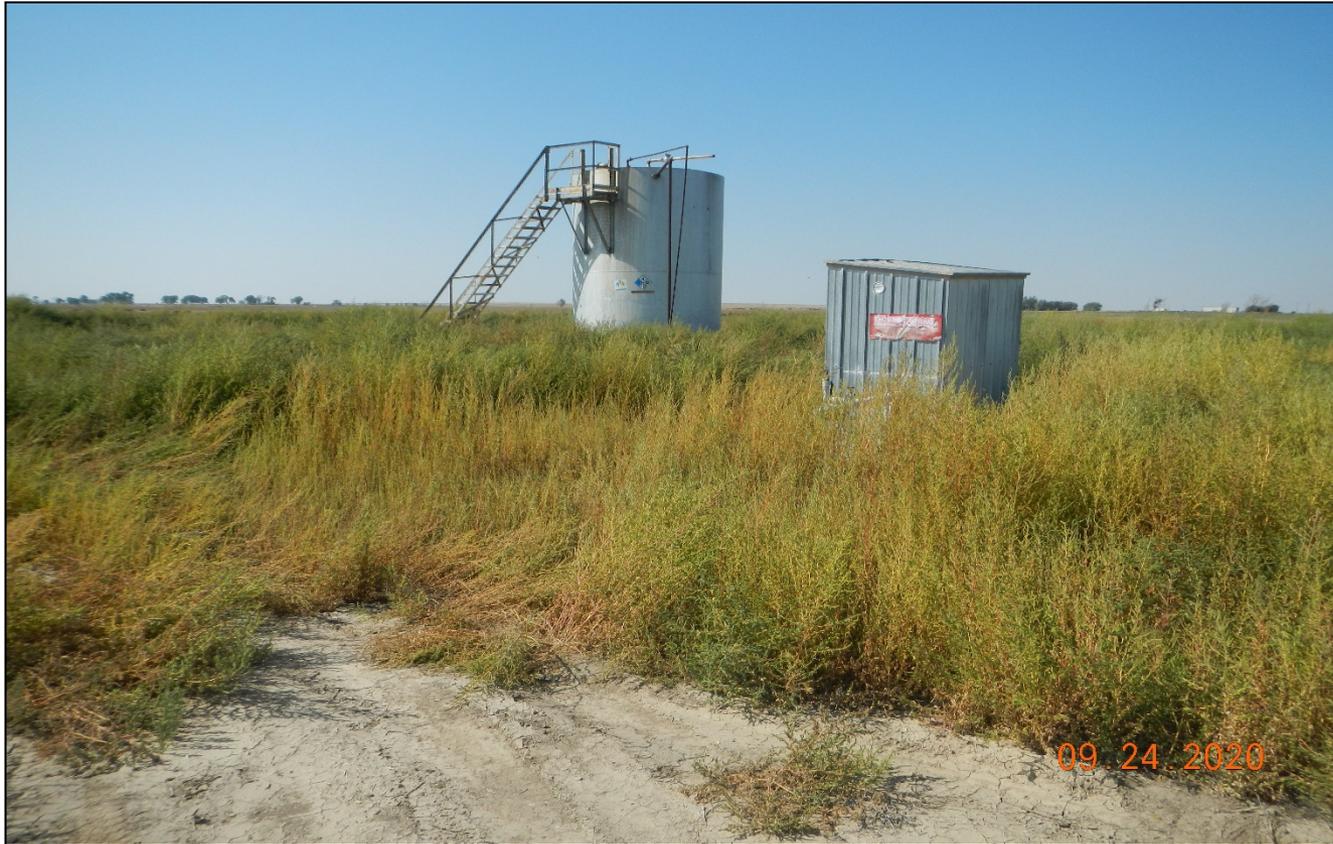
Photo 5. Facing southwest at the location. The meter shed and tank battery remains. All equipment should have been removed within 3 months of abandonment.

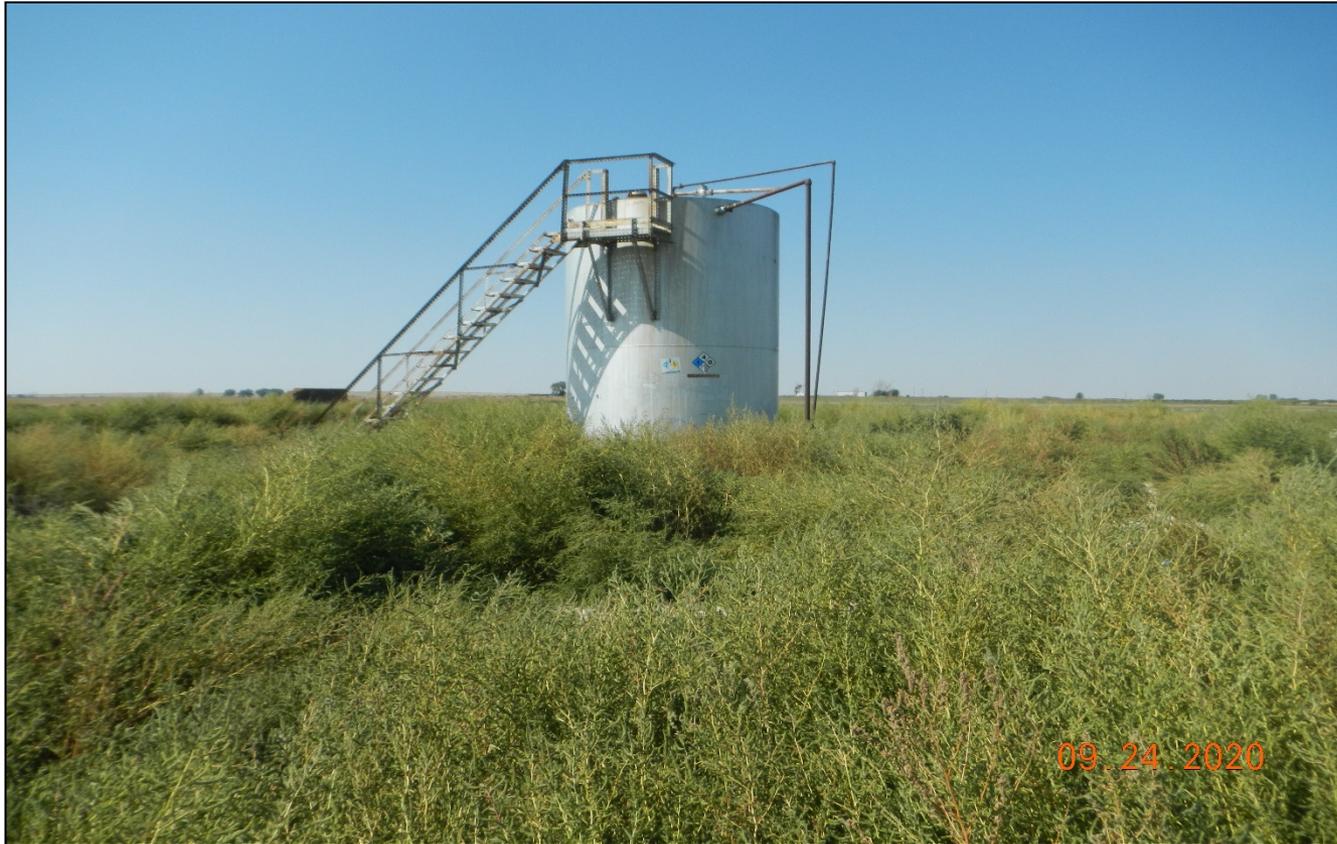
Photo 6. Facing toward the tank battery. The weeds are thick and overgrown that the surface of the location was not visible.

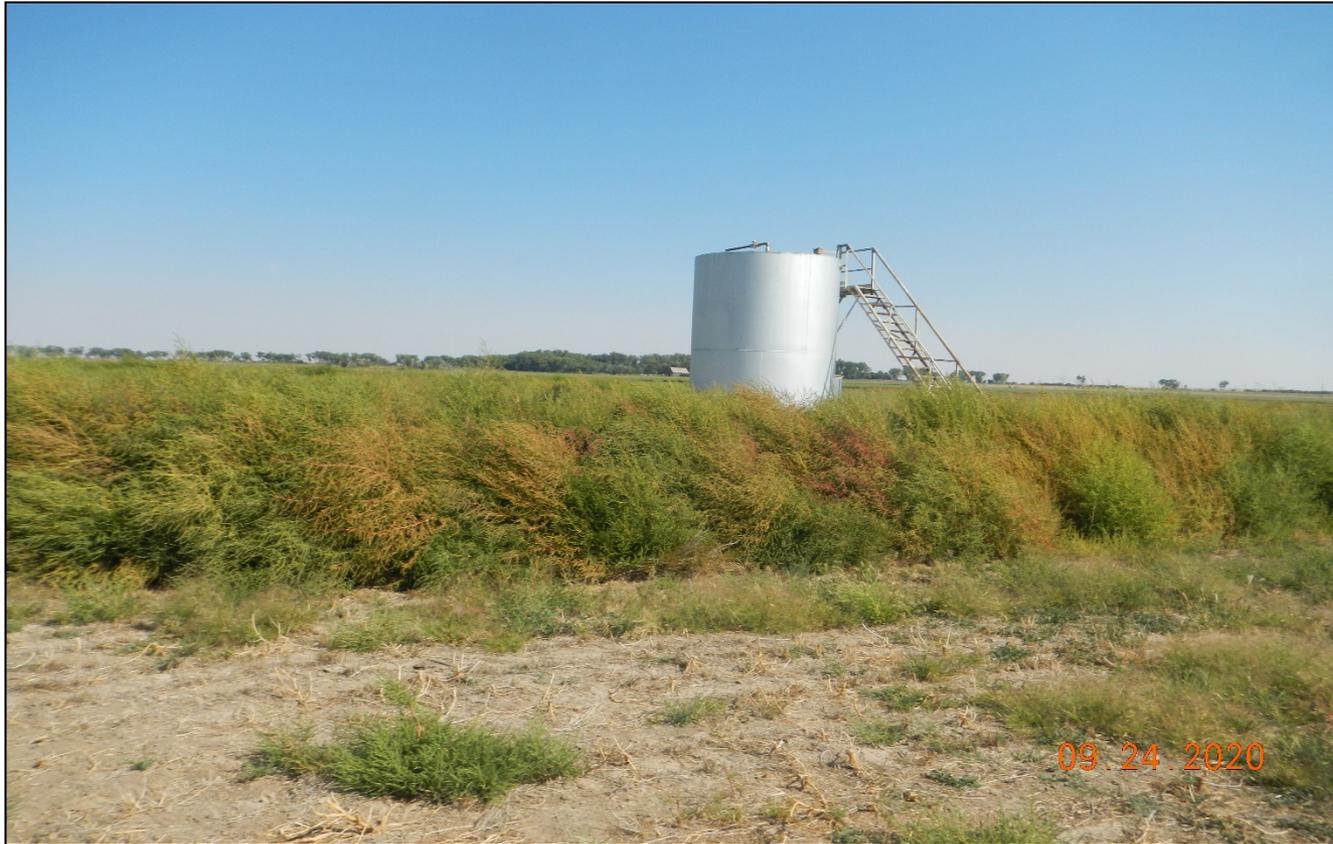
Photo 7. Facing northeast toward the location. The surrounding field has been mowed however the entire location is completely overgrown with Kochia.

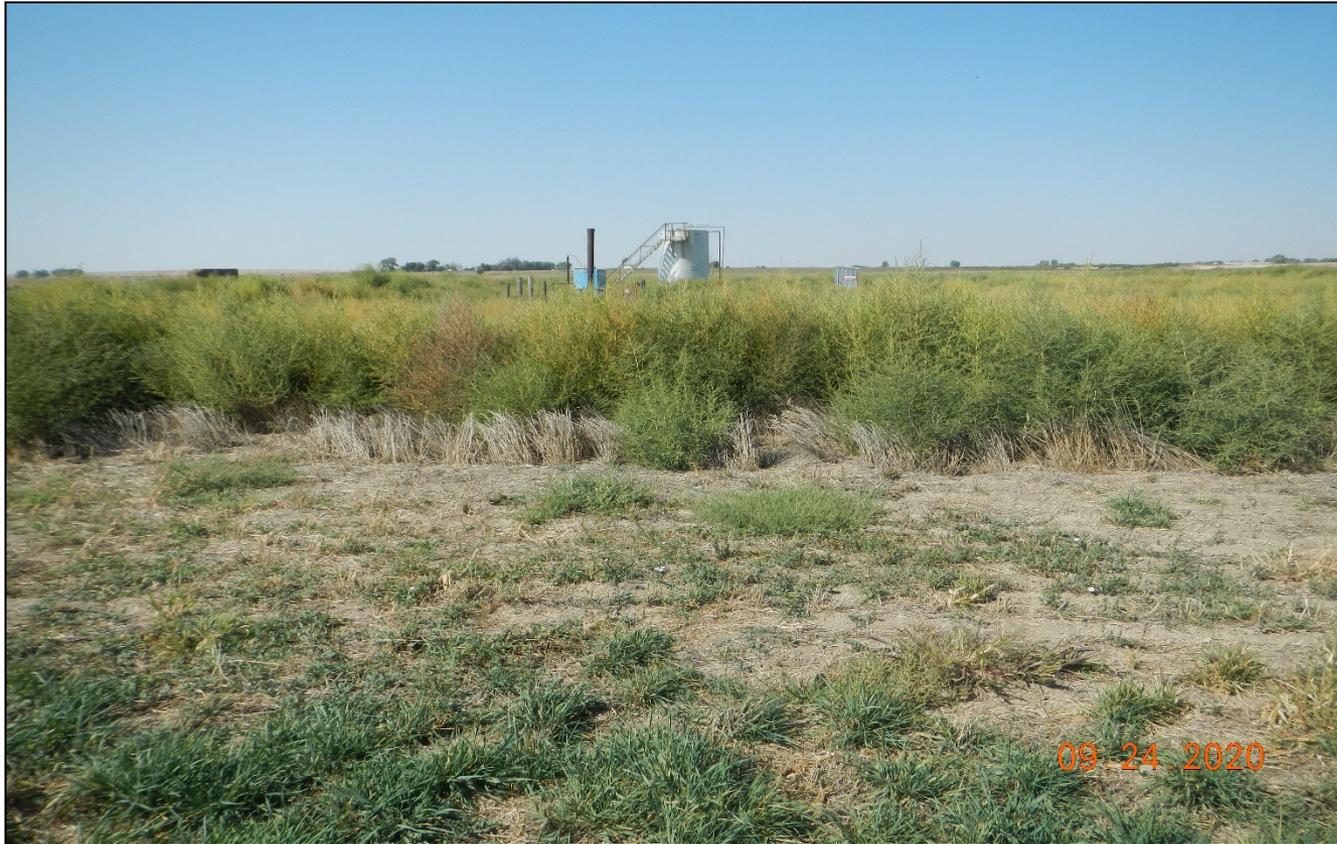
Photo 8. Facing west toward the location. The surrounding field has been mowed however the entire location is completely overgrown with Kochia.
