Inspection Photos
Operator: Maralex
API: 067-09880
Date: 9/29/2020

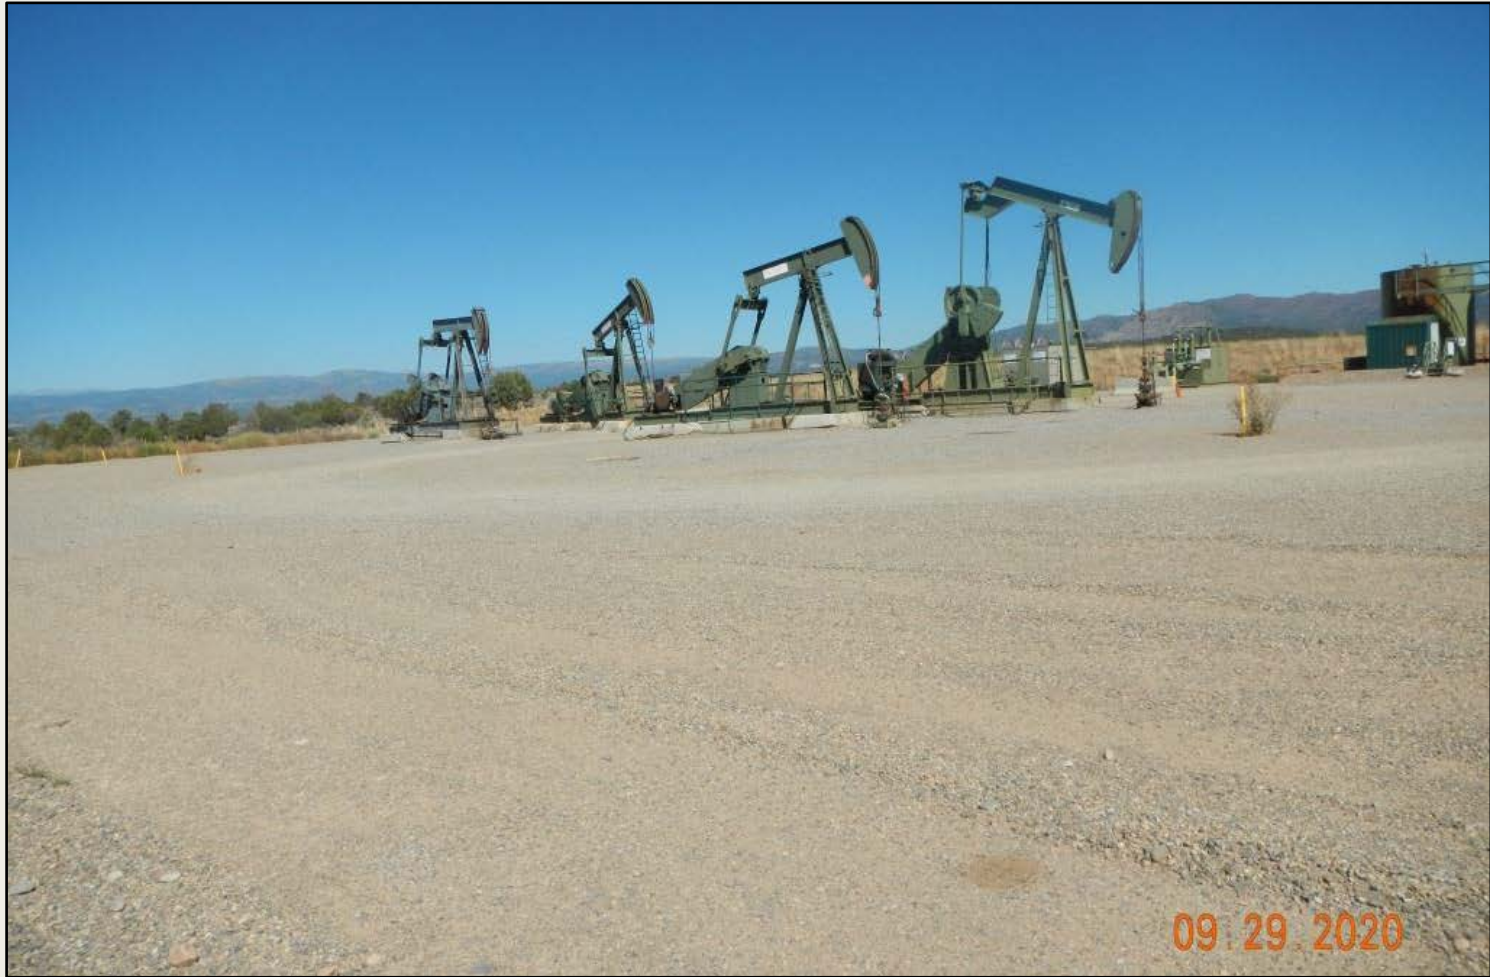
Photo 1. View of the project area from the southeastern corner facing center.

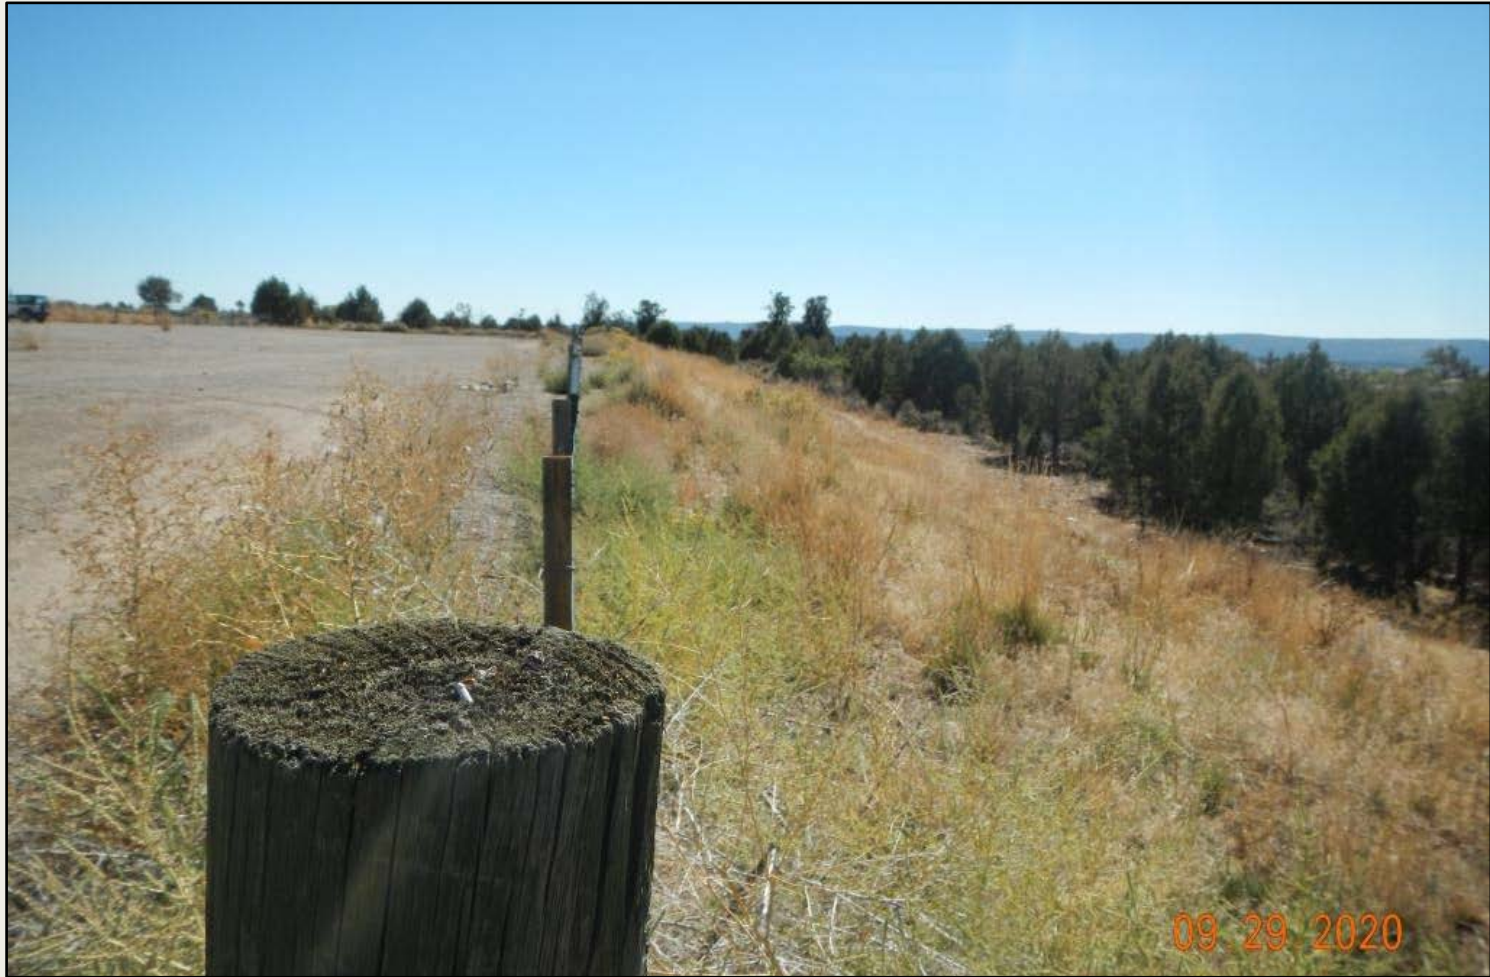
Photo 2. View of the western project area from the northwestern corner facing southward. Revegetation is progressing, largely with western wheatgrass and crested wheatgrass.

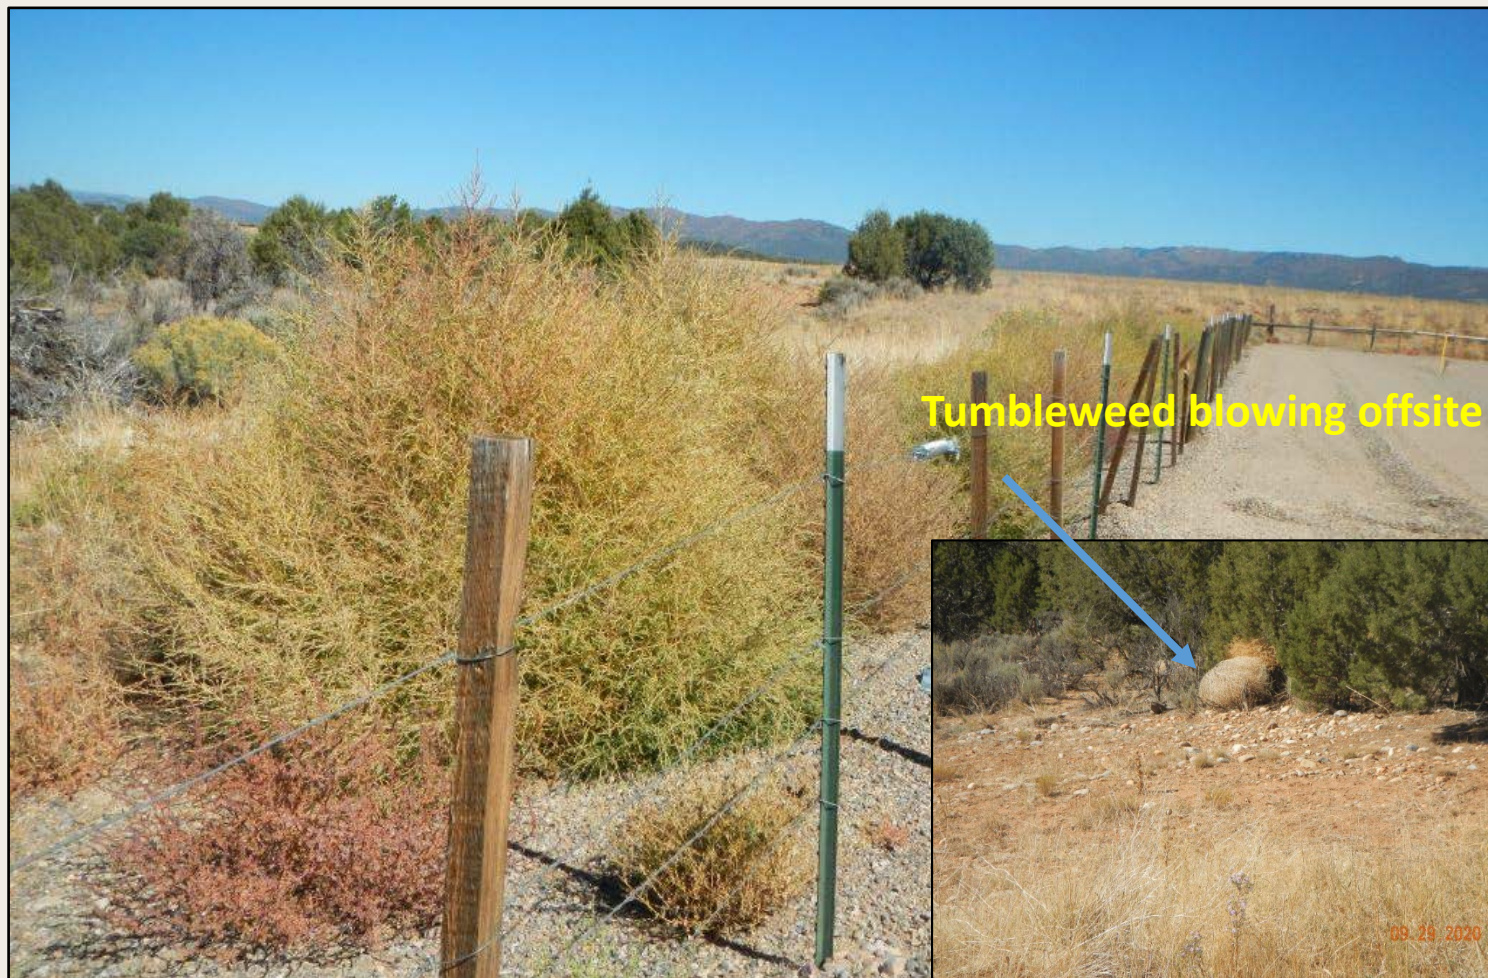
Photo 3. View of kochia plants growing along the northern edge of the working area, up to 5.5 ft tall. Kochia and Russian thistle debris observed blowing offsite.

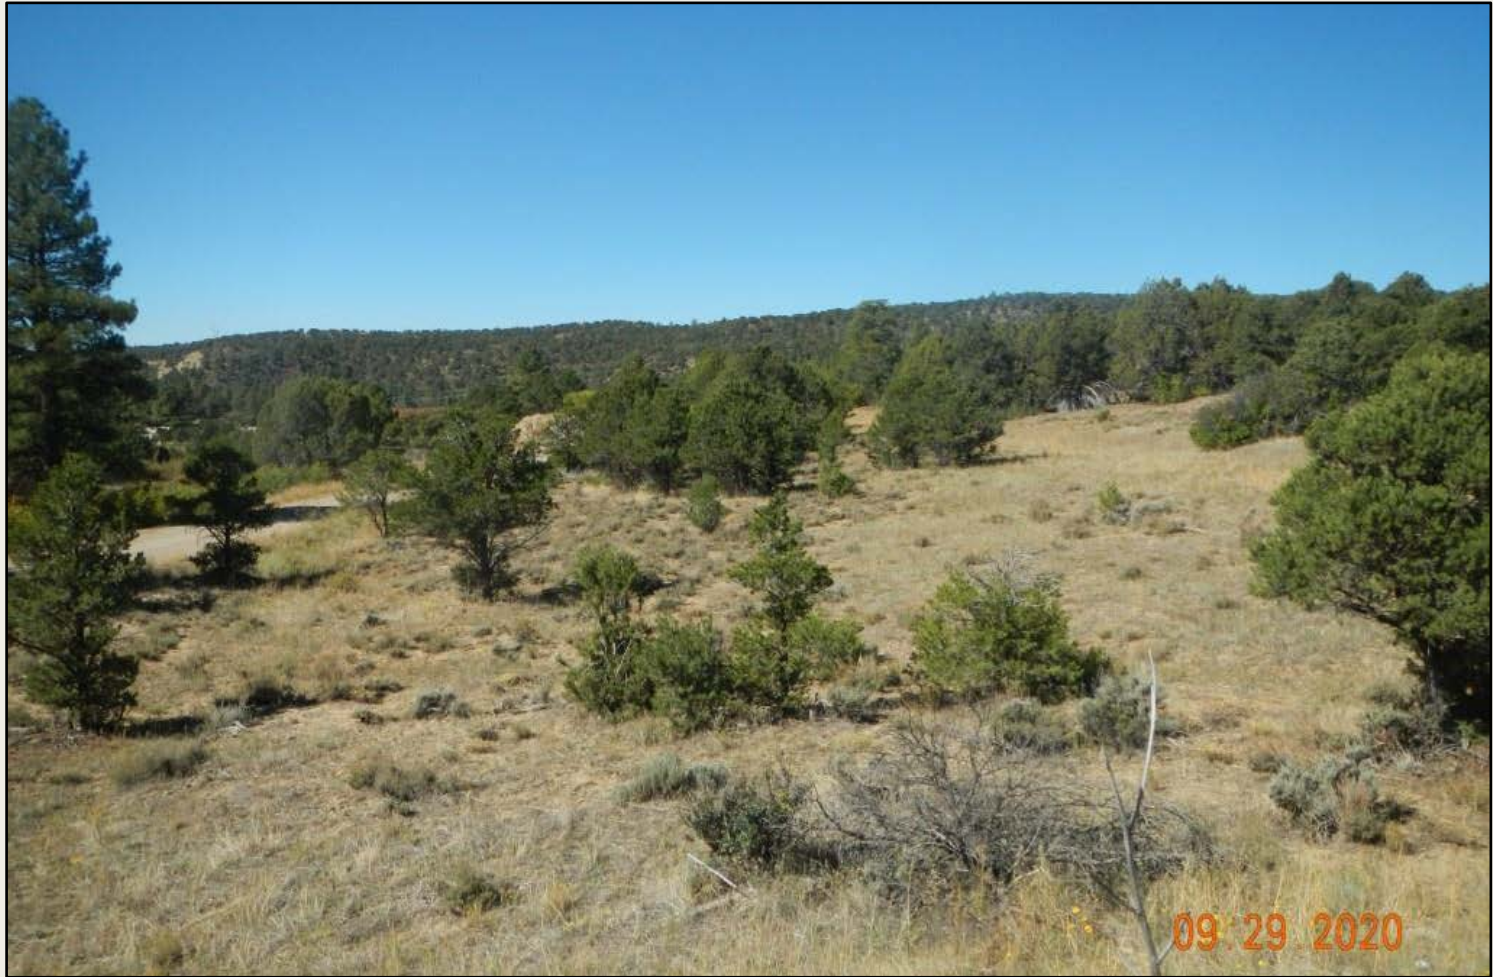
Photo 4. View of the reference area comprised of pinyon and juniper woodland with understory of black sagebrush, western wheatgrass, and gambel oak.
