**RE: Tiffany Gathering  
September 2020 Vegetation Monitoring**

**Tiffany Gathering**  
**September 2020**  
**Vegetation Monitoring Map**  
**BP America Production Co.**

Tiffany Gathering  
September Vegetation Monitoring  
Photographic Log  
BP America Production Co.

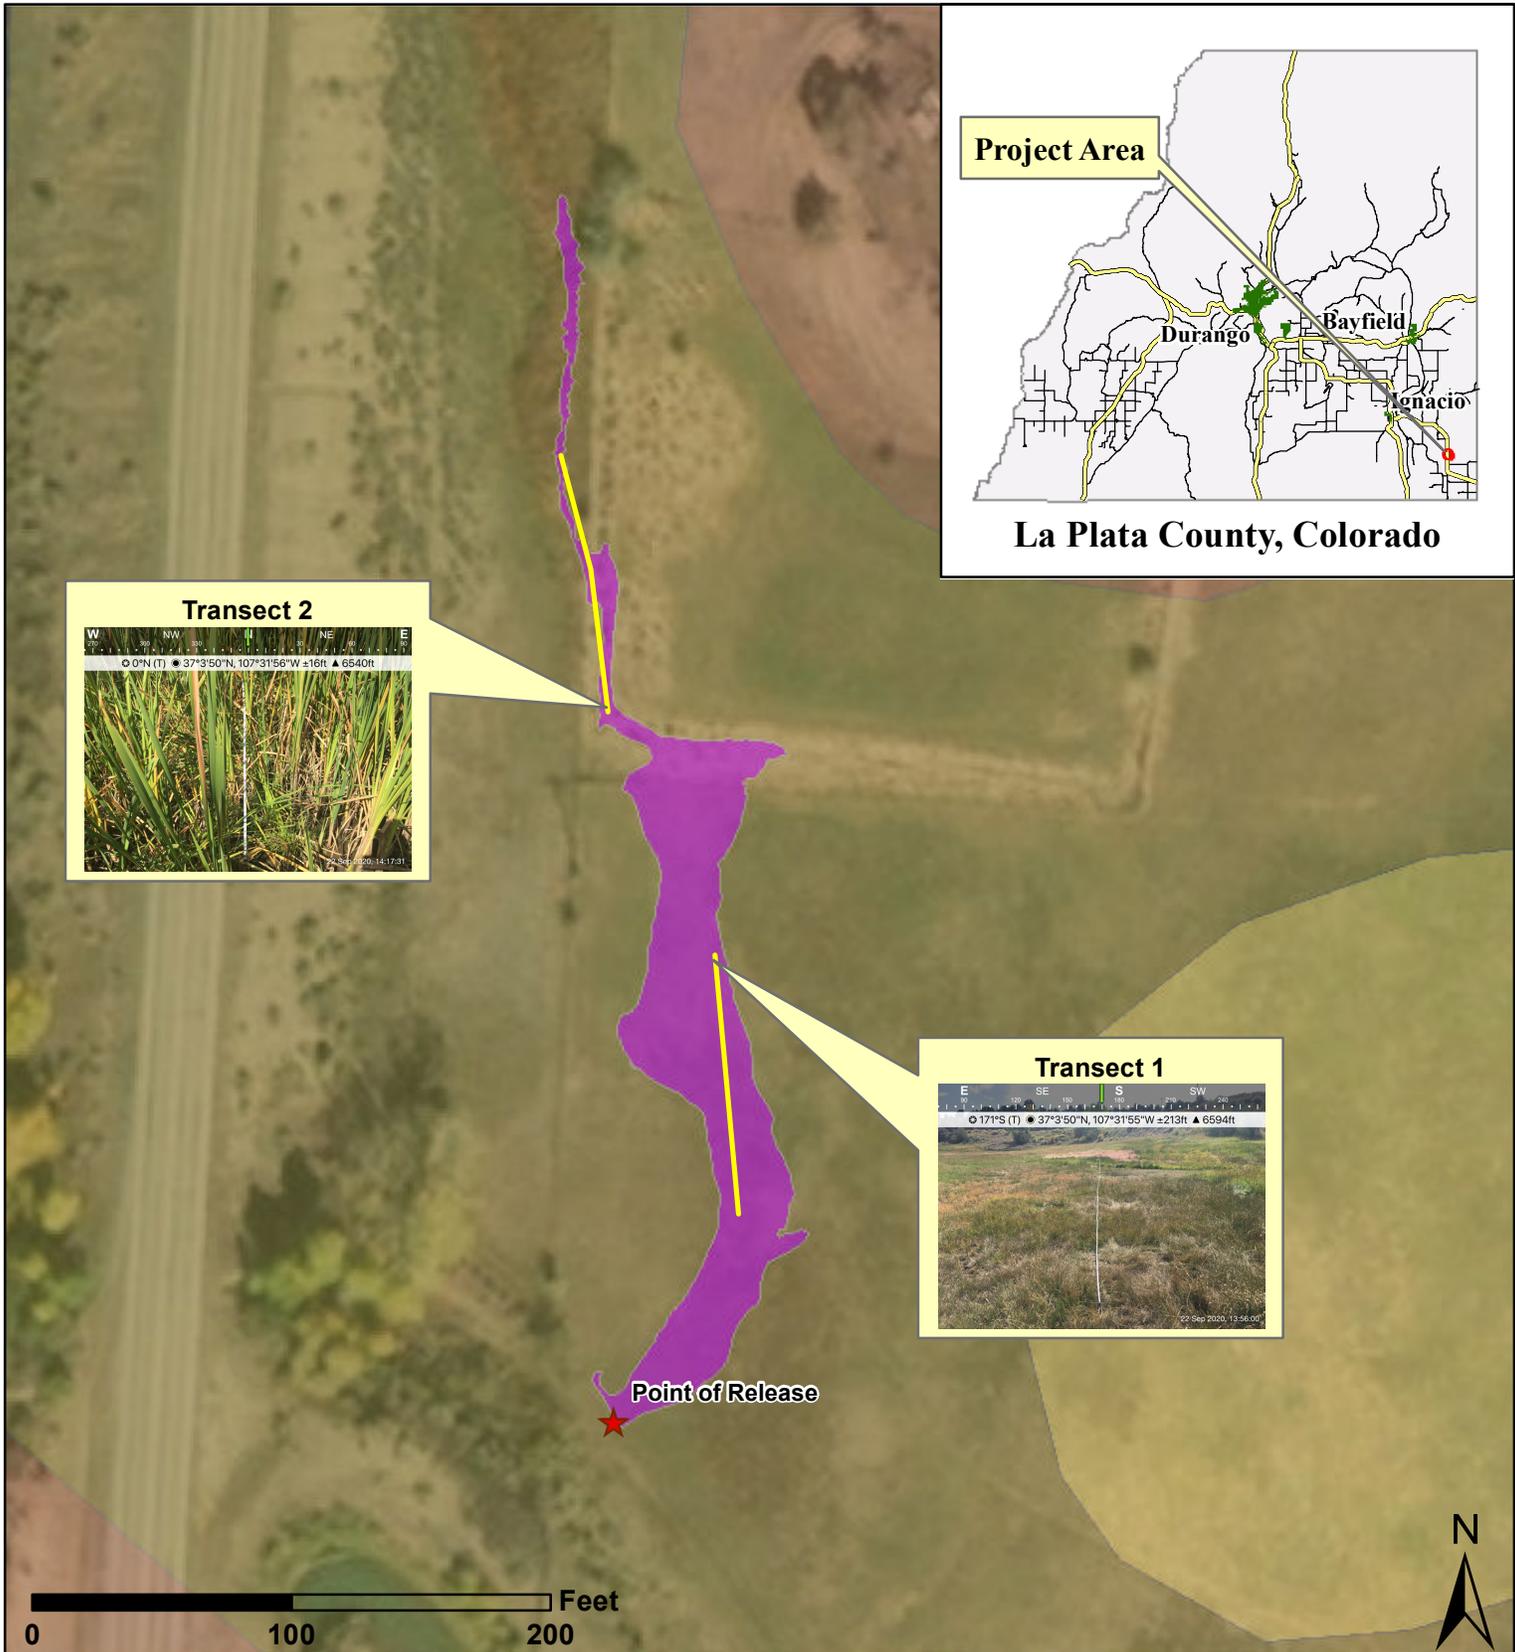
**FIGURE 1**

Transect locations and vegetation cover are provided in Table 1, a map of the project site with the transect locations can be found in Figure 1, photographs of the transects are provided in Attachment 1, and vegetation transect data can be found in Attachment 2.

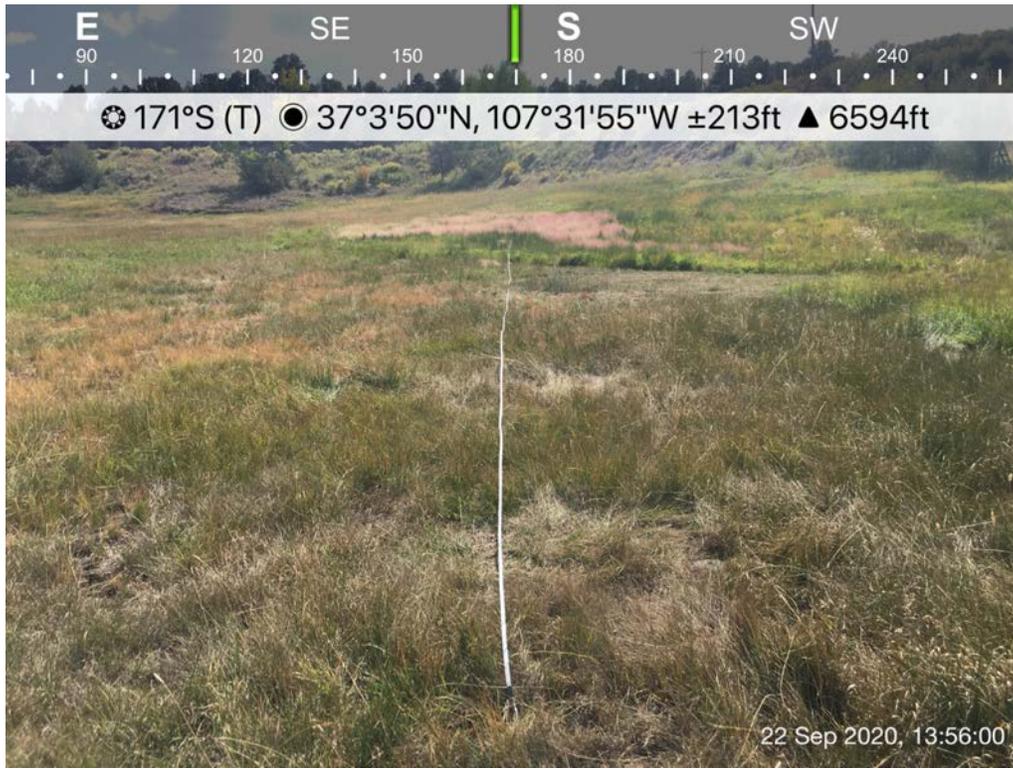
Vegetation cover was 84% in Transect 1 and 100% in Transect 2 during the September 2020 vegetation monitoring event. Vegetation cover in Transect 2 was consistent with the August 2020 monitoring event. Bare ground made up 8% of Transect 1 and there was no bare ground observed in Transect 2, which is consistent with the August 2020 monitoring event. A portion of Transect 1 was saturated due to flood irrigation. Transect 2 was located within an irrigation-influenced wetland area with flowing water.

Photo 1: Start of Transect 1, 9/22/2020.

Vegetation along the transect was consistent with seasonal and surrounding conditions.

Soil was saturated due to flood irrigation.

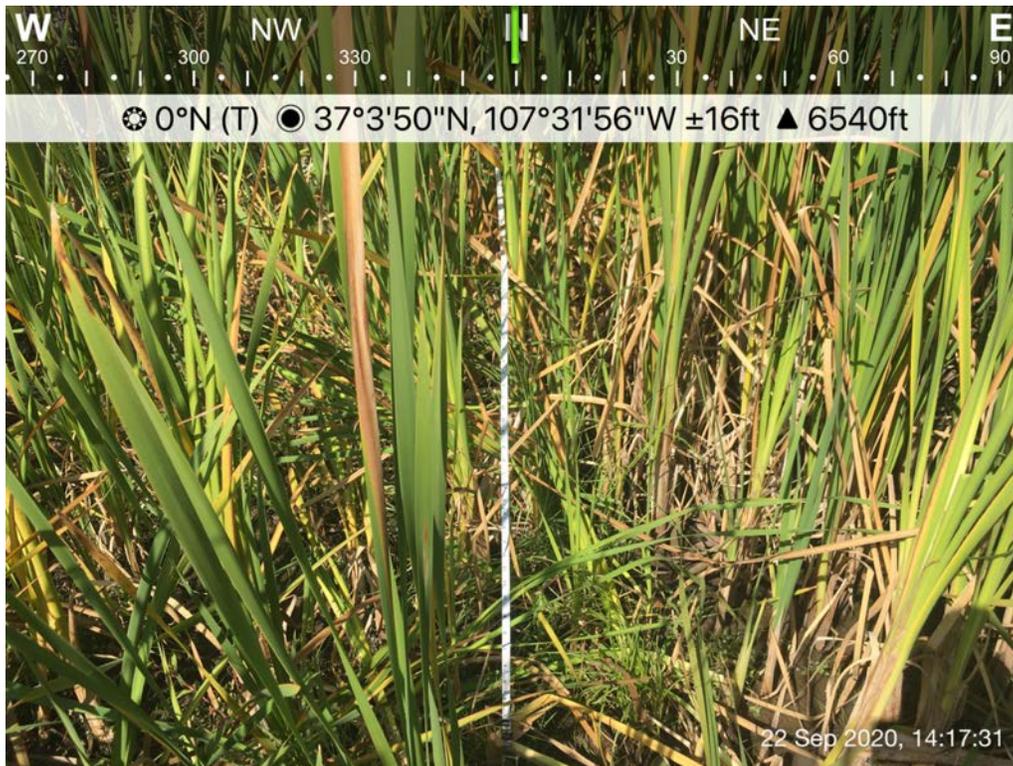
Photo 2: Start of Transect 2, 9/22/2020.

Vegetation along the transect was consistent with seasonal and surrounding conditions.

Transect is located in an irrigation-influenced wetland with flowing water.
