# Inspection Photos

API: 071-08256

Operator: TIMBER CREEK OPERATING

Inspection Date: 10/1/2020

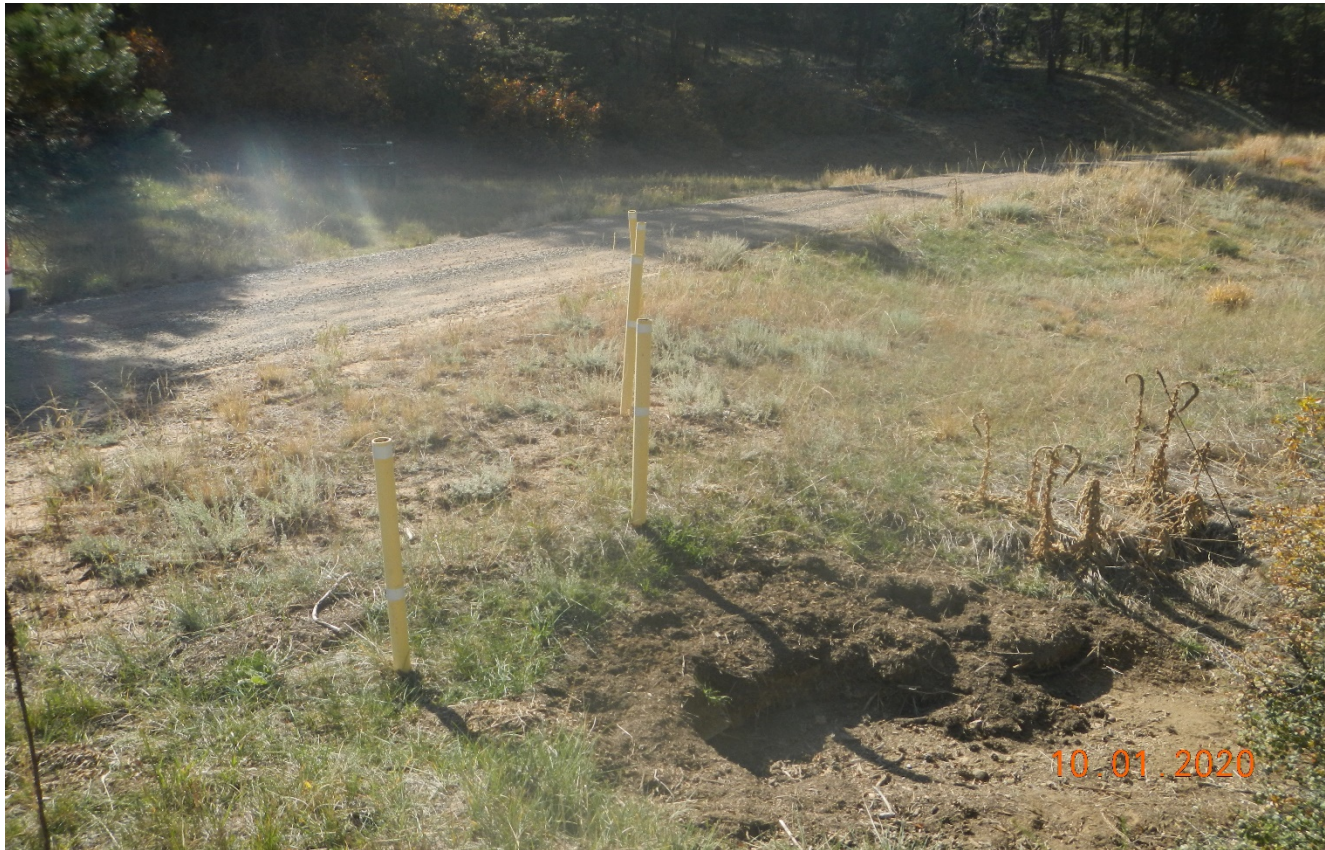
**Photo 1.** There is a plugged culvert along the main road.

Lat/Long:37.37.108595,-104.934612.

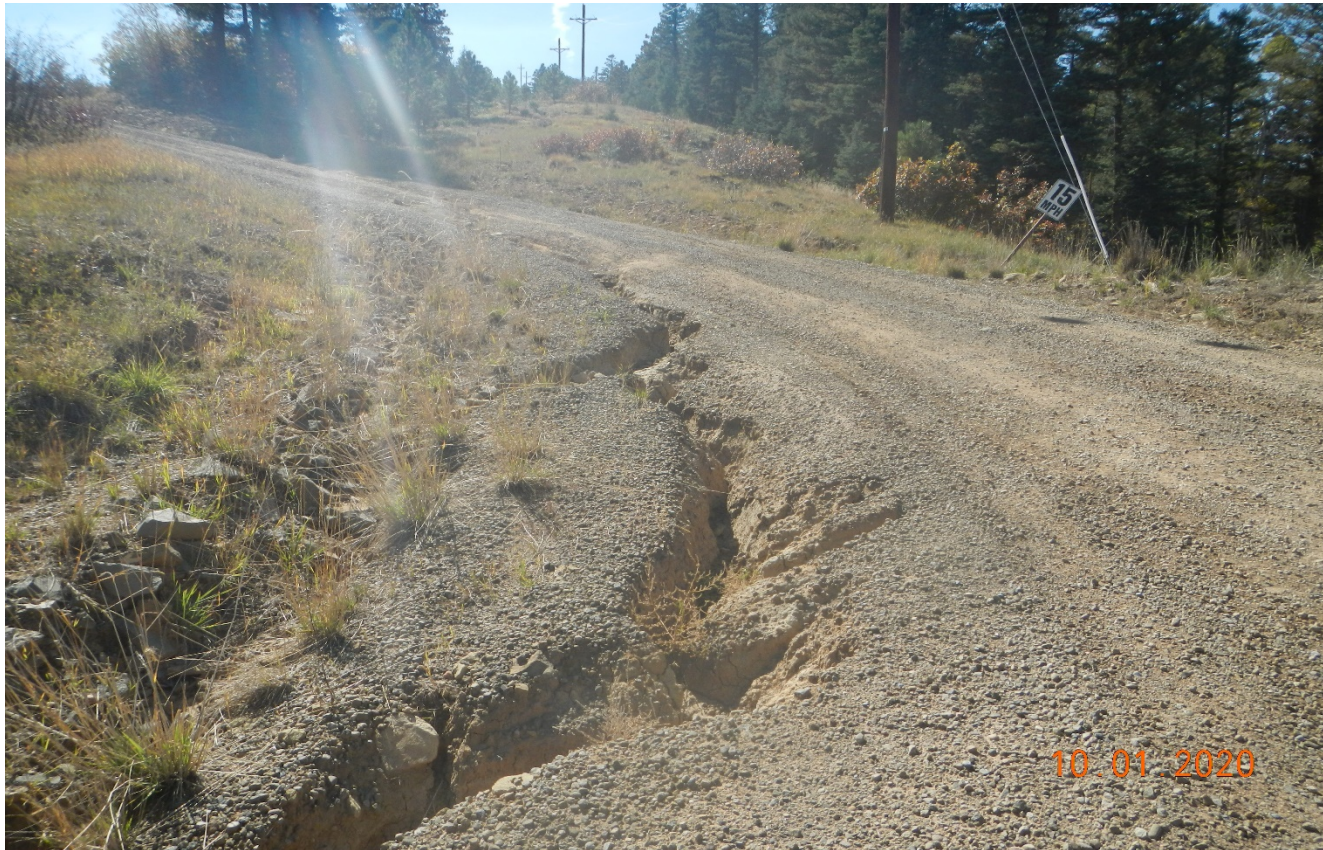
**Photo 2.** There is erosion that has occurred along the road ascending the hillside. Erosion needs to be repaired and BMP's need to be installed.

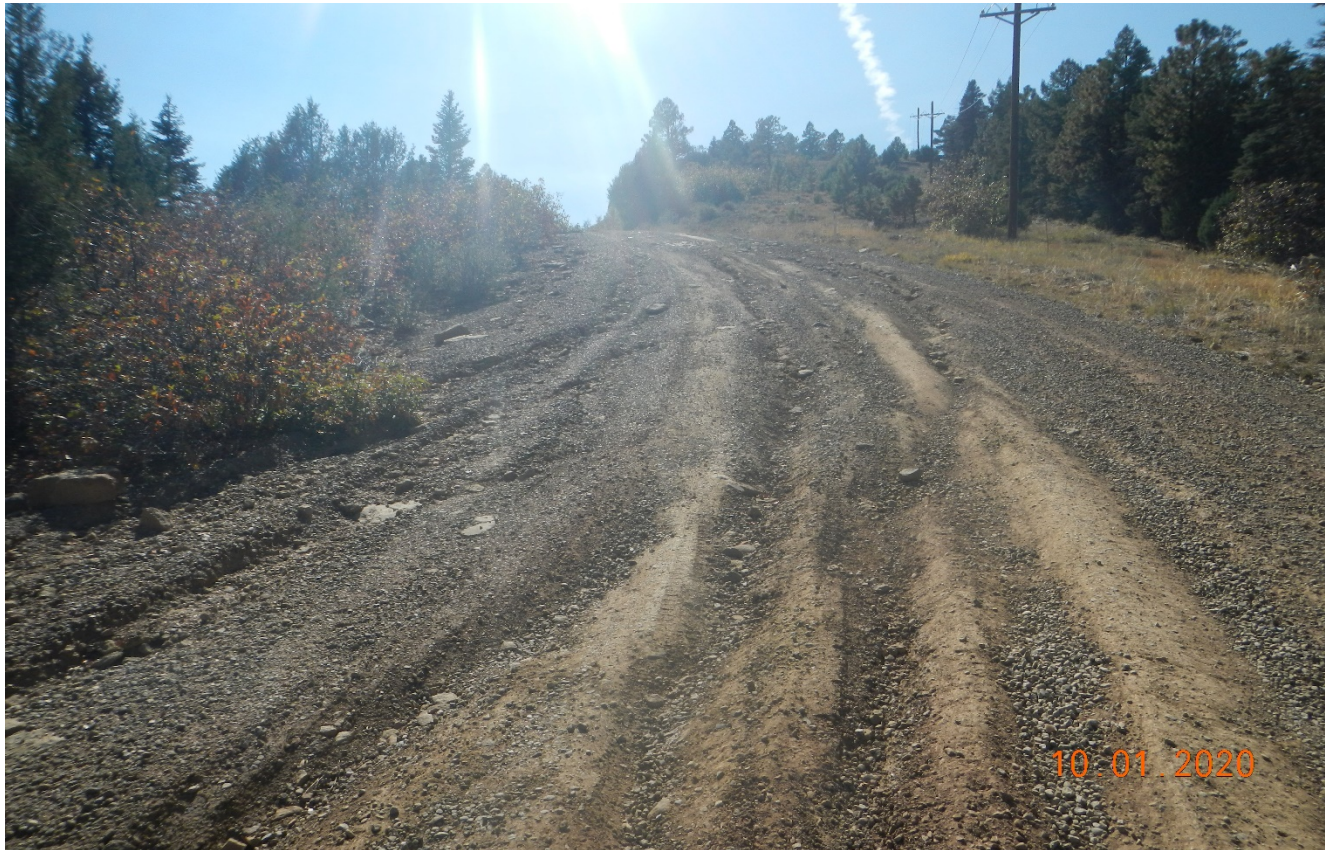
**Photo 3.** Facing west along the road. There is signs of erosion occurring down the road. BMP's need to be installed to prevent erosion and degradation of the road. E.G. Water bars.

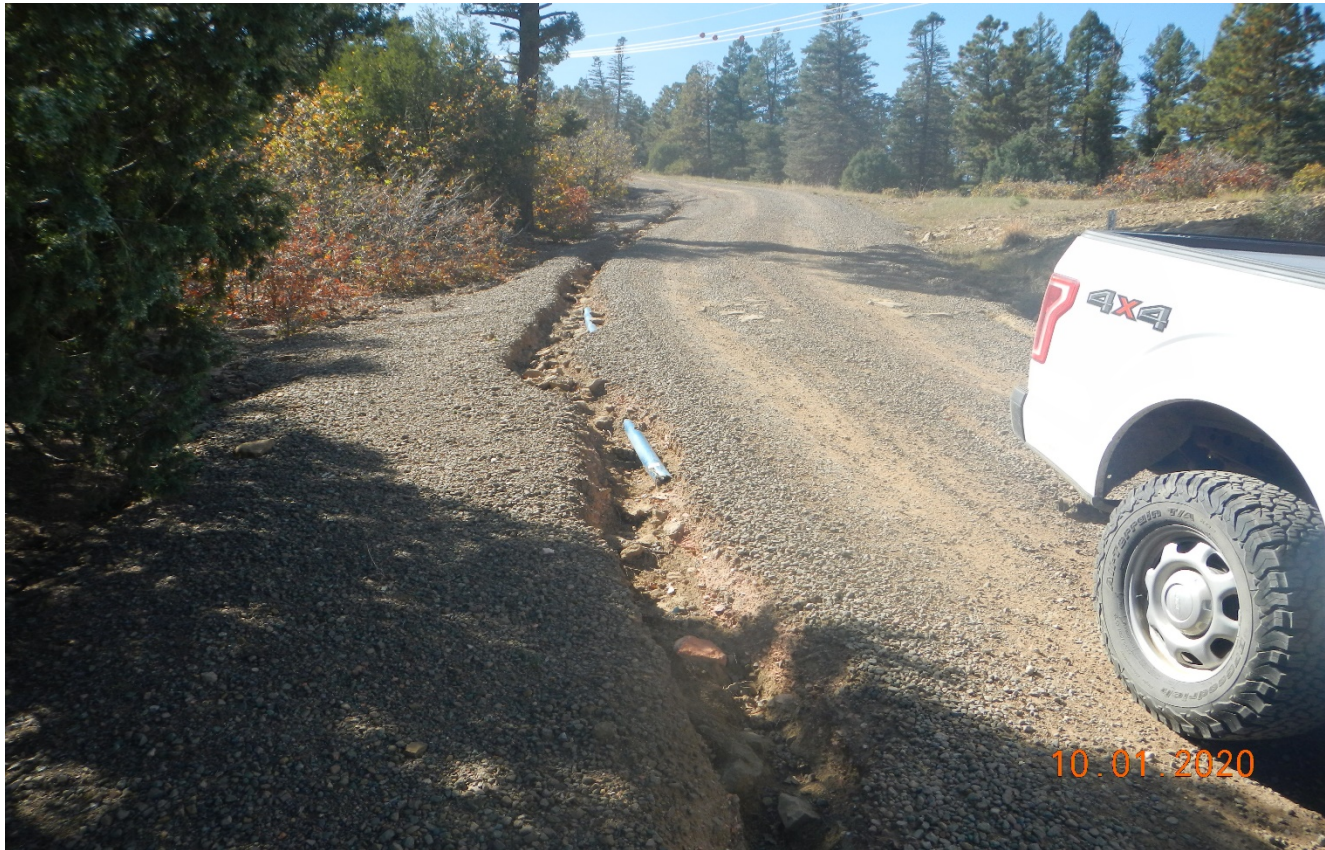
**Photo 4.** An eroaion channel has form along the steep grade of the road. Stormwater needs to be properly diverted and BMP's need to be installed. E.G Water bars, Sediment trap, check dams.

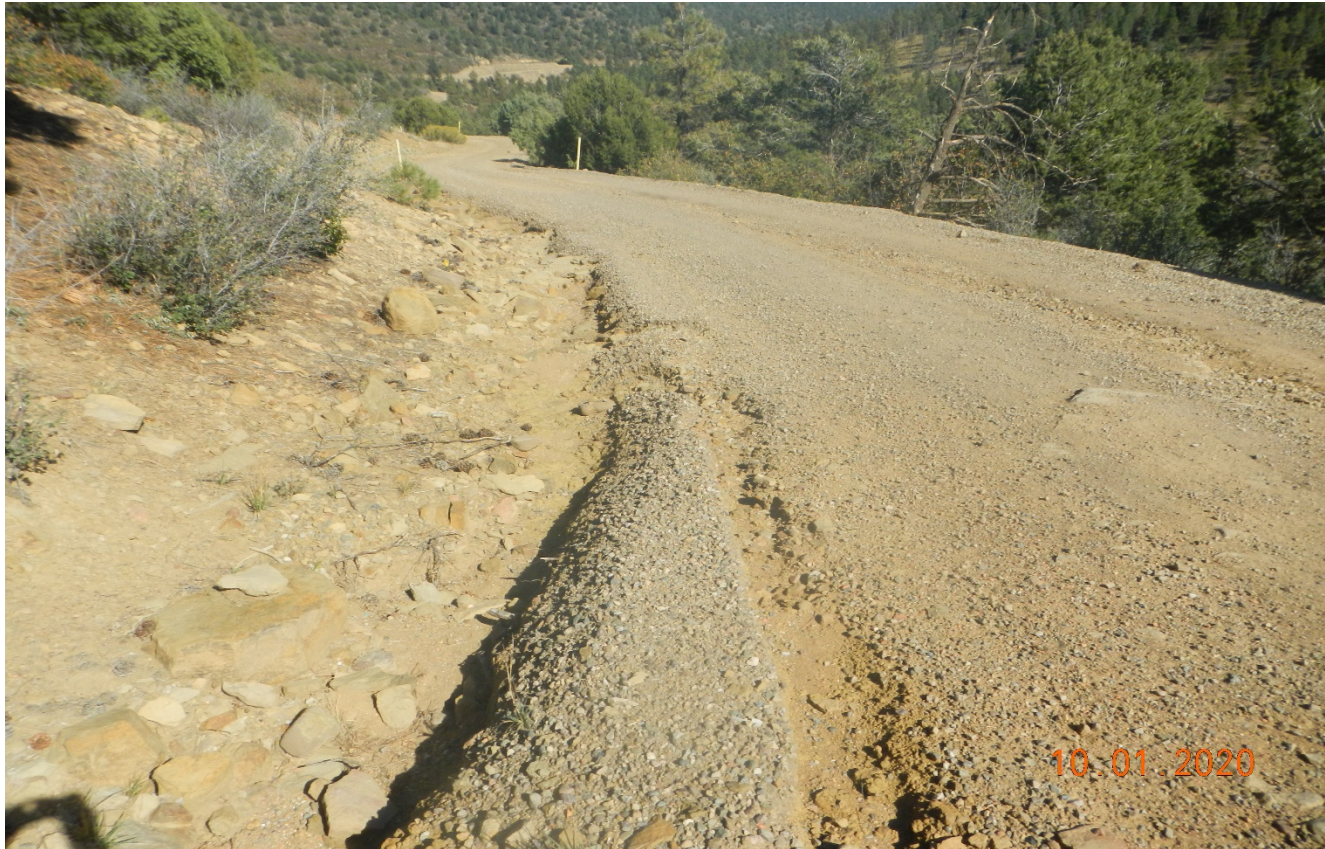
**Photo 5.** Stormwater is flowing down the road which is causing erosion and degradation of the road.

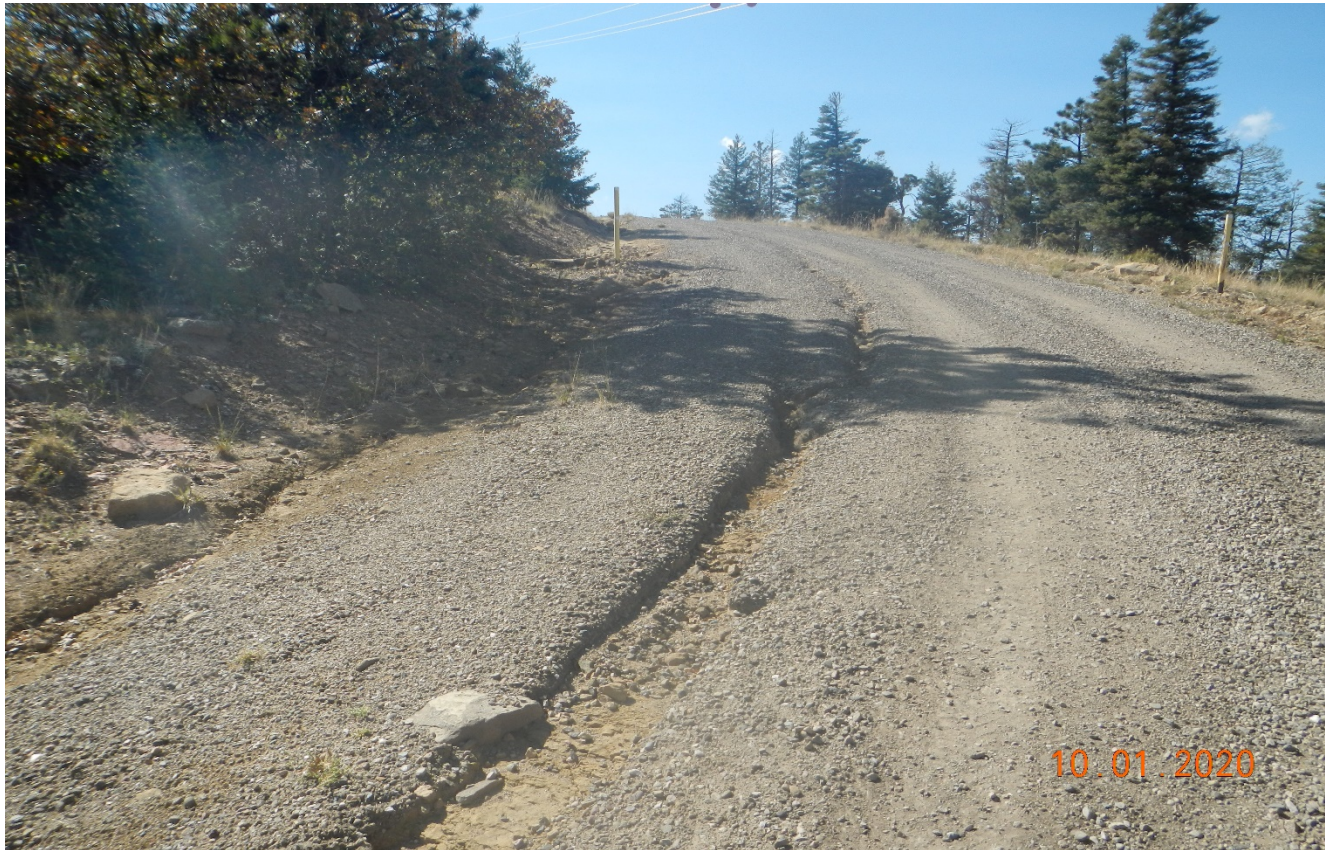
**Photo 6.** An erosion channel has formed along the steep grade of the road. Stormwater needs to be properly diverted and BMP's need to be installed. E.G Water bars, Sediment trap, check dams.
