Final Reclamation Inspection

Operator: MERIT ENERGY COMPANY - #56565

Location ID: 319665

Inspection Photos
Location Name: BERGMAN #1
Location ID: 319665

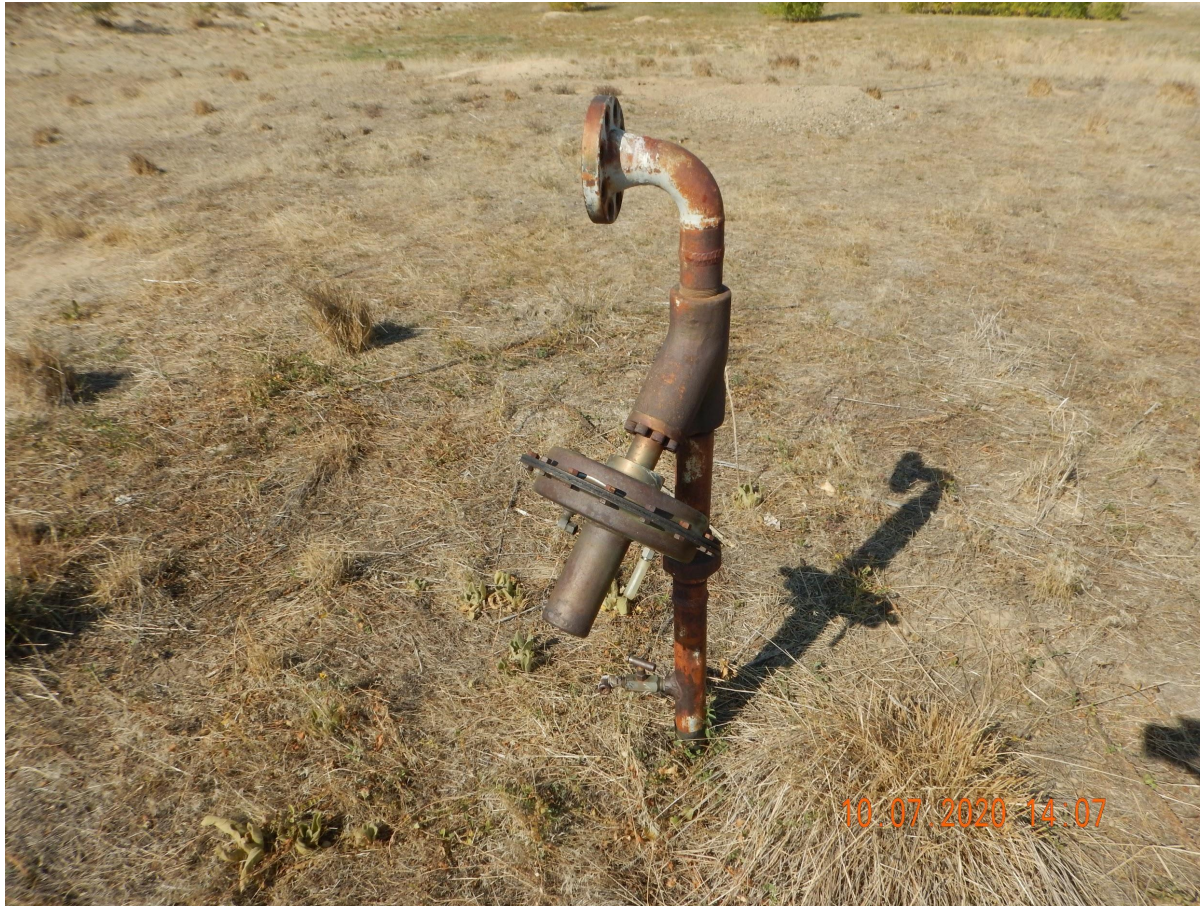
Photo 1. Photo taken from the location. Photo illustrates Operator has failed to remove all equipment.

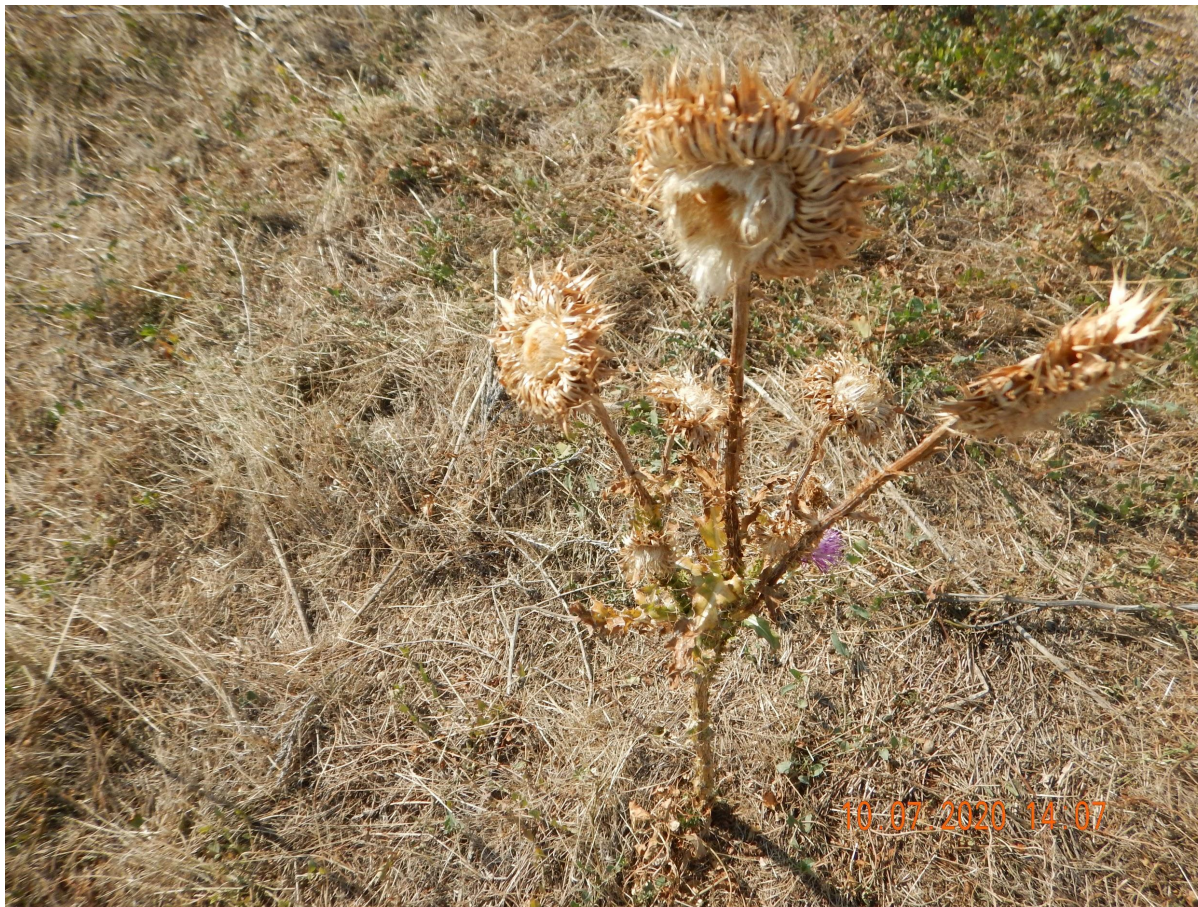
Photo 2. Photo taken from the location. Photo illustrates an unmanaged List B Colorado noxious weed, Musk thistle. Musk thistle was observed throughout the location.

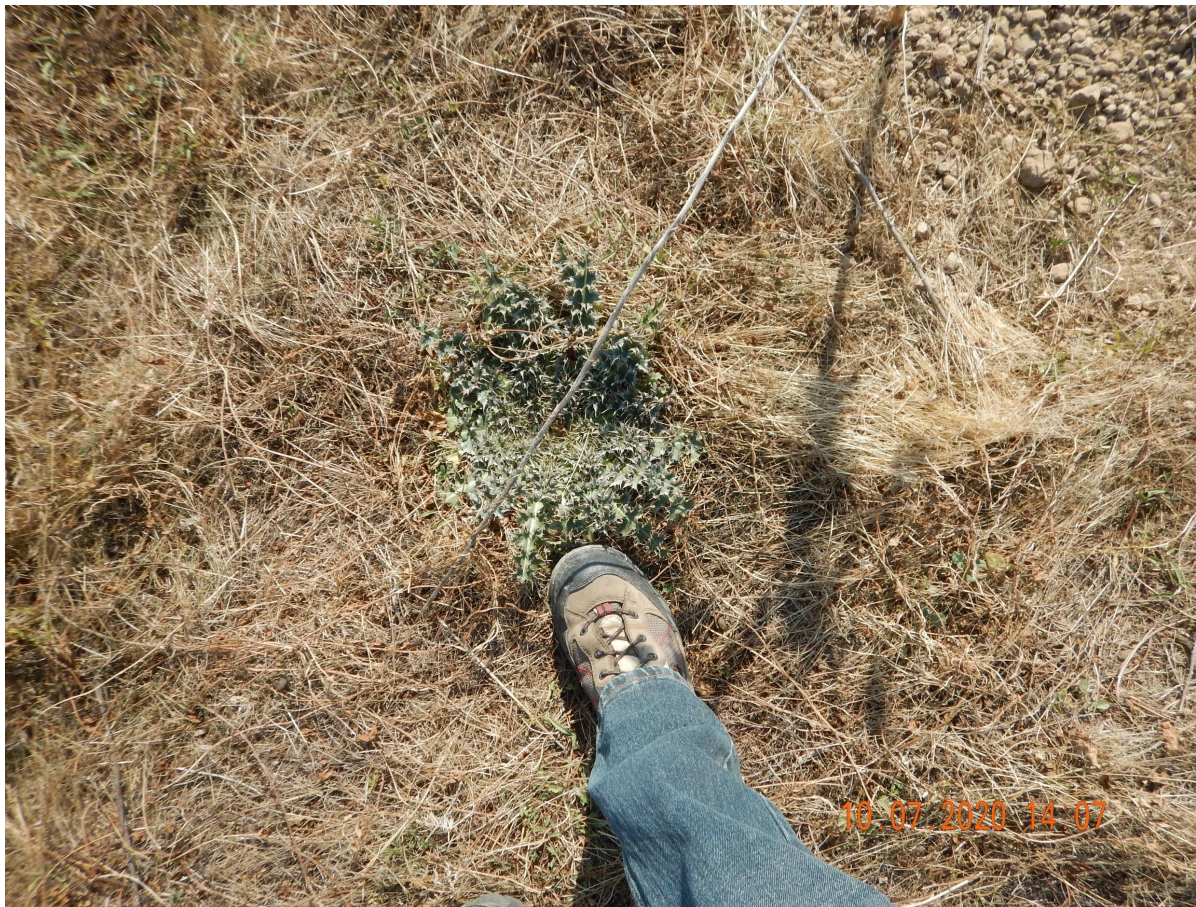
Photo 3. Photo taken from the location. Photo illustrates a rosette of a List B Colorado noxious weed, Musk thistle, and cheatgrass (dead grass vegetation), a List C Colorado noxious weed.

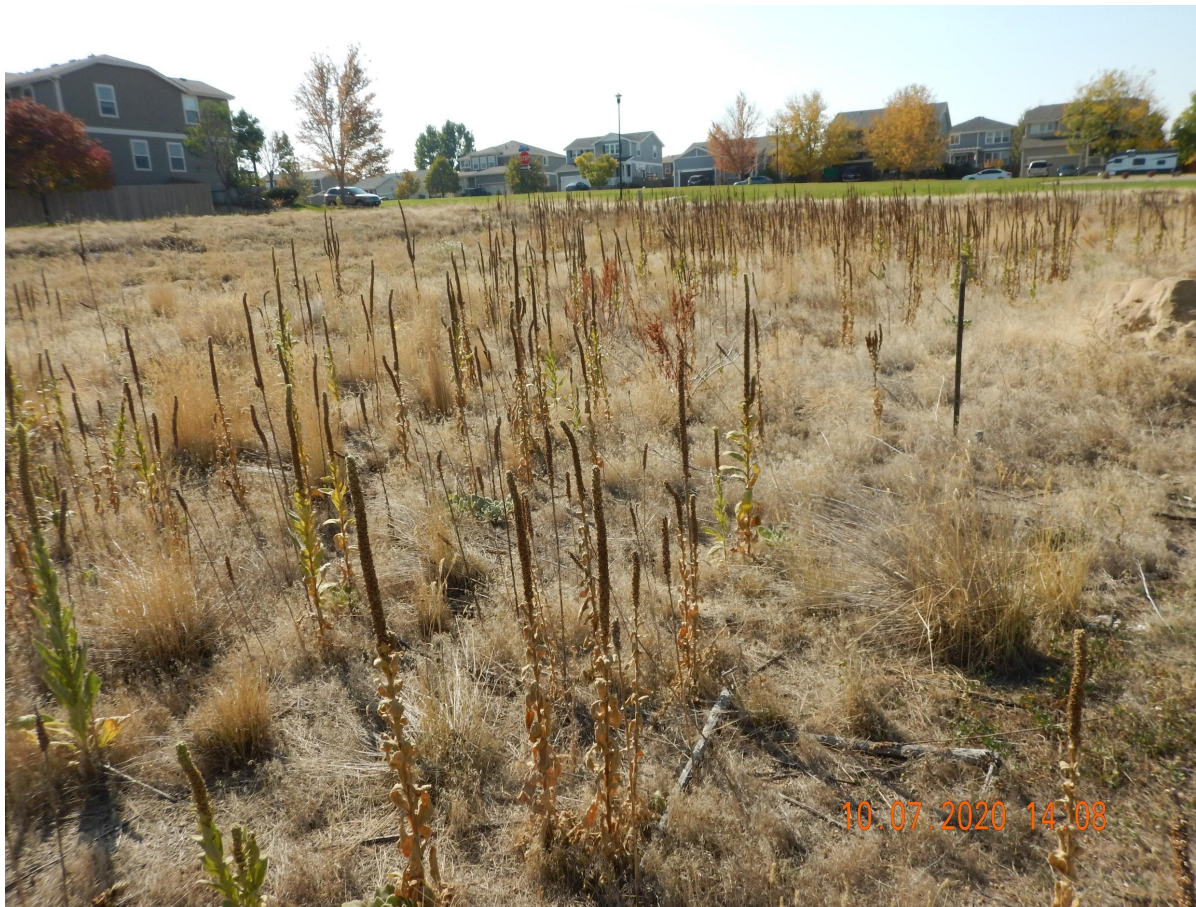
Photo 4. Photo taken from the location, facing West. Photo illustrates unmanaged List C Colorado noxious weeds, Common mullein. Common mullein was observed throughout the location.

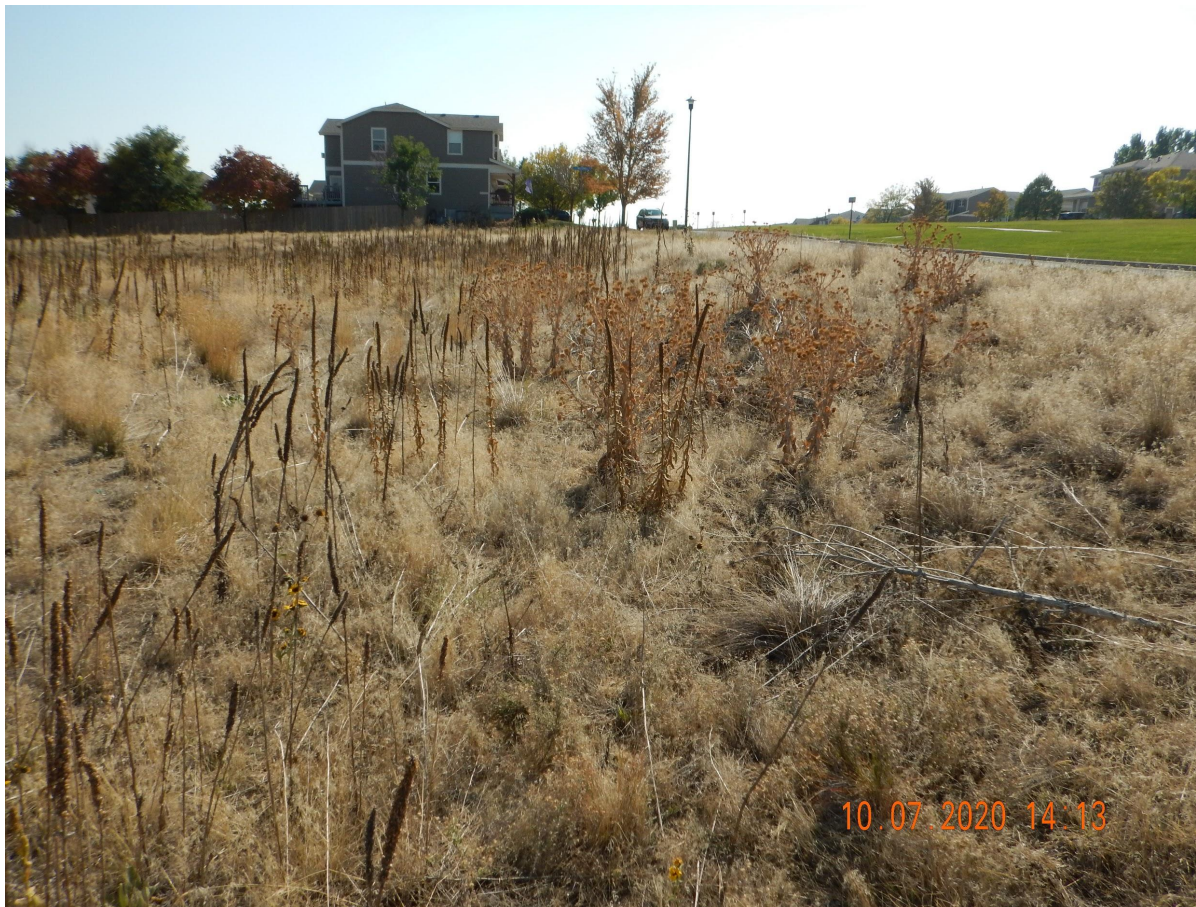
Photo 5. Photo taken from the location, facing South. Photo illustrates unmanaged List B Colorado noxious weeds, Scotch thistle. Scotch thistle was primarily observed along the western portion of the location.

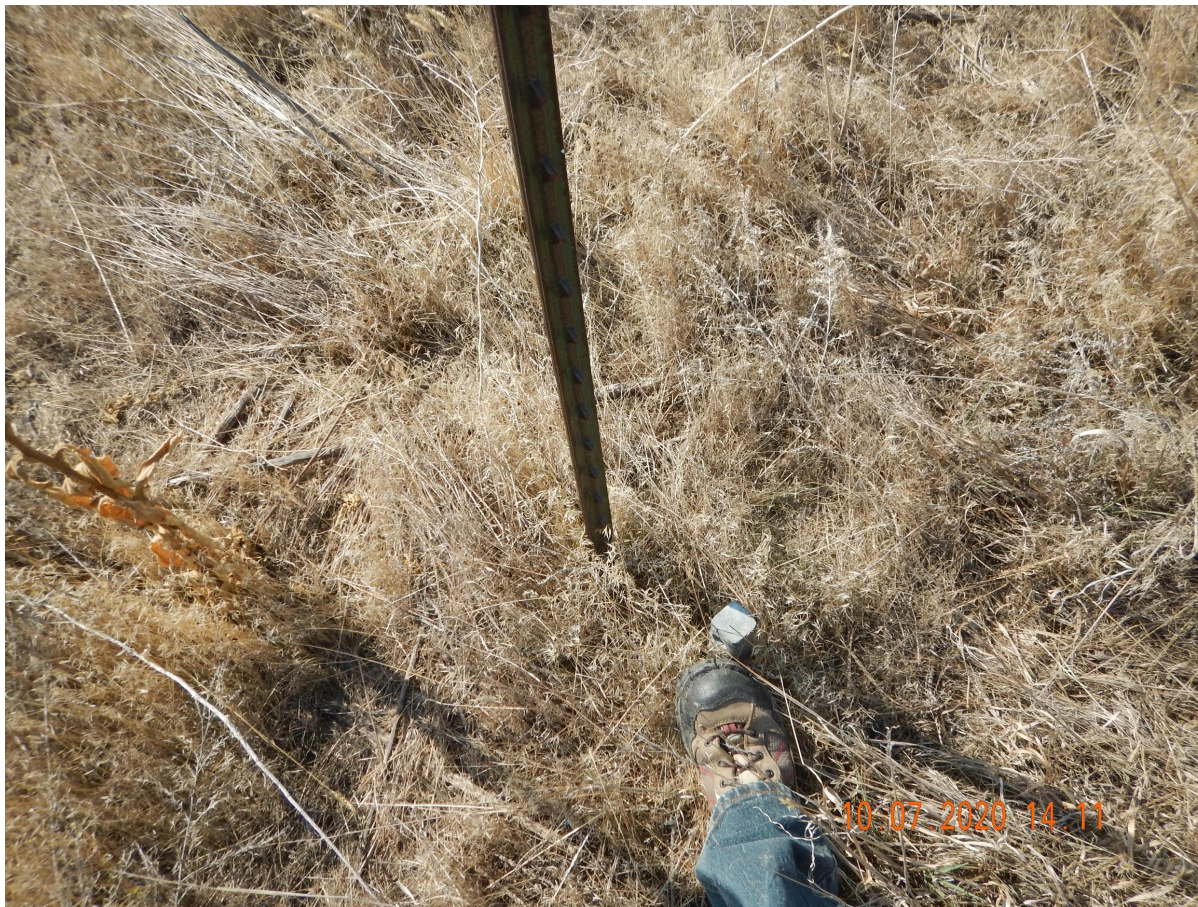
Photo 6. Photo taken from the location. Photo illustrates Operator has failed to remove the guy line anchor and t-post. All four guy line anchors remain at location.

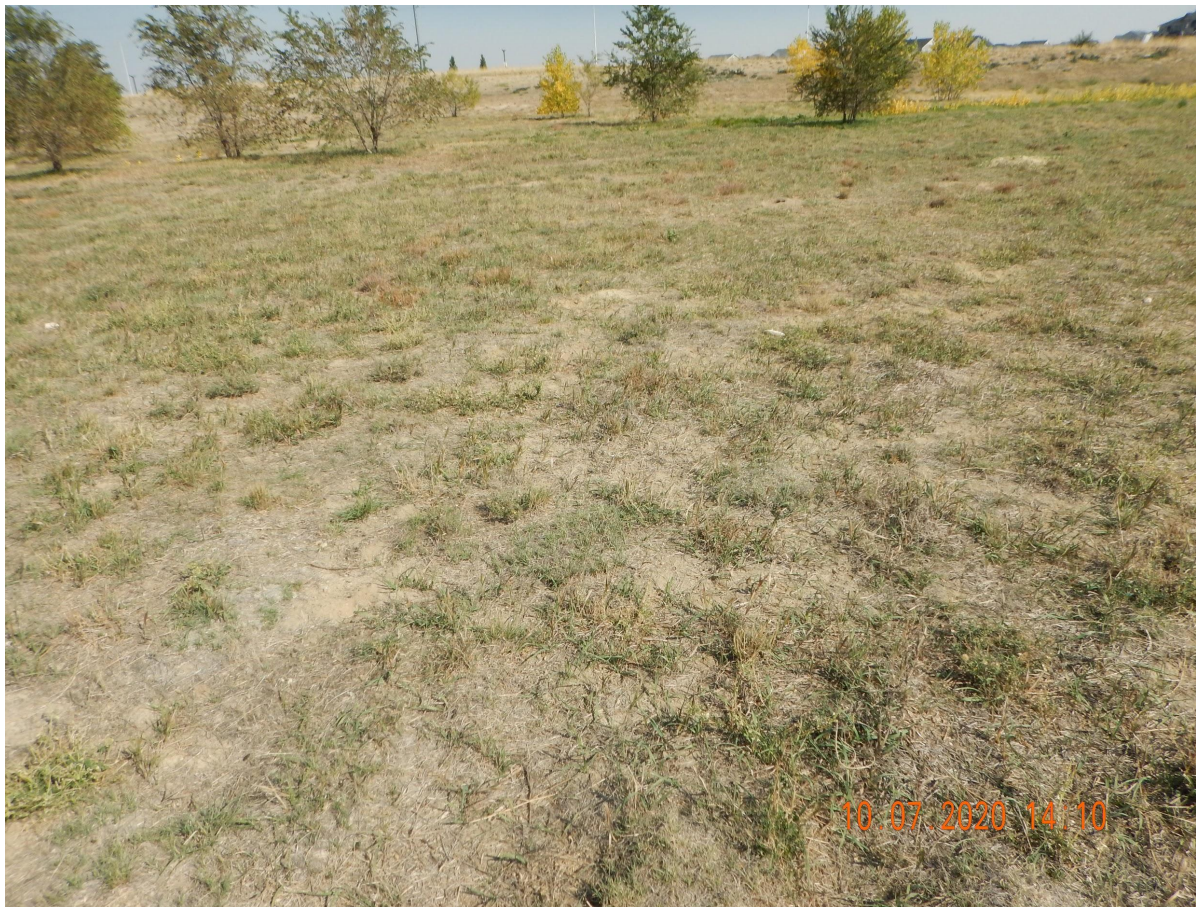
Photo 7. Reference photo taken east of the location, facing East. Photo illustrates the vegetative difference of the nearby reference area compared to the location.
