**SAMPLING RESULTS
SPILL REPORT #402486573
LINDA #2 LEASE
NENE SEC 30 T2S R52W
WASHINGTON COUNTY COLORADO**

**PREPARED BY:
CORAL PRODUCTION CORPORATION
1600 STOUT ST.
SUITE 1500
DENVER, CO 80202**

OCTOBER 20, 2020

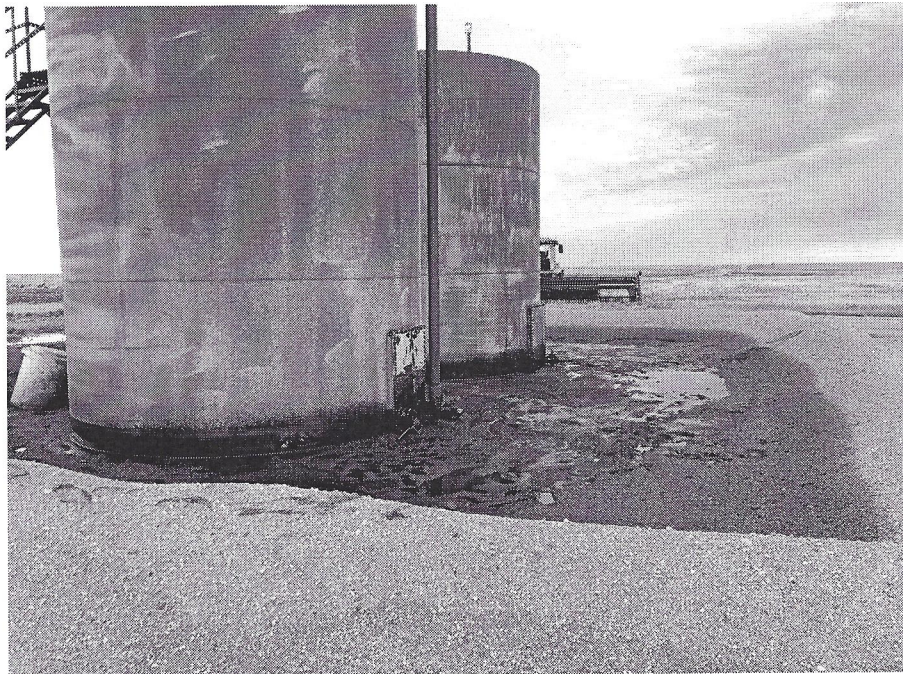
After fluid recovery
