Inspection Photos

Operator: BP America
API: 067-08630
Date: 10/20/2020

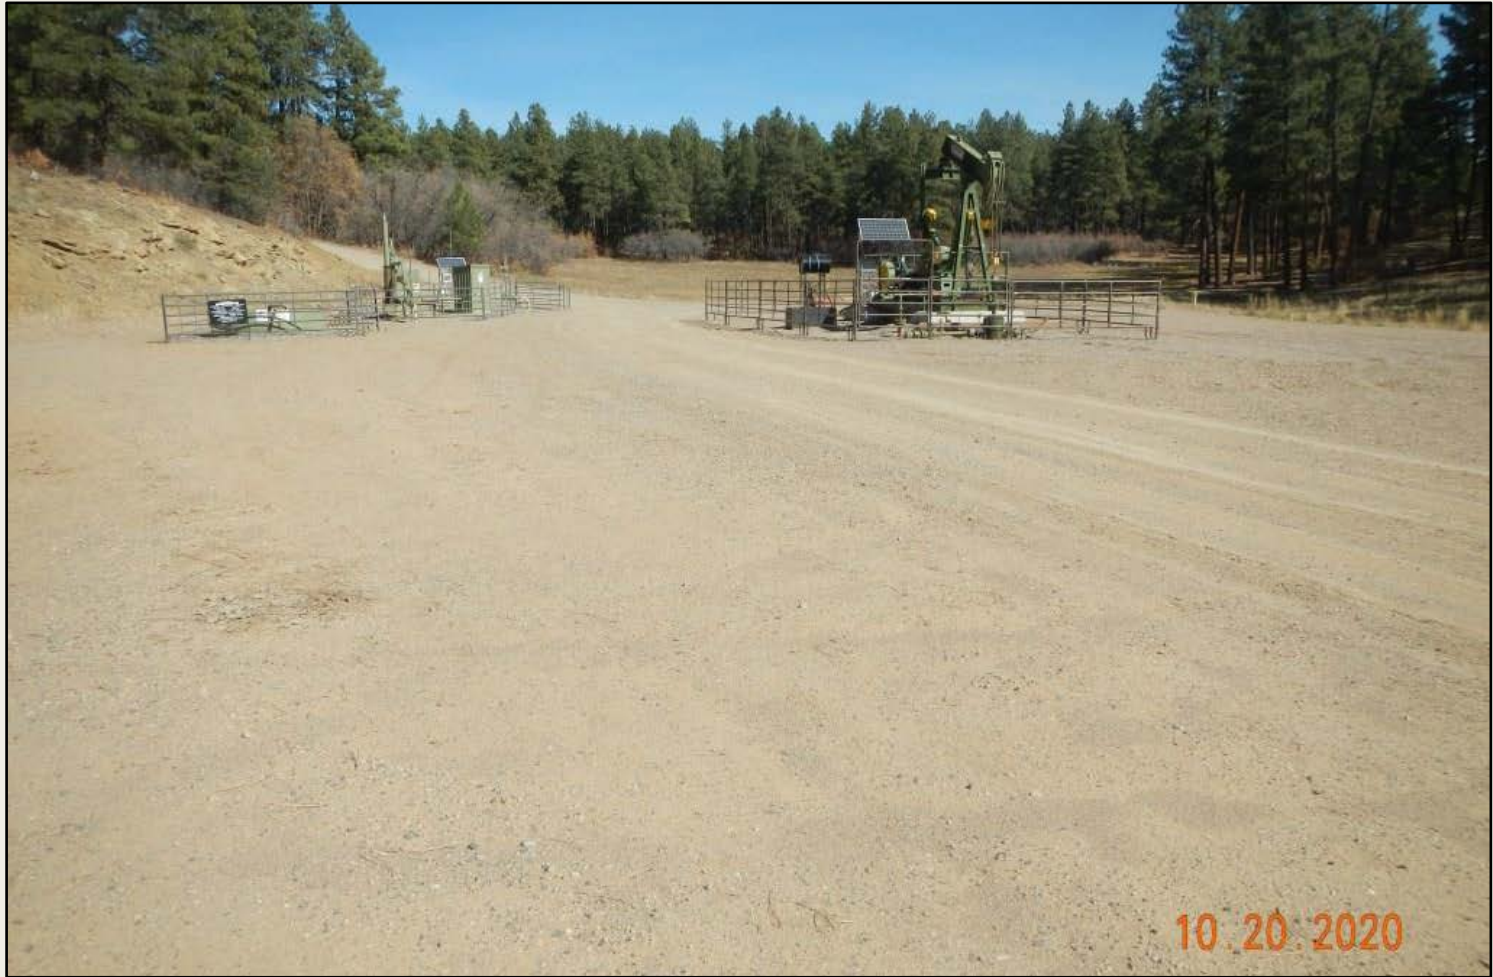
Photo 1. View of the eastern project area from the northeastern corner facing southward. Fill slope is graveled with scattered grasses such as western wheatgrass and smooth brome.

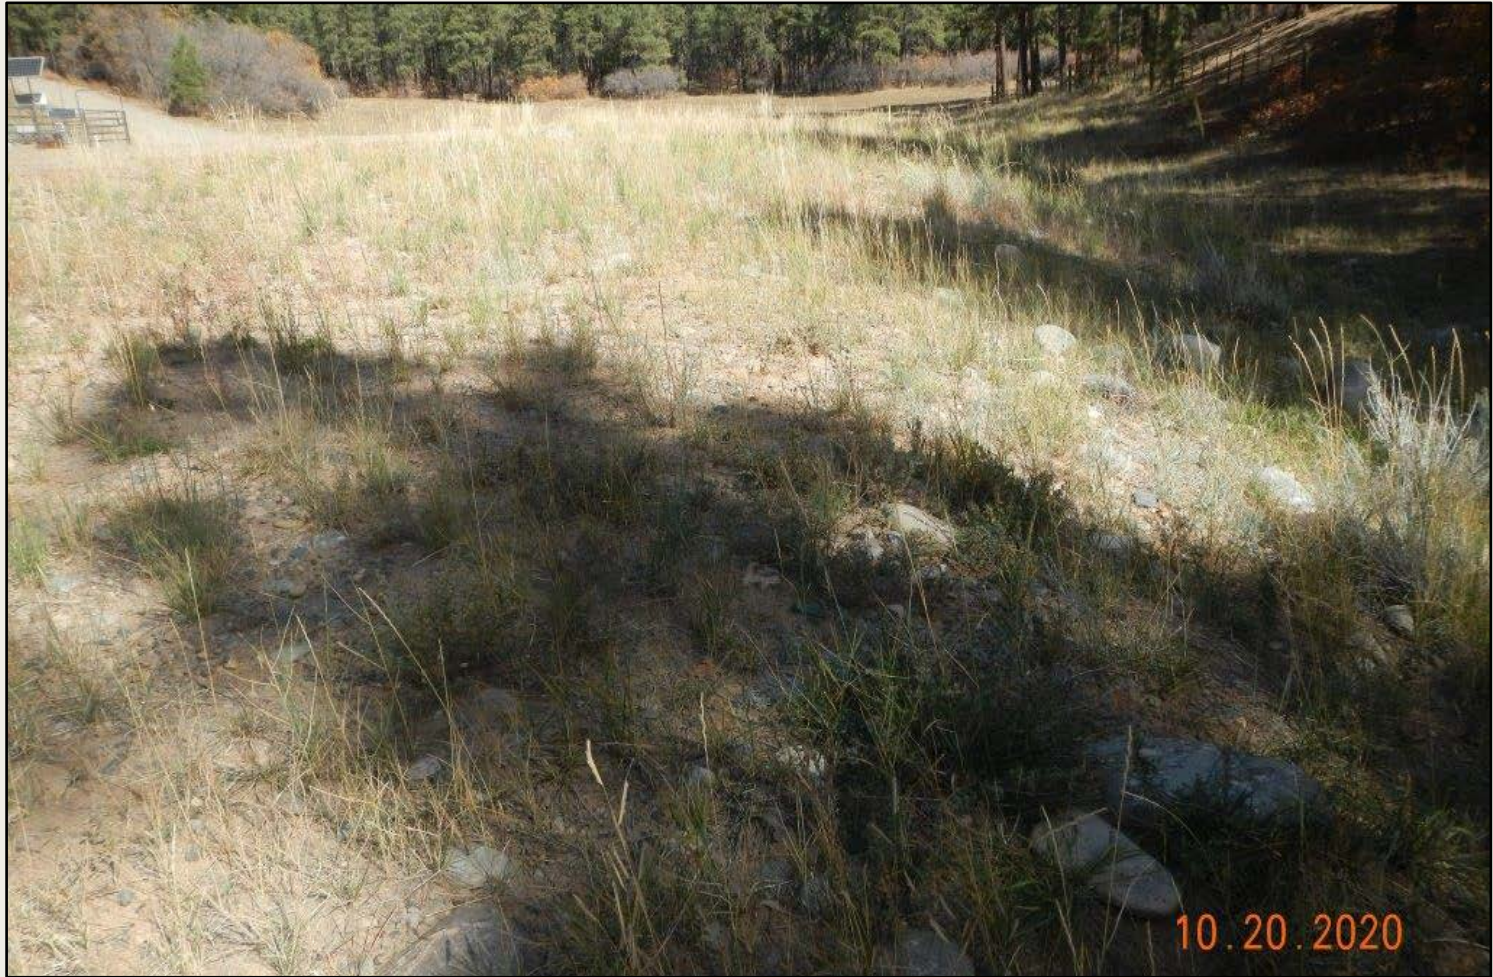
Photo 2. View of the northern fill slope from the northeastern corner facing westward.
