# Construction and Stormwater Inspection

Operator: NGL WATER SOLUTIONS DJ LLC- #10373

Location ID: 450612

Inspection Document #: 697502113

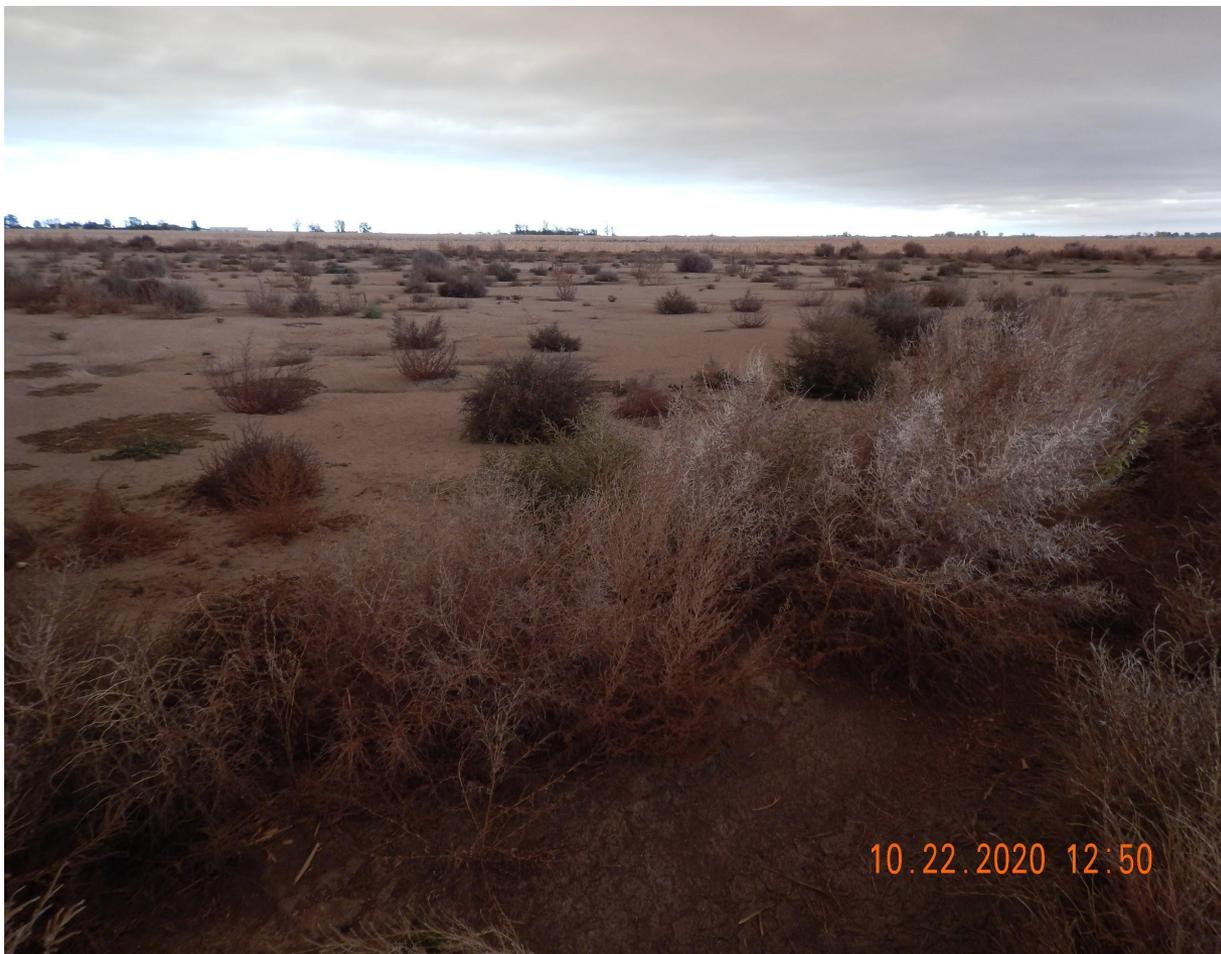
**Photo 1.** Photo taken from the southwestern location, facing Northeast. Photo illustrates unmanaged weeds (Kochia and Russian thistle) throughout the location.

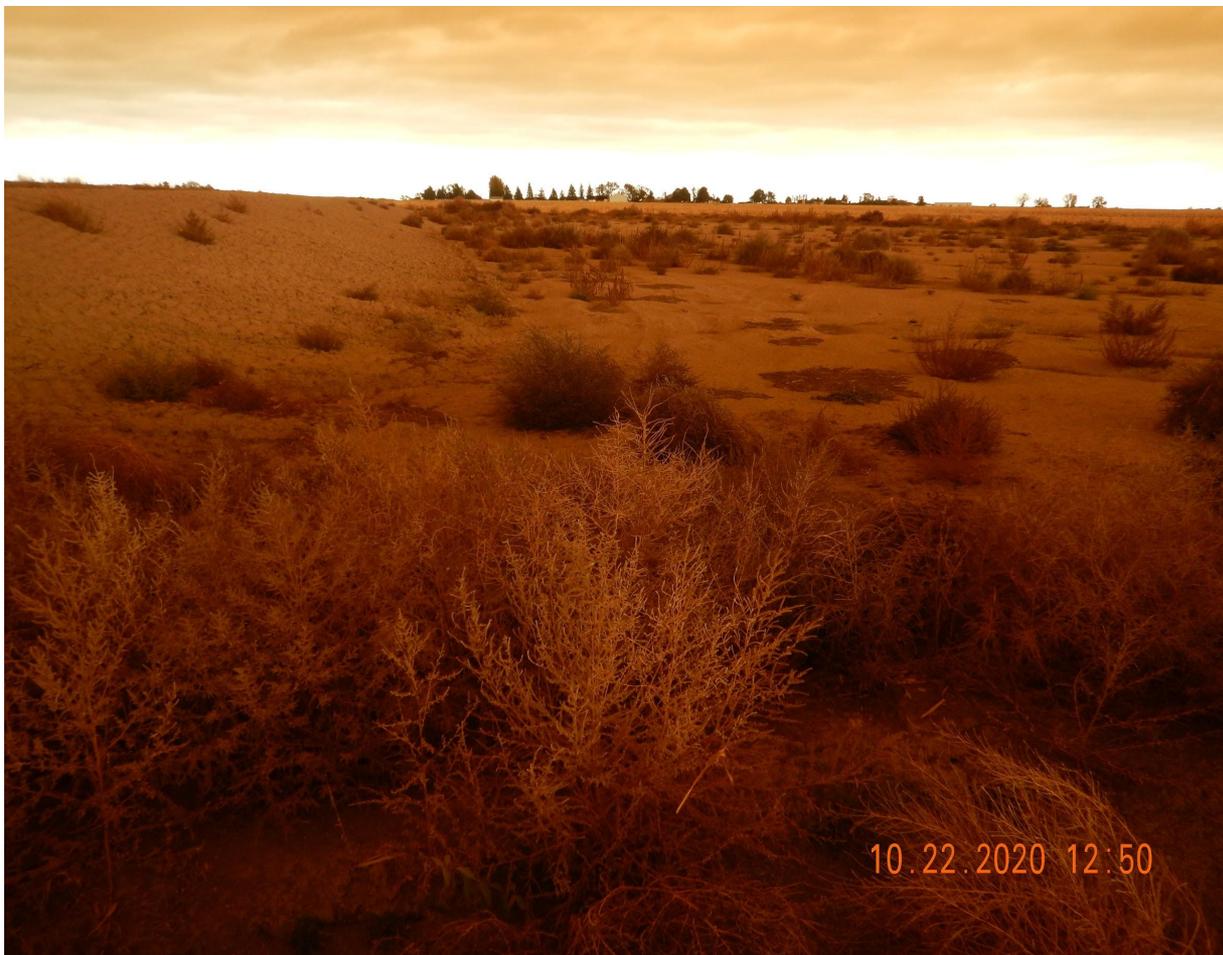
**Photo 2.** Photo taken from the southwestern location, facing North. See comments under Photo 1.

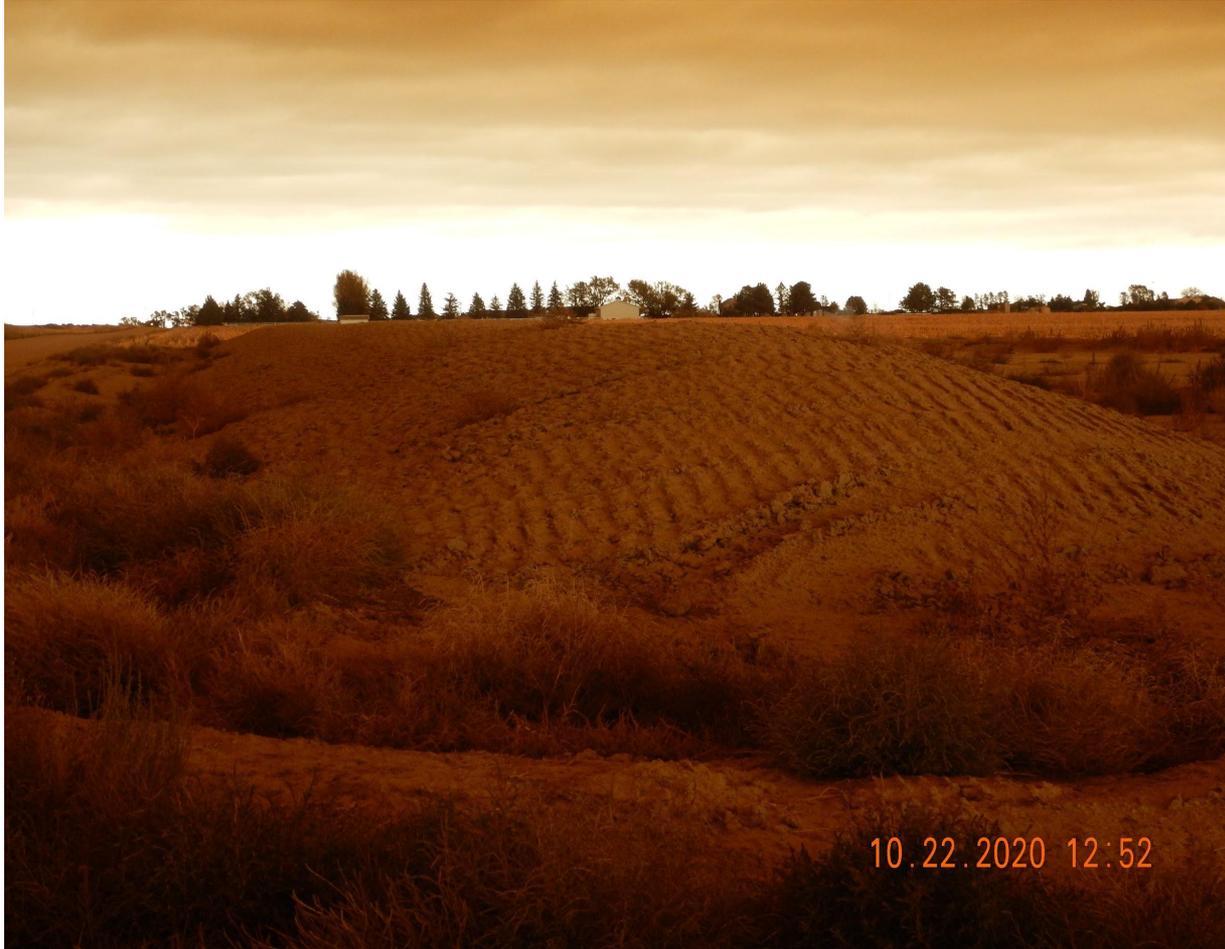
**Photo 3.** Photo taken from the southwestern location, facing North. Photo illustrates the topsoil stockpile has only been temporarily stabilized.
