Final Reclamation Inspection

October 28, 2020

Operator: HRM RESOURCES II LLC - 10548

Location ID: 313929

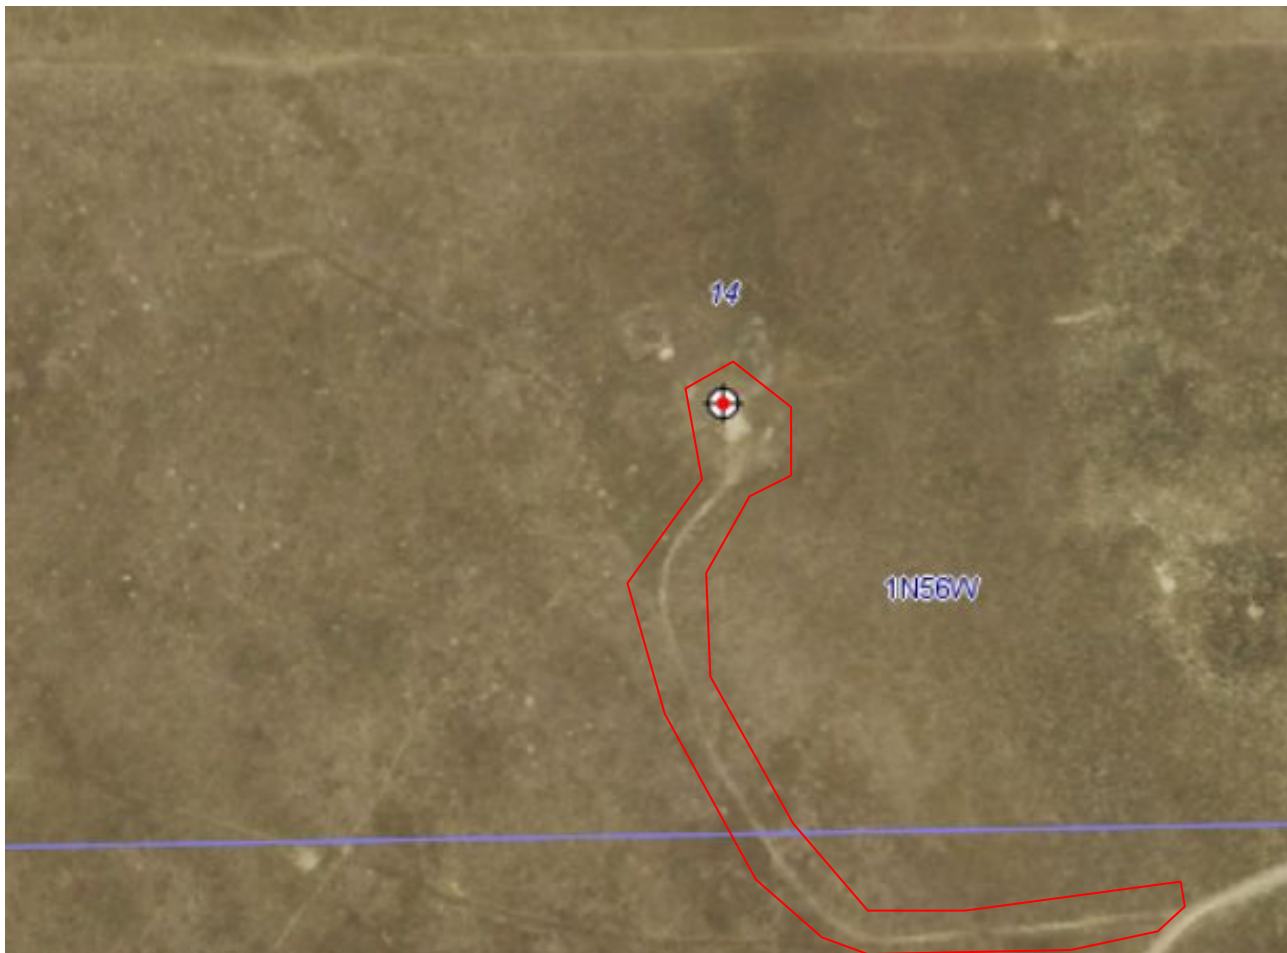
Photo 1. COGCC GISOnline 2019 aerial imagery illustrates the operator has failed to reclaim ~0.30 miles of road.

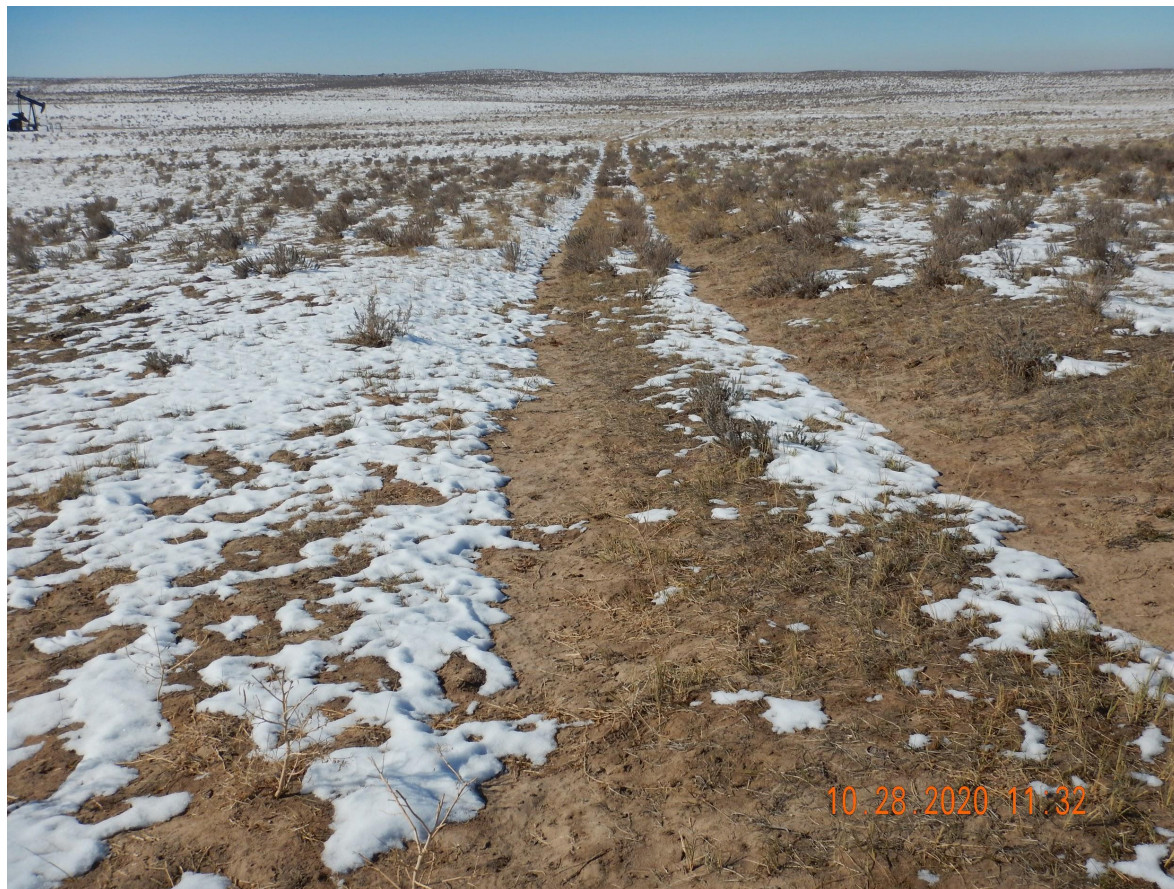
Photo 2. Photo taken from the southern access road, facing West. Photo illustrates the Operator has failed to reclaim the access road.

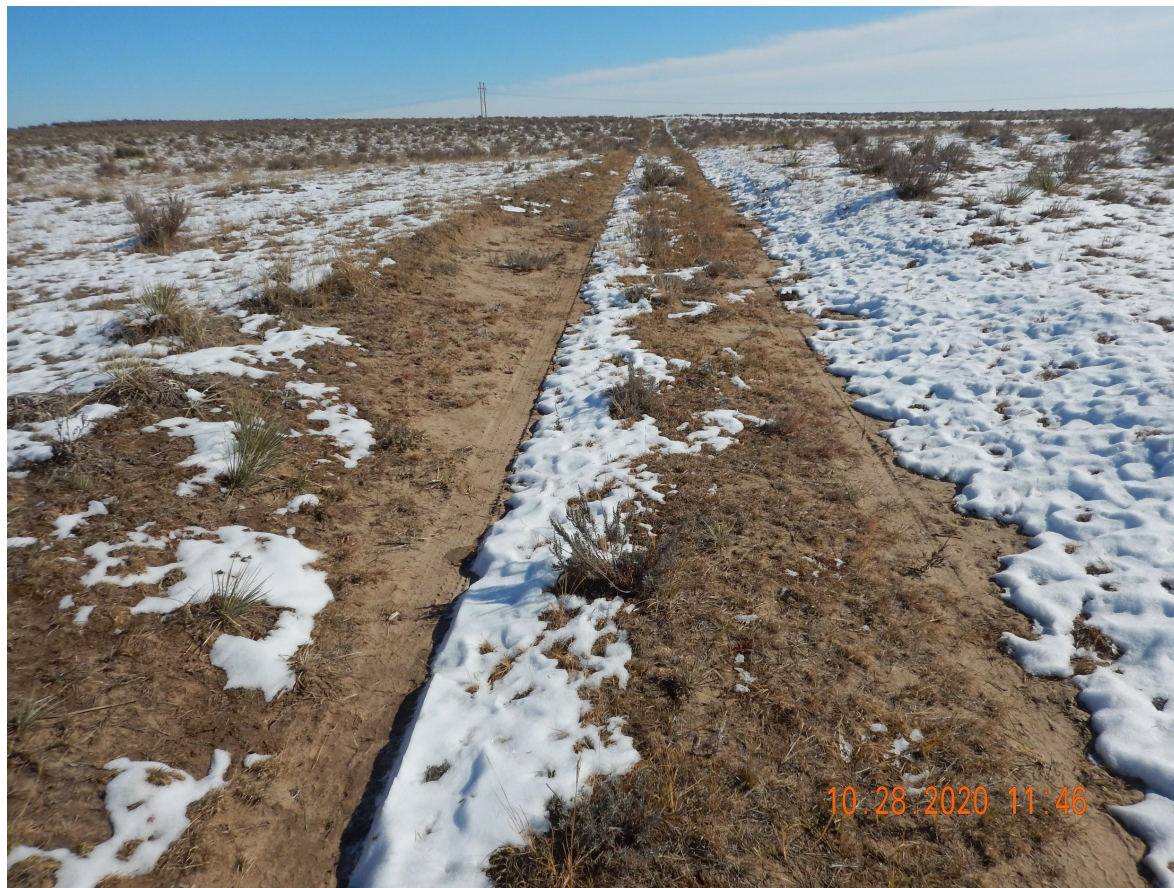
Photo 3. Photo taken from the western access road, facing East. Photo illustrates the Operator has failed to reclaim the access road.

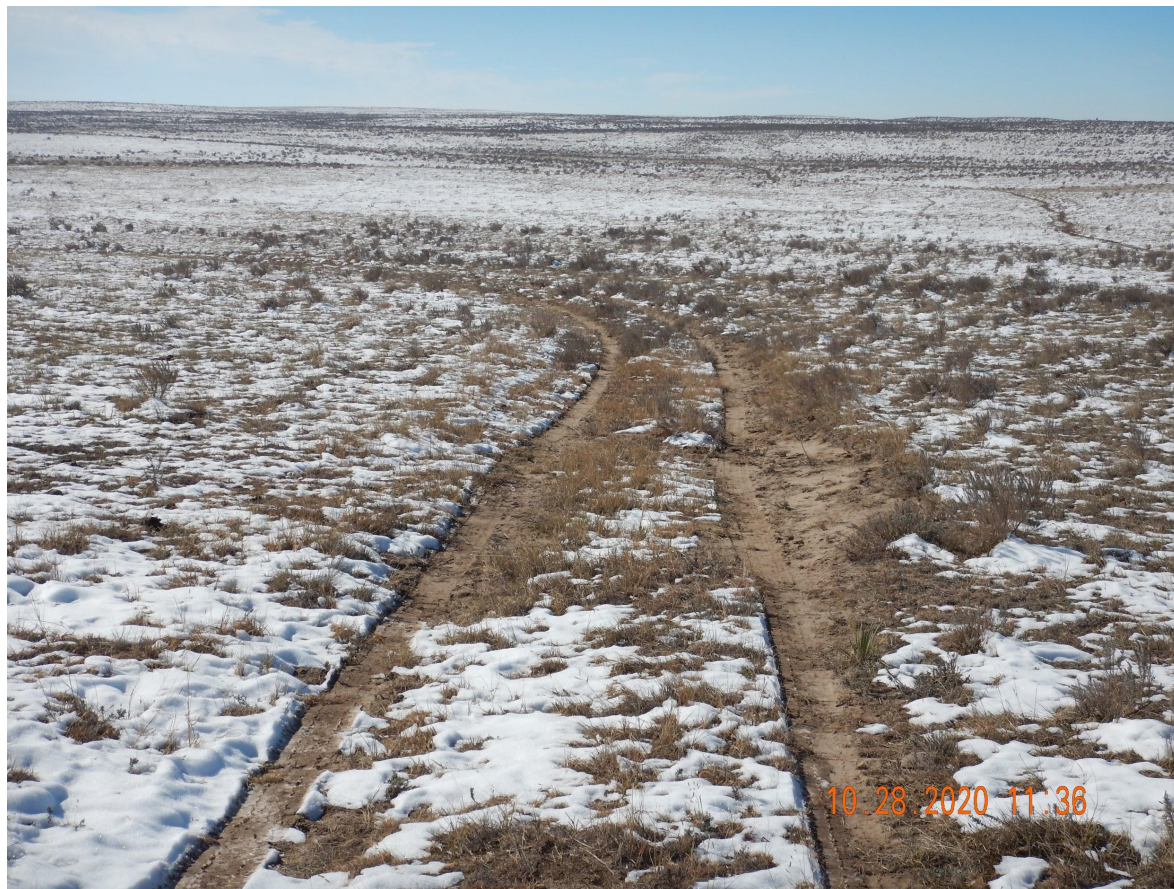
Photo 4. Photo taken from the northern access road, facing West. Photo illustrates the Operator has failed to reclaim the access road.

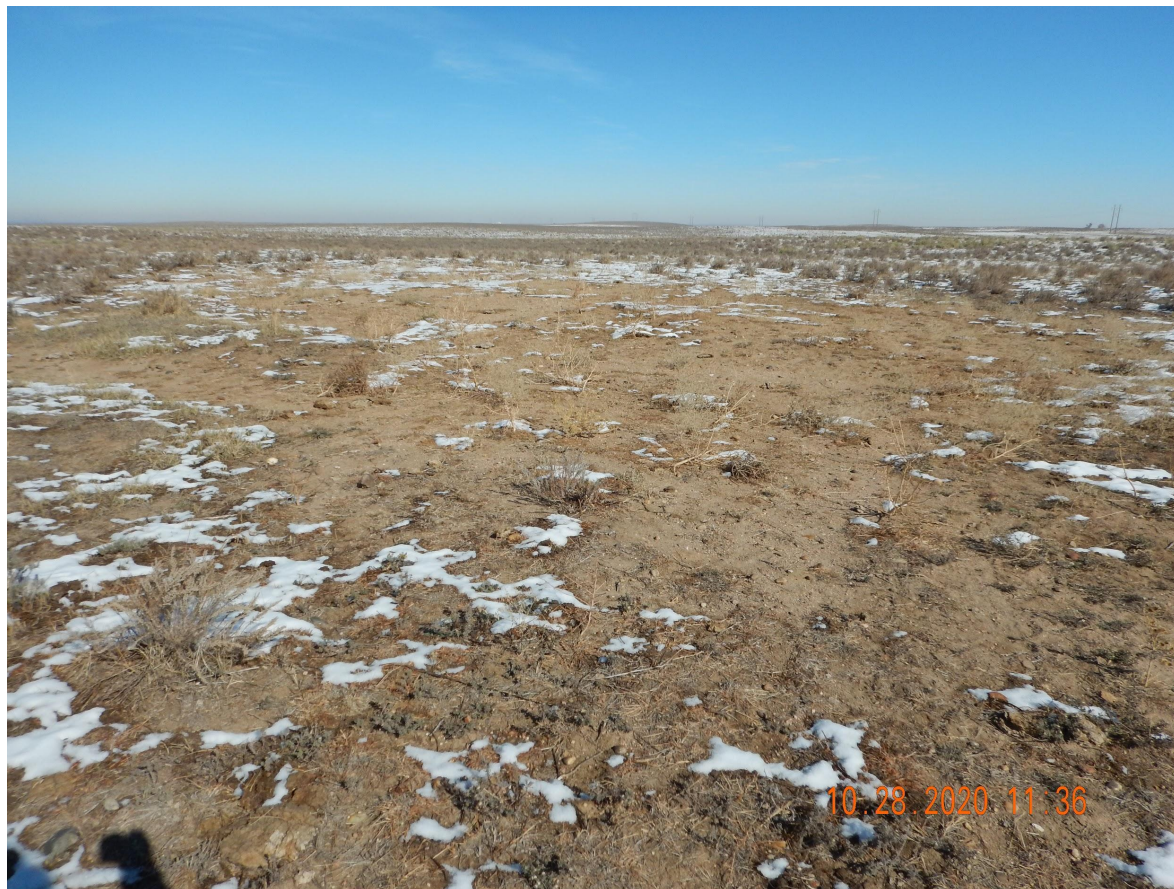
Photo 5. Photo taken from the well location, facing North. Photo illustrates an ~45'x~65 area where the pump jack was located has not been reclaimed. The well location is bare of vegetation.

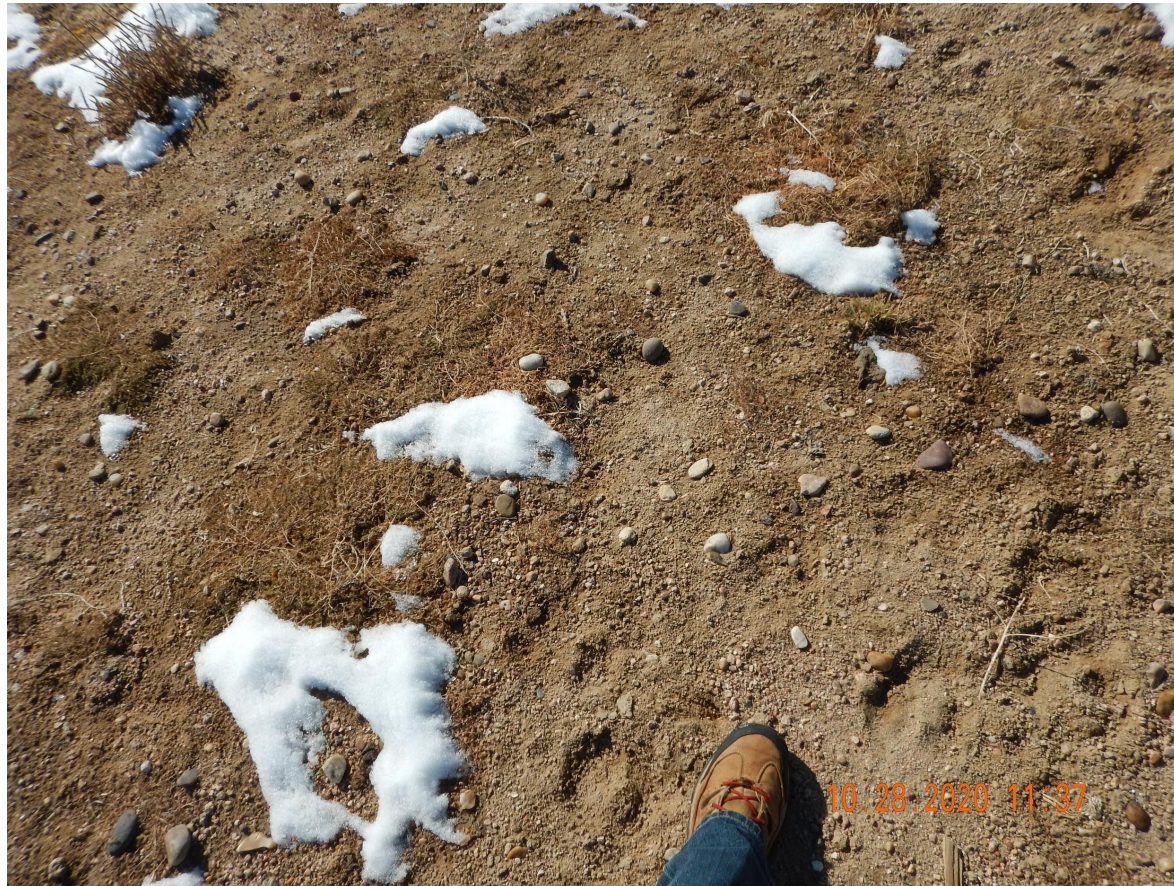
Photo 6. Close up photo of the well location, illustrating the bare ground.

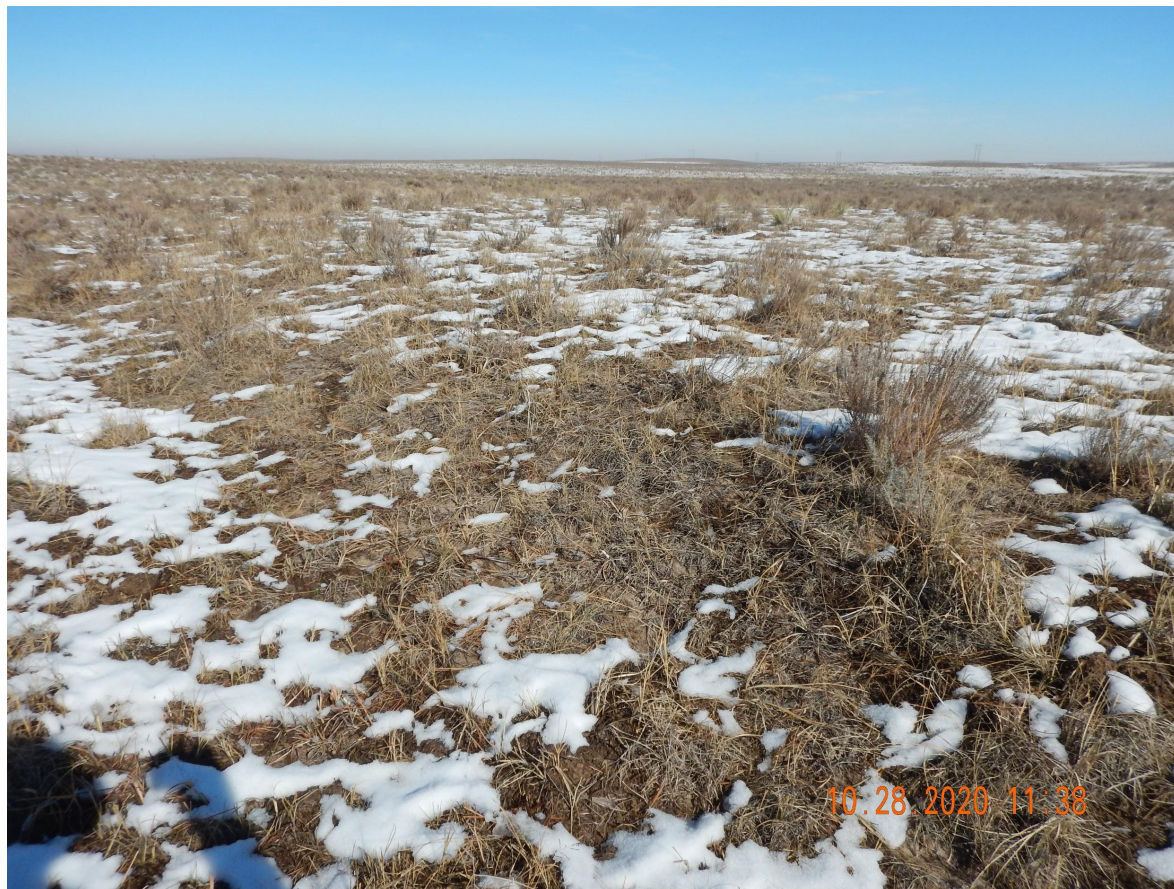
Photo 7. Reference photo taken north of the well location, facing North. Photo illustrates blue grama, purple three-awn, and sand sage.

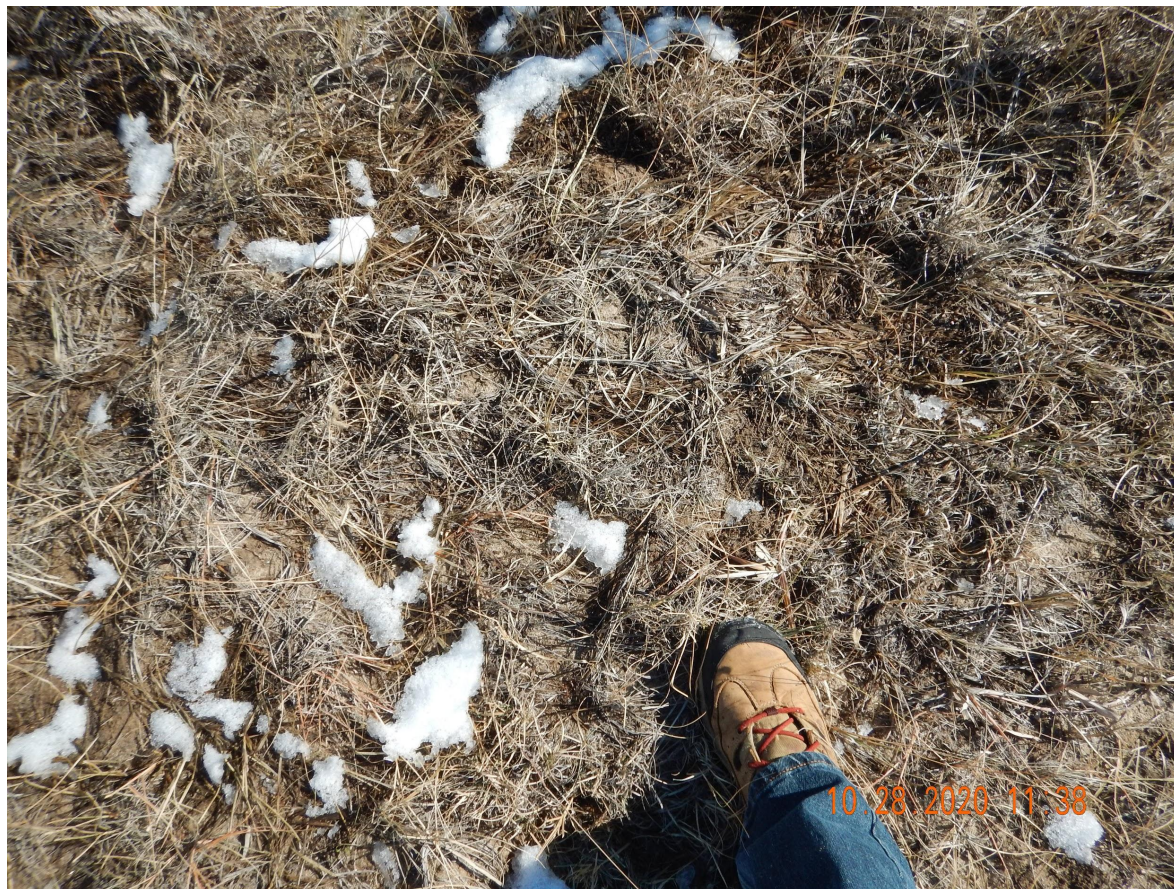
Photo 8. Close up reference photo taken north of the well location.
