Final Reclamation Inspection

Operator: MARKUS PRODUCTION, INC - 53790

API #: 05-123-15049

Inspection Photos
Location Name: BABB #15-14
API #: 05-123-15049

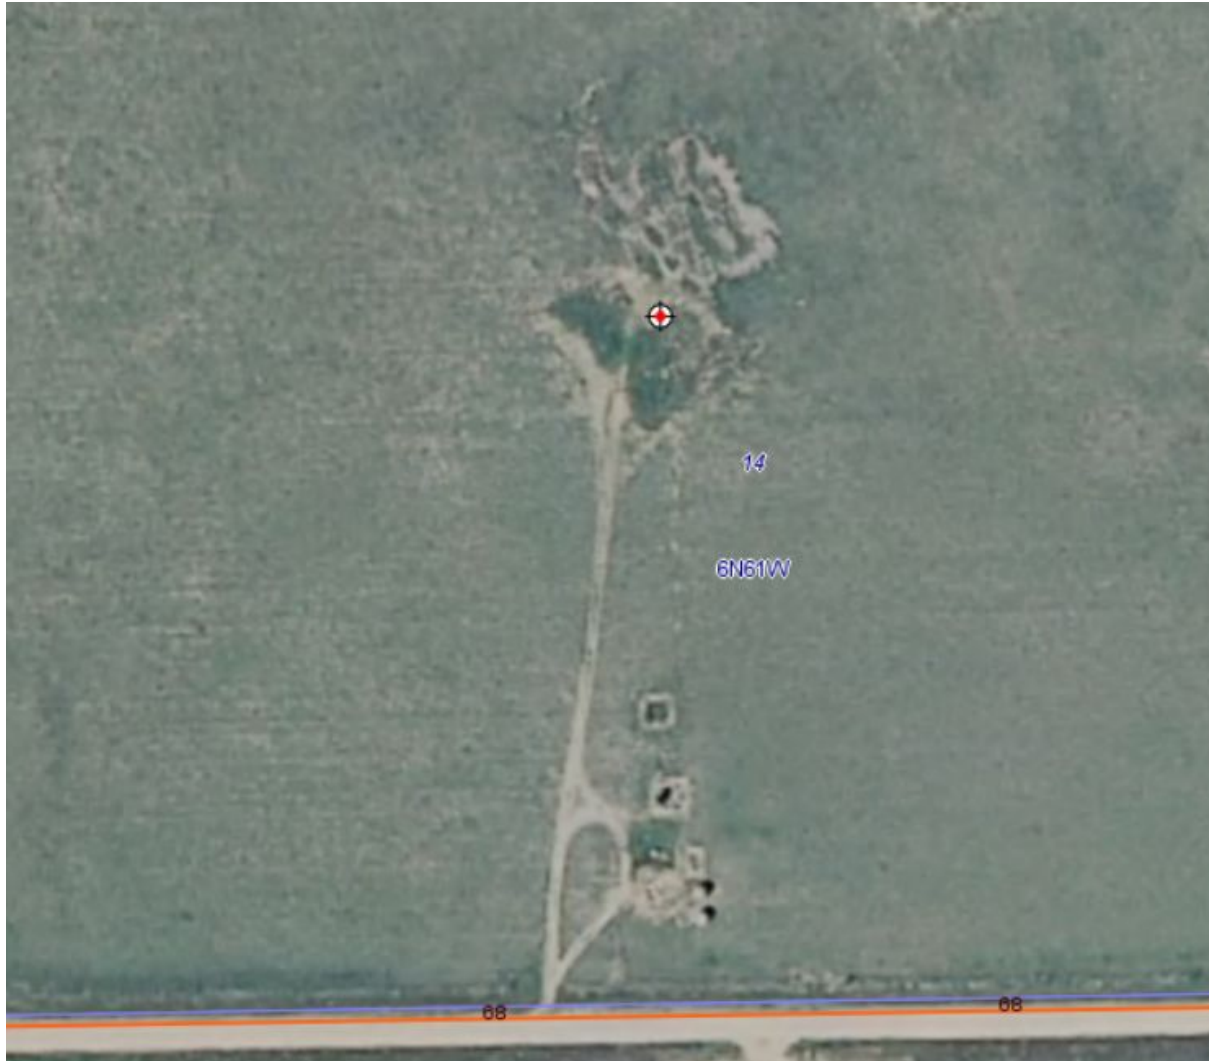
Photo 1. COGCC GISOnline aerial imagery from 2009 during active operations illustrates some of the surface disturbance.

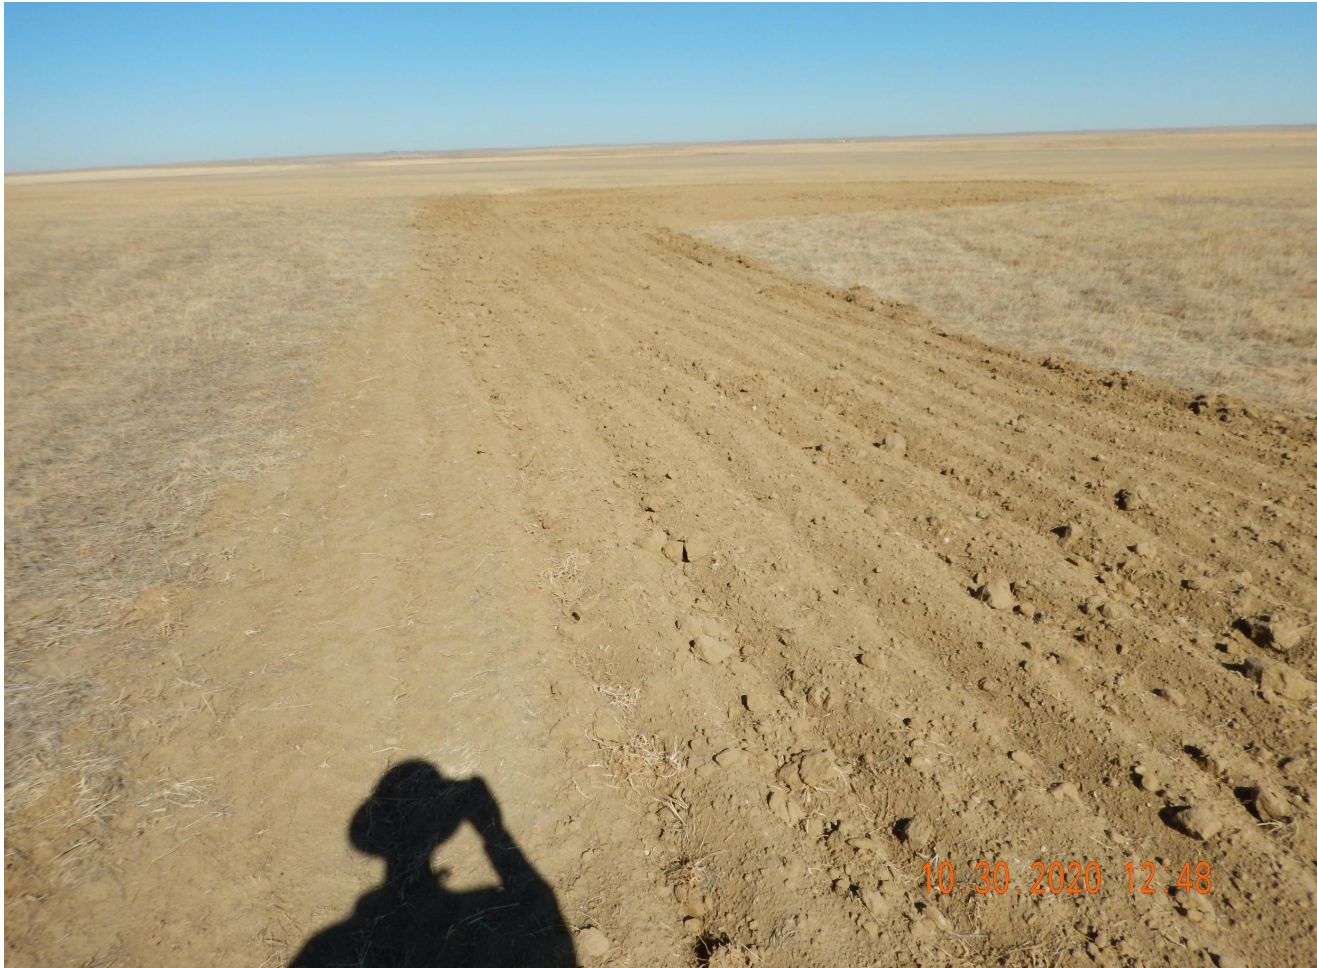
Photo 2. Photo taken from the entrance point off CR68, facing North. Photo illustrates recontouring has been performed but does not appear to be seeded.

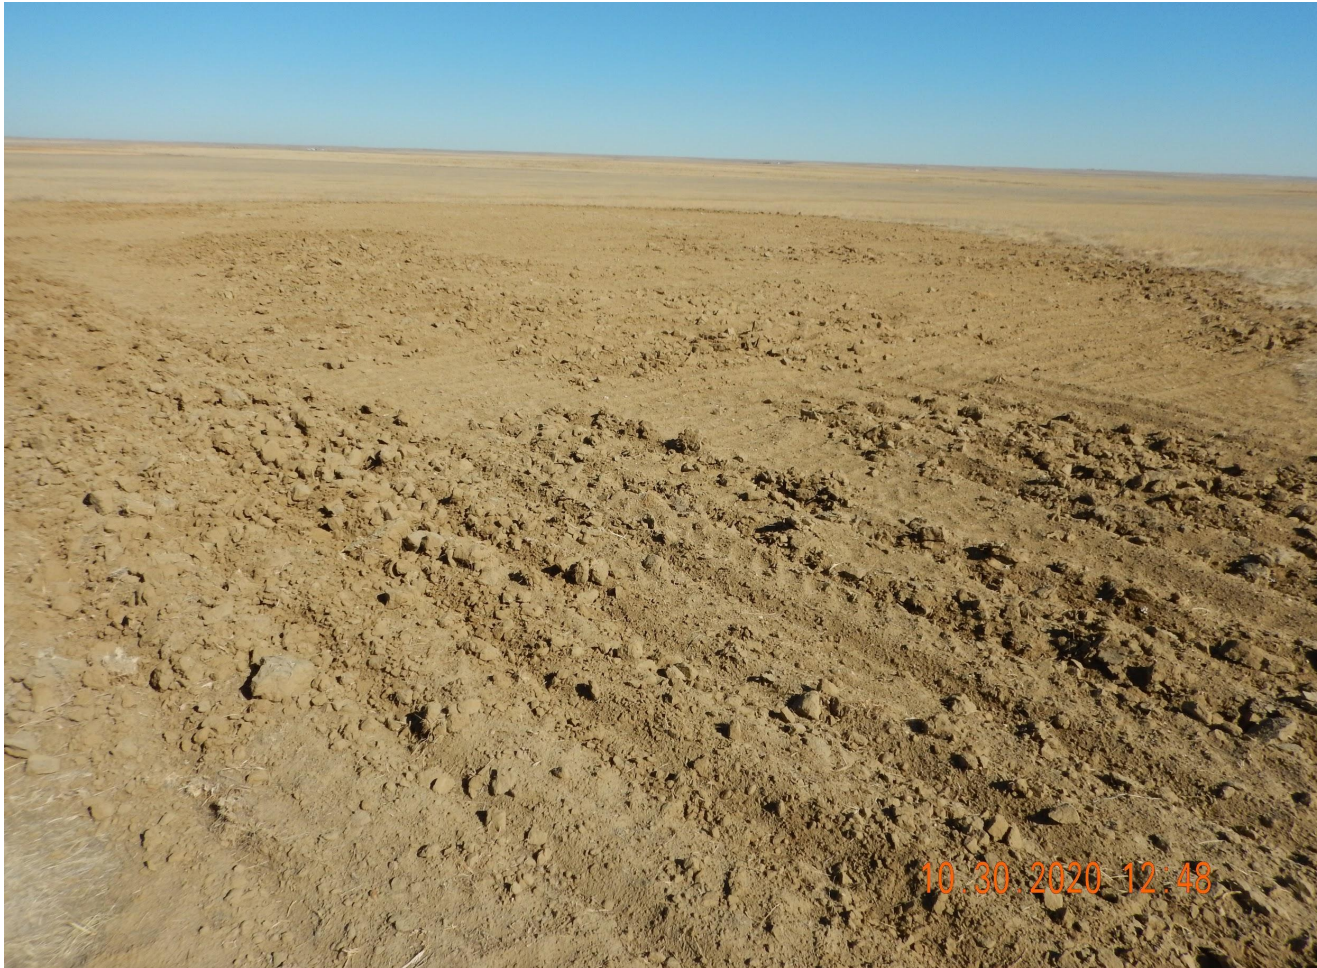
Photo 3. Photo taken from the southwestern pit area, facing Northeast. Photo illustrates recontouring has been performed but does not appear to be seeded.

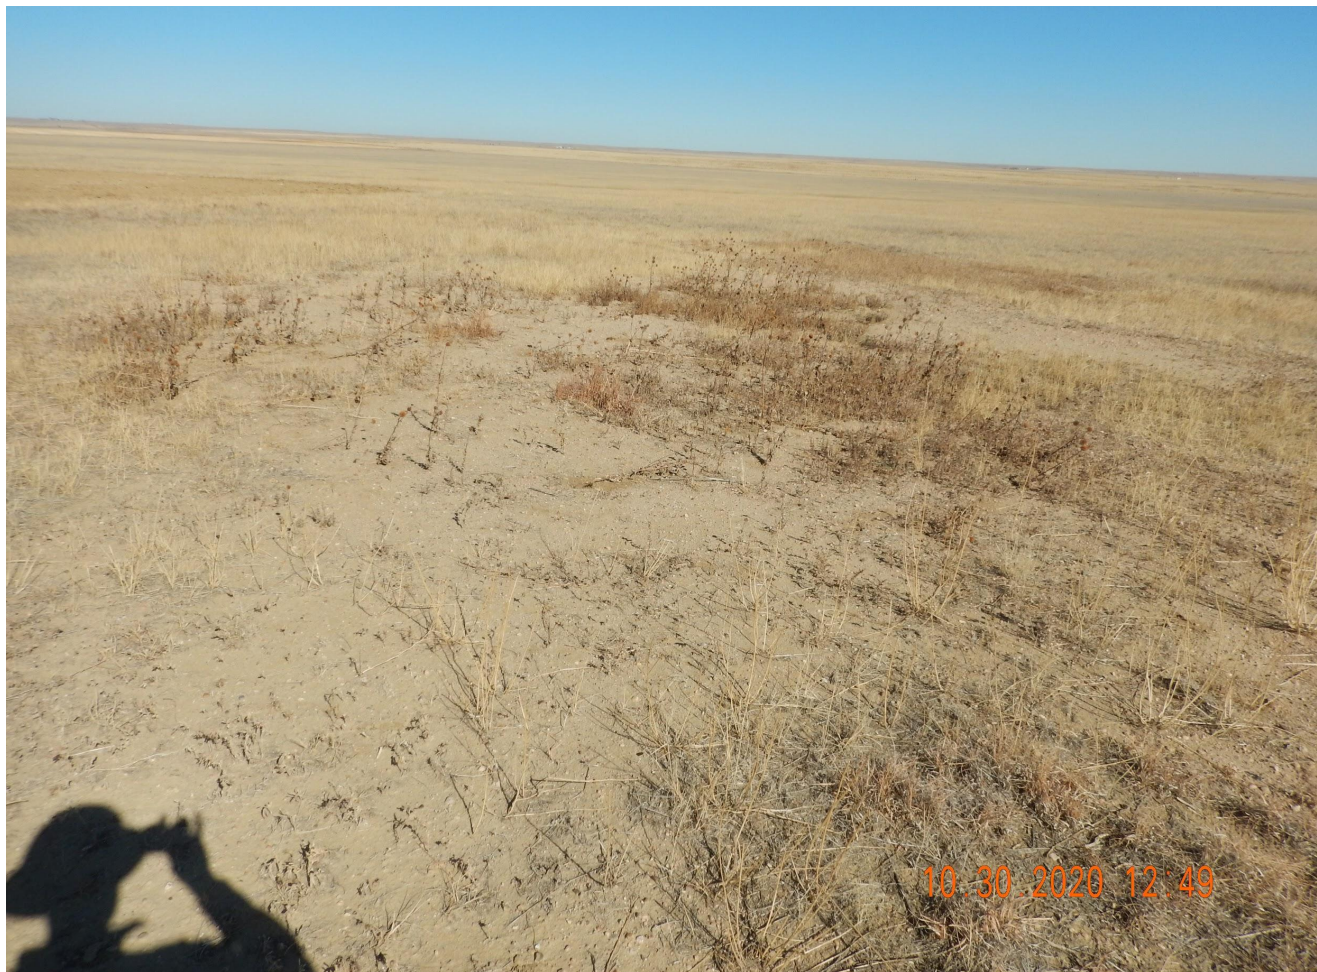
Photo 4. Photo taken south of the pit area, facing Northeast. Photo illustrates an area associated with the tank battery that is mostly bare soil or only growing annual vegetation.

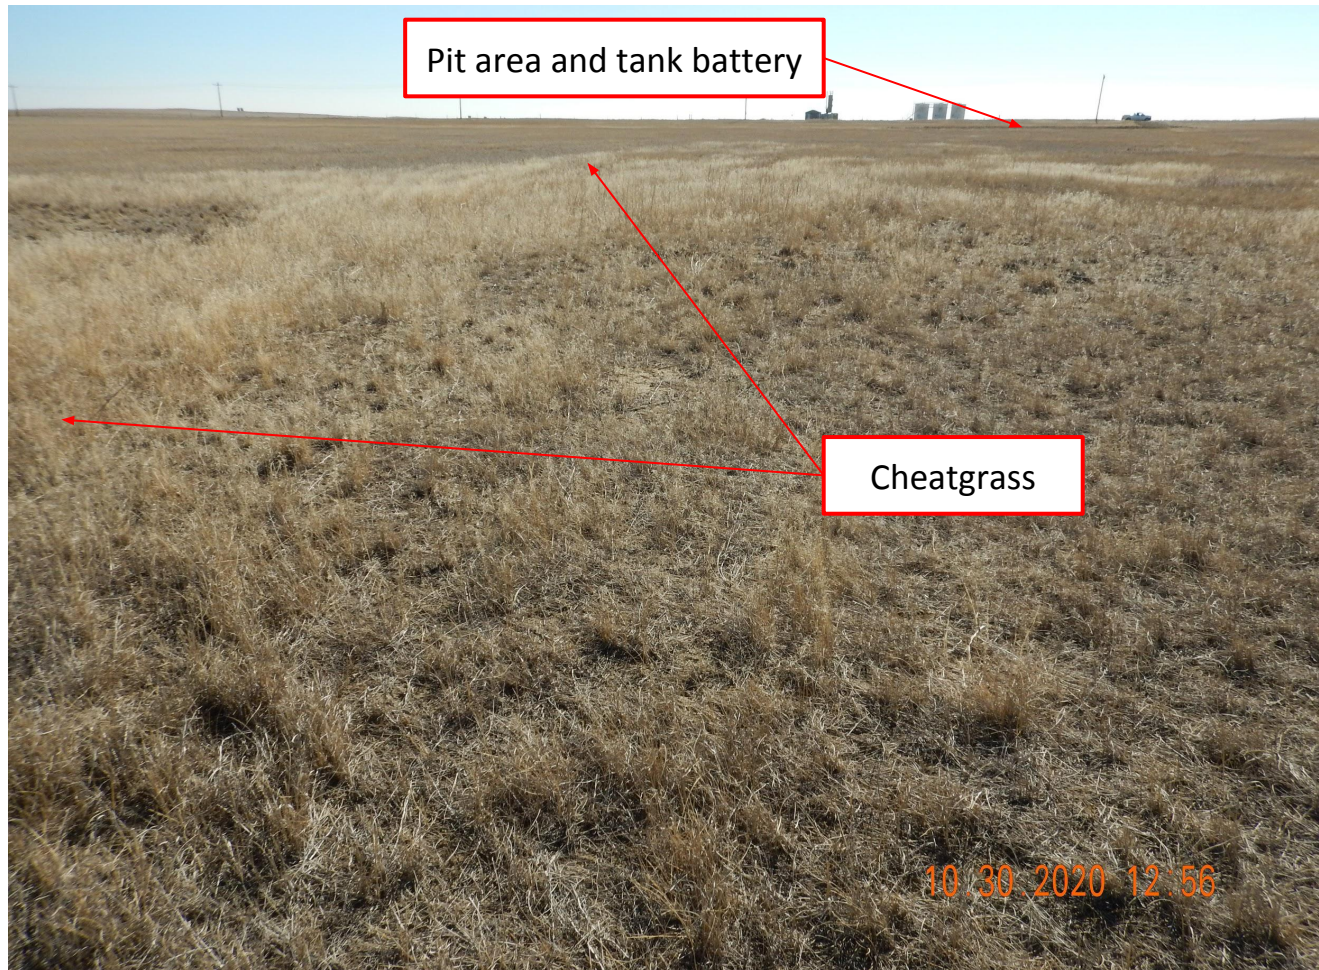
Photo 5. Photo taken from the well location, facing South. Photo illustrates a List C Colorado noxious weed, cheatgrass, which has established throughout portions of the well location. Cheatgrass was not observed in nearby reference areas. Cheatgrass is the uniform, yellowish vegetation illustrated in the photo.

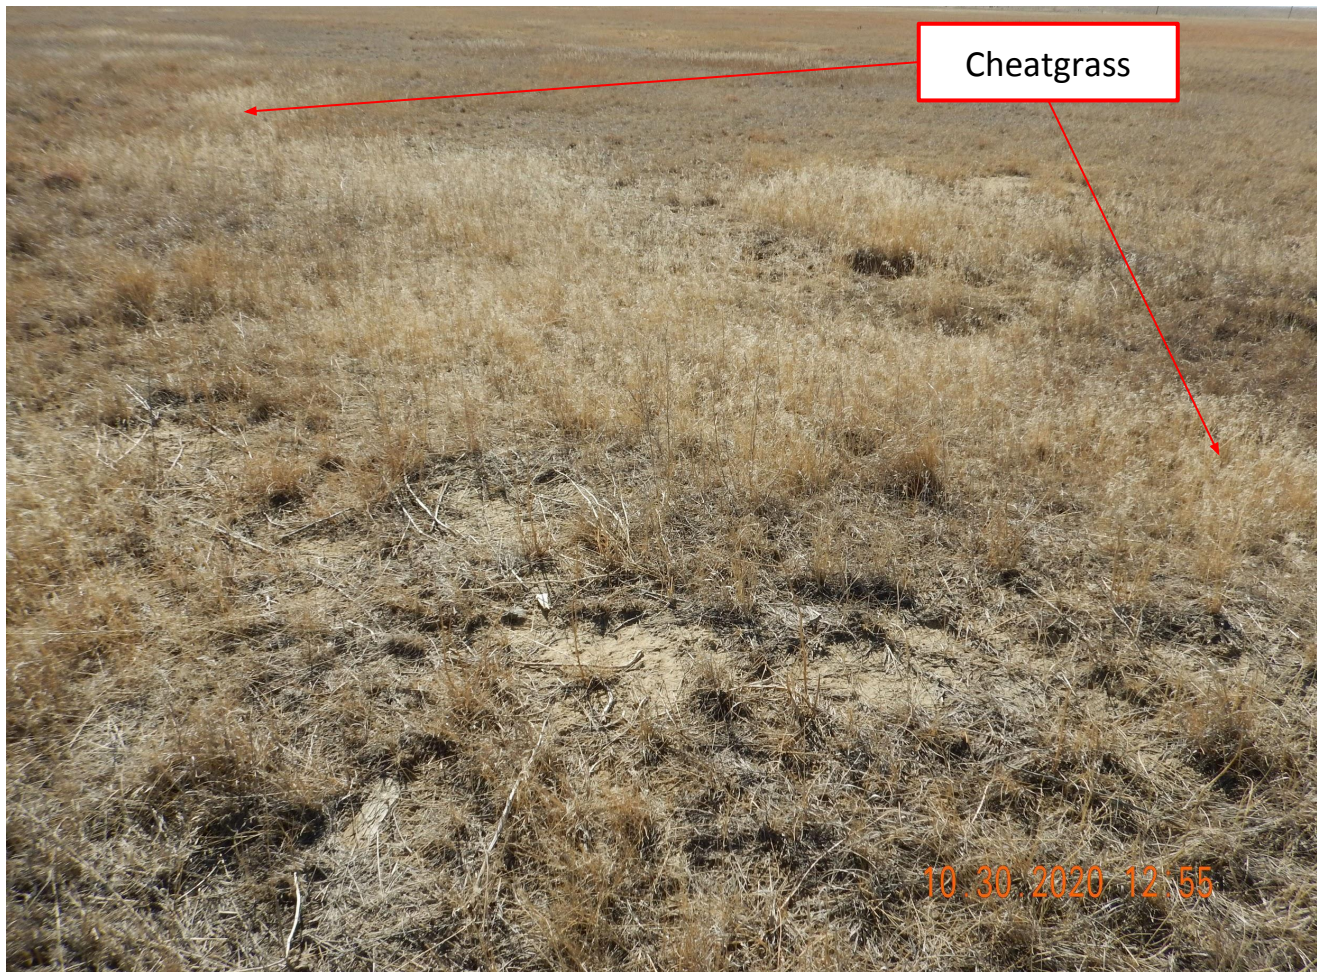
Photo 6. Photo taken from the well location, facing East. See comments under Photo 5.

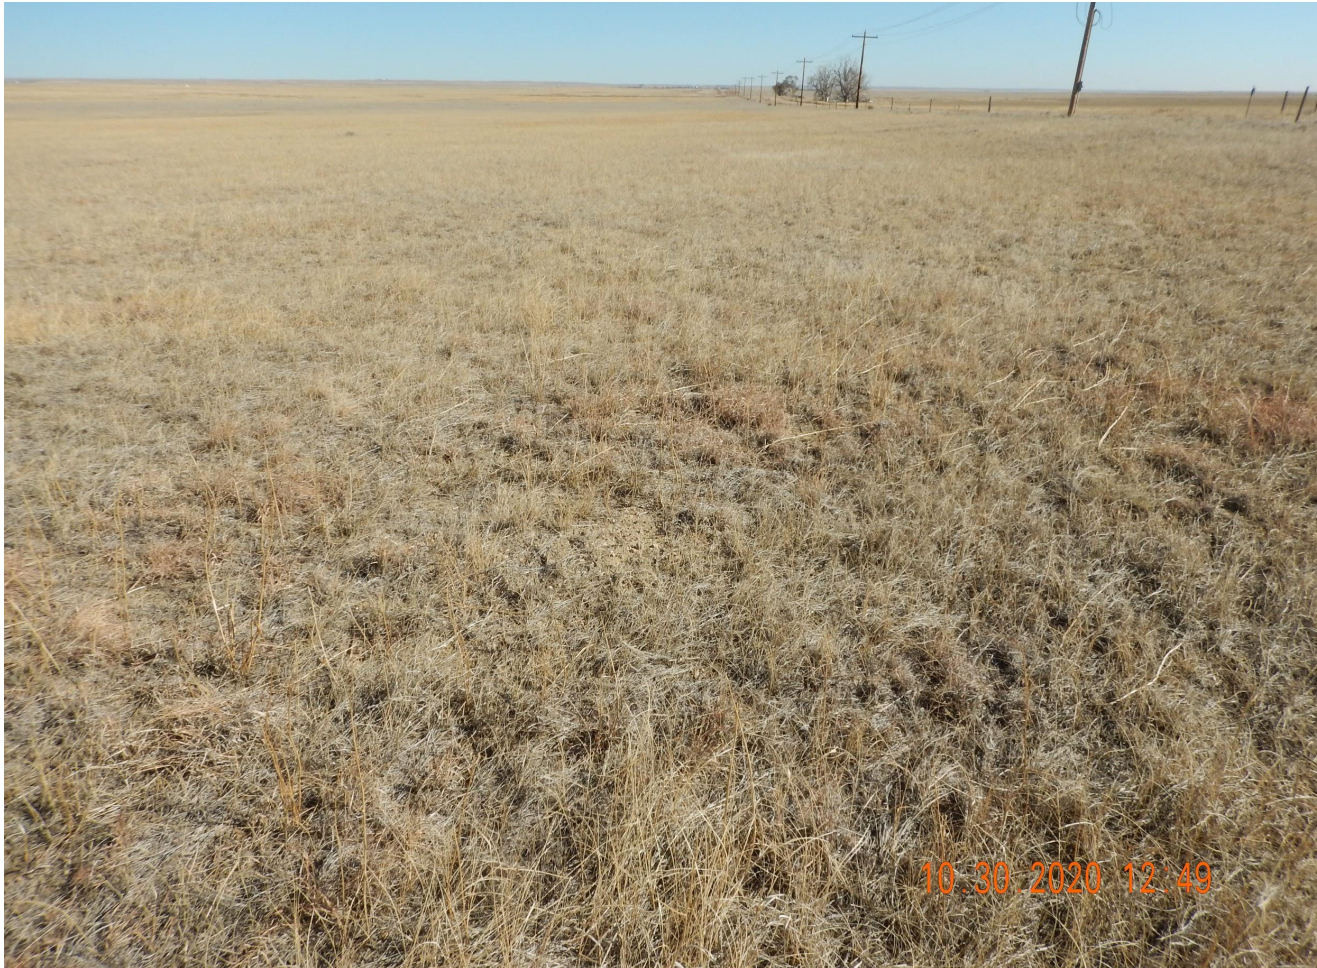
Photo 7. Reference photo taken east of the pit area, facing East.
