Final Reclamation Inspection

Operator: HRM RESOURCES II LLC - 10548

Location ID: 313899

Inspection Photos
Location Name: GIVAN #1
Location ID: 313899

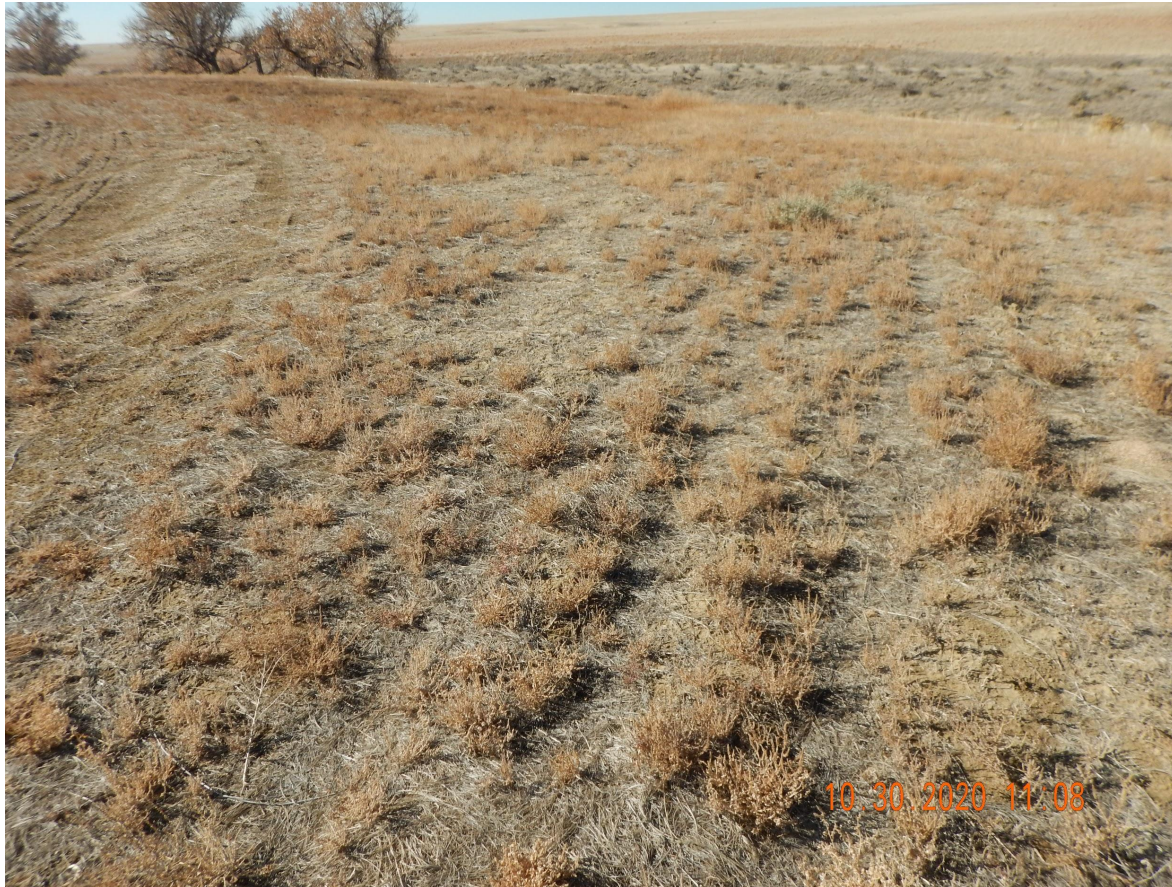
Photo 1. Photo taken from the associated offsite tank battery, facing West. Photo illustrates the tank battery does not meet Rule 1004 vegetative standards. Location is mostly comprised of weedy, annual vegetation (Russian thistle and Kochia).

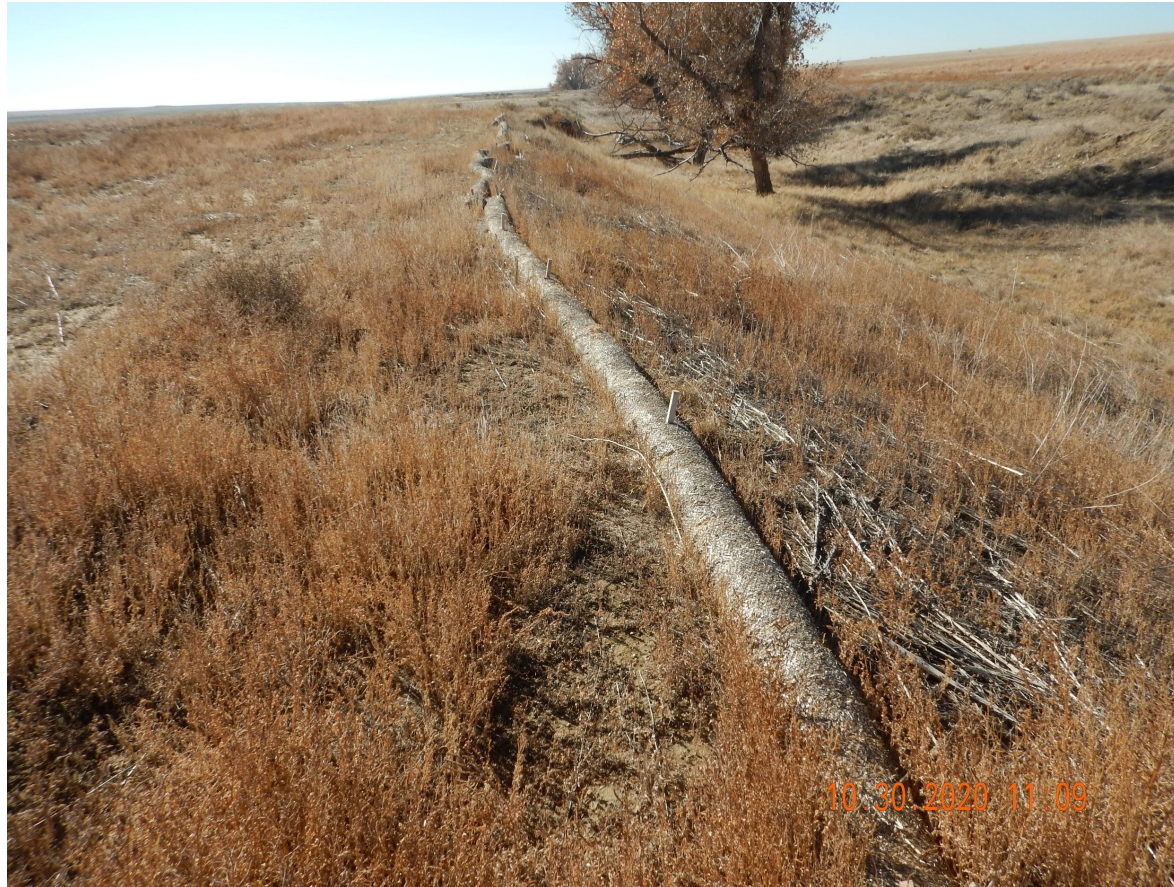
Photo 2. Photo taken from the associated offsite tank battery, facing South. Photo illustrates straw wattle BMPs installed in response to a previous corrective action inspection. Vegetation shown is Kochia and Russian thistle.

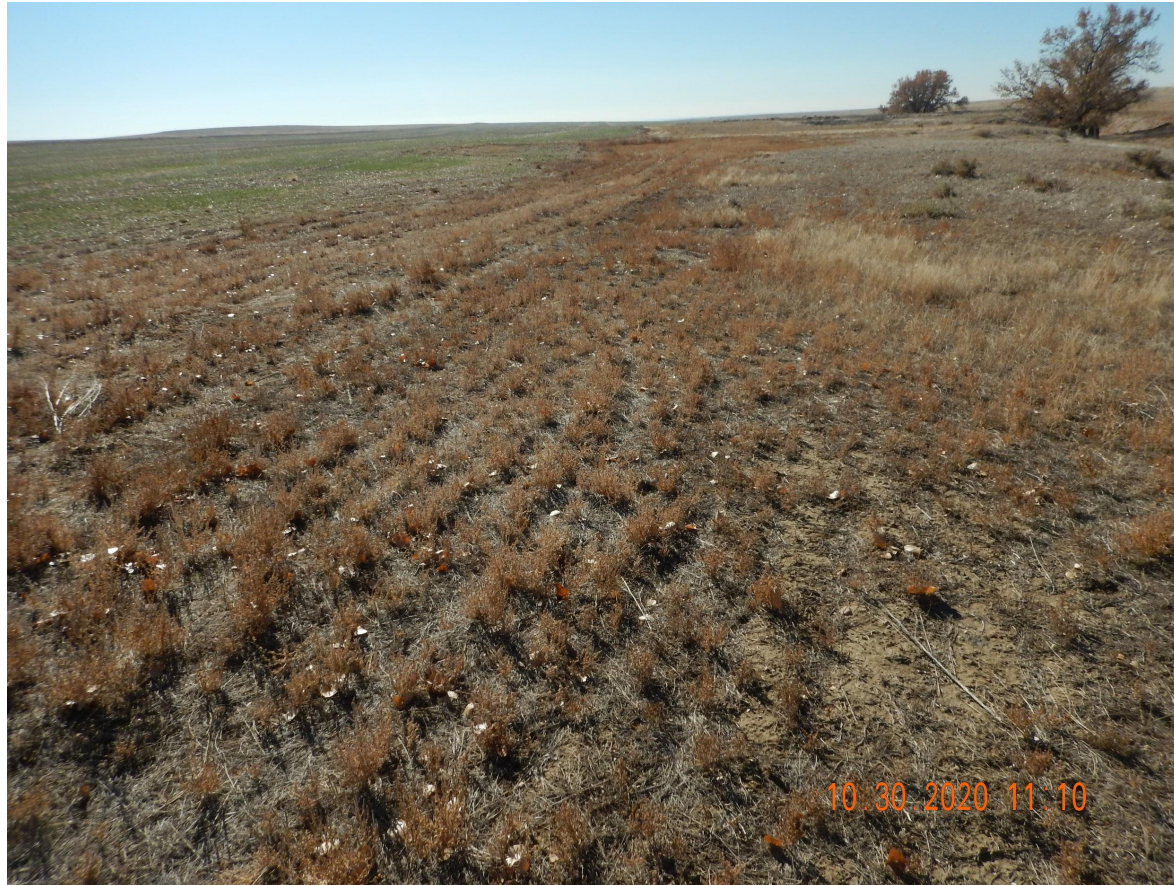
Photo 3. Photo taken from a portion of the well location access road, facing South. Photo illustrates the access road is mostly comprised of weedy, annual vegetation (Russian thistle and Kochia).

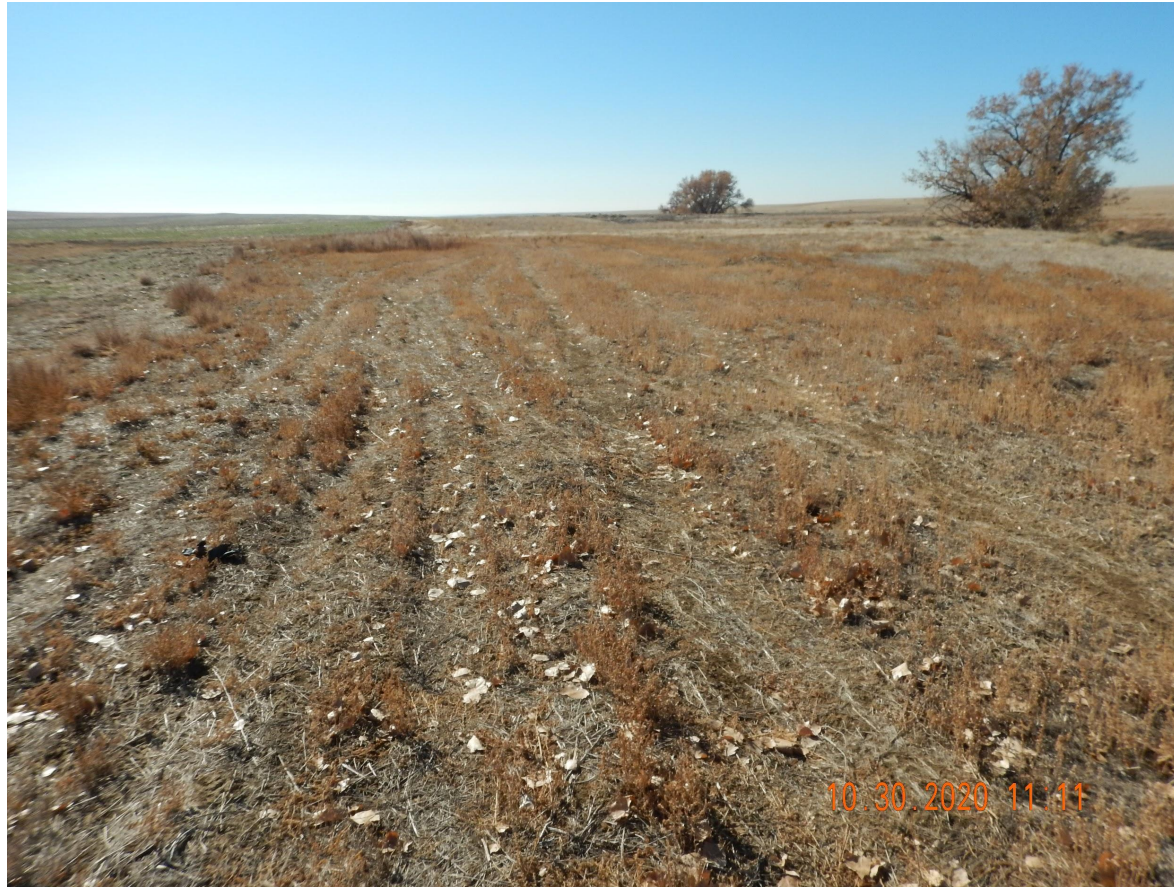
Photo 4. Photo taken from the well location, facing South. Photo illustrates the well location is mostly comprised of weedy, annual vegetation (Russian thistle and Kochia).

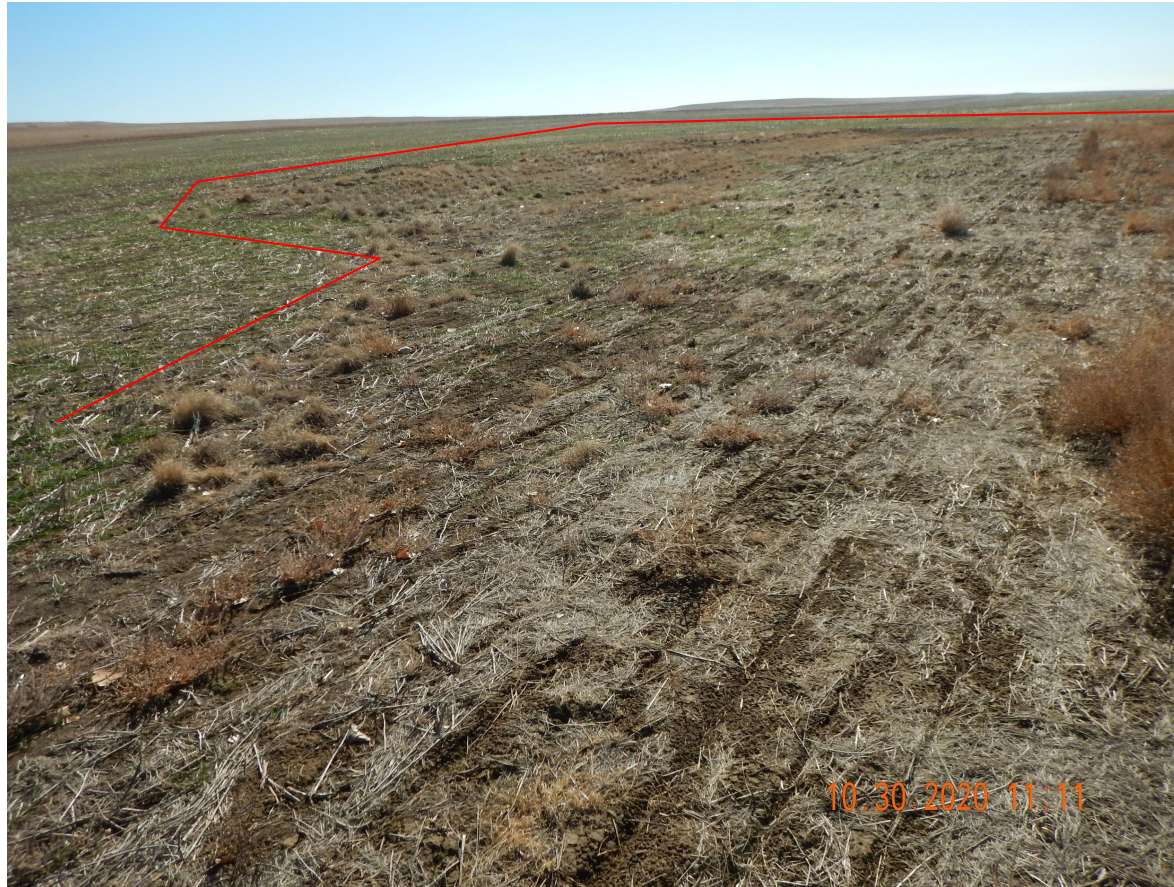
Photo 5. Photo taken from the well location, facing Southeast. Photo illustrates the eastern well location has not been properly recontoured to match the surrounding landscape. The eastern portion of the well location is within a crop field.
