Final Reclamation Inspection

Operator: CRESTONE PEAK RESOURCES OPERATING LLC - 10633

Location ID: 410164

Inspection Photos
Location Name: FREDRIKSEN-63N68W /28SENE
Location ID: 410164

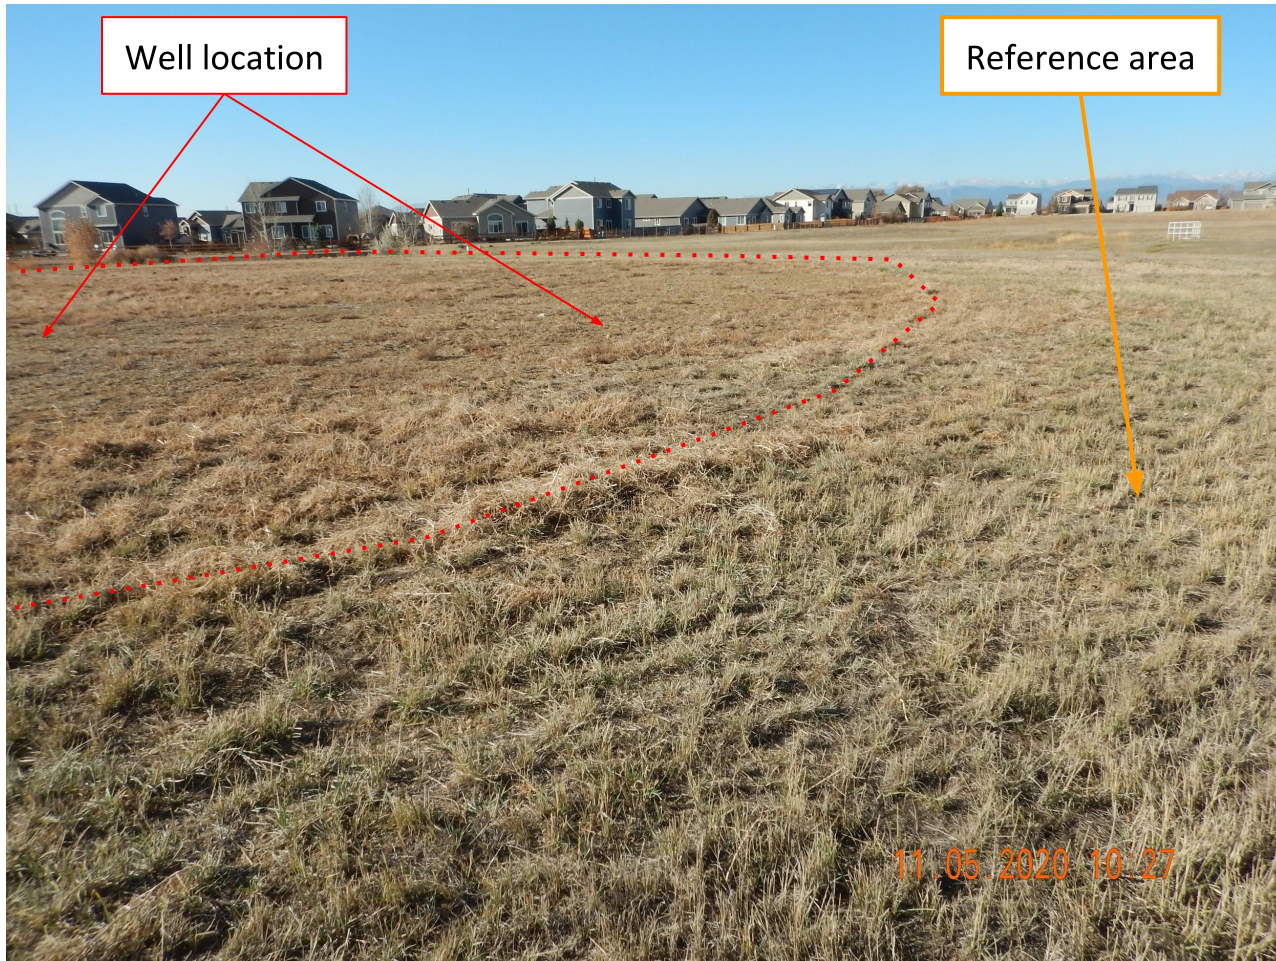
Photo 1. Photo taken from the northern plugged and abandoned well location, facing West. Photo illustrates the location is in-process of meeting Rule 1004 vegetative standards.

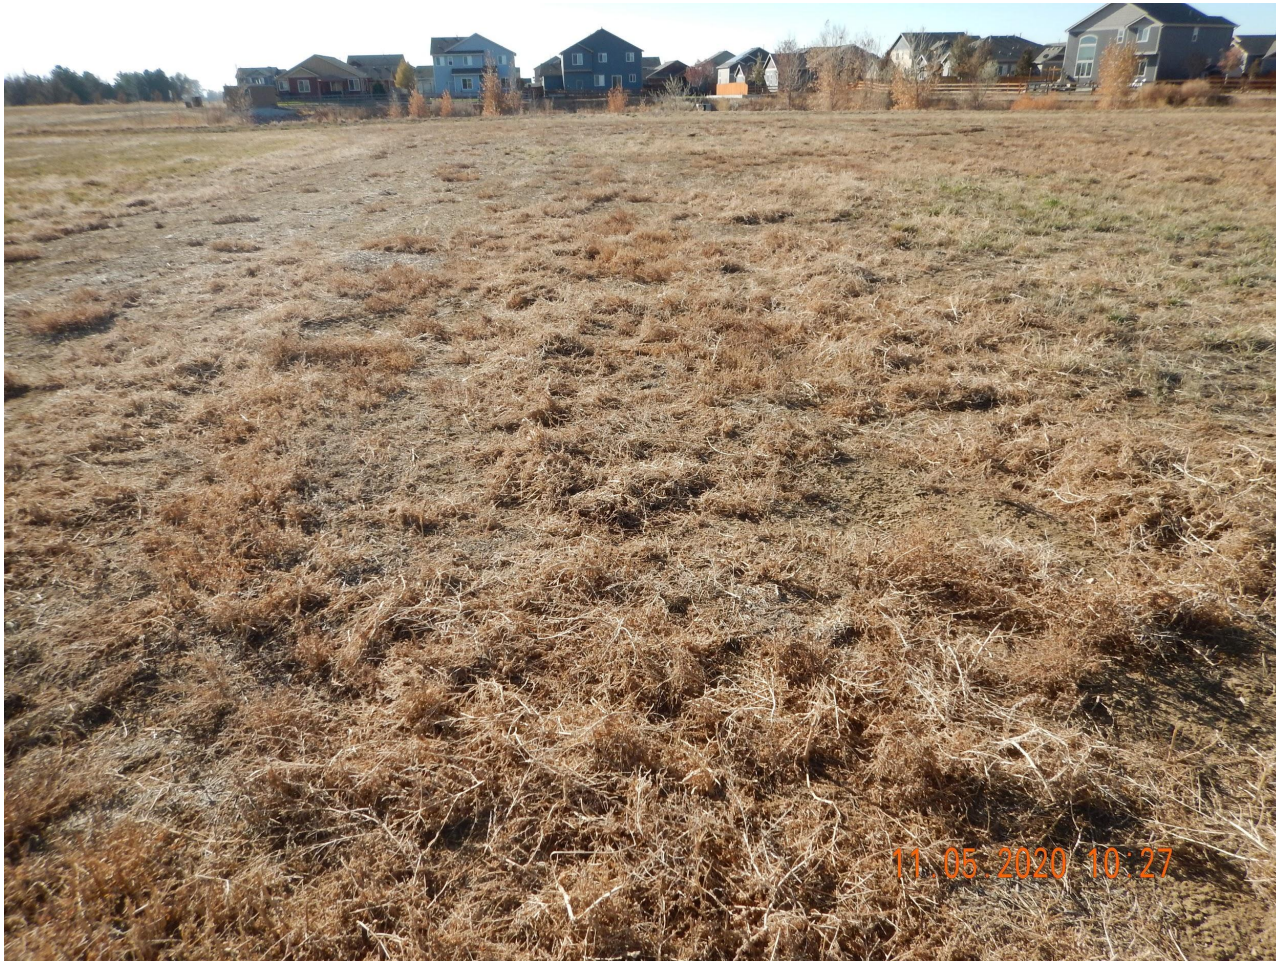
Photo 2. Photo taken from the northern plugged and abandoned well location, facing South. Photo illustrates some germination of desirable plant species. Appears the location has been mowed to control Russian thistle and Kochia.

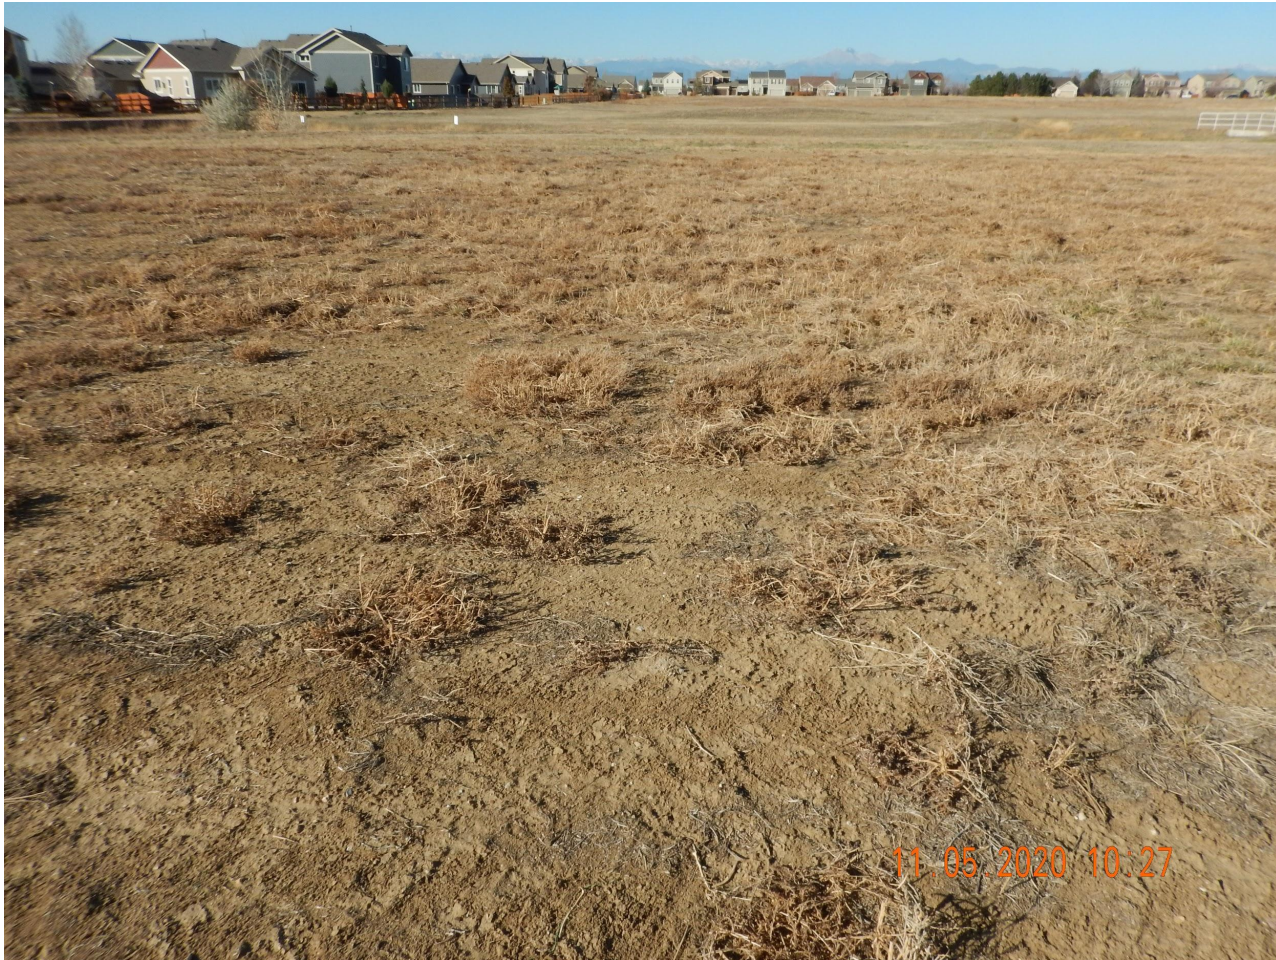
Photo 3. Photo taken from the southern plugged and abandoned well location, facing West. Photo illustrates all equipment has been removed.

See comments under Photos 1-2 regarding revegetation.

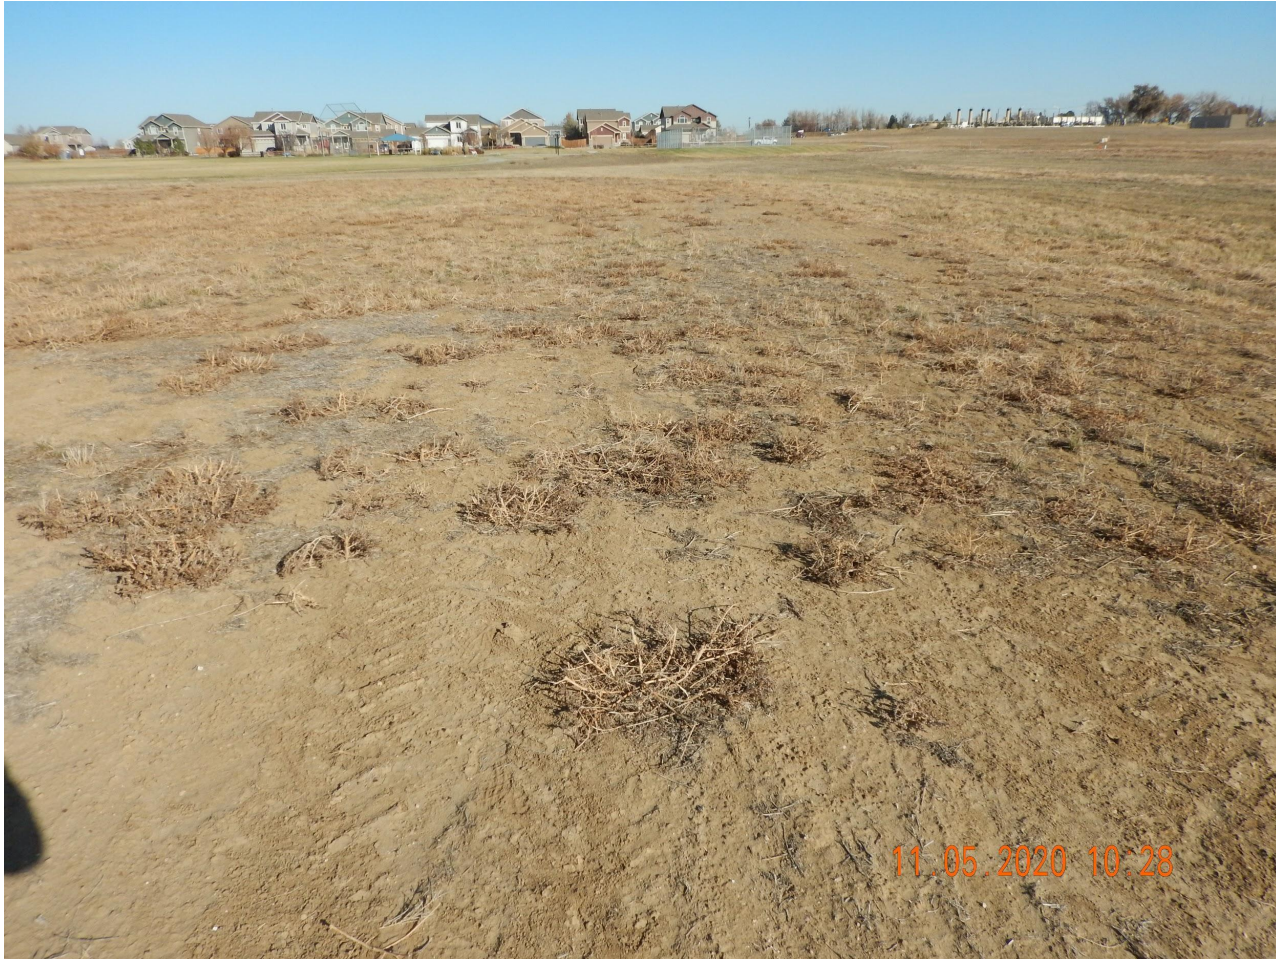
Photo 4. Photo taken from the southern plugged and abandoned well location, facing North. See comments under Photos 1-2 regarding revegetation.
