Inspection Photos

Operator: BP America
API: 067-07546
Date: 11/17/2020

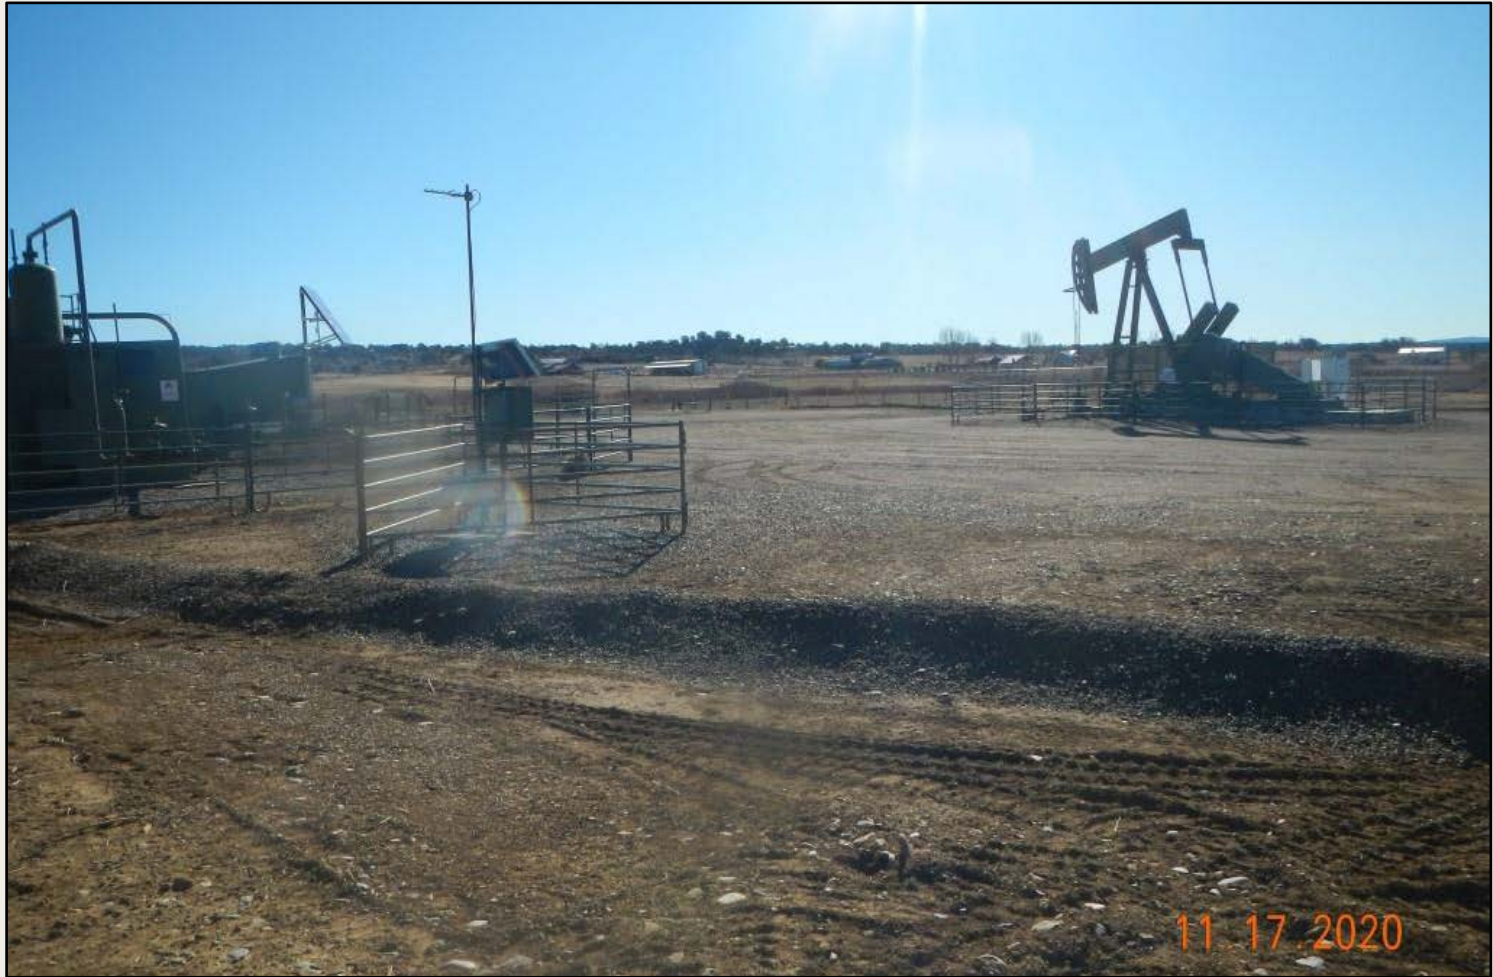
Photo 1. View of the project area from the northwestern corner facing center.

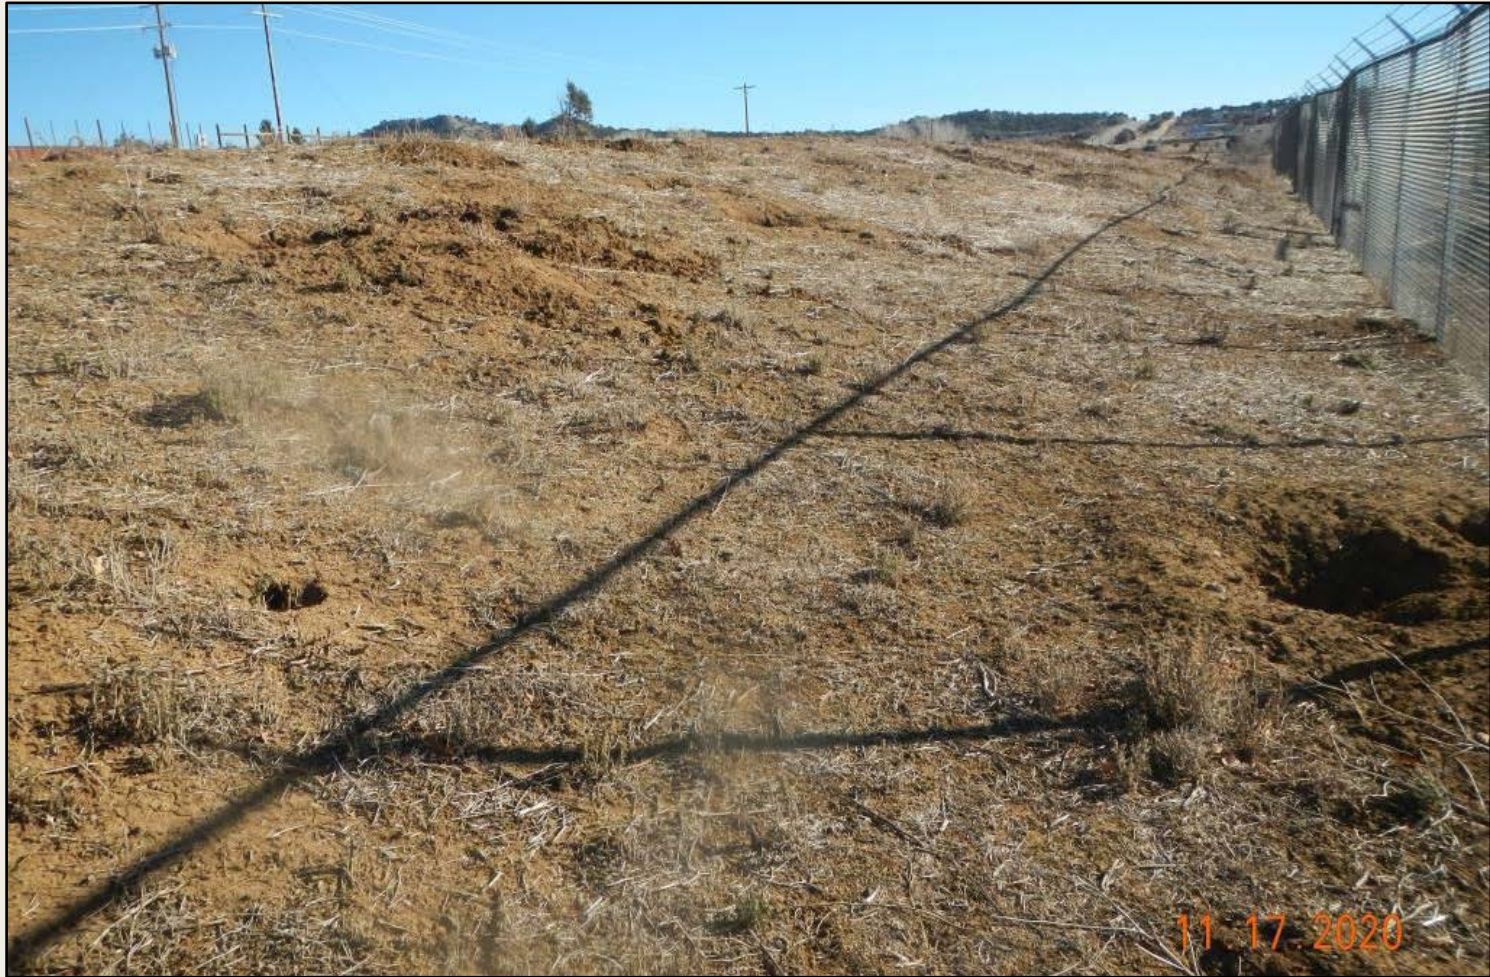
Photo 2. View of the northern project area from the northwestern corner facing eastward.

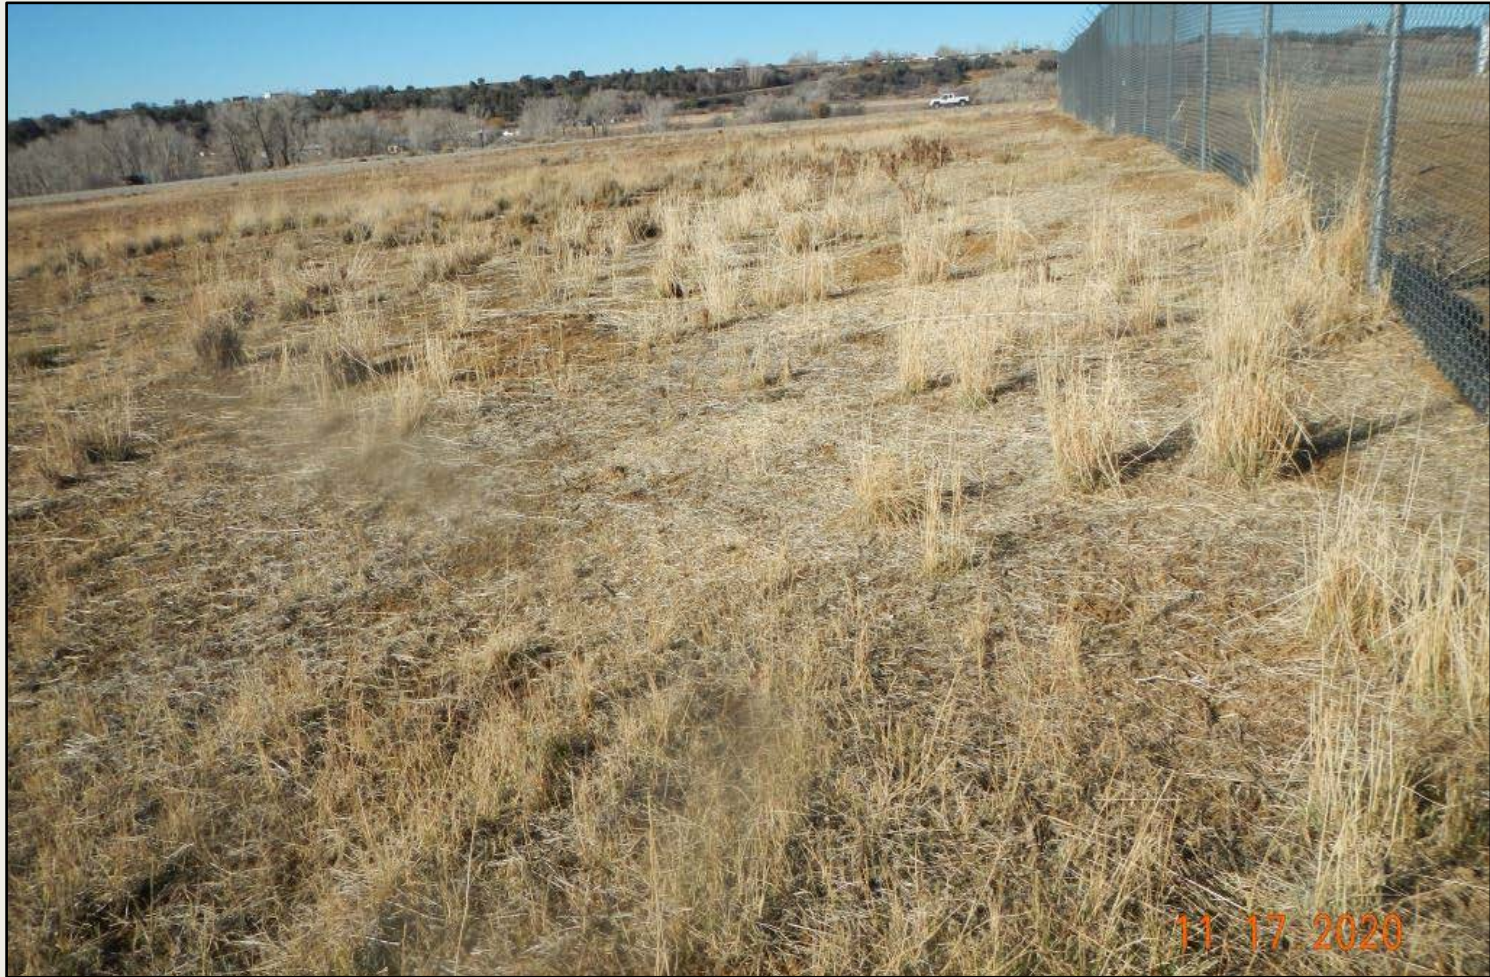
Photo 3. View of the southern project area from the southeastern corner facing westward. Grasses such as intermediate wheatgrass and smooth brome are becoming established.

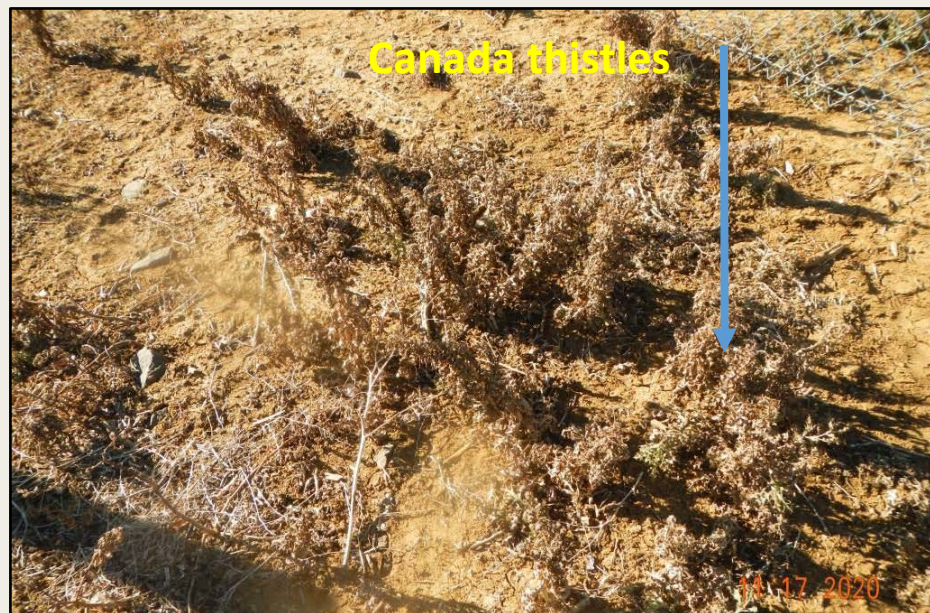
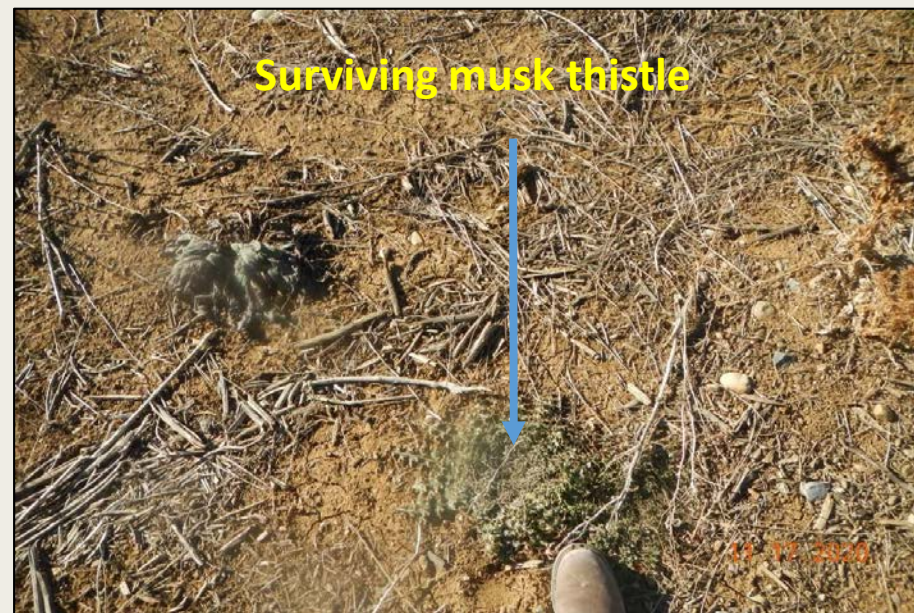
Photos 4/5. View of Canada thistles (left) and musk thistles (right) within the project area. Weeds largely appear treated, but surviving individuals remain. Weeds are largely treated, but surviving weeds remain.

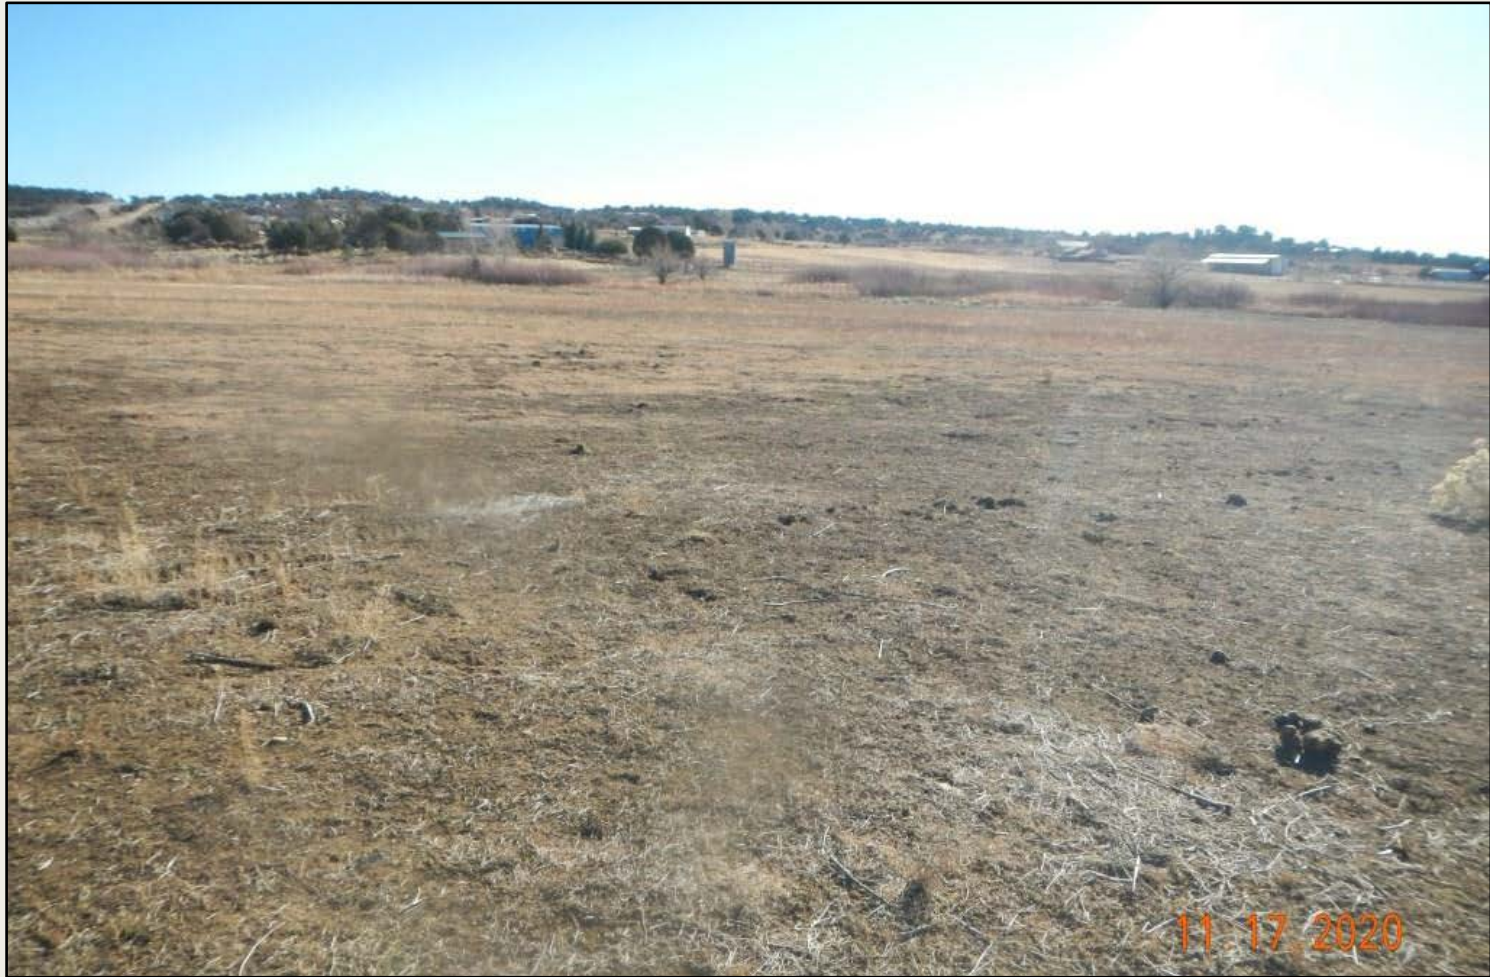
Photo 6. View of reference area comprised of open grass field, largely in a grazed and dormant vegetative condition at this time. Smooth brome and crested wheatgrass are identifiable.
