Inspection Photos

Operator: TEP ROCKY MOUNTAIN LLC #
96850

Location ID: 323963
Garfield, CO

Aaron Trujillo
NW Reclamation Specialist
COGCC

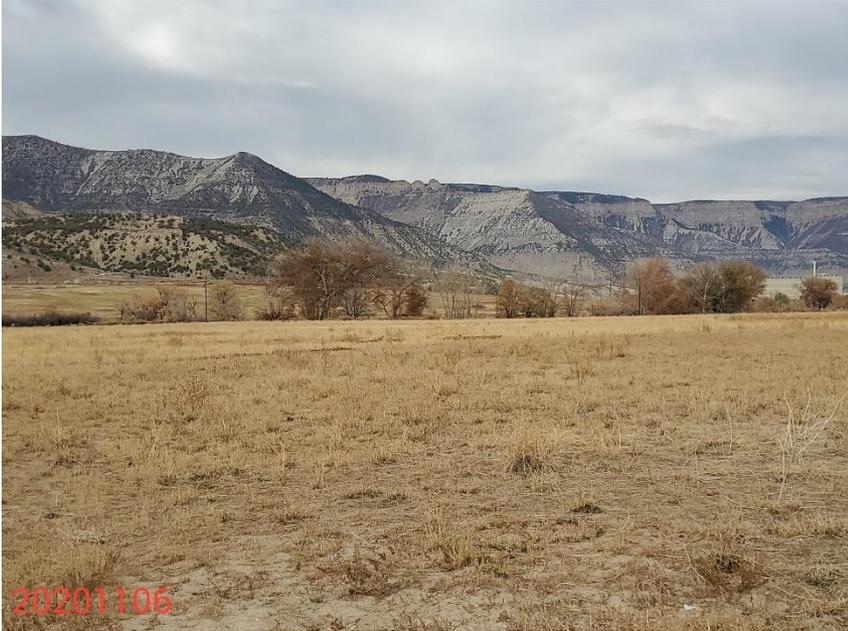
Photo 1: Photo shows well location. Well is located within cropland. Field is currently fallow; A followup inspection will need to be conducted once crop is established to determine compliance with COGCC 1000 series rules.

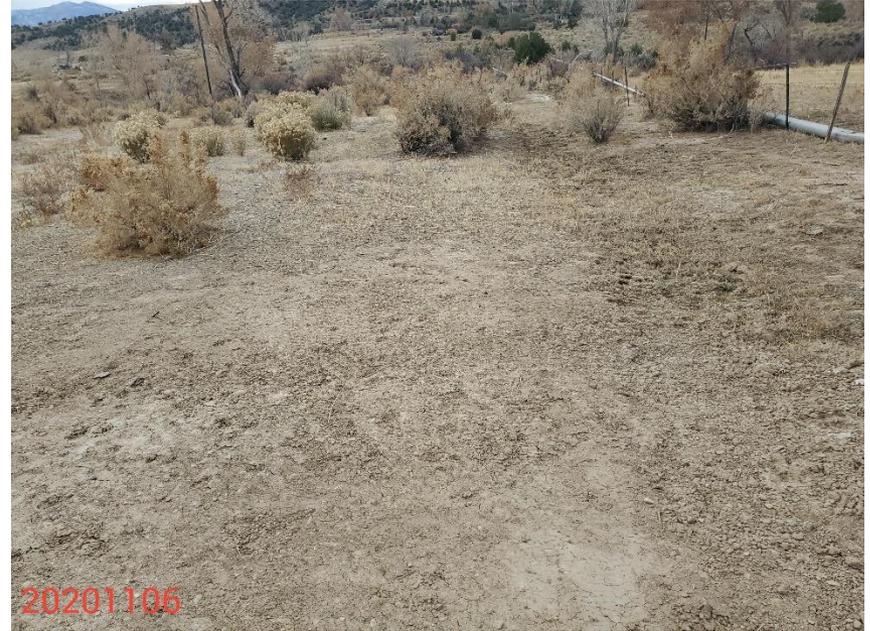
Photo 2: Photo shows riser equipment has been removed from the former tank battery facility.
