Inspection Photos

11/19/2020

Operator: GUNNISON ENERGY LLC - 10515

Location ID: 324457

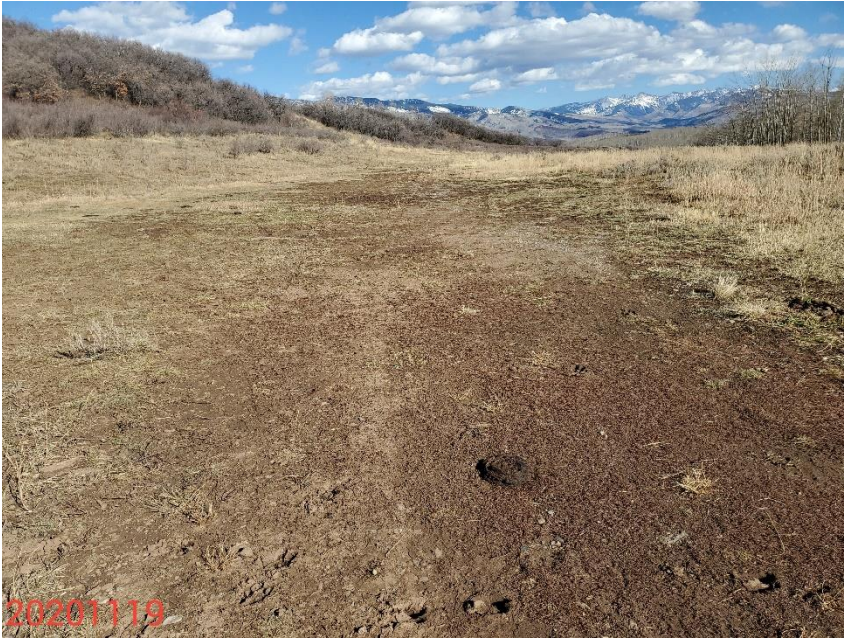
Photo 1: Photo taken from the west end of the Location, facing east. Photo shows Location remains out of compliance with 1004 rules and corrective actions; Final reclamation of the Location/access road has not been conducted.

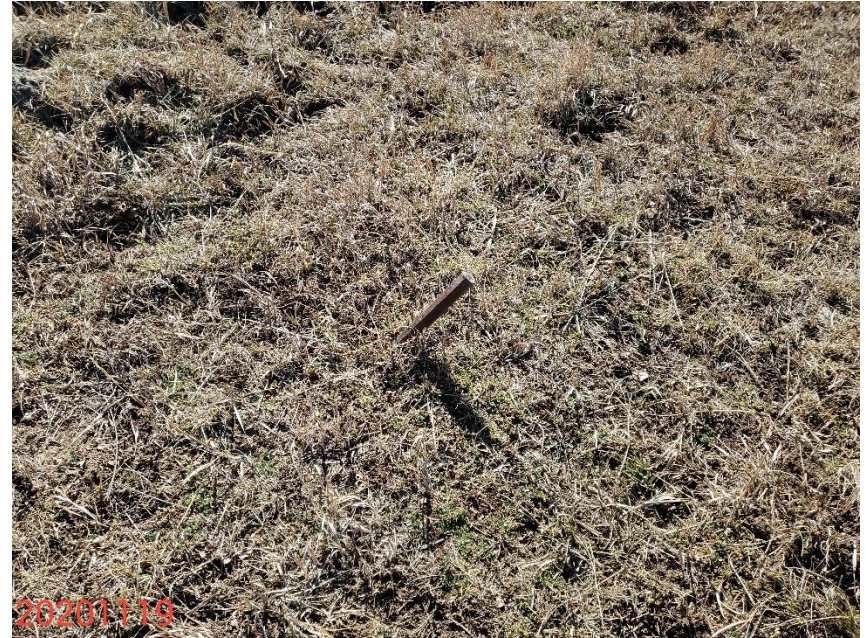
Photo 2: Photo taken from the northwest end of the Location. Photo shows anchor has not been removed.

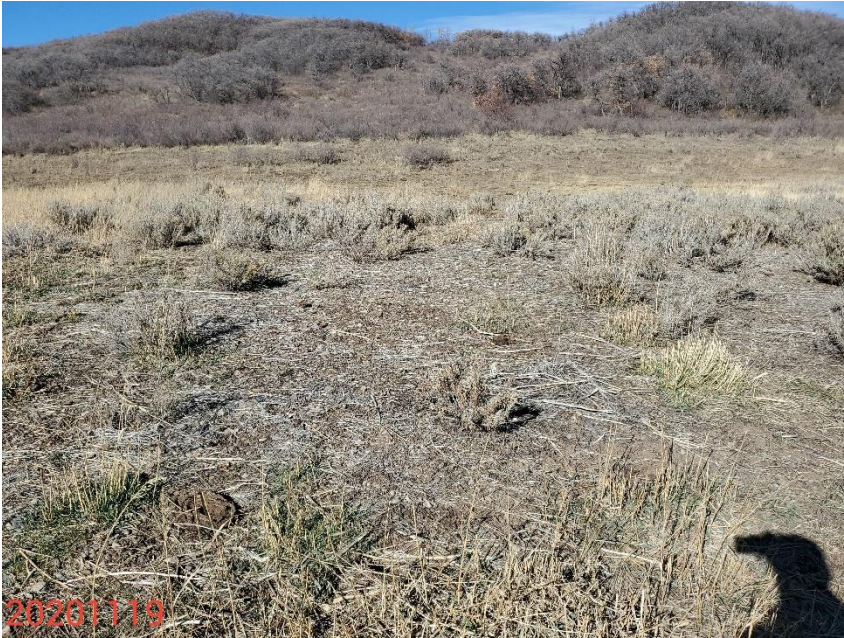
Photo 3: Photo taken from the southeastern areas of the Location, facing north. Photo shows areas where production equipment was Location. Gravel has not been removed from the areas, compaction alleviation conducted and reseeding.

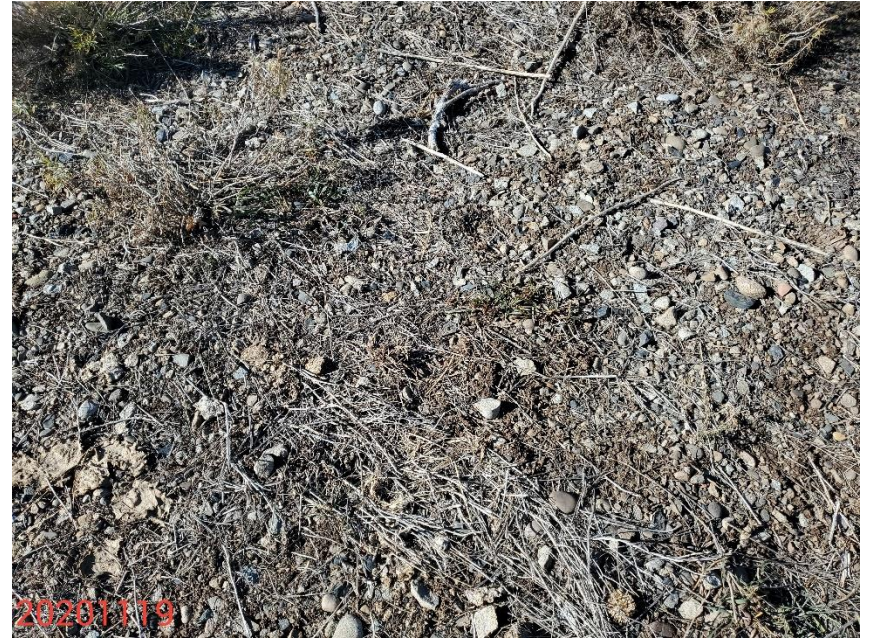
Photo 4: See comments under photo 3.

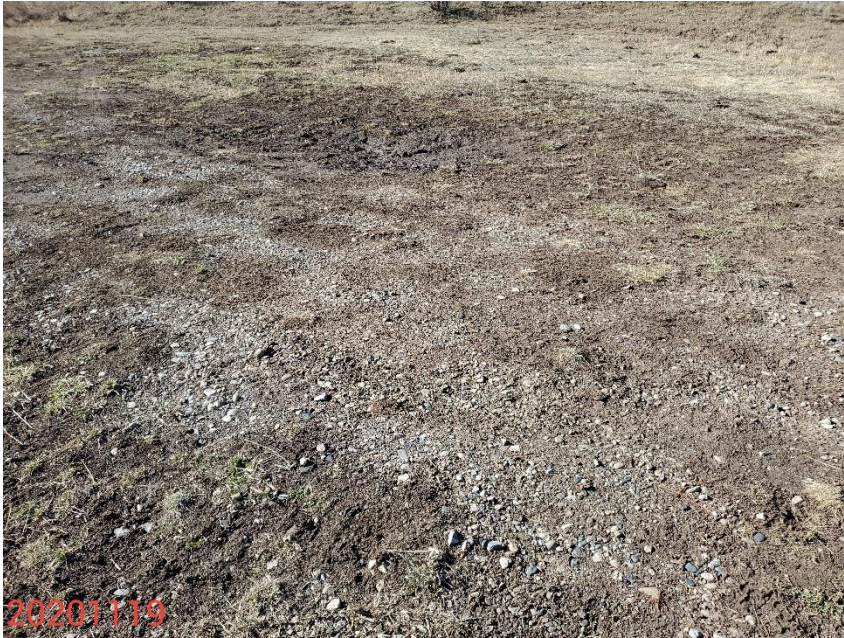
Photo 5: Photo taken from the east end of the Location, facing northwest. Photo shows Location remains out of compliance with 1004 rules and corrective actions; Final reclamation of the Location/access road has not been conducted. Photo also shows gravel remaining.

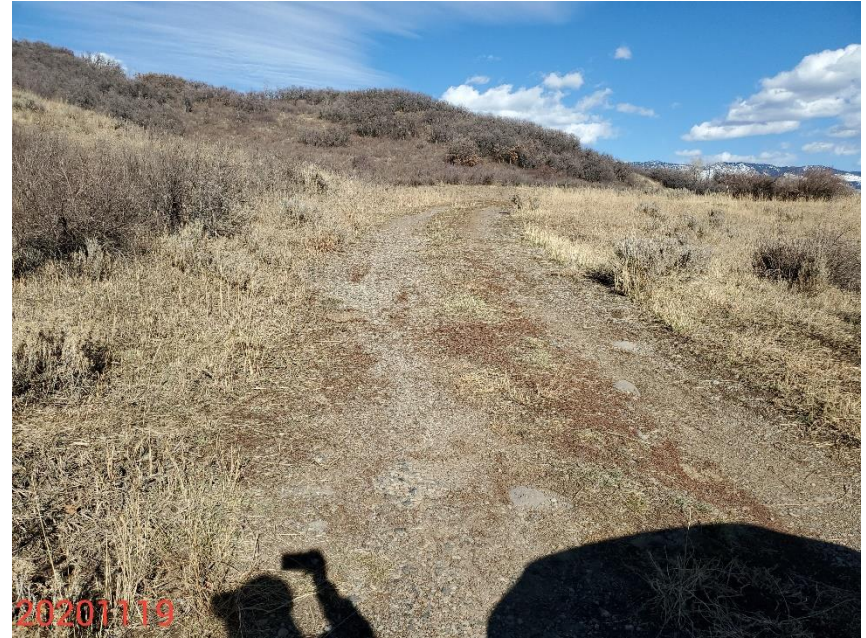
Photo 6: Photo taken from the access road, facing northeast. Photo shows Location remains out of compliance with 1004 rules and corrective actions; Final reclamation of the Location/access road has not been conducted.
