Inspection Photos

Operator: SG INTERESTS I LTD # 77330

Location ID: 422990

Inspection Photos
Operator Name: SG INTERESTS I LTD - 77330
Location ID: 414132

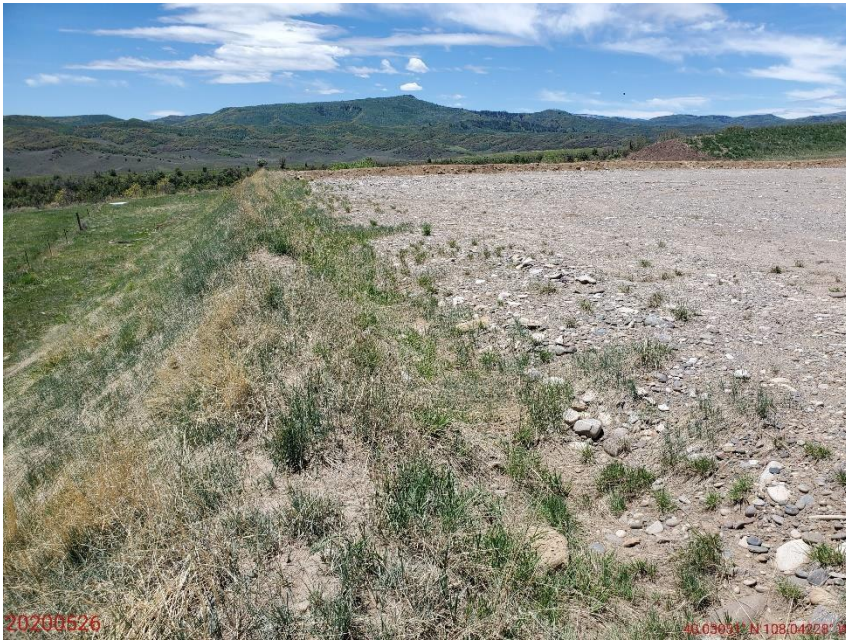
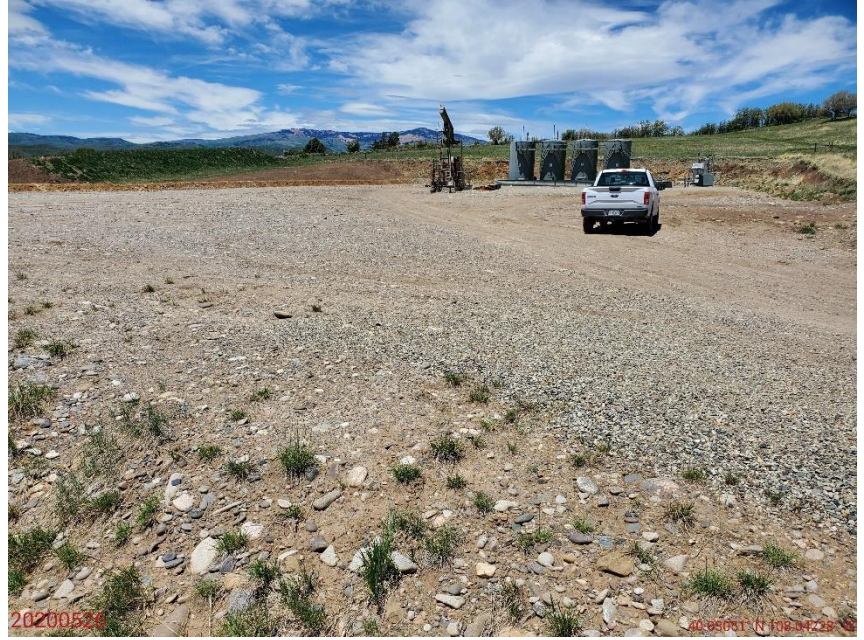
Photos taken from doc. #696201335. Photos show overview of the Location and current pad. Delayed IR variance doc. #401721595 expired, and required interim reclamation pursuant to 1003 rules no later than February 5th, 2020. Interim reclamation of areas not needed for production has not been conducted per 1003 rules, and Form 4 COAs.

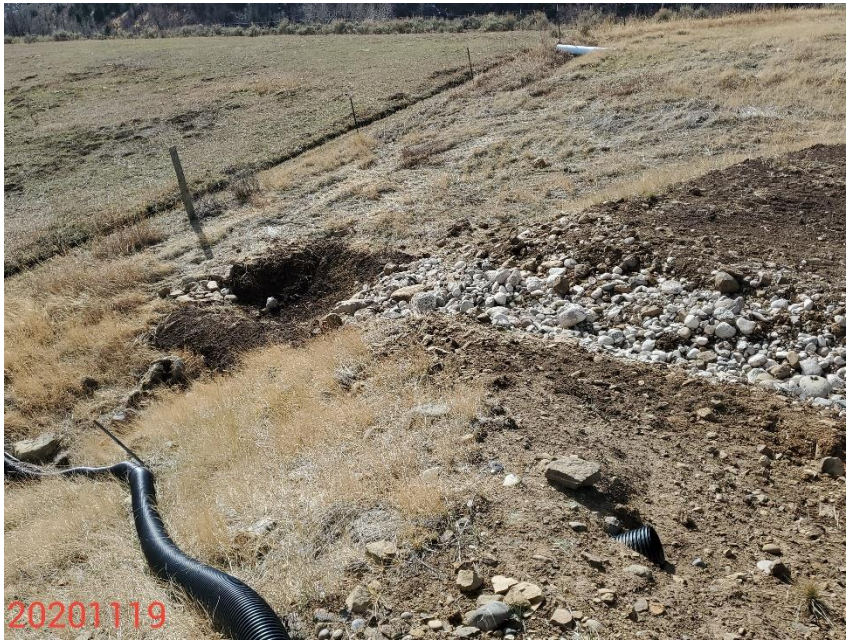
Photo 1: Photo taken from the stormwater ditch on the west end of the Location. Operator has installed a sediment trap. BMP insufficient in size for the site's conditions and have not been installed in accordance with good engineering practices.

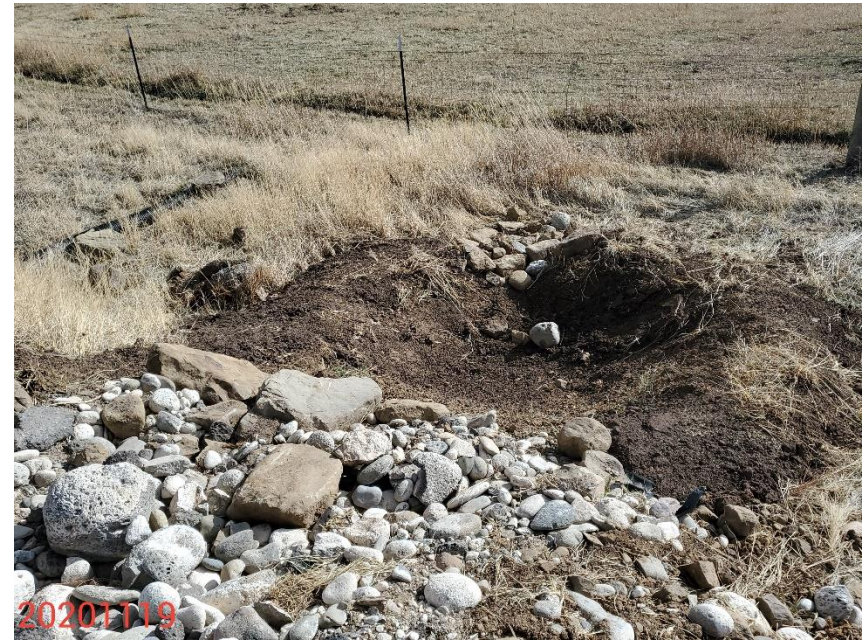
Photo 2: See comments under photo 1.

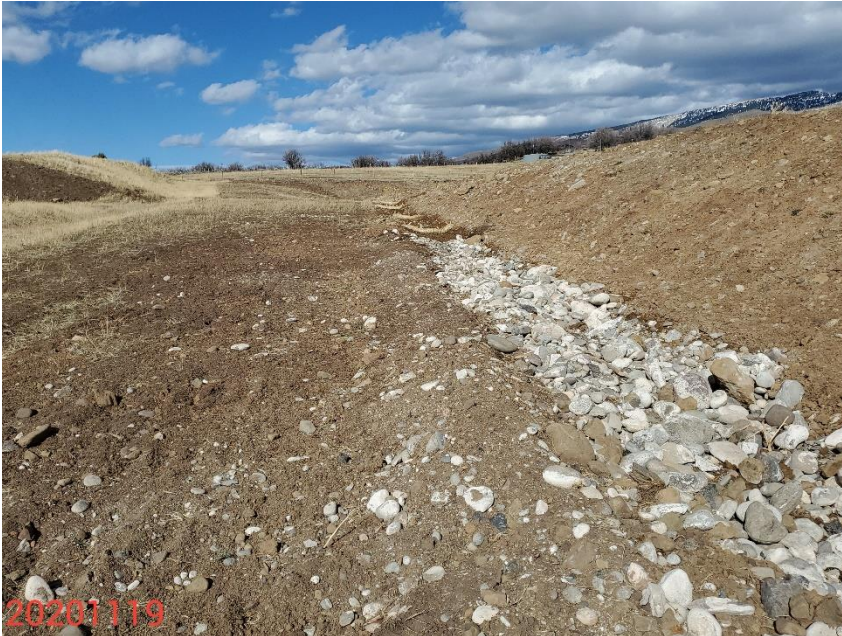
Photo 3: Photo taken from the stormwater ditch on the west end of the Location, facing north. Photo shows ditch BMP has not been constructed in accordance with good engineering per the sites conditions.

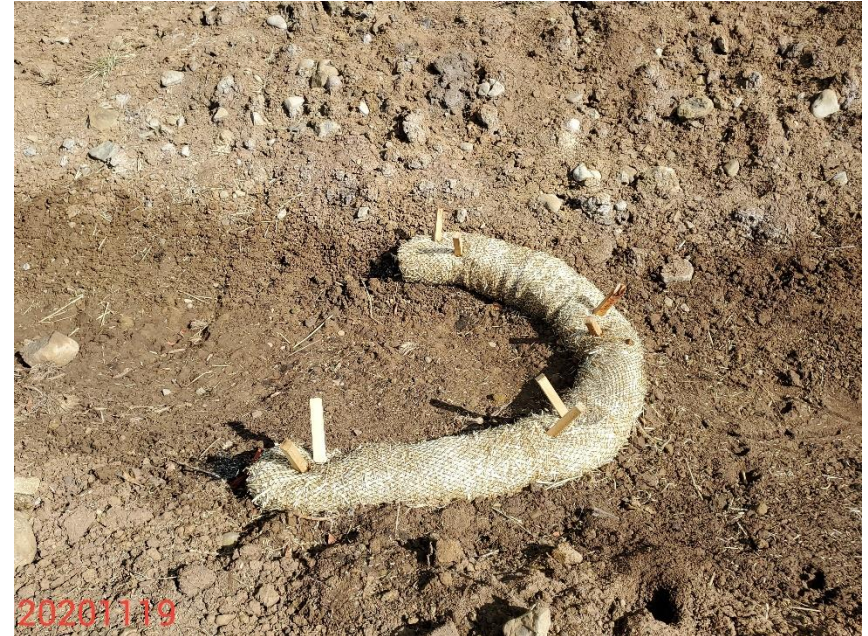
Photo 4: Photo taken from the stormwater ditch. Photo shows straw wattle as a velocity check in the ditch.

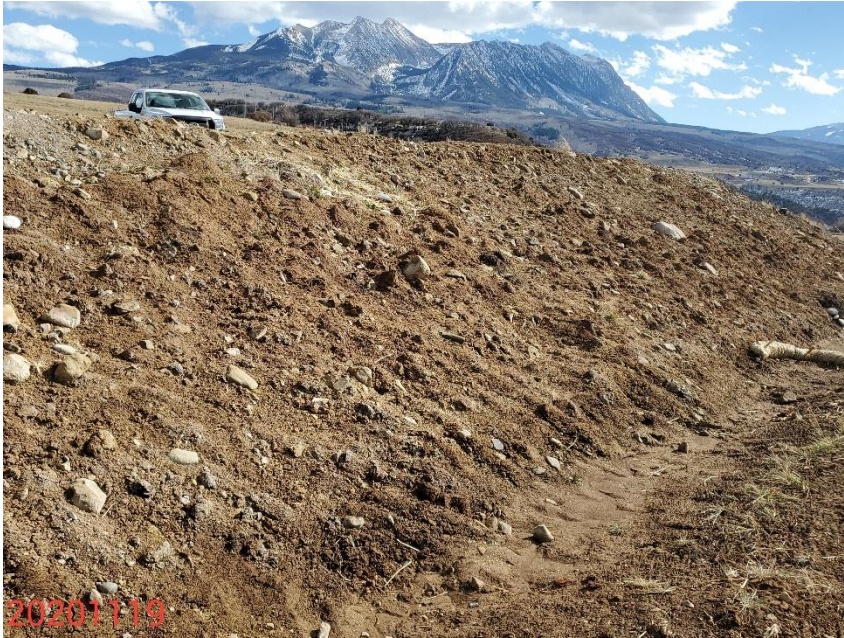
Photo 5: Photo taken from the west end of the Location, facing south east. Photo shows example of slopes on the Location where stabilization BMPs remain missing or insufficient.

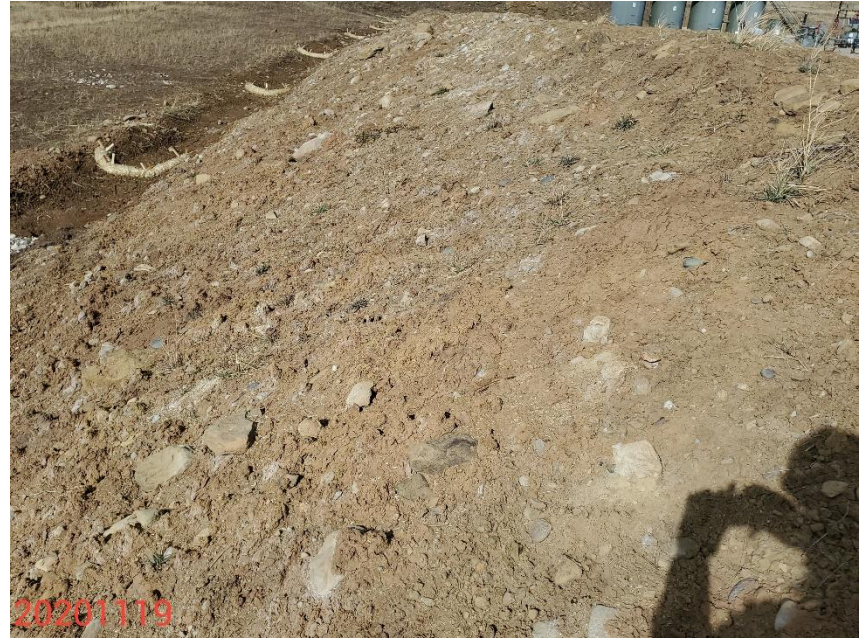
Photo 6: See comments under photo 5.
