Inspection Photos

Operator: Holcomb Operating
API: 067-06543
Date: 12/1/2020

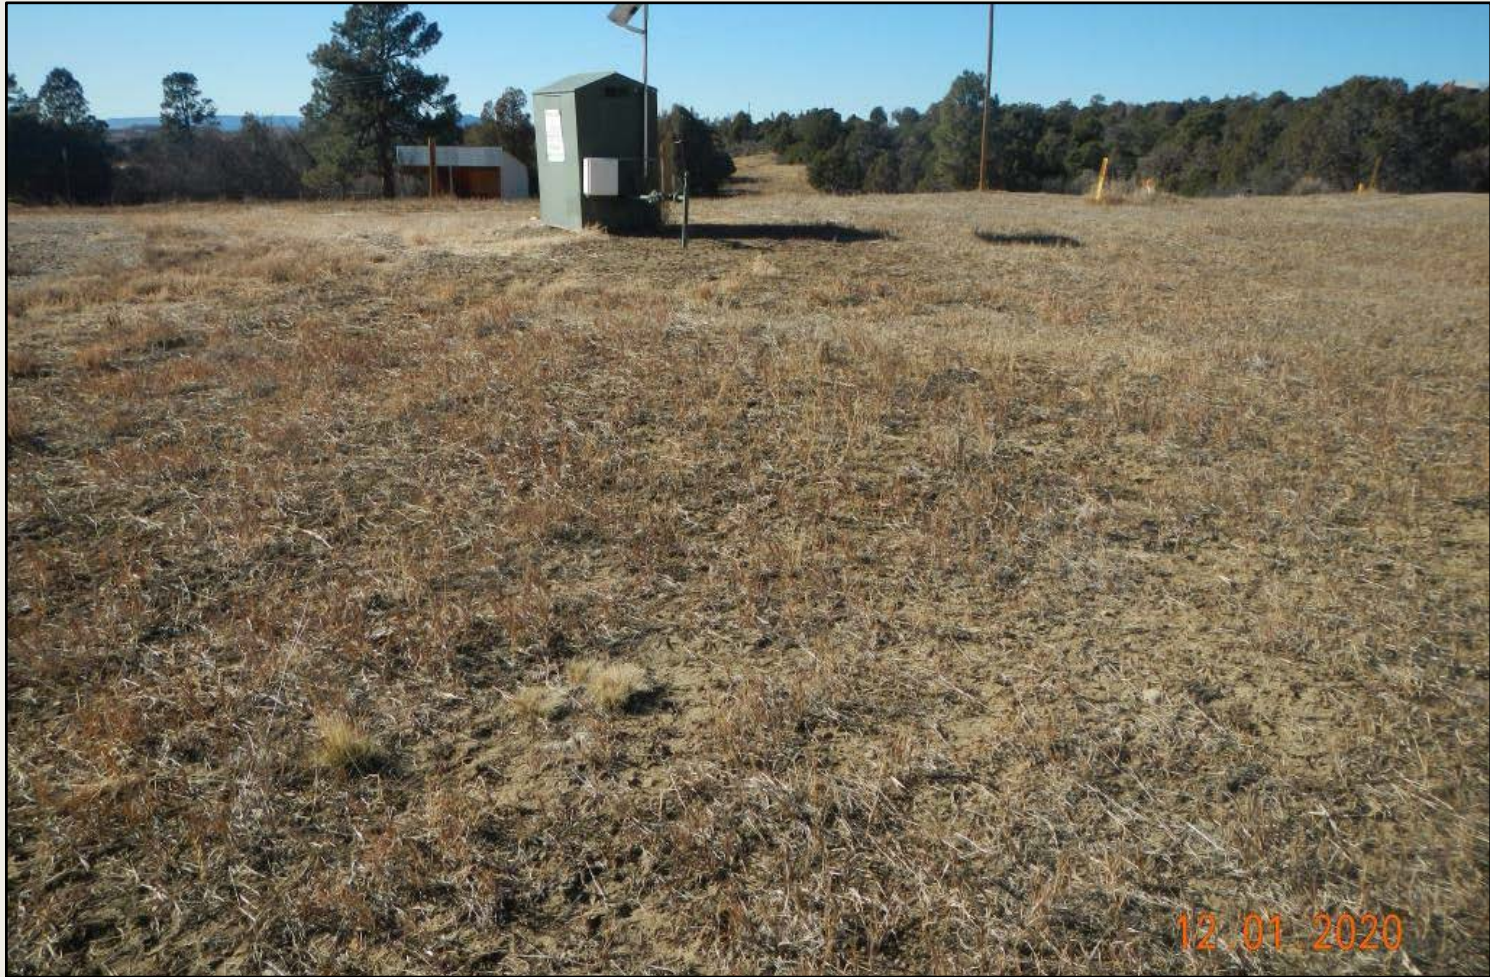
Photo 1. View of the norther project area from the northeastern corner facing westward.

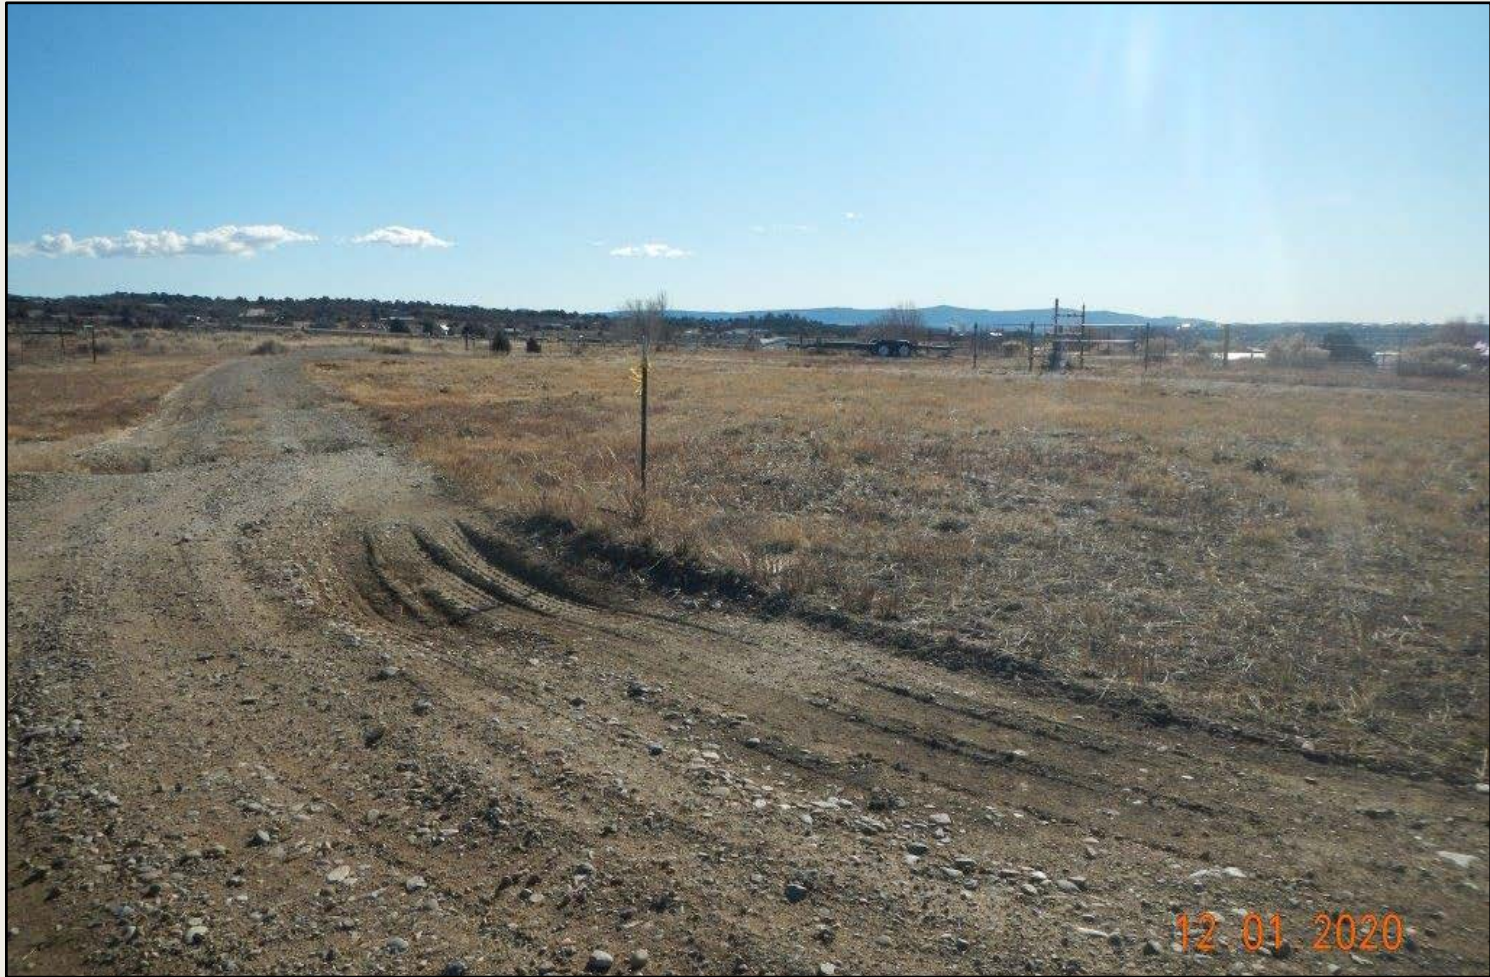
Photo 2. View of the project area from the northeastern corner facing center. Teardrop is revegetating, and vegetation is mowed. Species observed include smooth brome, western wheatgrass, and sand dropseed.

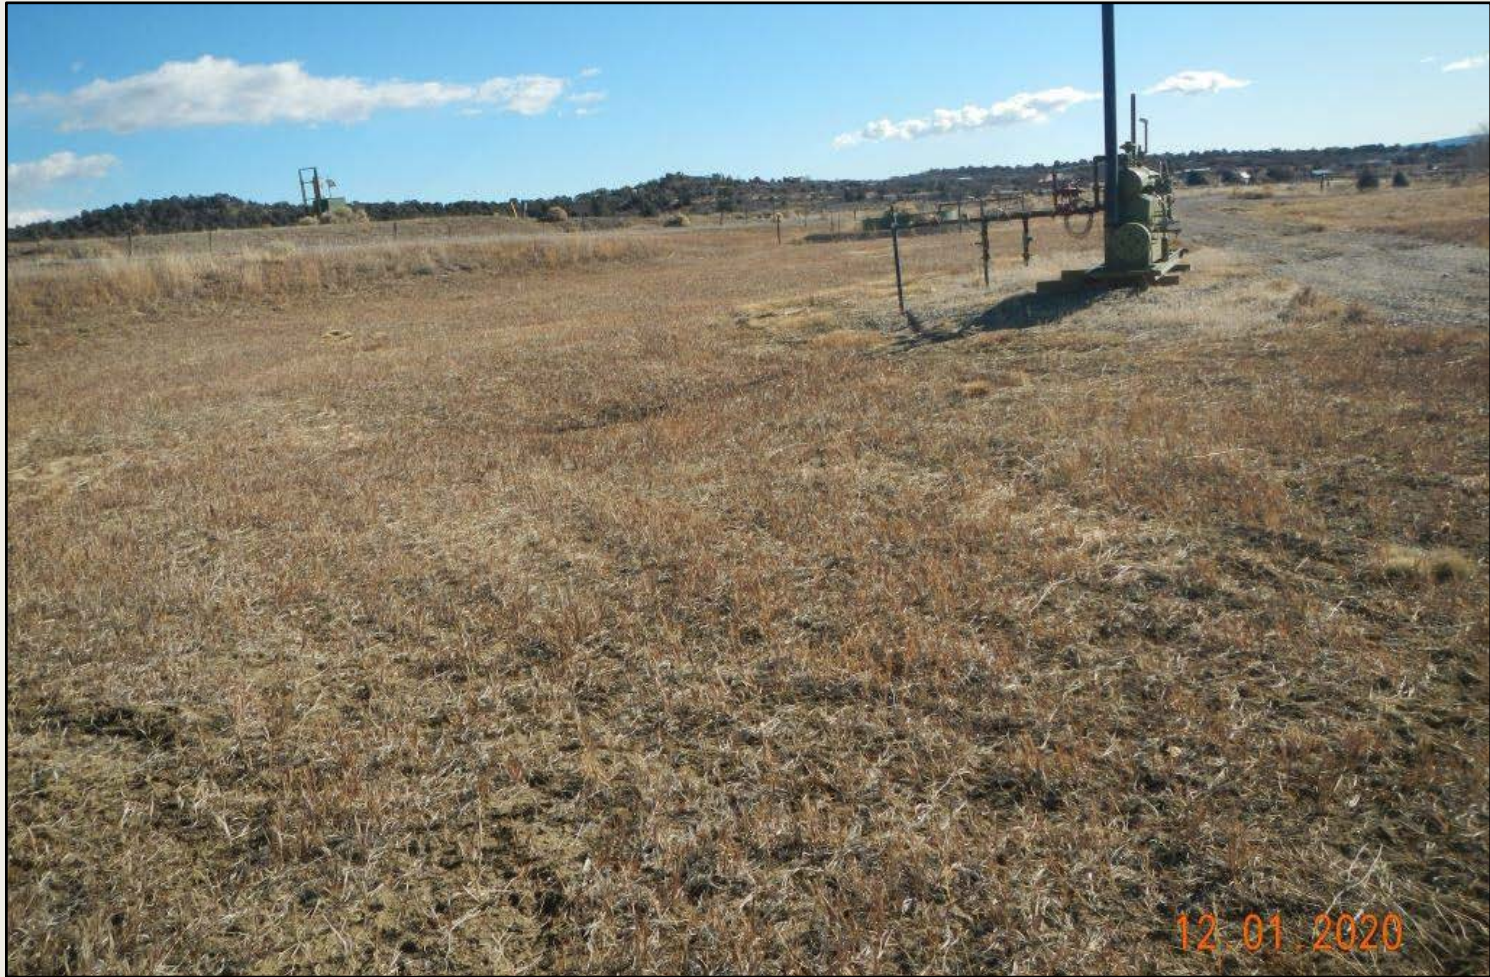
Photo 3. View of the eastern project area from the northeastern corner facing southward. Reference area is comprised of grass field similar to reference area, and sagebrush shrubland mosaic.

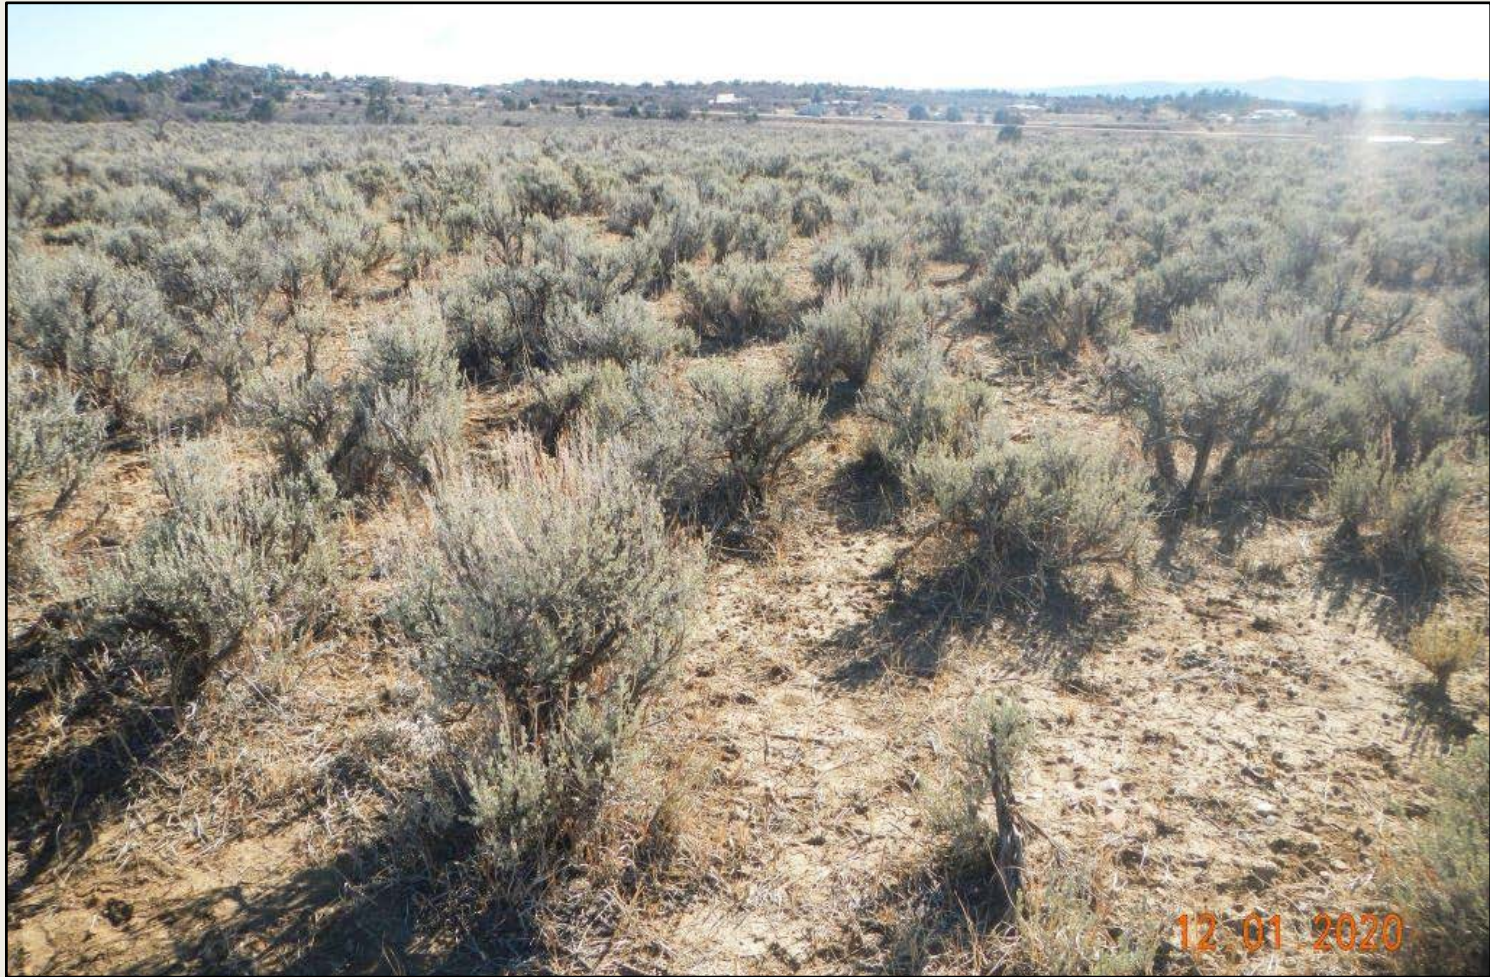
Photo 4. View of reference area vegetation comprised of sagebrush shrubland with understory of grasses and forbs such as blue grama, prickly pear, western wheatgrass, and snakeweed.
