# Inspection Photos

12/4/2020

Operator: CAERUS PICEANCE LLC - 10456

Location ID: 312527

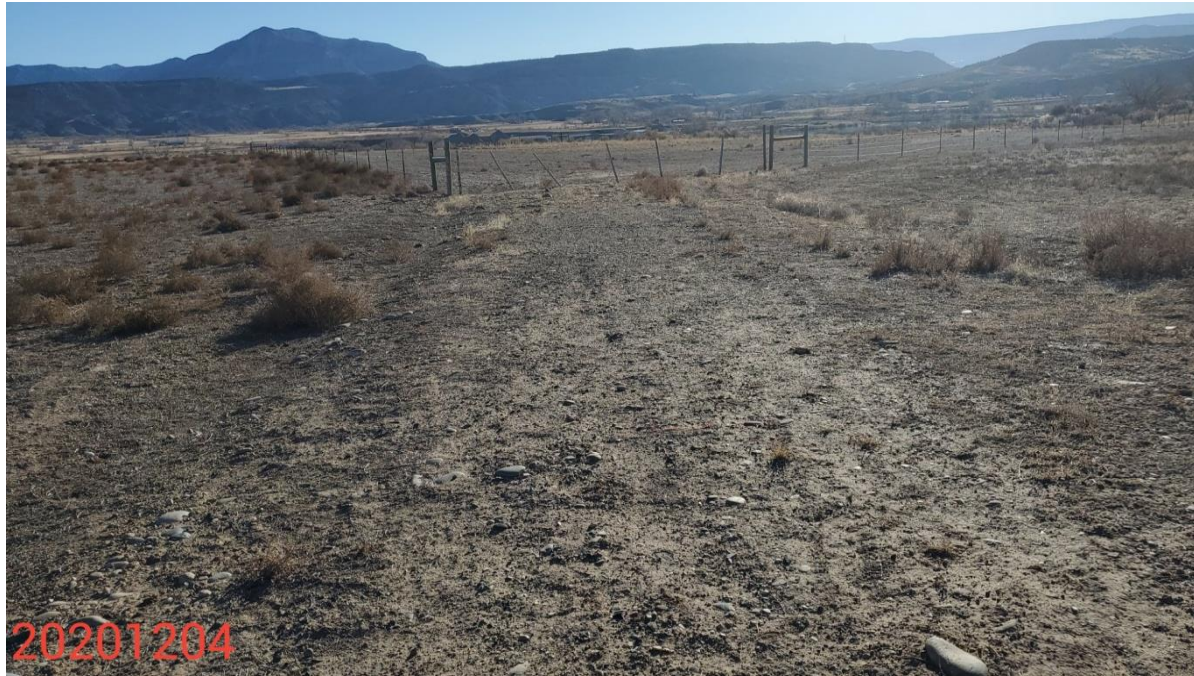
**Photo 1:** Photo taken from the location entrance, facing southeast. Photo shows access road and Location. Compaction evident at access road. Reclamation of Location and access road not progressing towards 1004 standards.

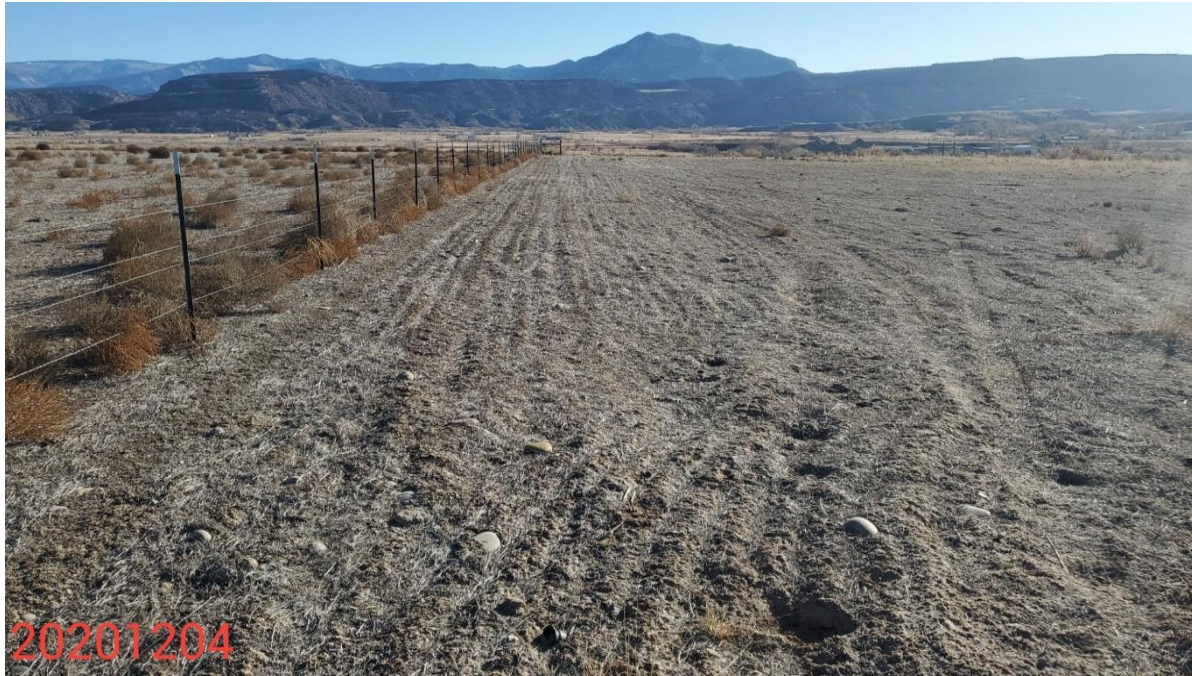
**Photo 2:** Photo taken from the northwest corner of the Location, facing east. Photo shows reclamation of the Location is not progressing towards 1004 standards; Insufficient desirable vegetative germination and establishment. Location predominantly bare/exposed soils.

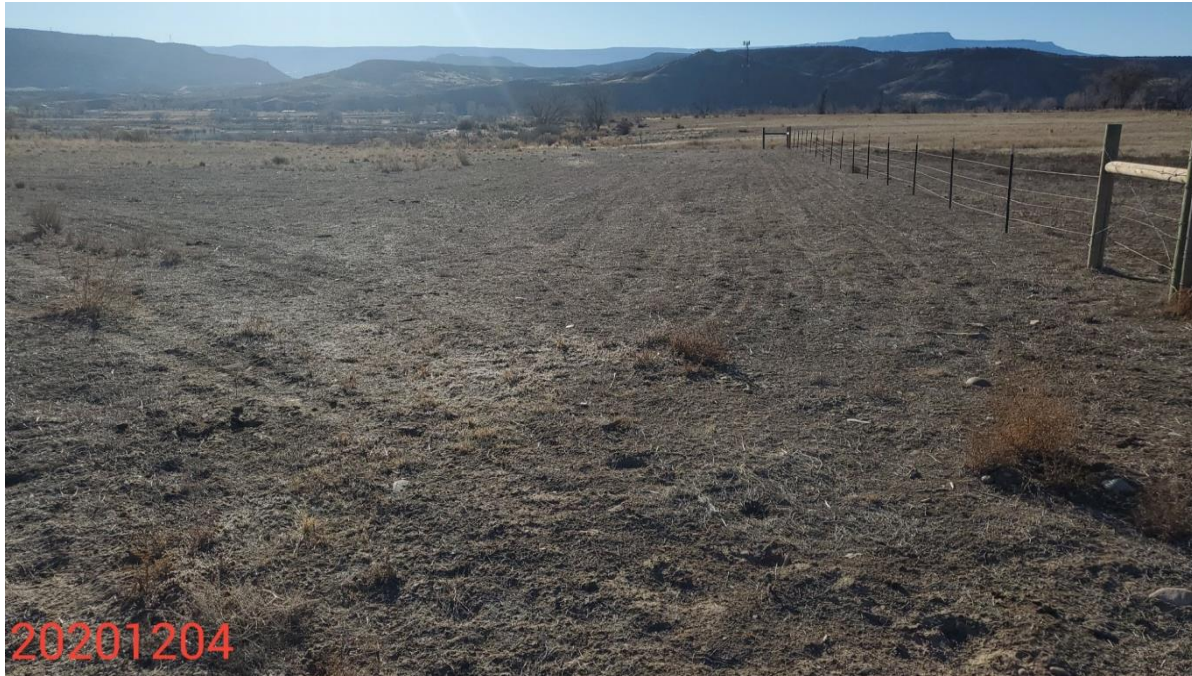
**Photo 3:** Photo taken from the northwest corner of the Location, facing south. Photo shows reclamation of the Location is not progressing towards 1004 standards; Insufficient desirable vegetative germination and establishment. Location predominantly bare/exposed soils.

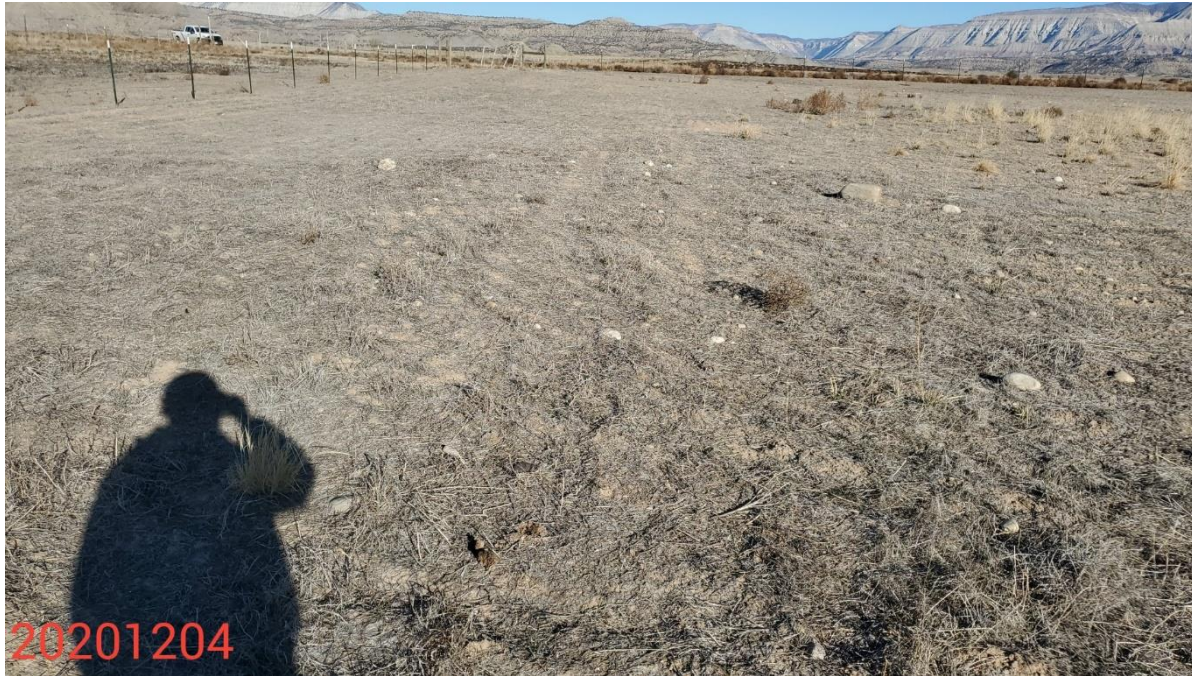
**Photo 4:** Photo taken from the southwest corner of the Location, facing north. Photo shows reclamation of the Location is not progressing towards 1004 standards; Insufficient desirable vegetative germination and establishment. Location predominantly bare/exposed soils.

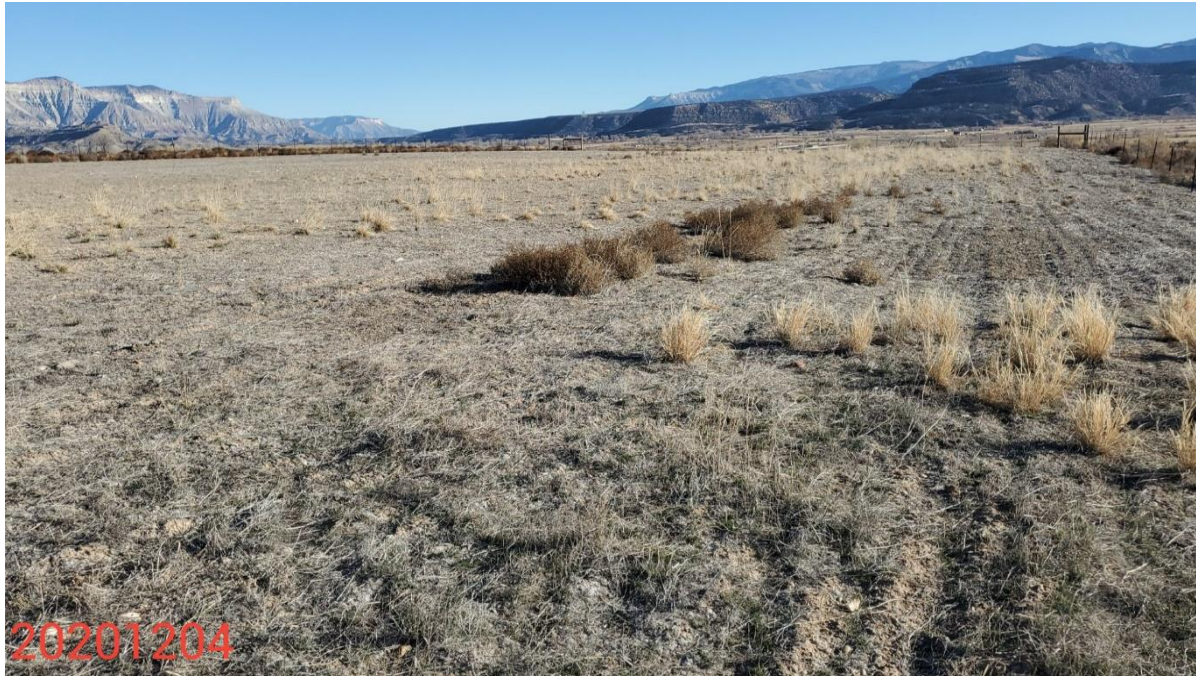
**Photo 5:** Photo taken from the southwest corner of the Location, facing east. Photo shows reclamation of the Location is not progressing towards 1004 standards; Insufficient desirable vegetative germination and establishment. Location predominantly bare/exposed soils.

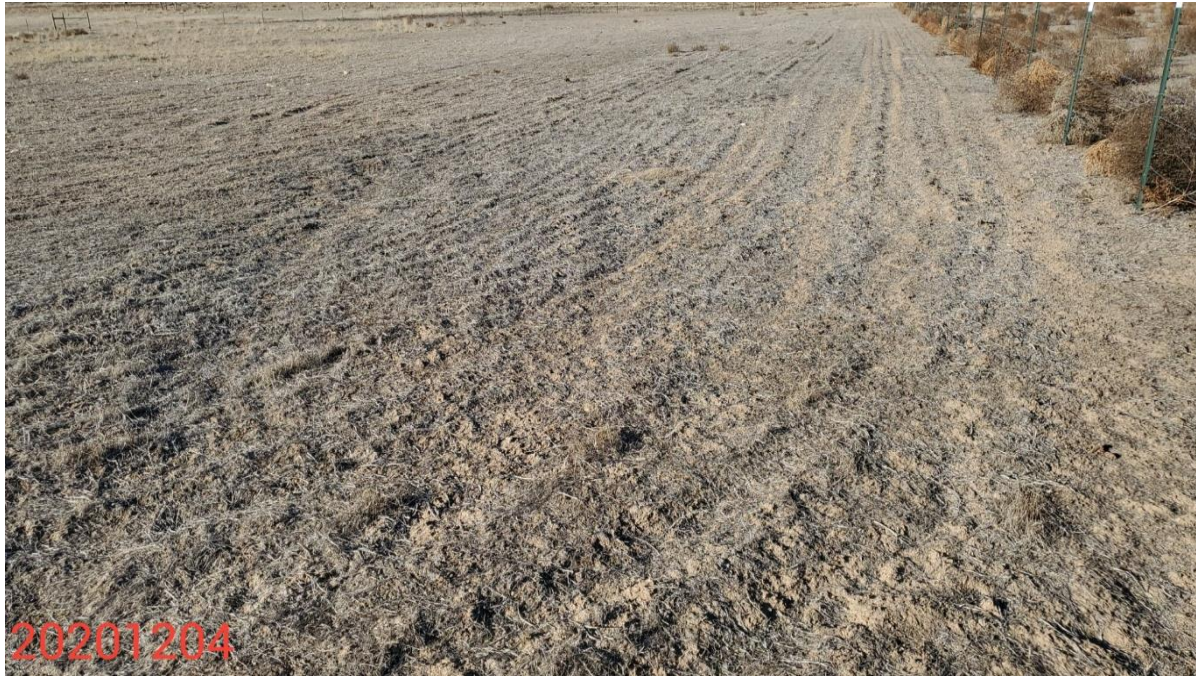
**Photo 6:** Photo taken from the Location. Photo shows desirable perennial vegetative germination and establishment is insufficient. Location is not progressing towards 1004 reclamation standards.

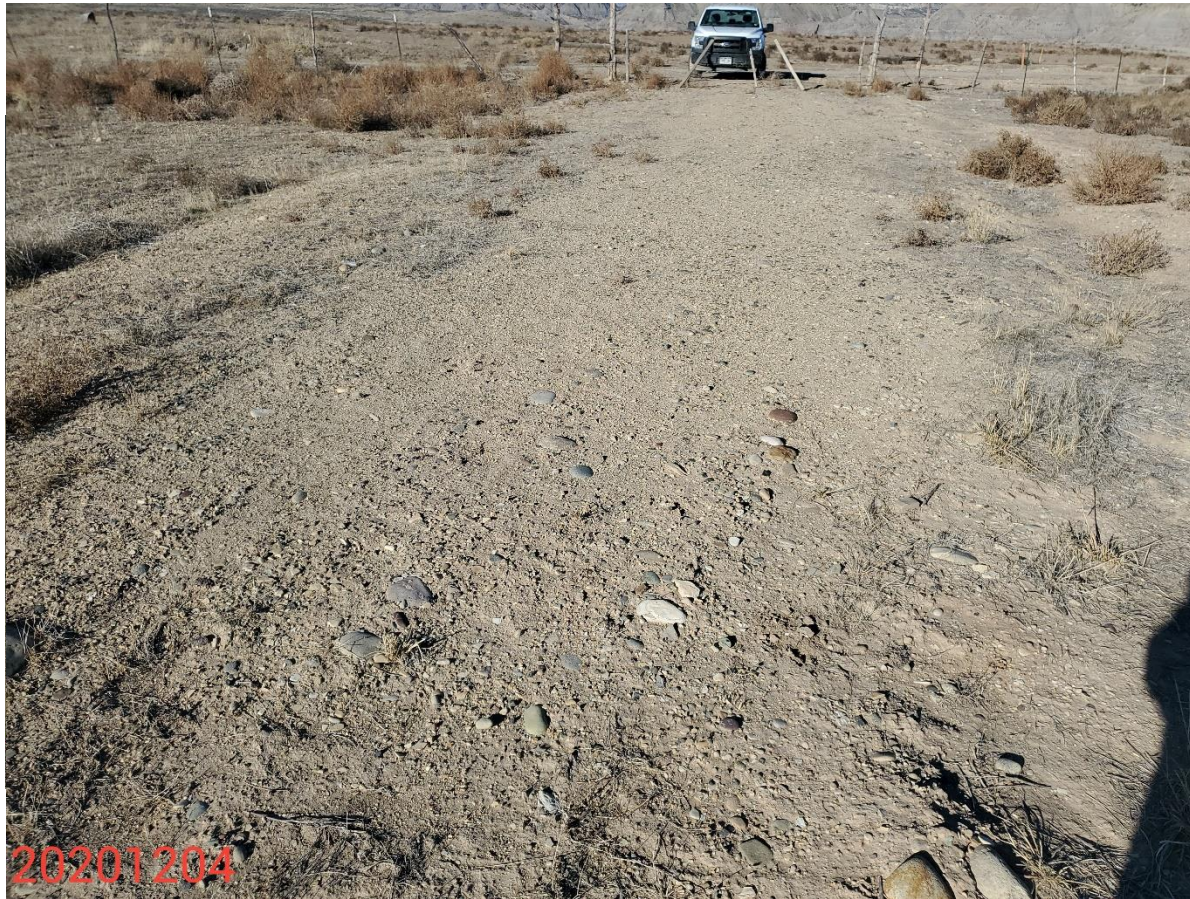
**Photo 7:** Photo taken from the access road. Unable to find evidence that compaction alleviation has been conducted at access road. Insufficient desirable vegetative germination and establishment. Access road predominantly bare/exposed soils.
