Inspection Photos

12/8/2020

Operator: LARAMIE ENERGY LLC - 10433

Location ID: 323893

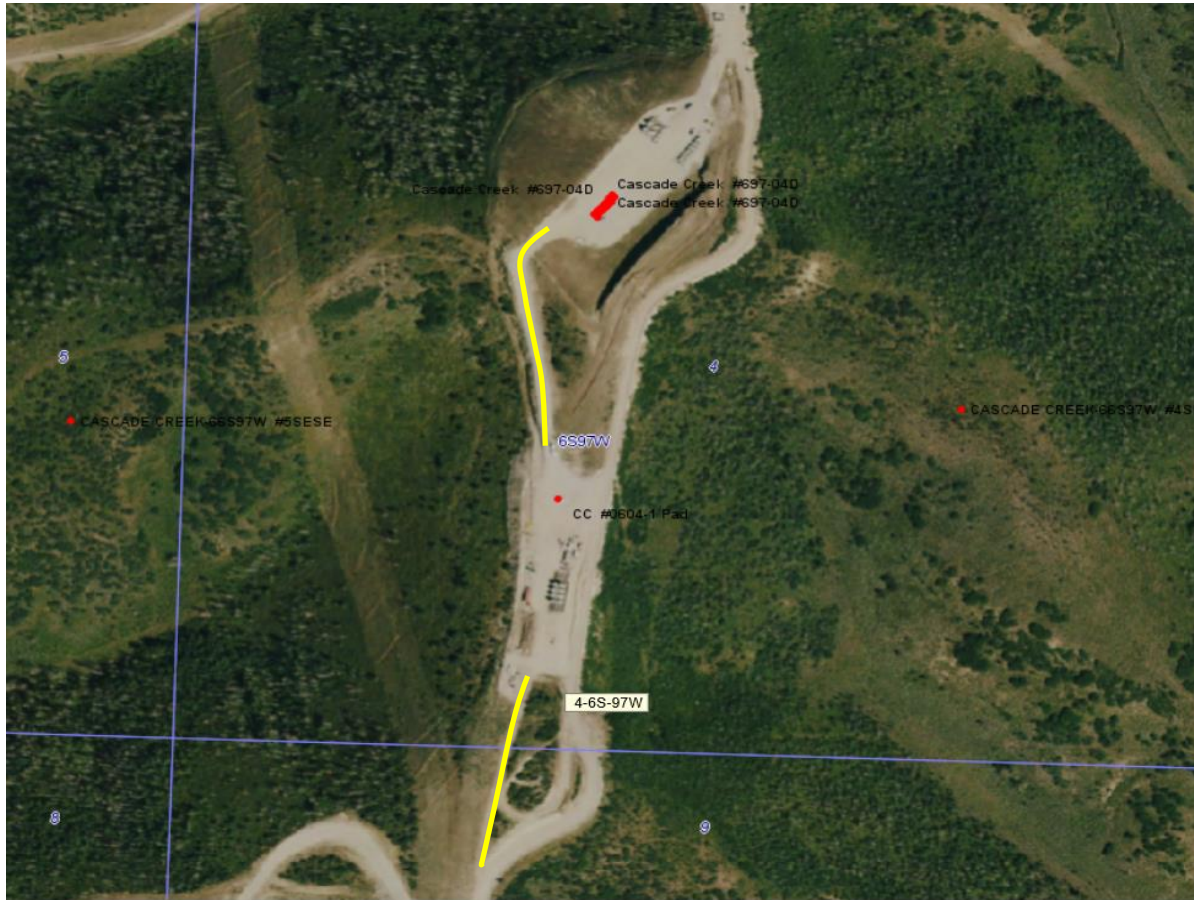
Photo 1: 2019 COGIS aerial image. Photo shows two parallel access roads leading to the CC 0604-1 Pad, and the Cascade Creek 697-04D. This does not comport with Rule 1002.e “surface disturbance minimization” requirements regarding access roads. Roads identified in yellow will require reclamation.

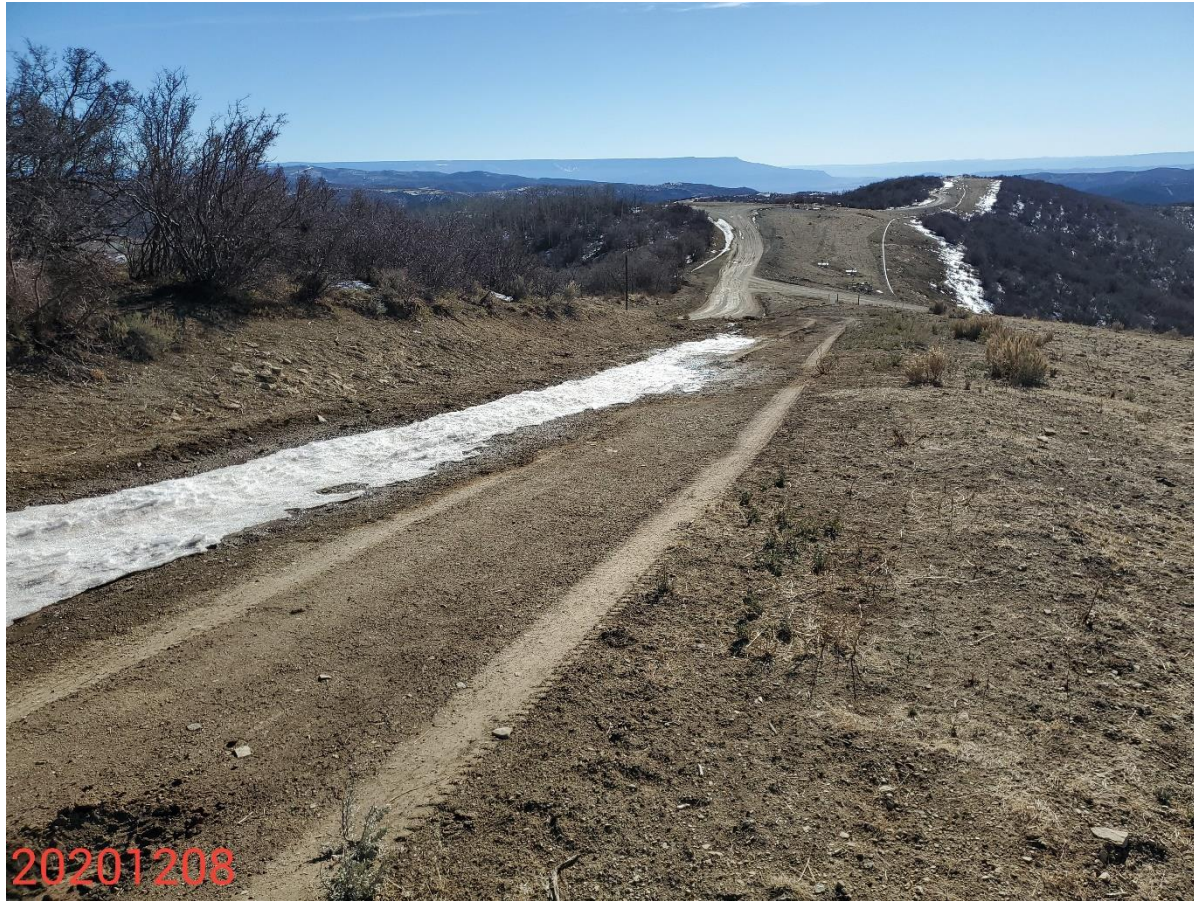
Photo 2: Two access roads travel parallel north and south of one another. Photo shows the access road that travels from the southwestern end of the CC 0604-1 Pad Location, facing south.

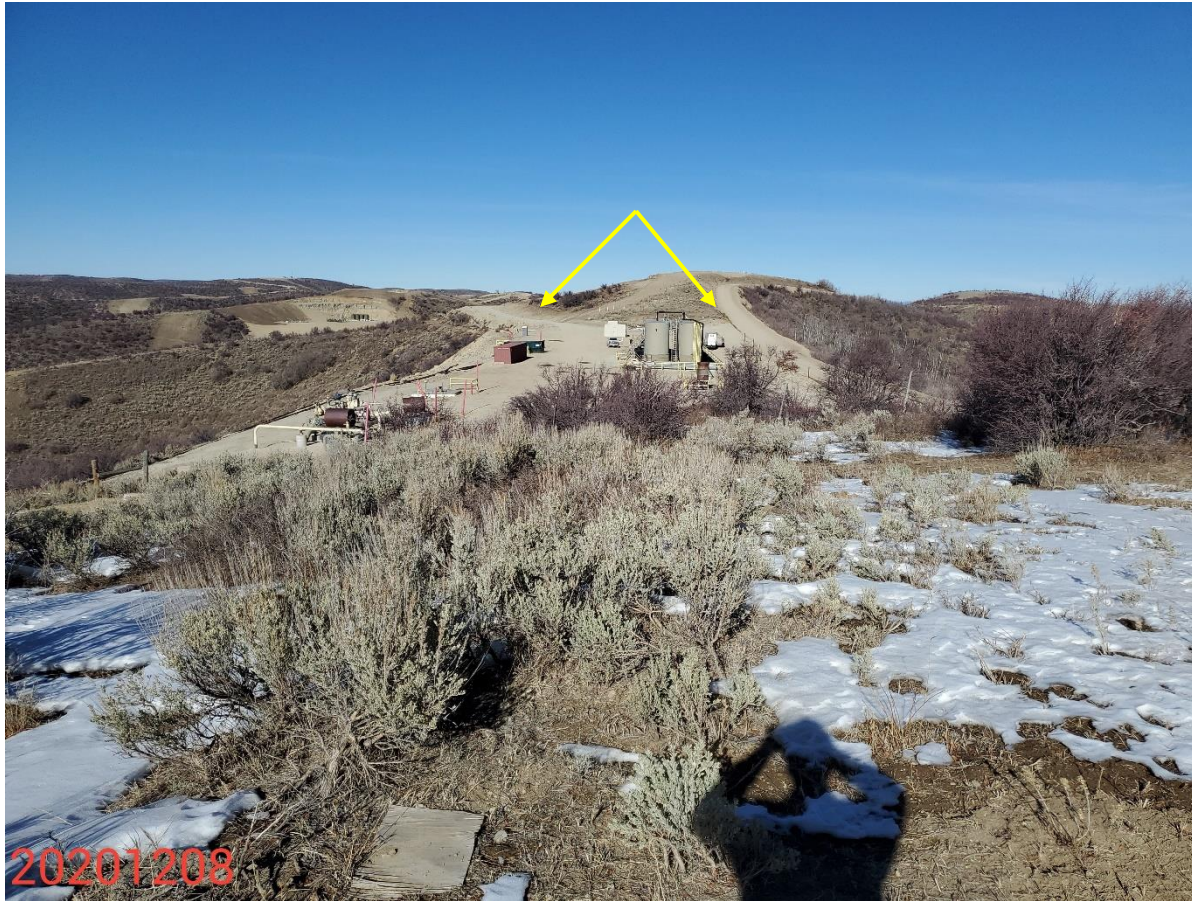
Photo 3: Photo taken from the south of the CC 0604-1 Pad Location, facing north. Photo shows the two parallel access roads that travel from the CC 0604-1 Pad Location, and the Cascade Creek 697-04D Location (See photo 1).

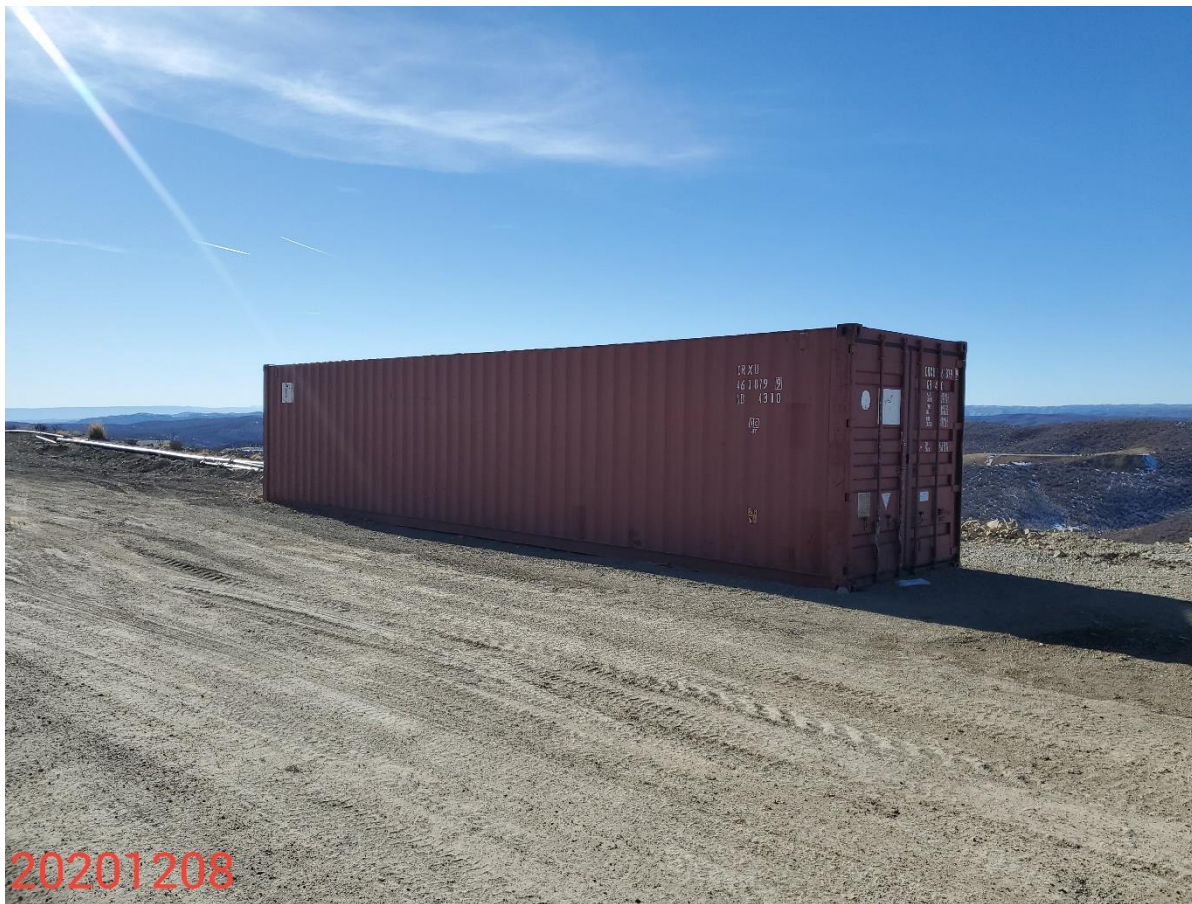
Photo 4: Photo taken from the west end of the Location. Photo shows container stored on location. Equipment not needed for production and requires removal.

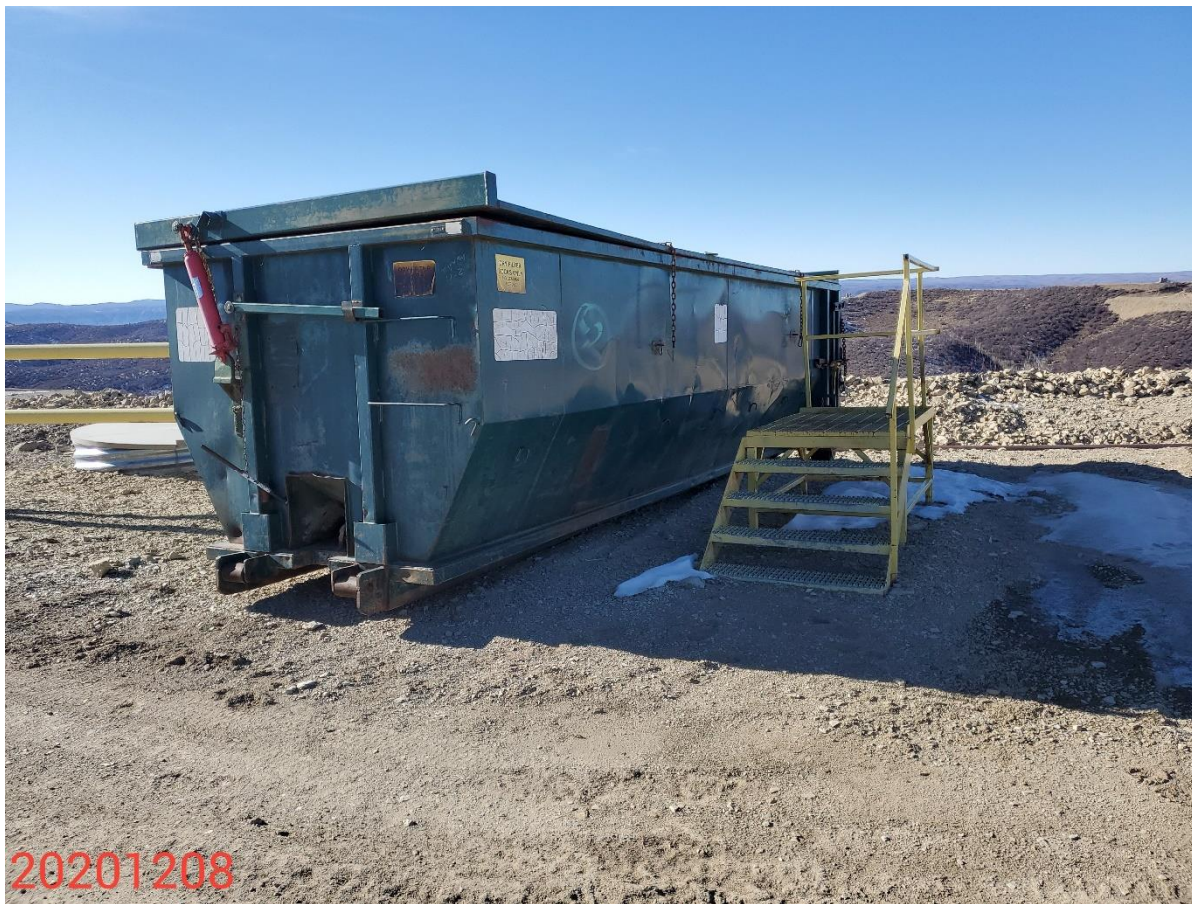
Photo 5: Photo taken from the west end of the Location. Photo shows container stored on location. Equipment not needed for production and requires removal.

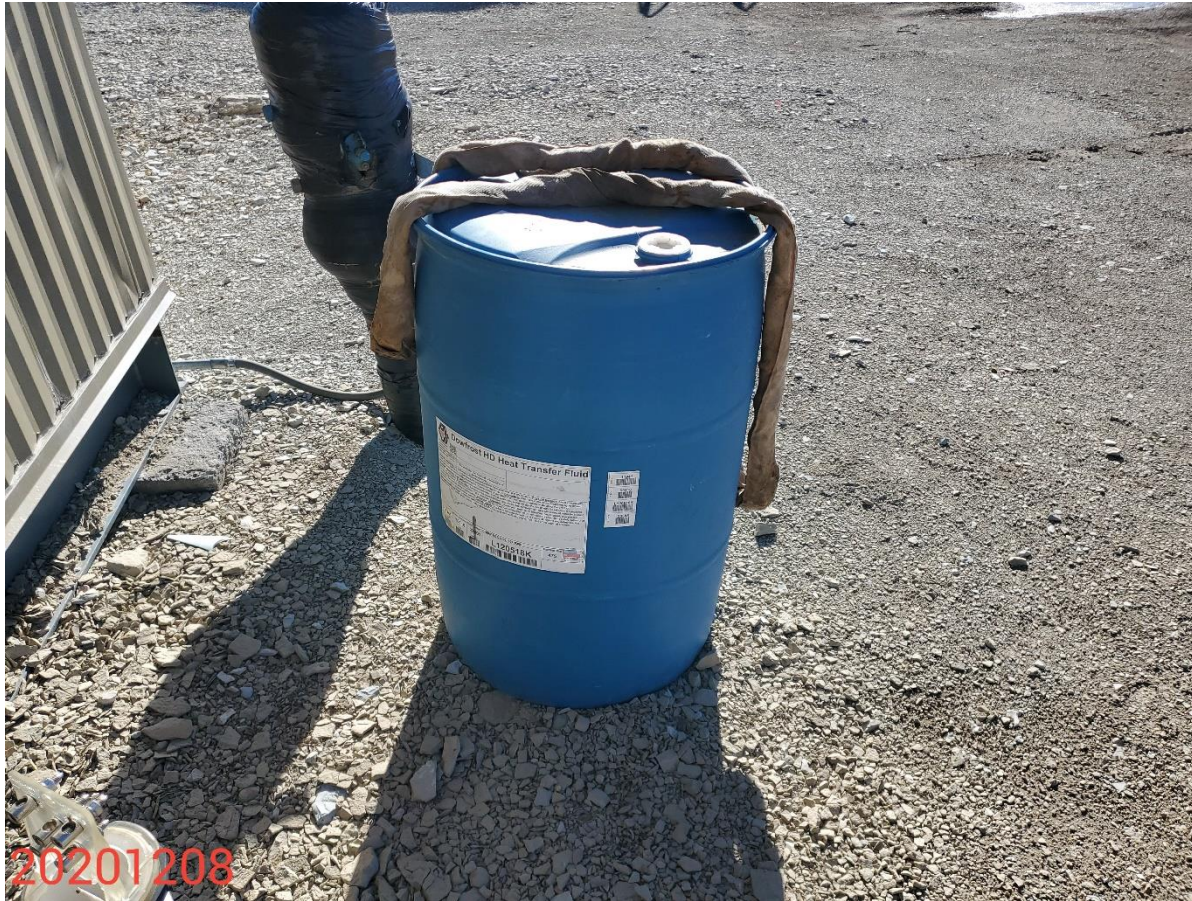
Photo 6: Shows barrel containing “heat transfer fluid” stored on the location. This is not proper materials management; Place barrel into secondary containment, or remove and properly stored.

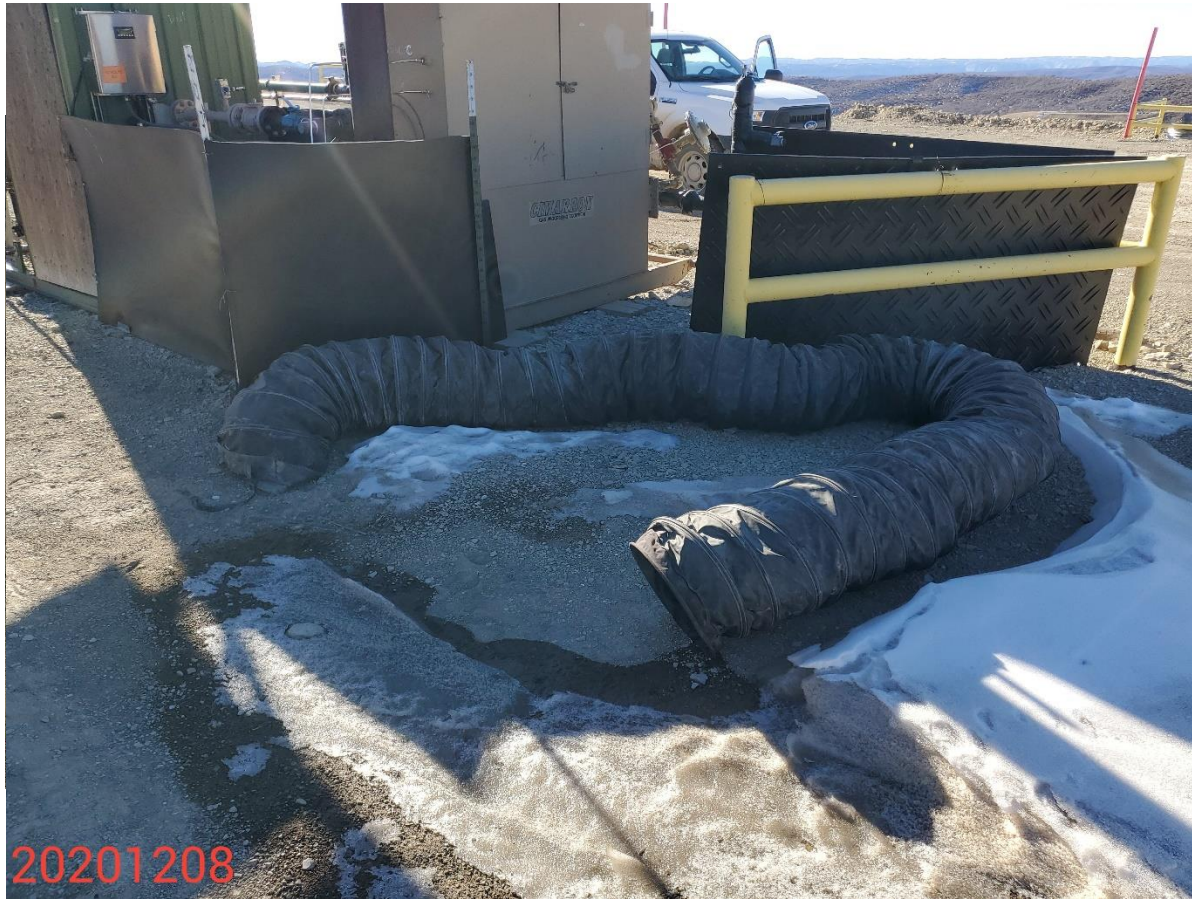
Photo 7: Photo shows equipment not stored in a workman-like manner.

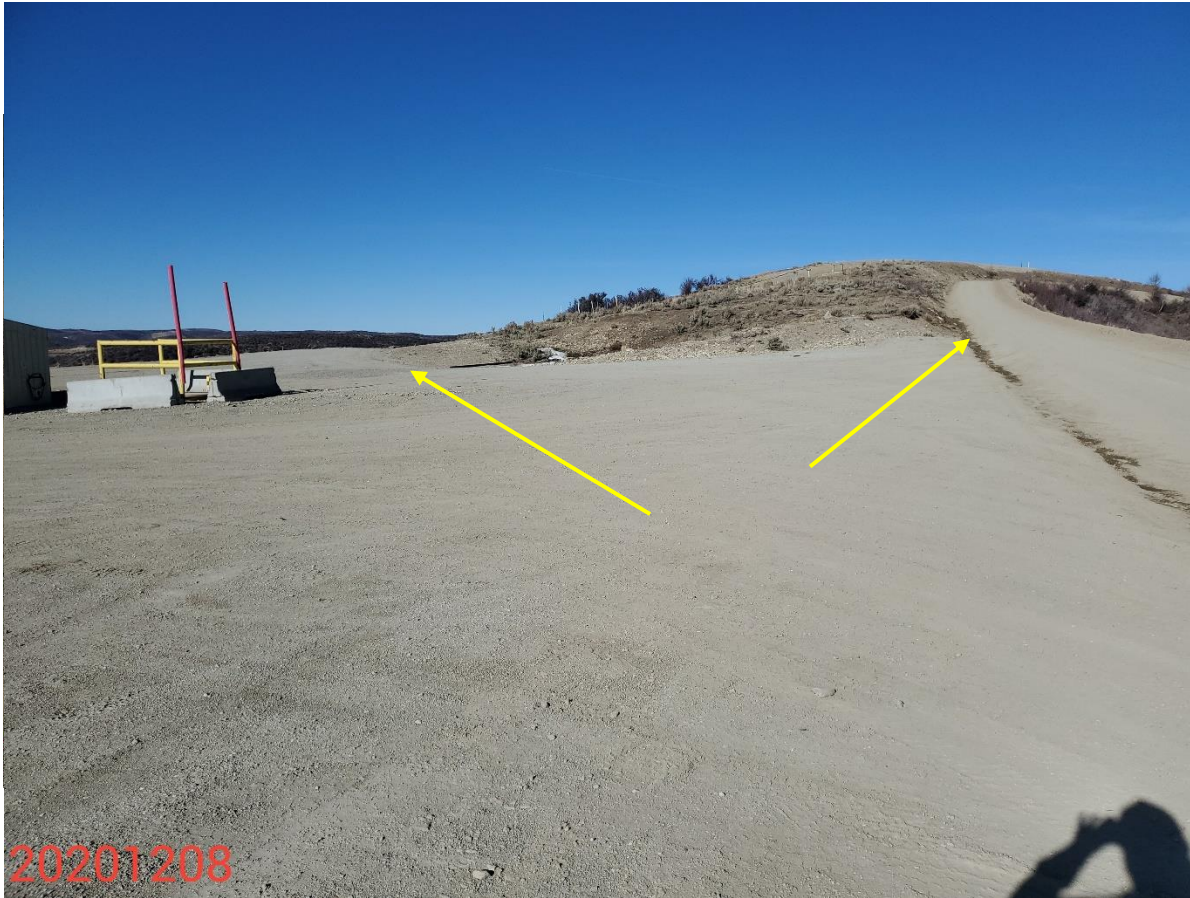
Photo 8: Photo taken from the north end of the CC 0604-1 Pad Location, facing north. Photo shows the two parallel access roads that travel from the CC 0604-1 Pad Location, and the Cascade Creek 697-04D Location (See photo 1).

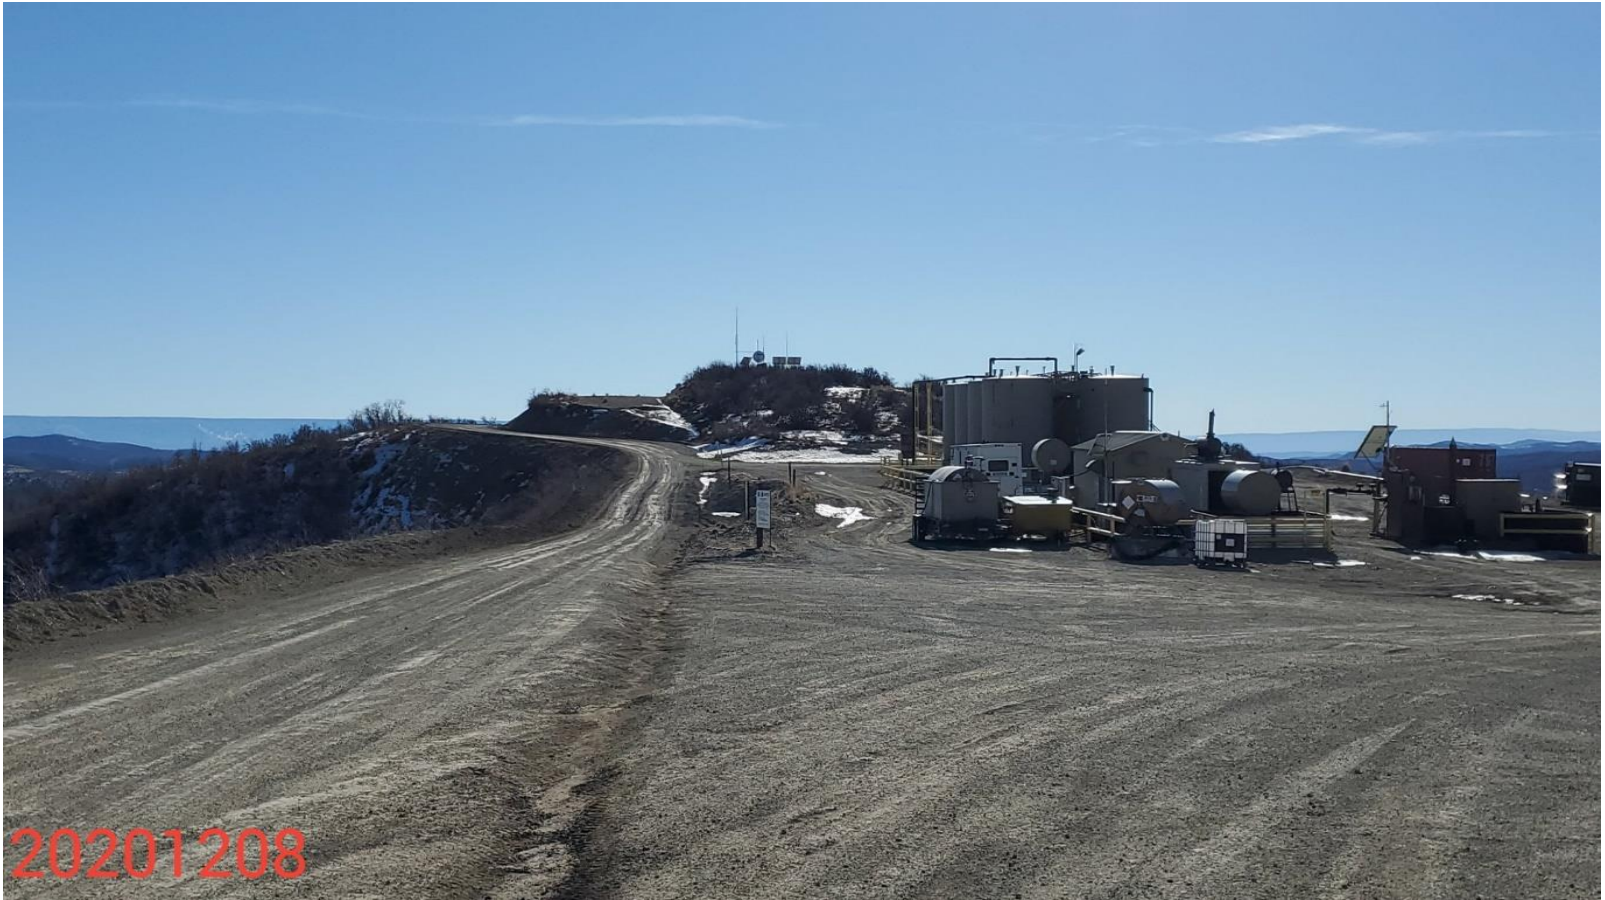
Photo 9: Photo taken from the north end of the CC 0604-1 Pad Location, facing south. There are currently 2 access roads, and 4 access points (on the northwest, northeast, southwest and southeast) to the CC 0604-1 Pad . Photo shows eastern access road

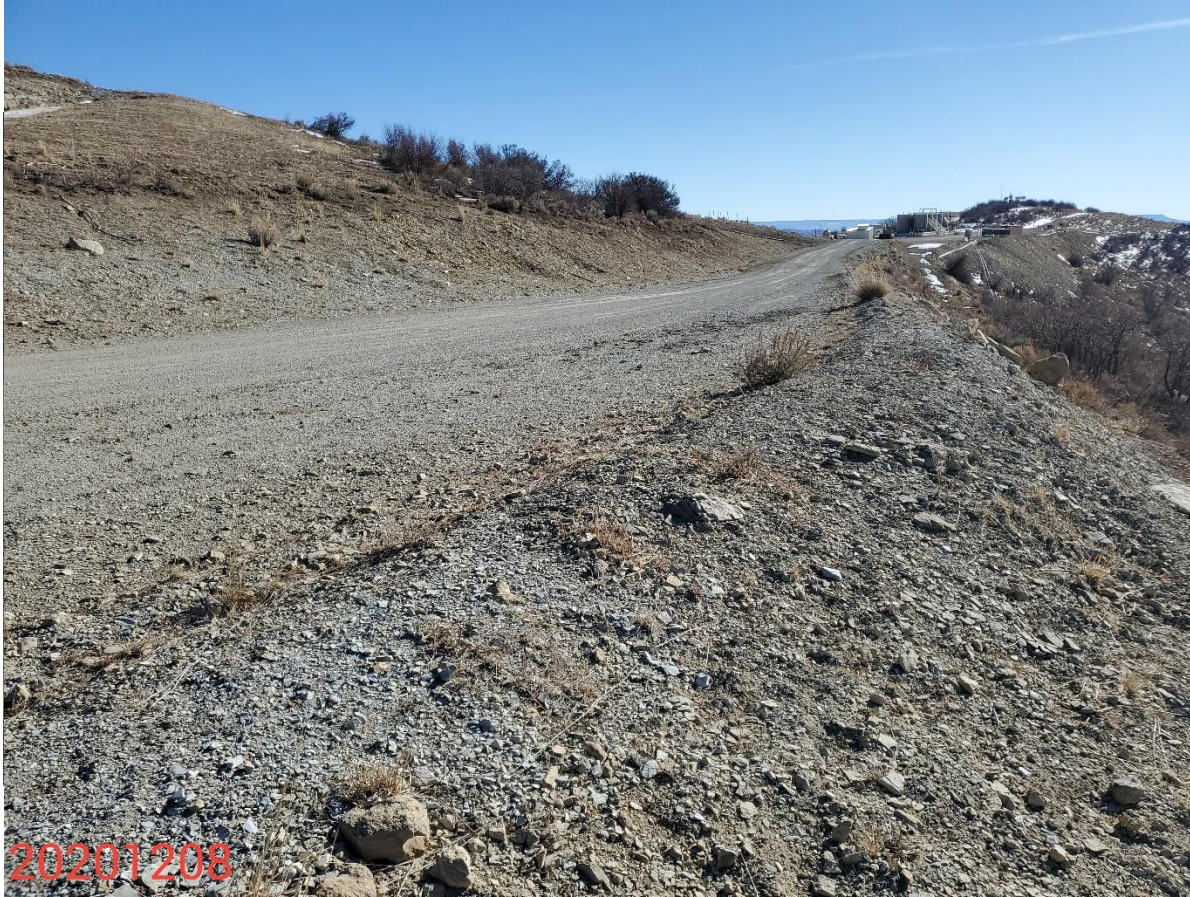
Photo 10: Photo taken from the southwest corner of the Cascade Creek 697-04D location. Photo shows additional access road leading to the CC 0604-1 Pad. This is additional disturbance that does not comport with Rule 1002.e

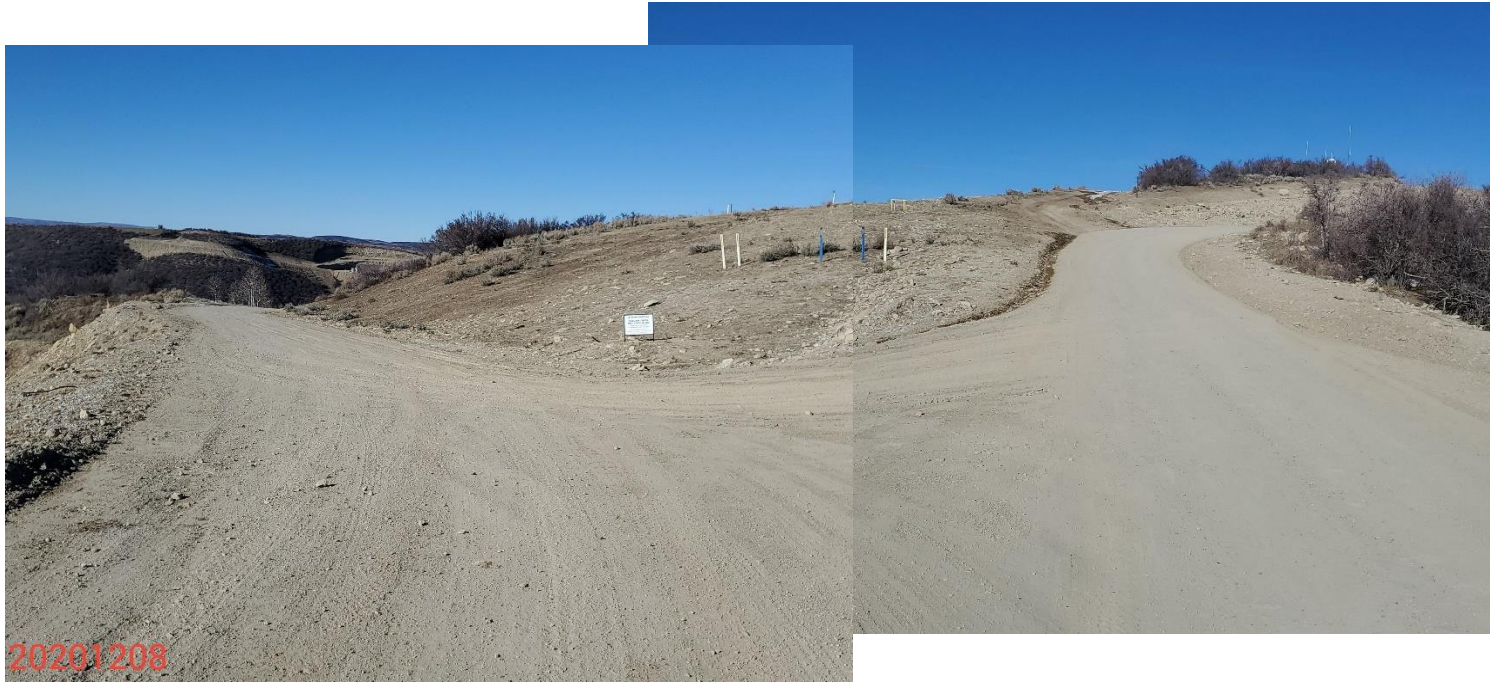
Photo 11: Photo taken from the south of the CC 0604-1 Pad Location, facing north. Photo shows the two access roads that run parallel to one another to the CC 0604-1 Pad.
