Inspection Photos

Location Name: PAPPENHEIM-67N64W /26SWSE

Location #: 302874

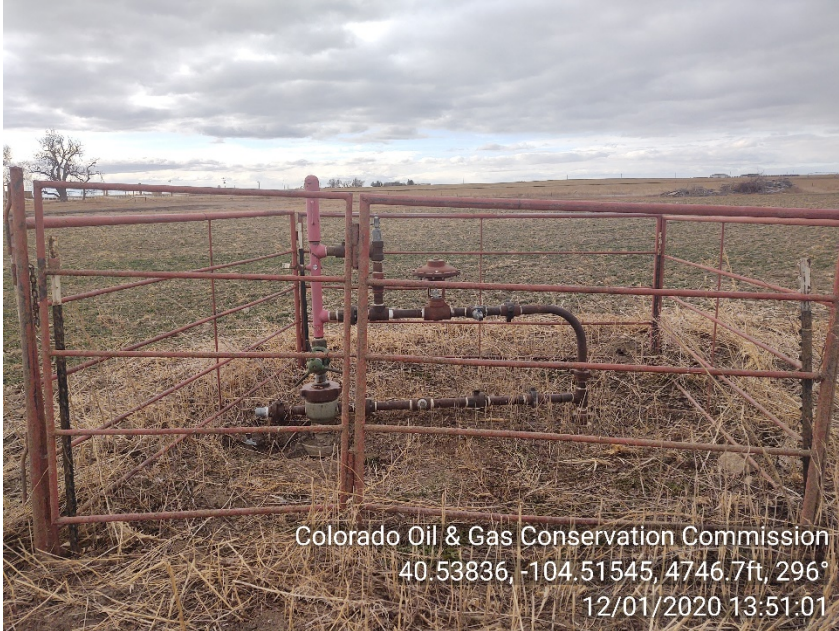
Photo #1

Pappenheim 34-26 (05-123-29961) Wellsite

Shut-In | SI

Company / Well name NOT posted

Emergency number NOT posted at well

prior insp.

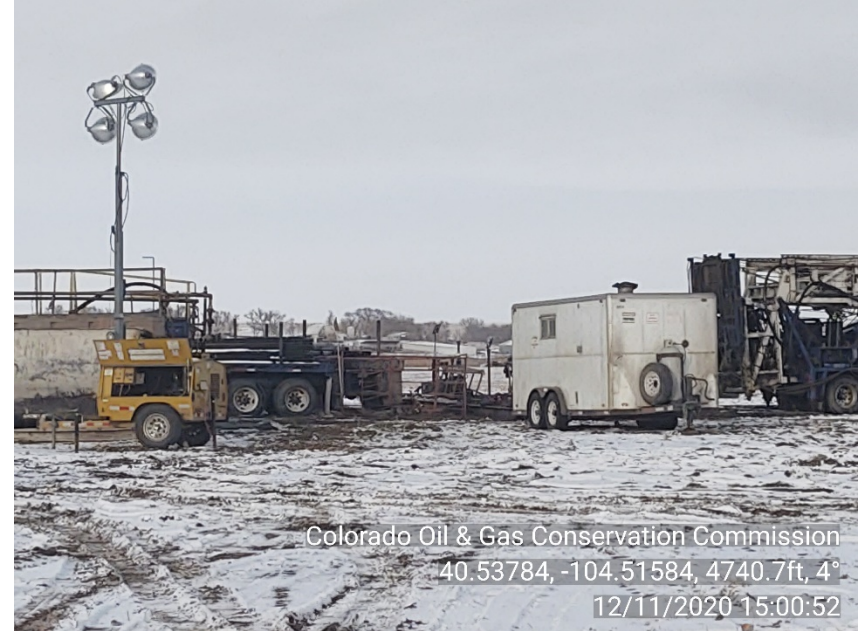
Photo #2

Pappenheim 34-26 Wellsite

Plugged & Abandoned | PA

Plugging Operations: Cementing | Final Plugging

Corrective Action for NO signage issues: Clear

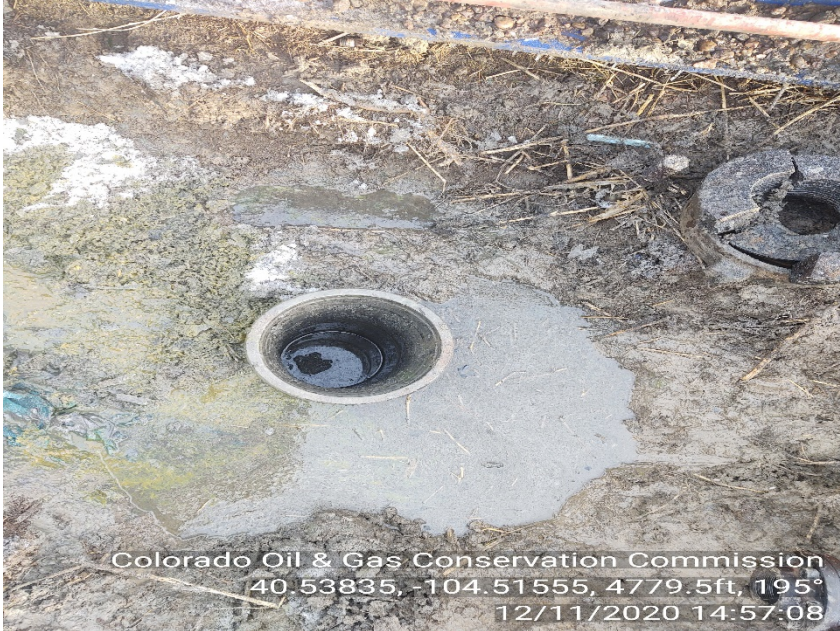
Photo #3

Pappenheim 34-26 (05-123-29961) Wellsite

Plugged & Abandoned | PA

Plugging Operations: Cementing | Final Plugging

Cement to surface

NOT Cut & Capped

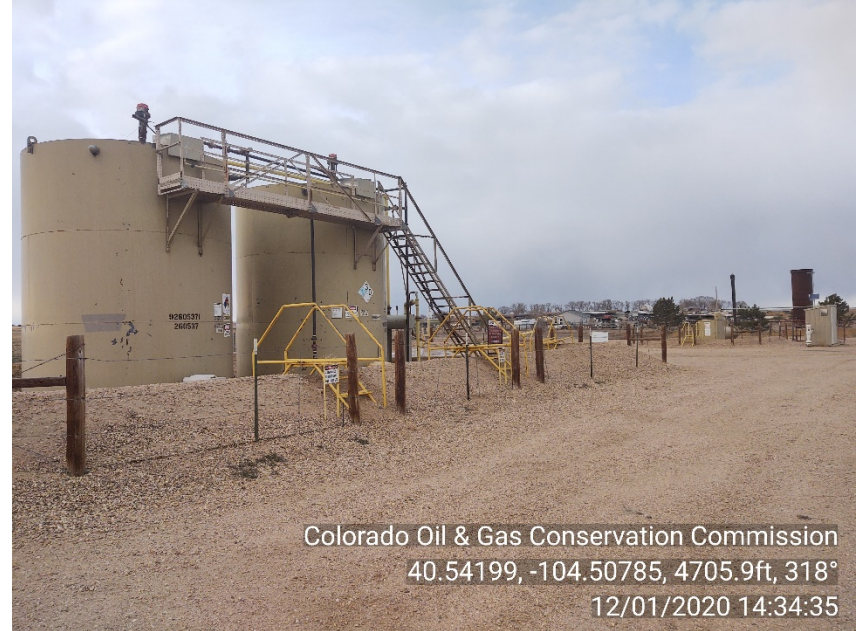
Photo #4

Pappenheim 43-26, 33-26, 34-26, 44-26 Battery site

Inactive | Shut-down.

prior insp.
